JOURNEY RISK MANAGEMENT (JRM) STUDY

Salem Terminal TO SAMY FUEL STATION

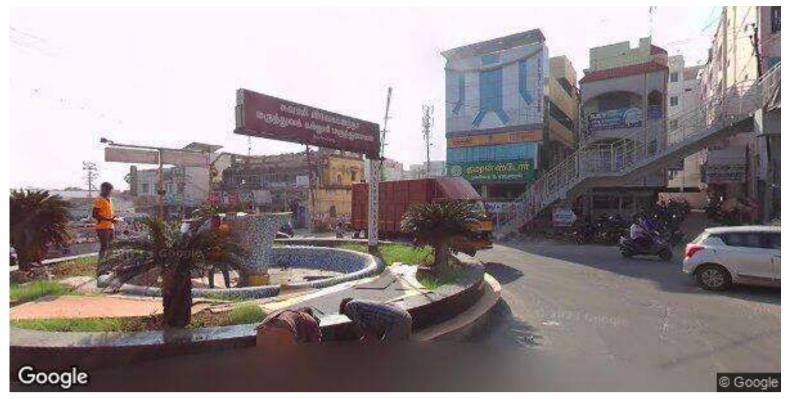
Risk Type: Roundabout
Risk Level: High
Speed Limit: 15 KM/Hr
Coordinates: 11.38395, 77.89480

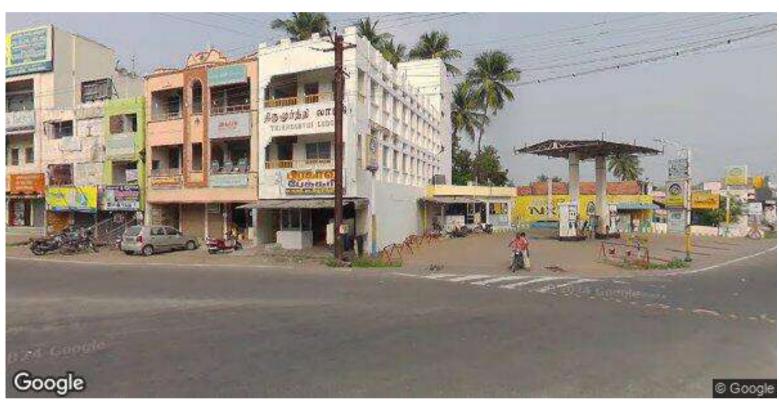
Risk Type: Roundabout
Risk Level: High
Speed Limit: 15 KM/Hr
Coordinates: 11.00172, 77.56268

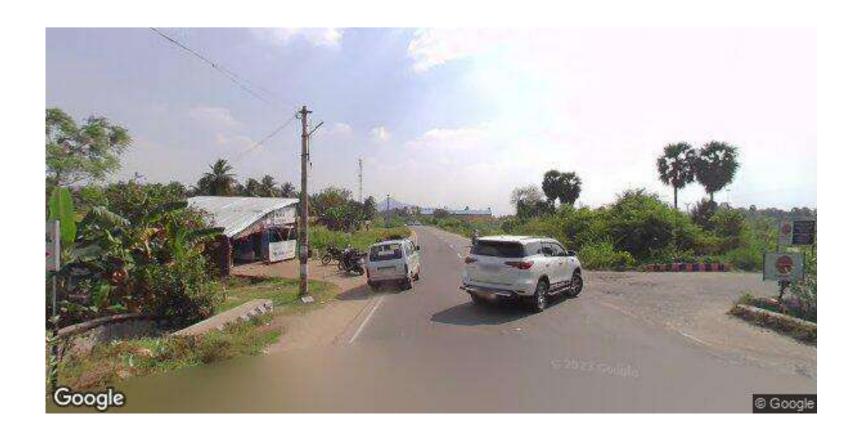
Coordinates: 11.44029, 77.87544

Risk Type: Turn
Risk Level: High
Speed Limit: 15 KM/Hr

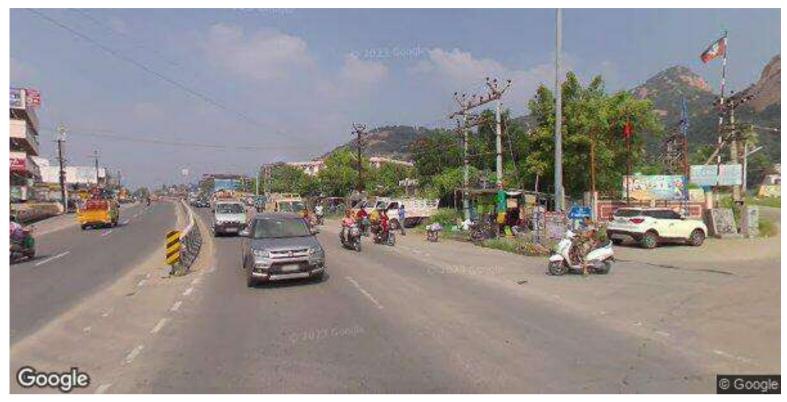
Coordinates: 11.39671, 77.88878

Risk Type: Turn
Risk Level: Medium
Speed Limit: 30 KM/Hr

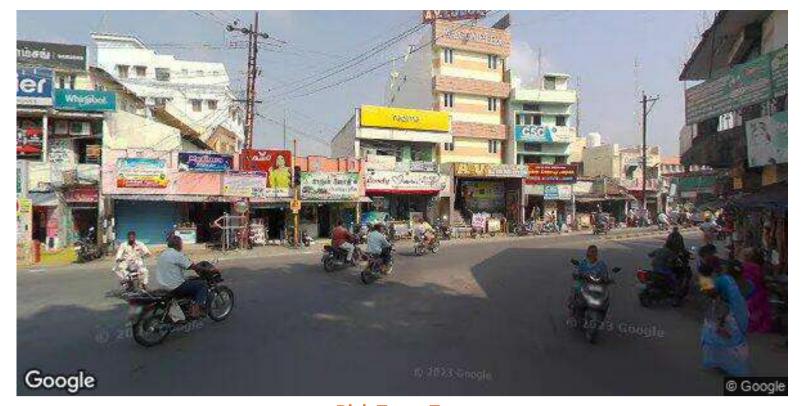
Risk Type: Turn
Risk Level: High
Speed Limit: 15 KM/Hr
Coordinates: 11.37842, 77.89452

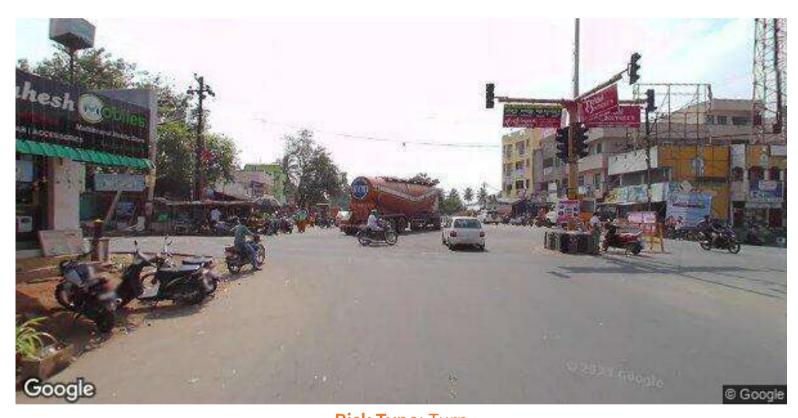
Risk Type: Turn
Risk Level: Medium
Speed Limit: 30 KM/Hr
Coordinates: 11.36616, 77.88885

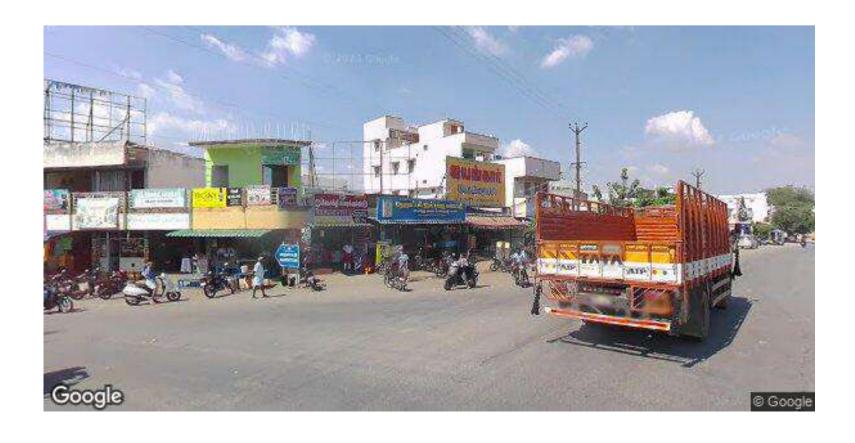
Coordinates: 11.36602, 77.88875

Risk Type: Turn
Risk Level: Medium
Speed Limit: 30 KM/Hr

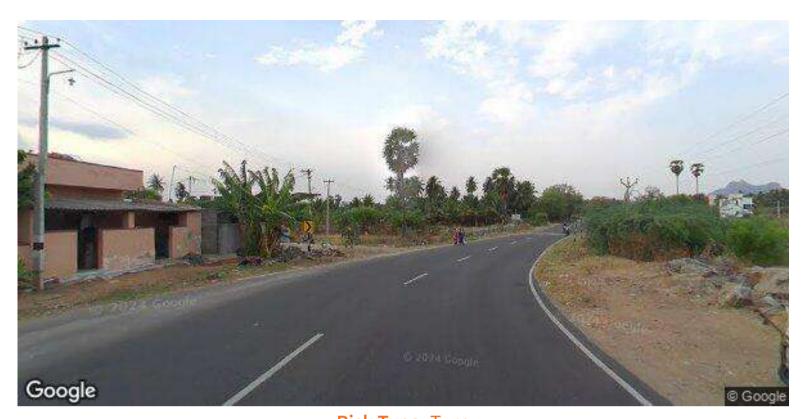
Risk Type: Turn
Risk Level: Medium
Speed Limit: 30 KM/Hr
Coordinates: 11.33882, 77.86218

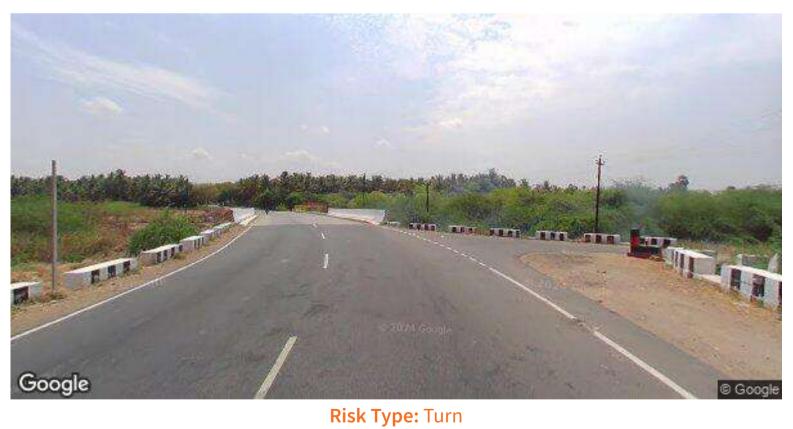
Risk Level: Medium
Speed Limit: 30 KM/Hr
Coordinates: 11.31747, 77.84240

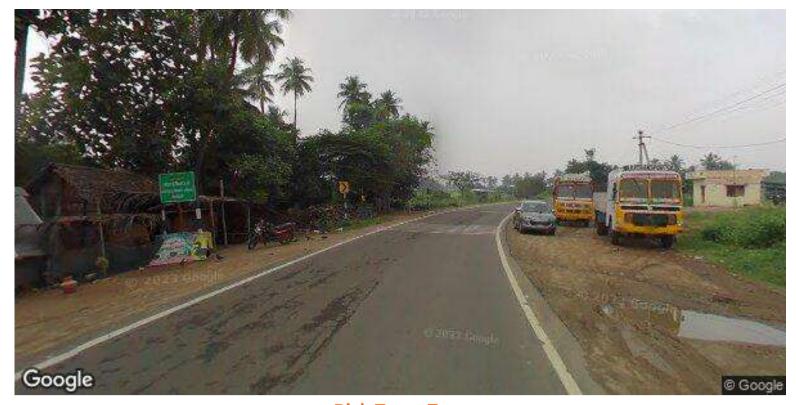
Risk Type: Turn
Risk Level: Medium
Speed Limit: 30 KM/Hr
Coordinates: 11.30951, 77.77608

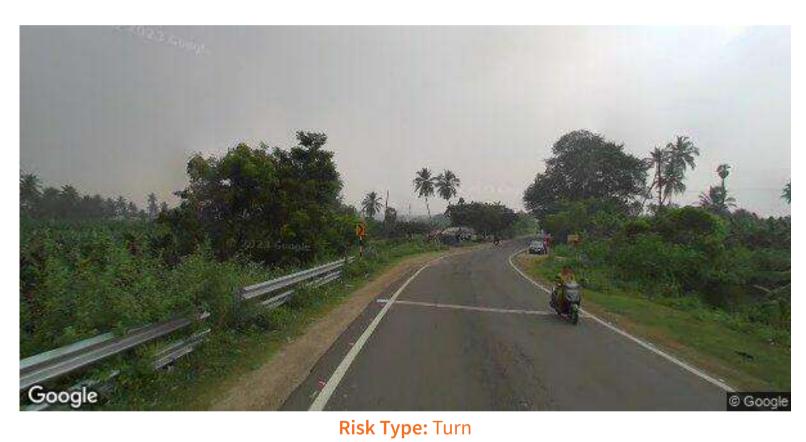
Risk Level: Medium
Speed Limit: 30 KM/Hr
Coordinates: 11.31118, 77.77139

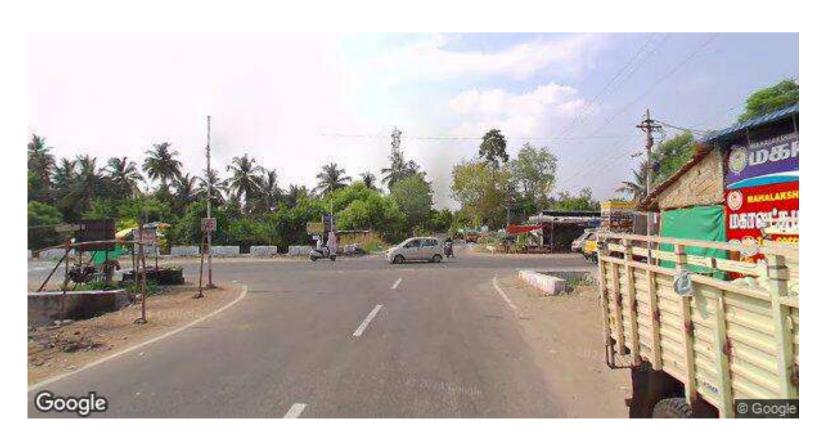
Coordinates: 11.29473, 77.74685

Risk Type: Turn
Risk Level: High
Speed Limit: 15 KM/Hr

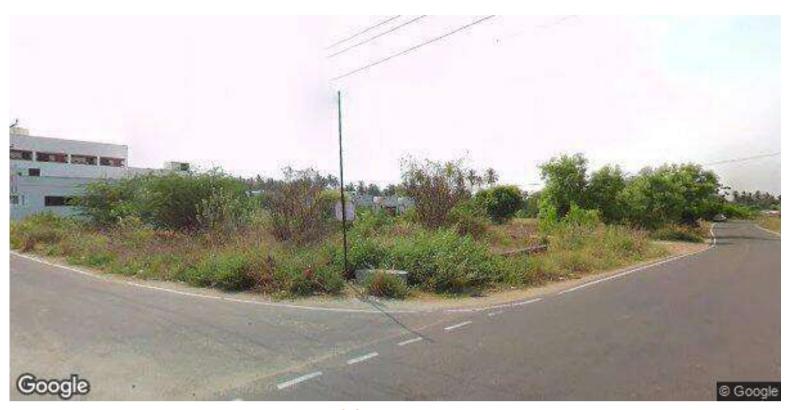
Coordinates: 11.29133, 77.74660

Risk Type: Turn
Risk Level: High
Speed Limit: 15 KM/Hr

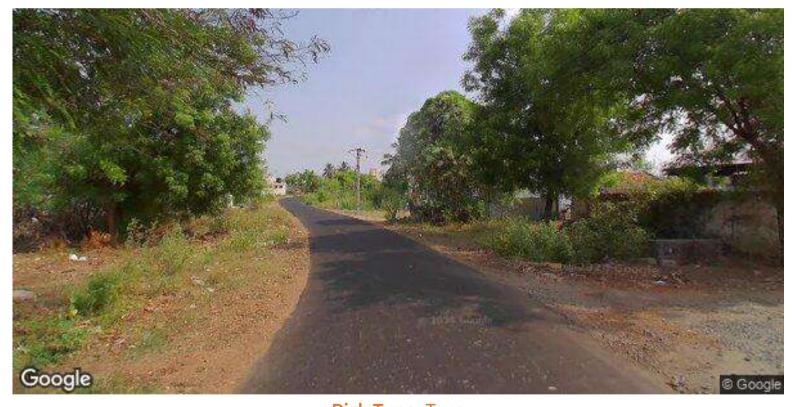
Risk Type: Turn
Risk Level: Medium
Speed Limit: 30 KM/Hr
Coordinates: 11.28844, 77.74319

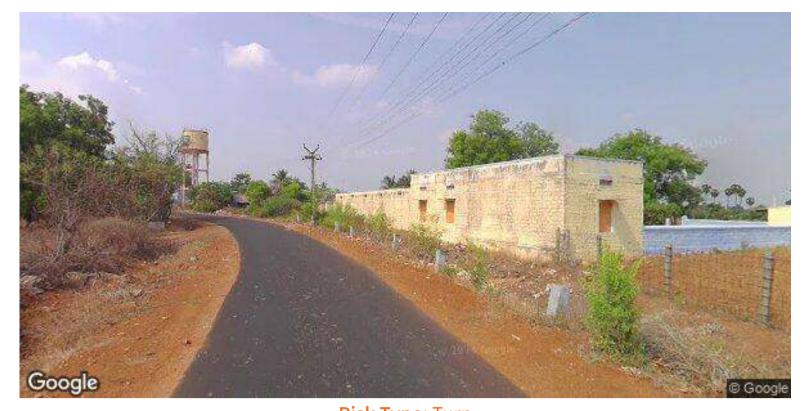
Risk Type: Turn
Risk Level: Medium
Speed Limit: 30 KM/Hr
Coordinates: 11.28558, 77.74271

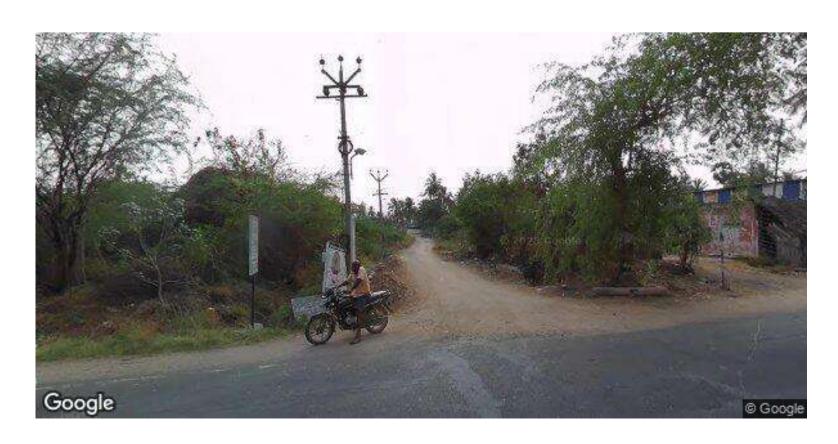
Coordinates: 11.27330, 77.72711

Risk Type: Blind Spot Risk Level: Blind Spot Speed Limit: 10 KM/Hr

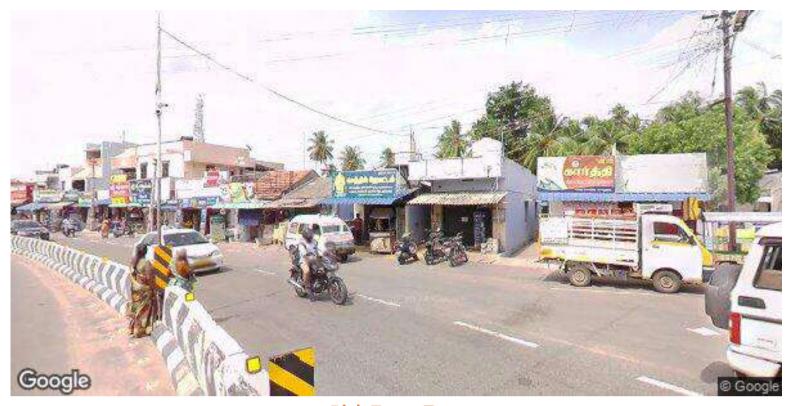
Risk Type: Turn
Risk Level: Medium
Speed Limit: 30 KM/Hr
Coordinates: 11.23047, 77.71792

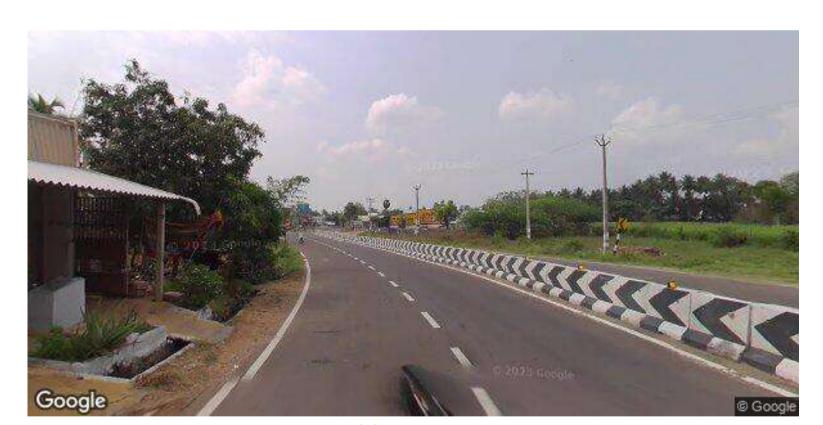
Risk Type: Turn
Risk Level: Medium
Speed Limit: 30 KM/Hr
Coordinates: 11.22378, 77.71384

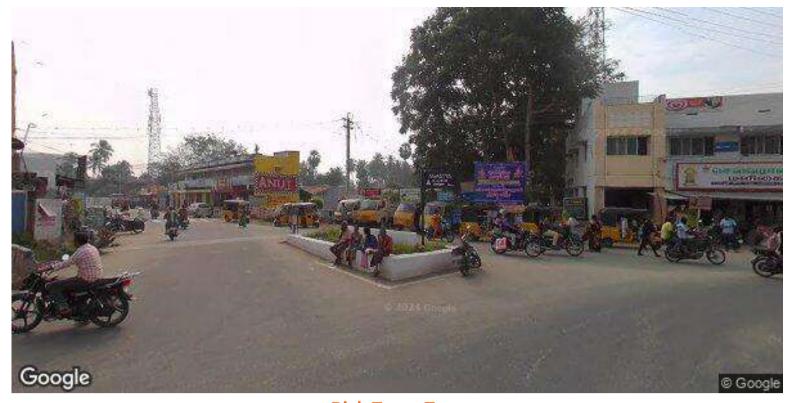
Risk Type: Turn
Risk Level: Medium
Speed Limit: 30 KM/Hr
Coordinates: 11.15952, 77.70067

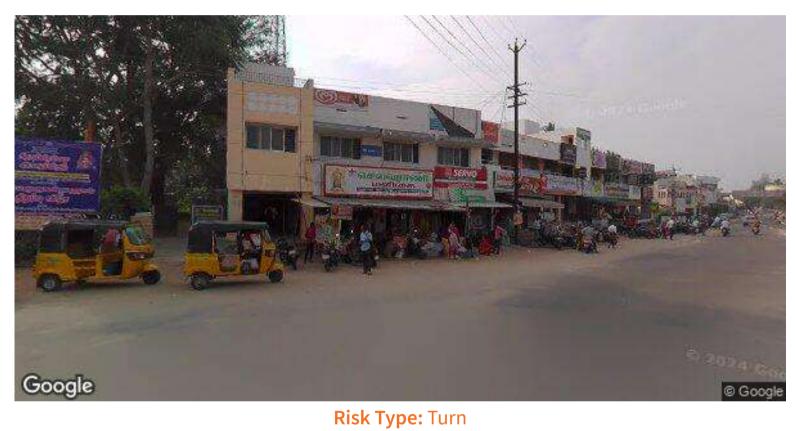
Risk Level: High
Speed Limit: 15 KM/Hr
Coordinates: 11.15943, 77.70068

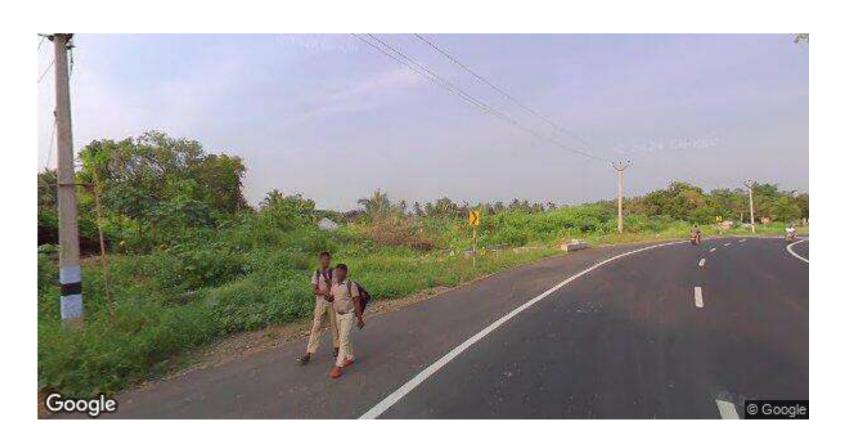
Coordinates: 11.11733, 77.67191

Risk Type: Turn
Risk Level: Medium
Speed Limit: 30 KM/Hr

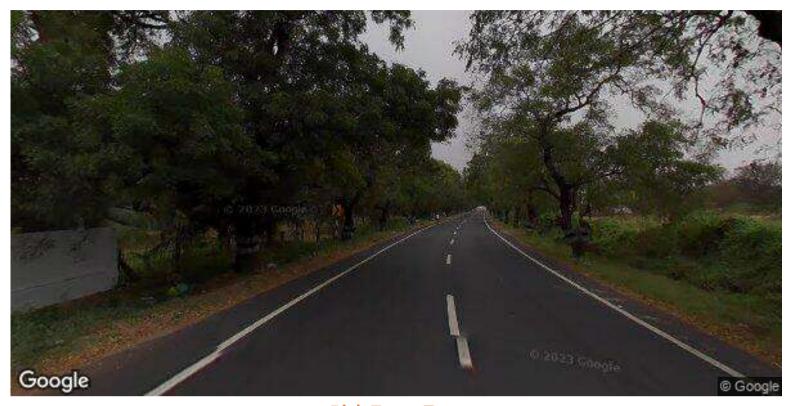
Risk Type: Turn
Risk Level: Medium
Speed Limit: 30 KM/Hr
Coordinates: 11.10471, 77.67058

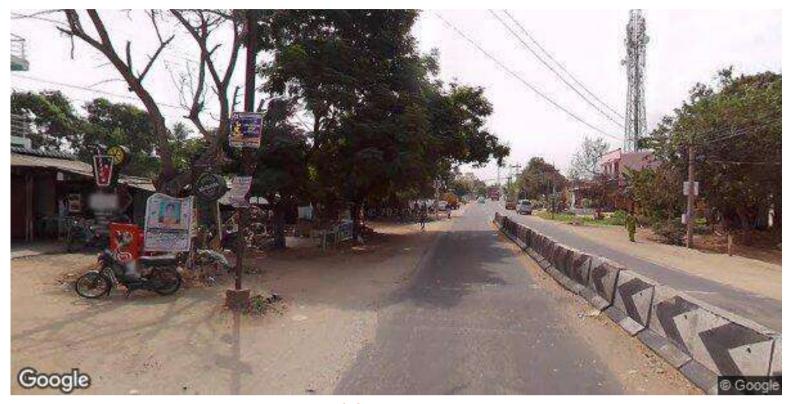
Coordinates: 11.00826, 77.56962

Risk Type: Turn
Risk Level: Medium
Speed Limit: 30 KM/Hr

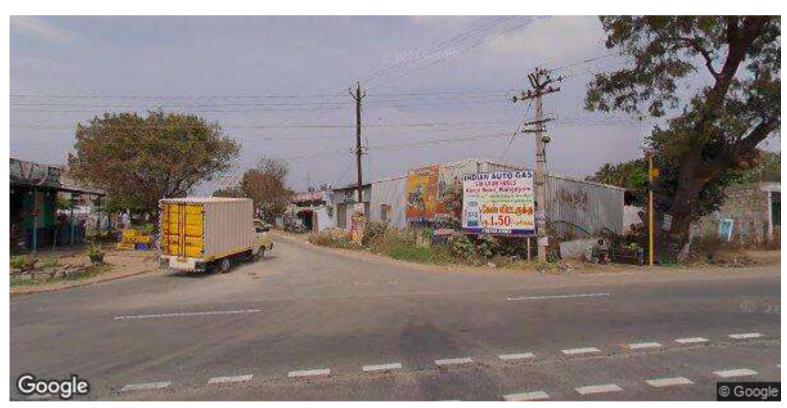
Coordinates: 11.00058, 77.56882

Risk Type: Blind Spot
Risk Level: Blind Spot
Speed Limit: 10 KM/Hr
