# JOURNEY RISK MANAGEMENT (JRM) STUDY

#### Salem Terminal To SREE SUNTHARAM AGENCIES

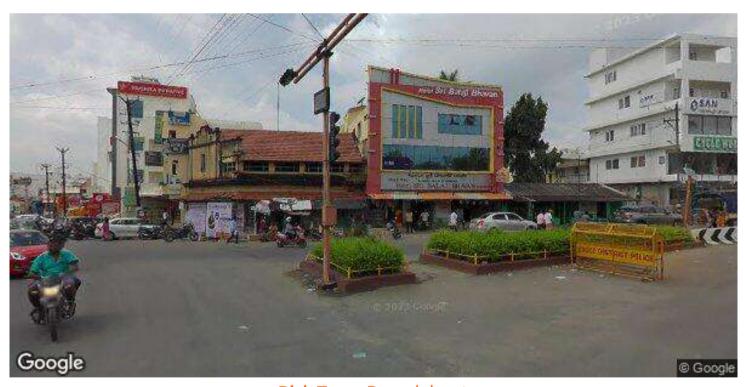
Risk Type: Roundabout
Risk Level: High
Speed Limit: 15 KM/Hr
Coordinates: 11.27925, 77.58494

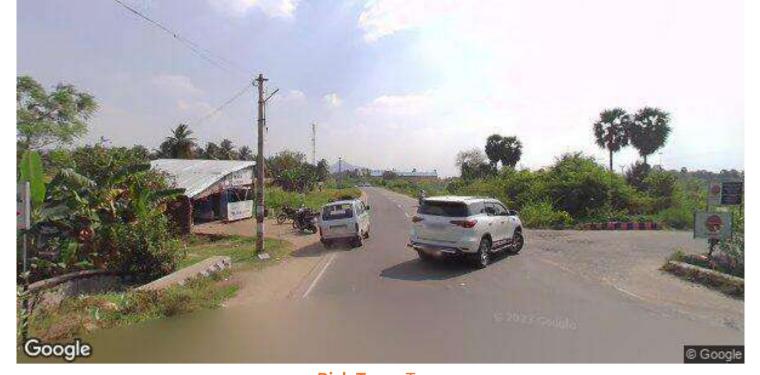
Risk Type: Turn
Risk Level: High
Speed Limit: 15 KM/Hr
Coordinates: 11.44029, 77.87544

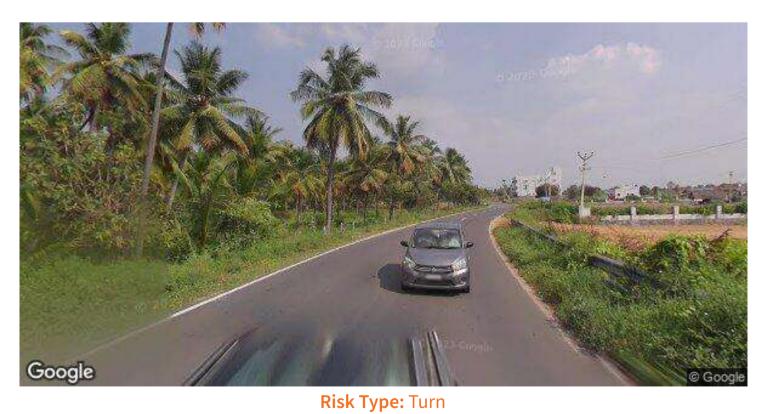
Risk Level: Medium

Speed Limit: 30 KM/Hr Coordinates: 11.45357, 77.85789

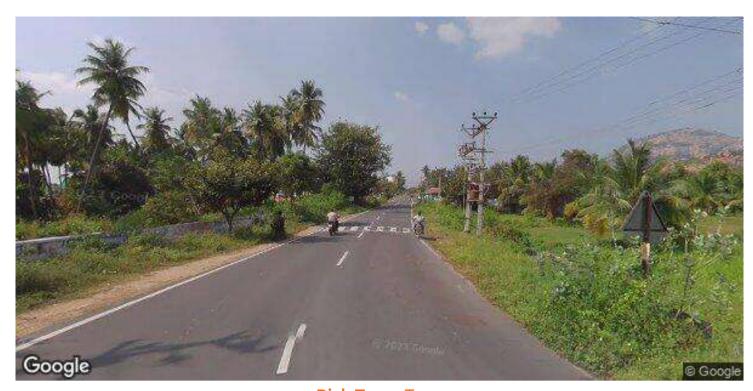
Risk Type: Turn
Risk Level: Medium
Speed Limit: 30 KM/Hr
Coordinates: 11.45352, 77.85698

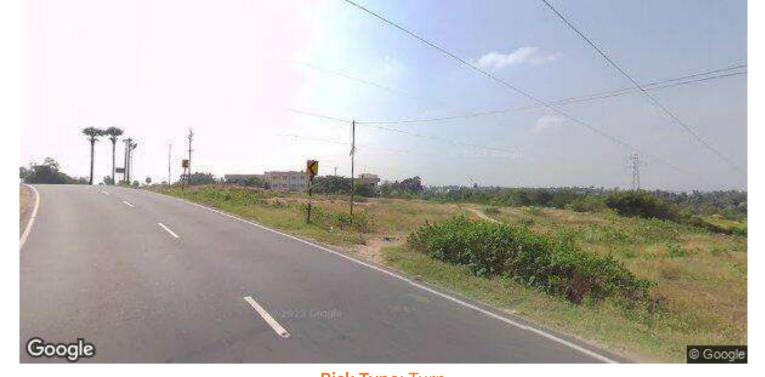
Risk Type: Turn
Risk Level: Medium
Speed Limit: 30 KM/Hr
Coordinates: 11.46048, 77.85036

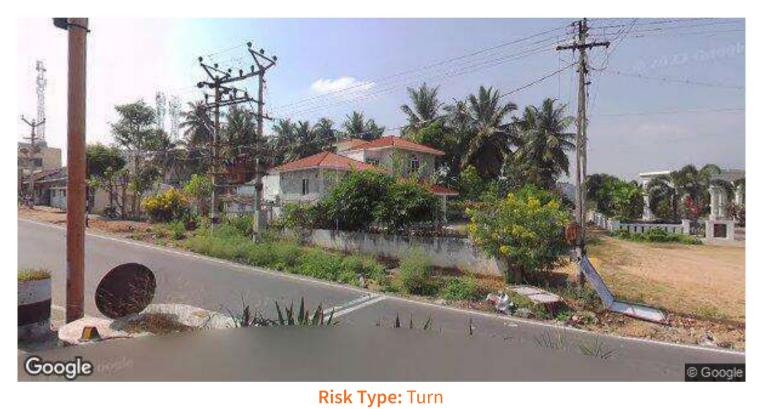
Risk Level: Medium
Speed Limit: 30 KM/Hr
Coordinates: 11.46303, 77.84945

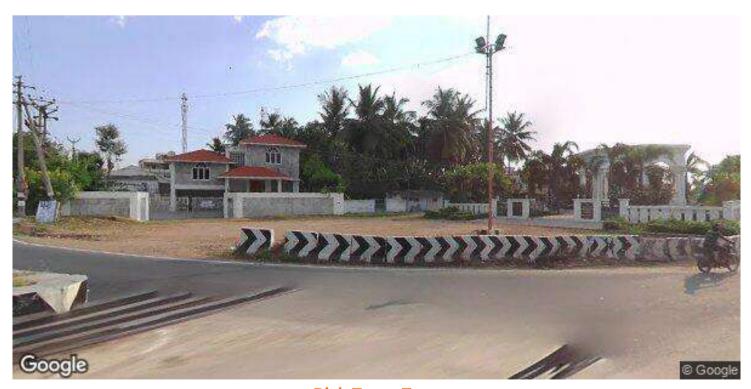
Risk Type: Turn
Risk Level: Medium

Speed Limit: 30 KM/Hr Coordinates: 11.46314, 77.84928

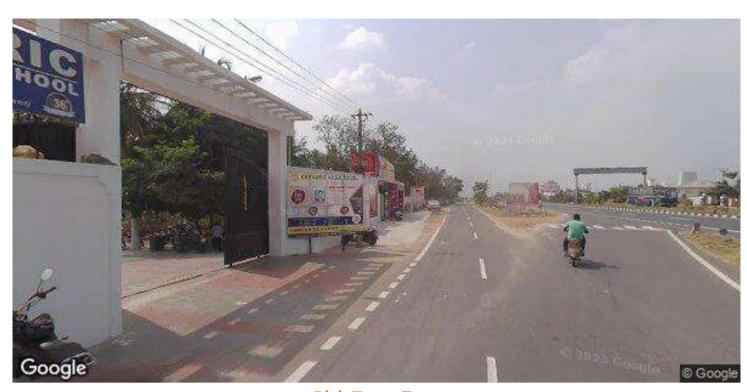
Risk Type: Turn
Risk Level: Medium
Speed Limit: 30 KM/Hr
Coordinates: 11.45509, 77.81383

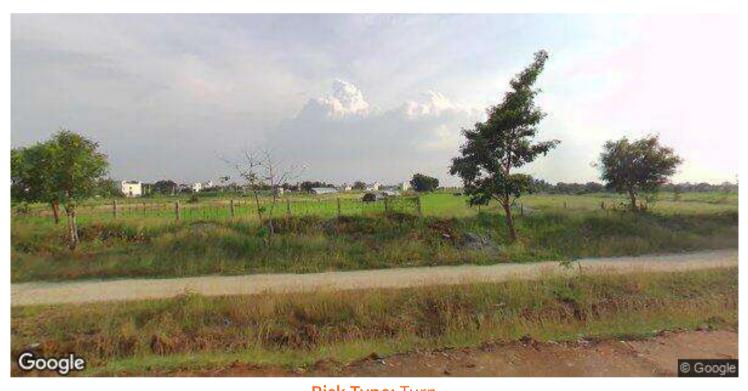
Risk Type: Turn
Risk Level: Medium
Speed Limit: 30 KM/Hr
Coordinates: 11.29288, 77.59029

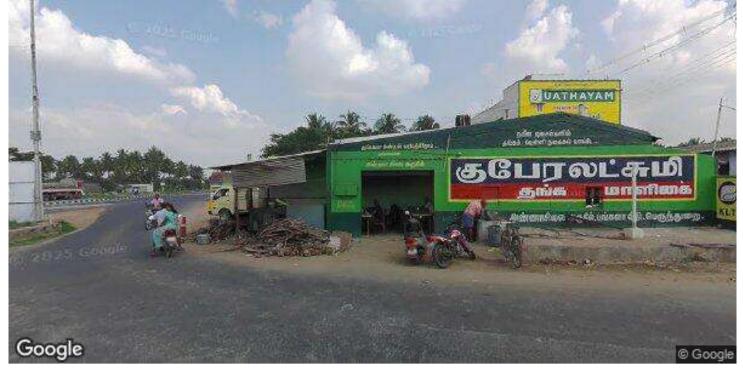
Risk Type: Turn
Risk Level: High
Speed Limit: 15 KM/Hr

**Coordinates:** 11.29158, 77.58600

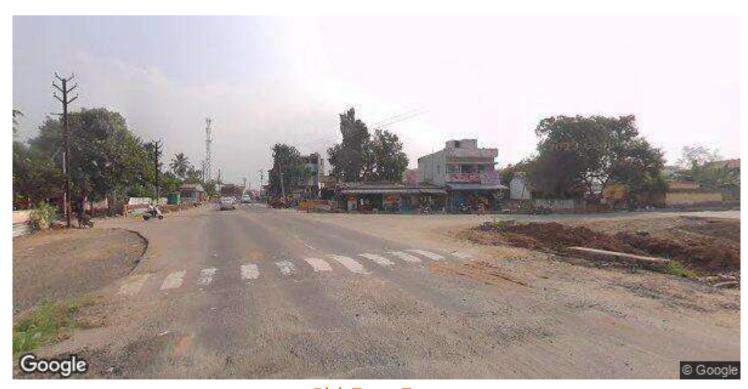
Risk Type: Turn
Risk Level: Medium

Speed Limit: 30 KM/Hr Coordinates: 11.22673, 77.58027

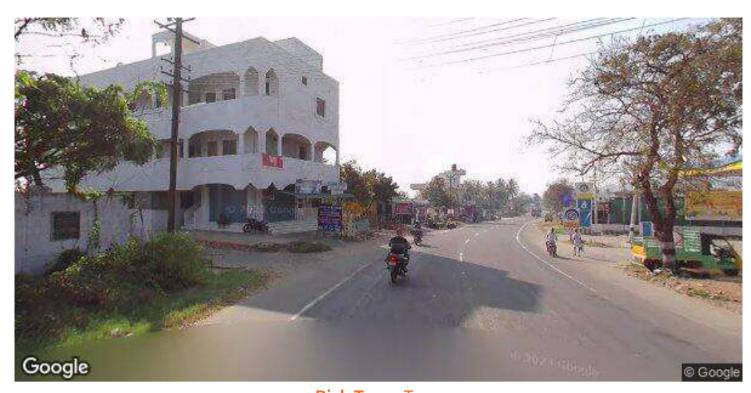
Risk Type: Turn
Risk Level: Medium
Speed Limit: 30 KM/Hr
Coordinates: 11.17652, 77.59985

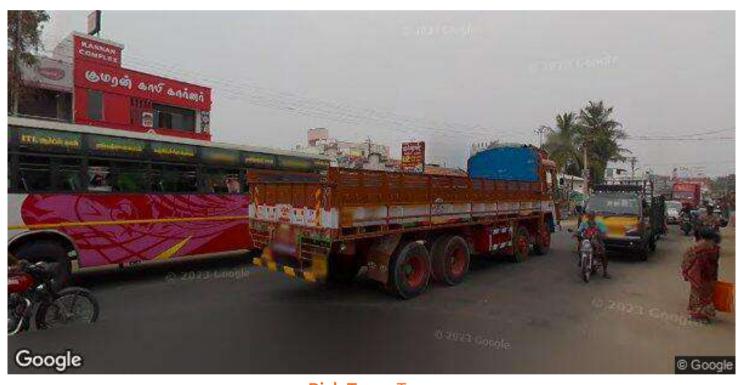
Risk Type: Turn
Risk Level: Medium
Speed Limit: 30 KM/Hr
Coordinates: 11.16555, 77.60233

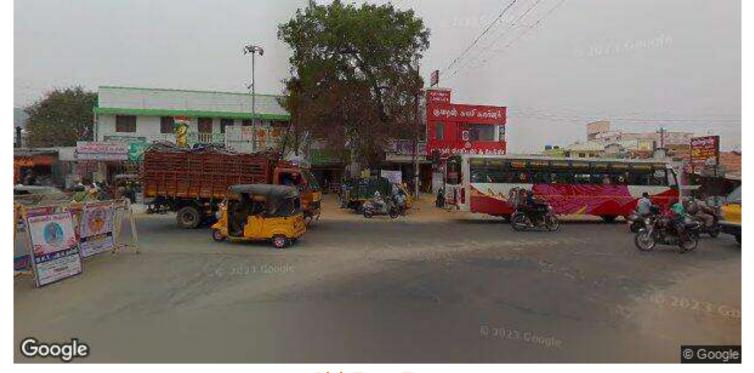
Risk Type: Turn
Risk Level: Medium
Speed Limit: 30 KM/Hr
Coordinates: 11.16547, 77.60241

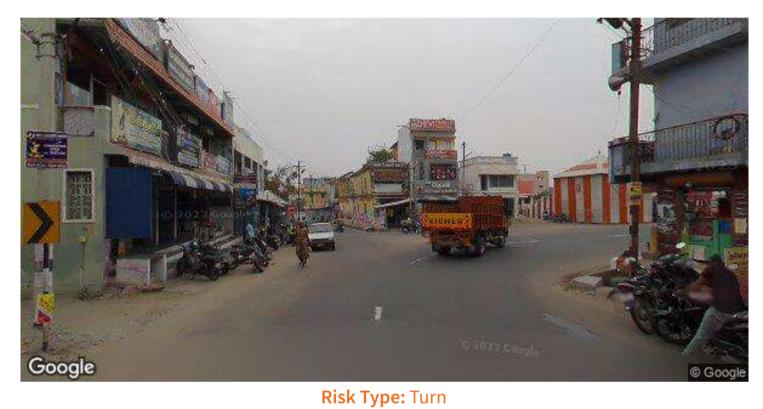
Risk Level: Medium
Speed Limit: 30 KM/Hr
Coordinates: 11.16531, 77.60369

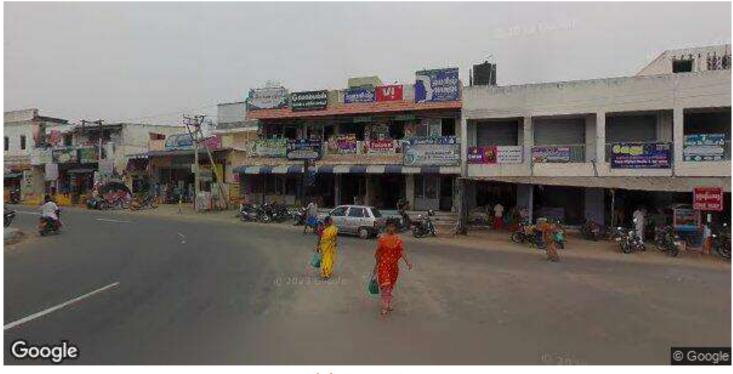
Risk Type: Turn Risk Level: High **Speed Limit:** 15 KM/Hr

**Coordinates:** 11.16521, 77.60379
