# JOURNEY RISK MANAGEMENT (JRM) STUDY

#### Salem Terminal to SRI SAKTHI AGENCY

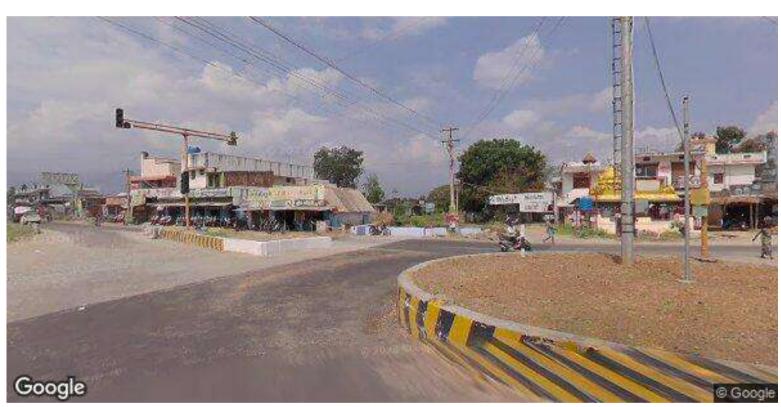
**Coordinates:** 11.56355, 77.59597

Risk Type: Roundabout

Risk Level: High

Speed Limit: 15 KM/Hr

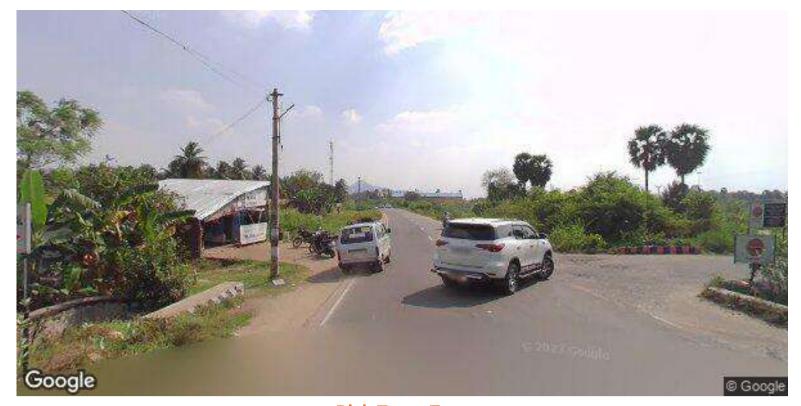
Risk Type: Turn
Risk Level: High
Speed Limit: 15 KM/Hr
Coordinates: 11.44029, 77.87544

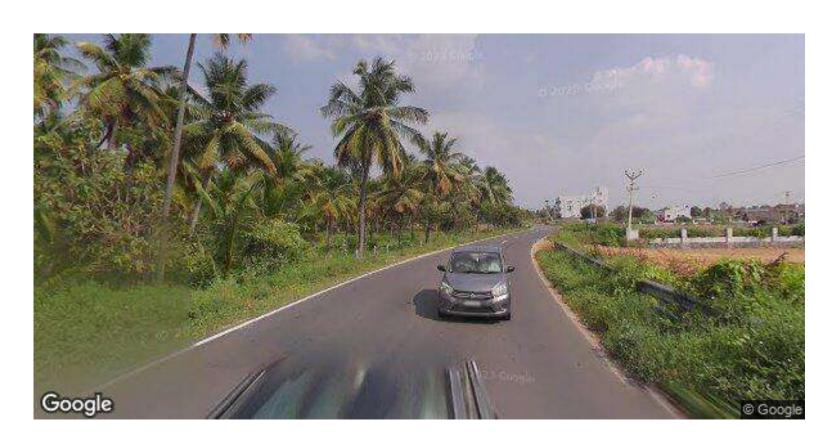
**Coordinates:** 11.45357, 77.85789

Risk Type: Turn
Risk Level: Medium
Speed Limit: 30 KM/Hr

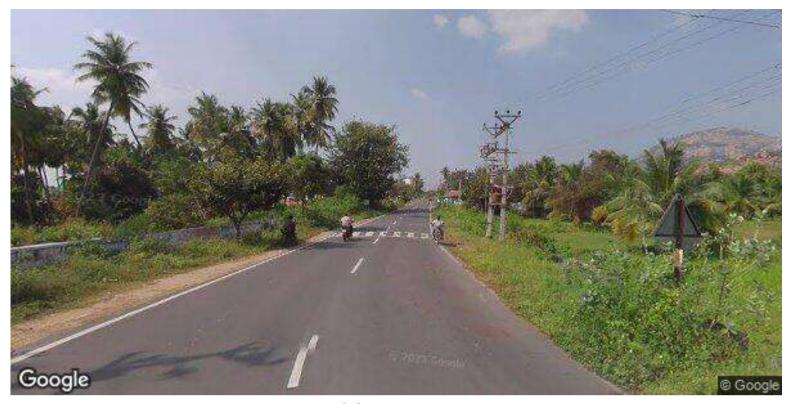
Risk Type: Turn
Risk Level: Medium
Speed Limit: 30 KM/Hr
Coordinates: 11.45352, 77.85698

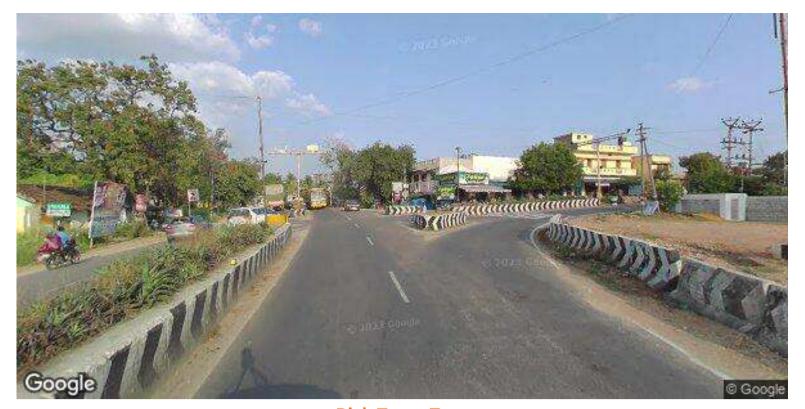
Risk Type: Turn
Risk Level: Medium
Speed Limit: 30 KM/Hr
Coordinates: 11.46318, 77.84913

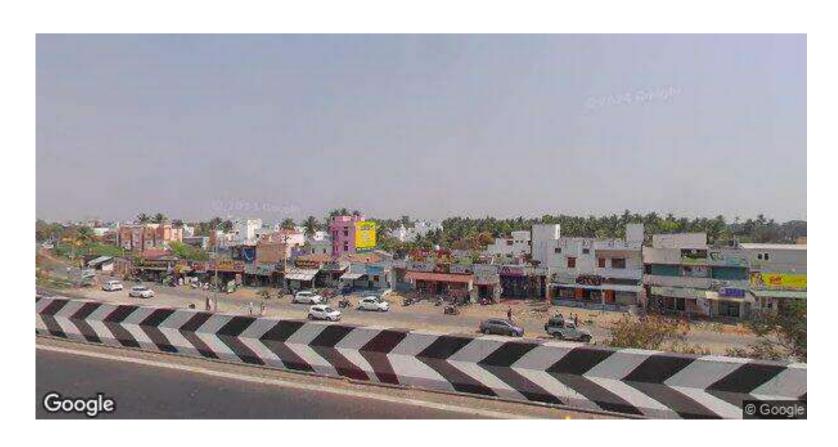
**Coordinates:** 11.43003, 77.67551

Risk Type: Turn
Risk Level: Medium
Speed Limit: 30 KM/Hr

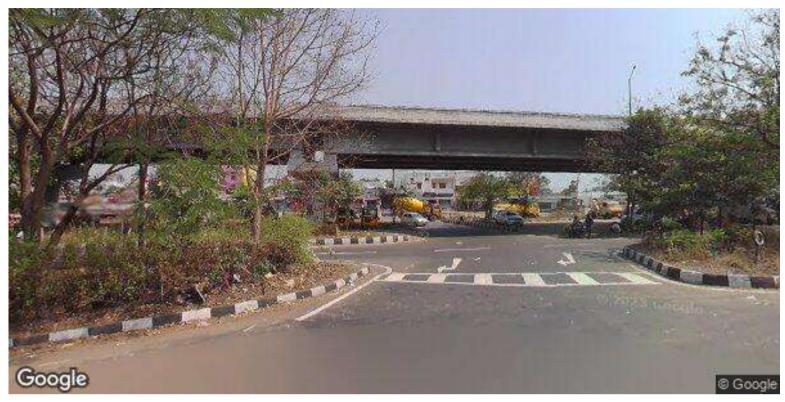
**Coordinates:** 11.43026, 77.67525

Risk Type: Turn
Risk Level: High
Speed Limit: 15 KM/Hr

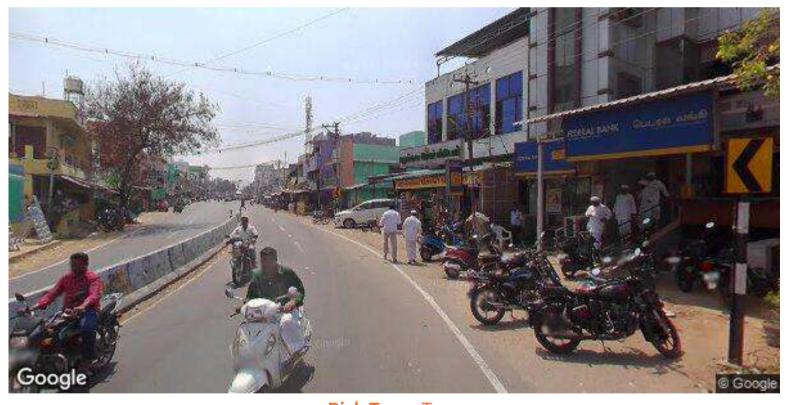
Risk Type: Turn
Risk Level: Medium
Speed Limit: 30 KM/Hr
Coordinates: 11.43769, 77.67810

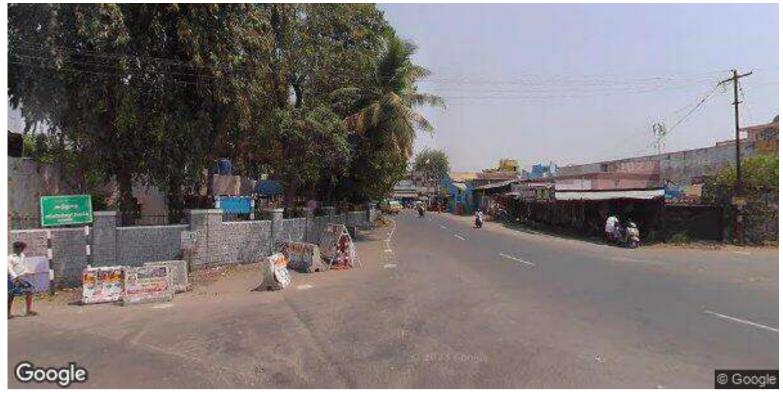
Risk Type: Turn
Risk Level: High
Speed Limit: 15 KM/Hr
Coordinates: 11.43863, 77.68223

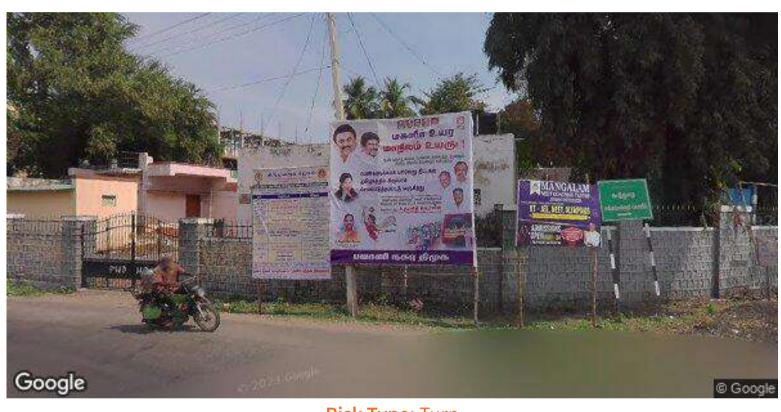
Risk Type: Turn
Risk Level: Medium
Speed Limit: 30 KM/Hr
Coordinates: 11.43871, 77.68228

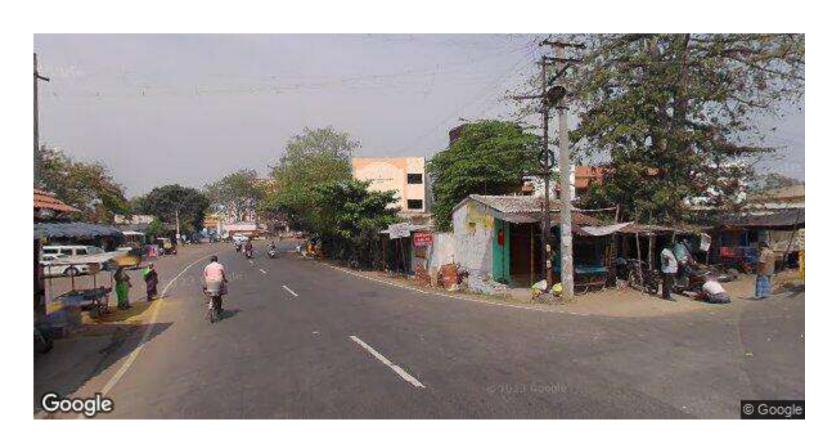
**Coordinates:** 11.43965, 77.68224

Risk Type: Turn
Risk Level: Medium
Speed Limit: 30 KM/Hr

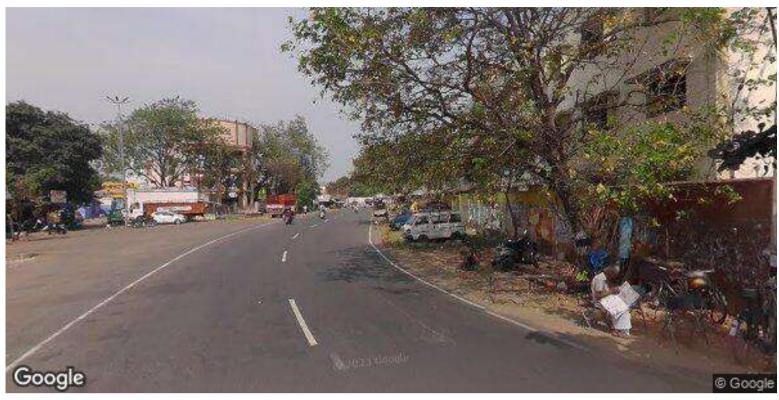
**Coordinates:** 11.43997, 77.68198

Risk Type: Turn
Risk Level: Medium
Speed Limit: 30 KM/Hr

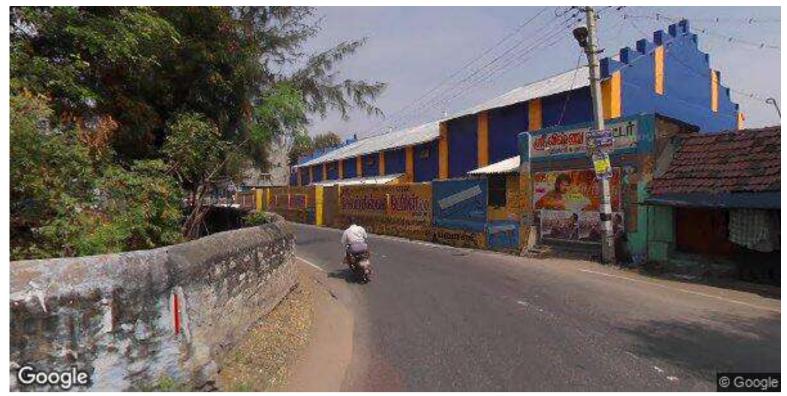
Risk Type: Turn
Risk Level: High
Speed Limit: 15 KM/Hr
Coordinates: 11.44119, 77.68217

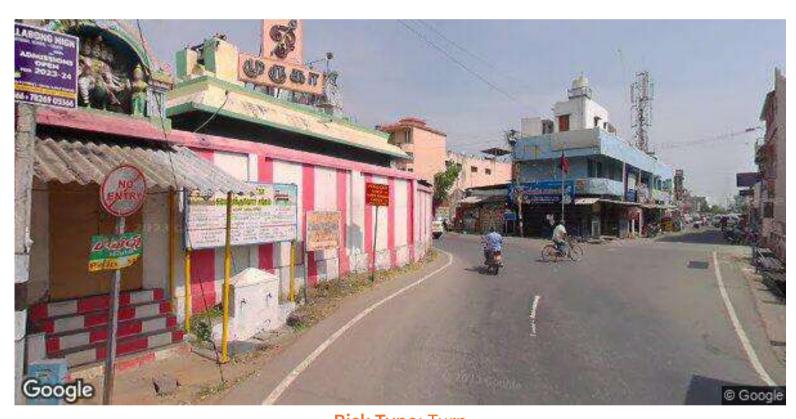
Risk Type: Turn
Risk Level: Medium
Speed Limit: 30 KM/Hr
Coordinates: 11.44295, 77.68261

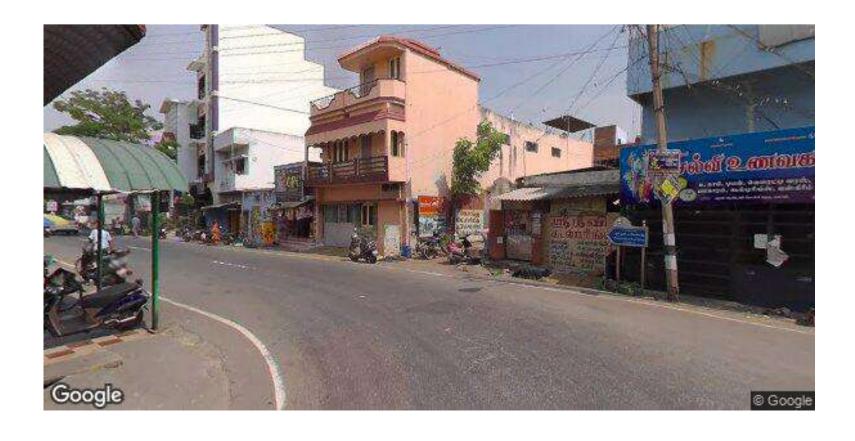
**Coordinates:** 11.44300, 77.68275

Risk Type: Turn
Risk Level: High
Speed Limit: 15 KM/Hr

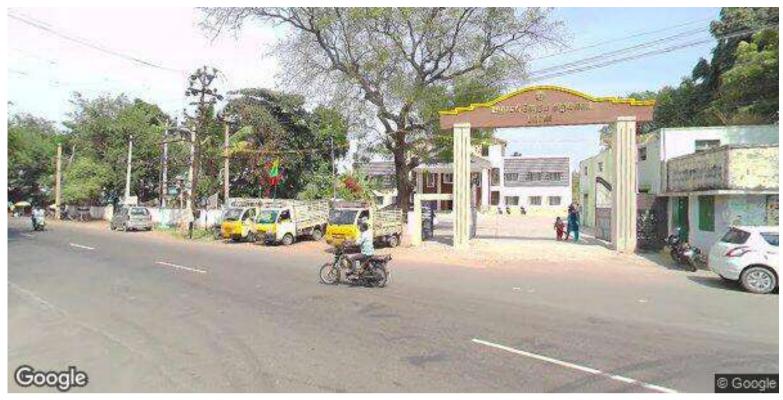
**Coordinates:** 11.44853, 77.68331

Risk Type: Turn
Risk Level: High
Speed Limit: 15 KM/Hr

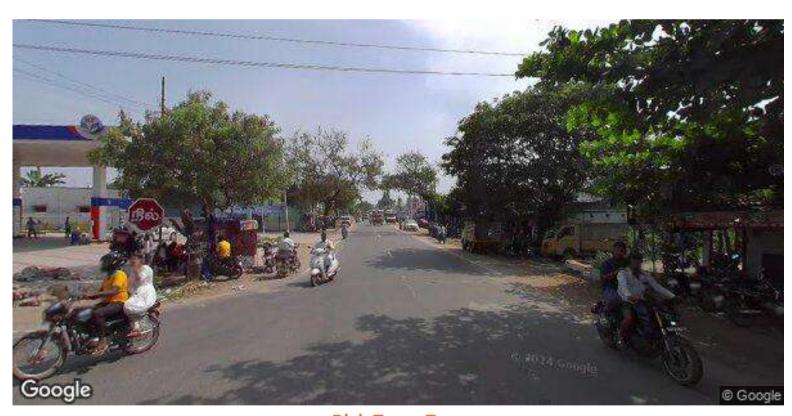
Risk Type: Turn
Risk Level: High
Speed Limit: 15 KM/Hr
Coordinates: 11.45649, 77.67621
