# JOURNEY RISK MANAGEMENT (JRM) STUDY

### Salem Terminal TO PARIYUR CORPORATION

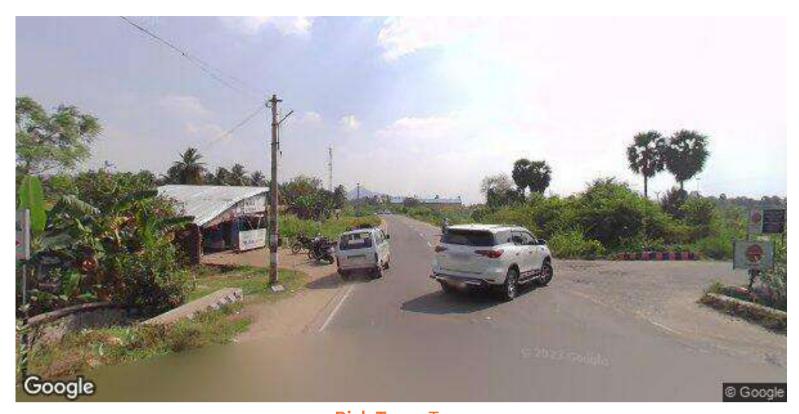
Risk Type: Turn
Speed Limit: 15 KM/Hr
Distance from Start: 0.31 km
Coordinates: 11.44029, 77.87544

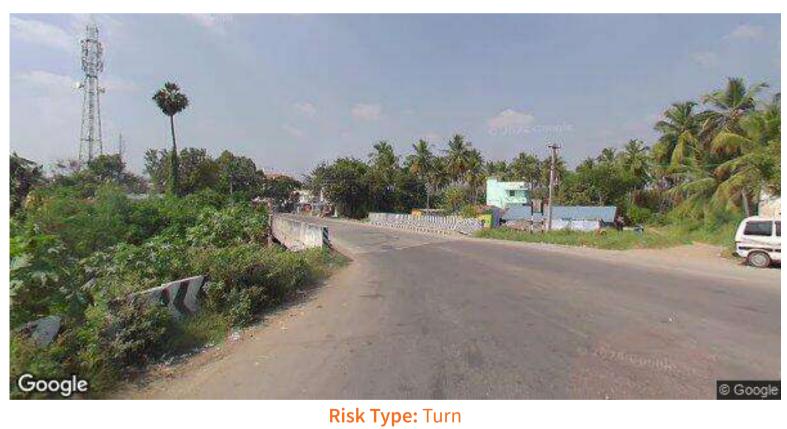
Speed Limit: 15 KM/Hr
Distance from Start: 1.36 km
Coordinates: 11.44893, 77.87413

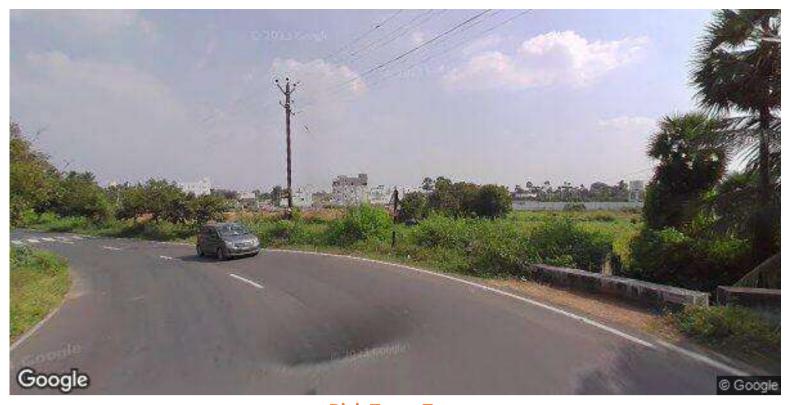
Risk Type: Turn
Speed Limit: 15 KM/Hr
Distance from Start: 3.34 km
Coordinates: 11.45350, 77.85700

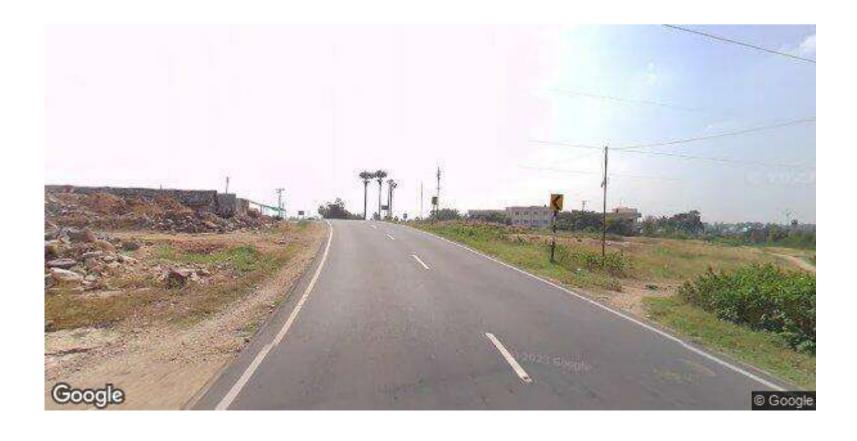
Risk Type: Turn
Speed Limit: 15 KM/Hr
Distance from Start: 4.37 km

**Coordinates:** 11.46046, 77.85037

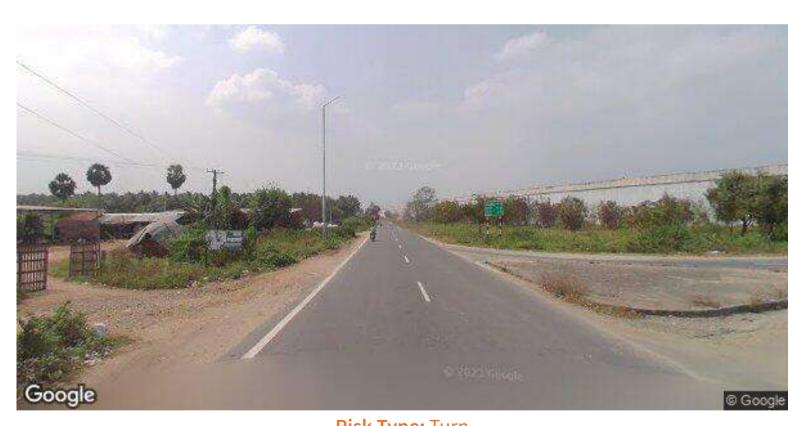
Risk Type: Turn
Speed Limit: 15 KM/Hr
Distance from Start: 8.38 km
Coordinates: 11.45542, 77.81725

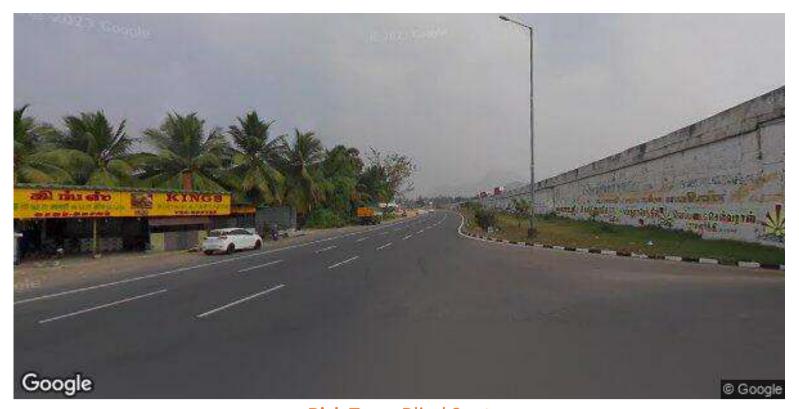
Risk Type: Blind Spot
Speed Limit: 10 KM/Hr
Distance from Start: 8.52 km
Coordinates: 11.45634, 77.81673

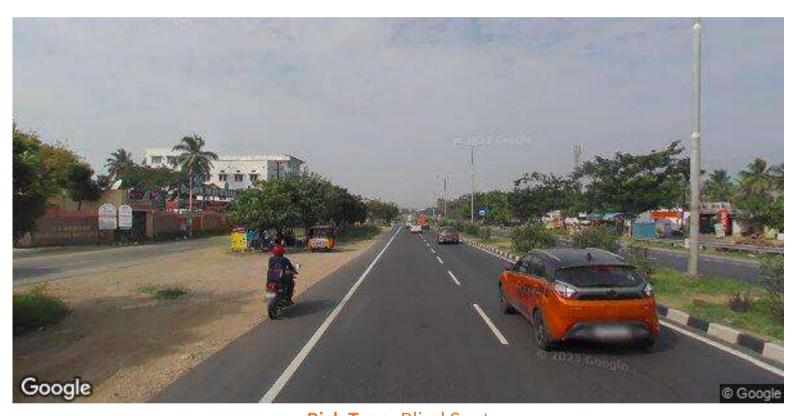
Risk Type: Blind Spot
Speed Limit: 10 KM/Hr
Distance from Start: 18.67 km
Coordinates: 11.44530, 77.72783

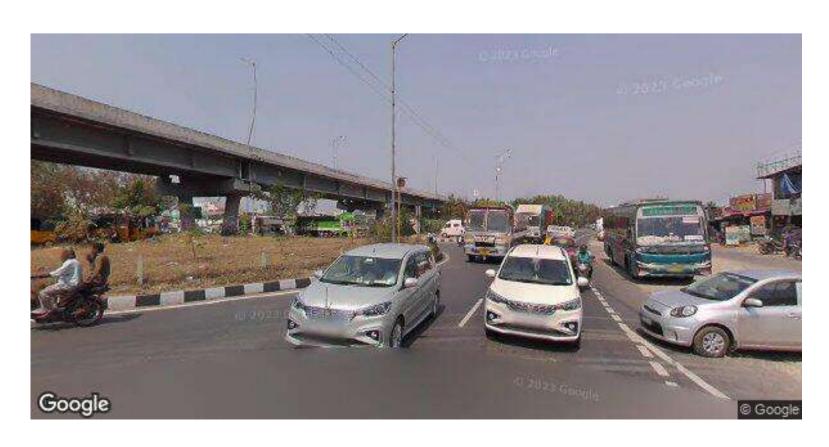
Risk Type: Turn
Speed Limit: 15 KM/Hr
Distance from Start: 24.89 km

**Coordinates:** 11.43001, 77.67575

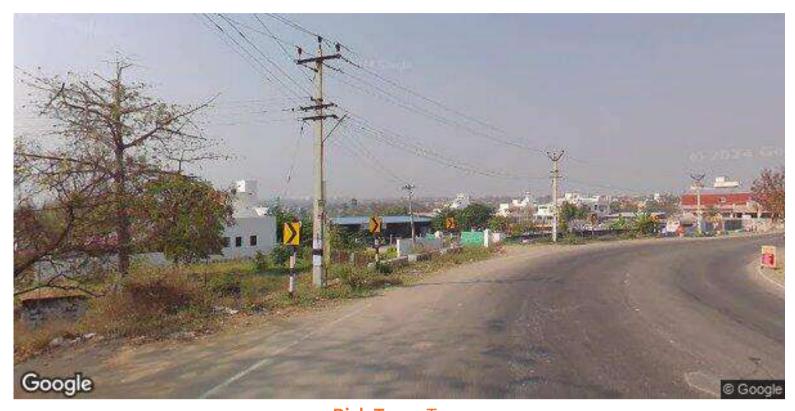
Risk Type: Turn
Speed Limit: 15 KM/Hr
Distance from Start: 25.60 km
Coordinates: 11.43273, 77.67018

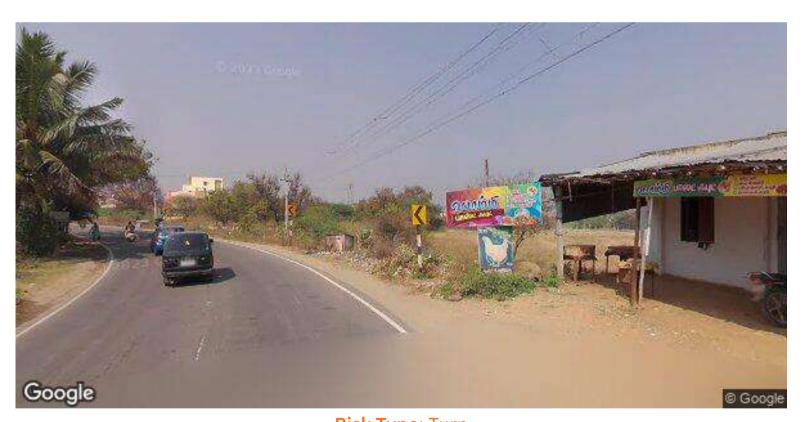
Risk Type: Turn
Speed Limit: 15 KM/Hr
Distance from Start: 25.98 km
Coordinates: 11.43346, 77.66700

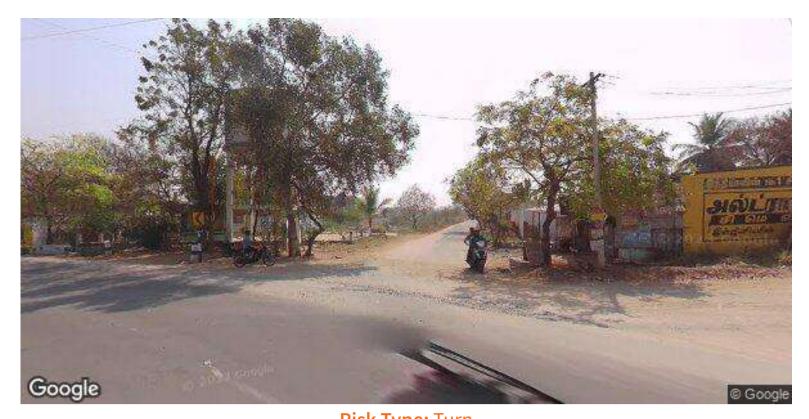
Risk Type: Turn
Speed Limit: 15 KM/Hr
Distance from Start: 26.17 km
Coordinates: 11.43225, 77.66561

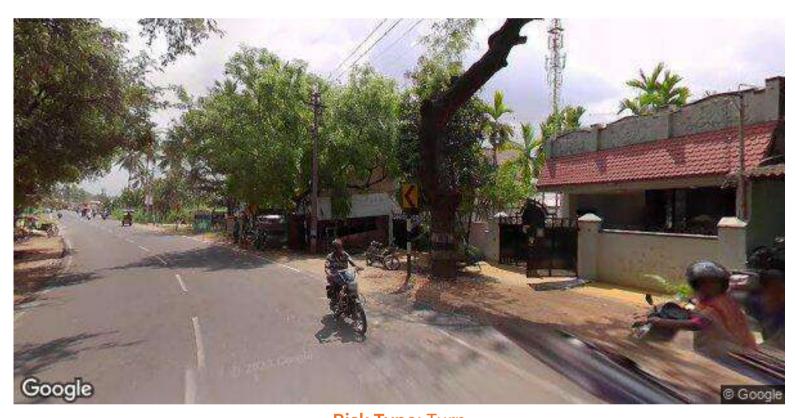
Risk Type: Turn
Speed Limit: 15 KM/Hr
Distance from Start: 36.97 km
Coordinates: 11.42837, 77.56935

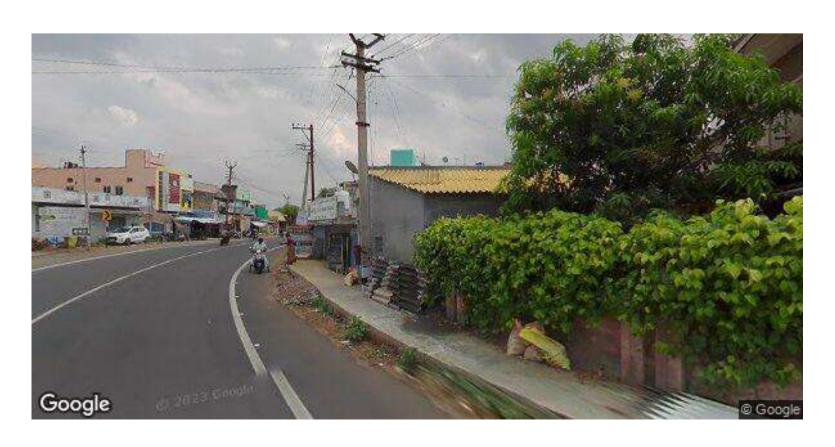
Risk Type: Turn
Speed Limit: 15 KM/Hr
Distance from Start: 37.39 km

**Coordinates:** 11.42821, 77.56543

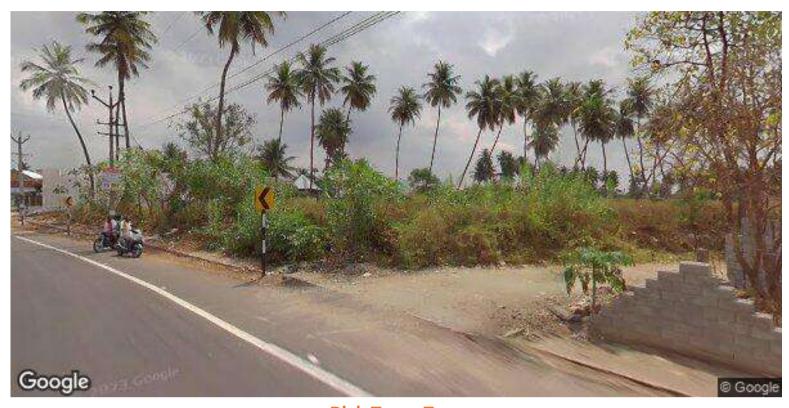
Risk Type: Turn
Speed Limit: 15 KM/Hr
Distance from Start: 37.61 km
Coordinates: 11.42707, 77.56407

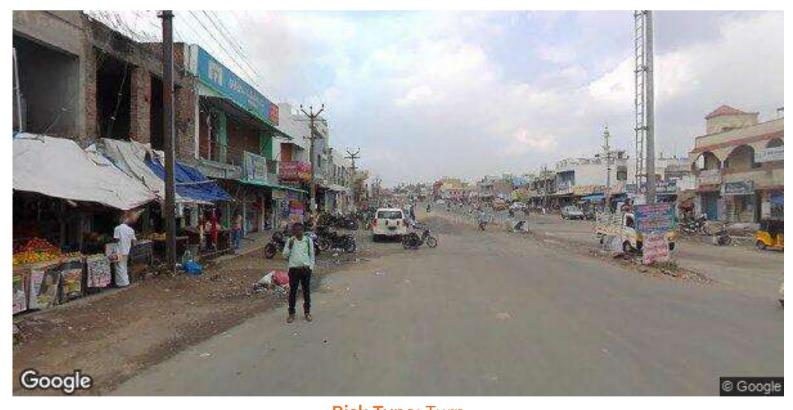
Risk Type: Turn
Speed Limit: 15 KM/Hr
Distance from Start: 38.45 km
Coordinates: 11.42329, 77.55798

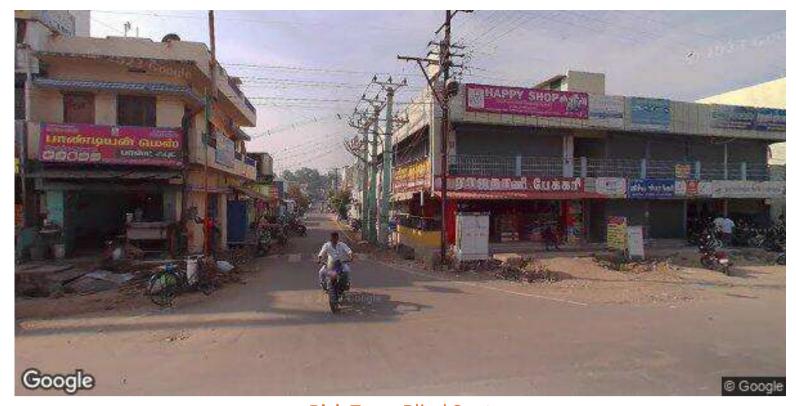
Risk Type: Blind Spot
Speed Limit: 10 KM/Hr
Distance from Start: 51.59 km
Coordinates: 11.45462, 77.44375

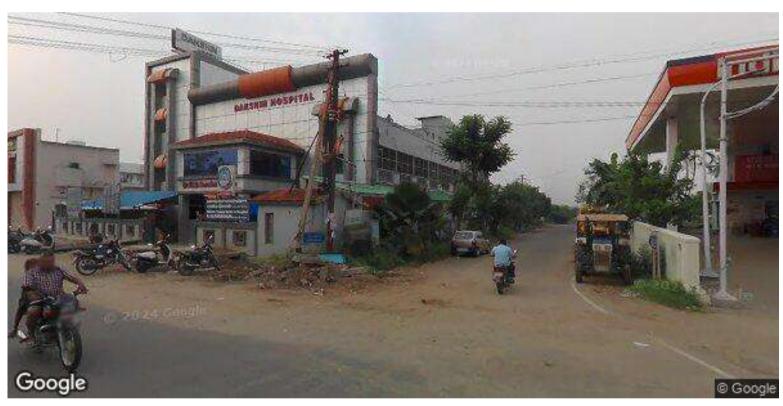
Risk Type: Blind Spot
Speed Limit: 10 KM/Hr
Distance from Start: 51.83 km
Coordinates: 11.45420, 77.44634
