JOURNEY RISK MANAGEMENT (JRM) STUDY

Salem Terminal To SRI ALMP AGENCIES

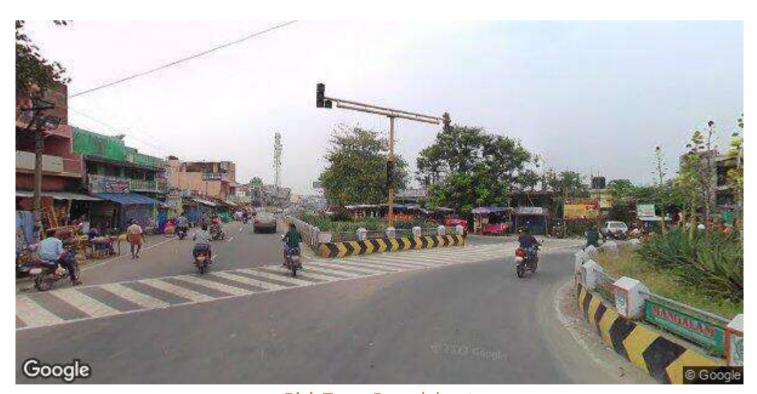
Risk Type: Roundabout
Risk Level: High
Speed Limit: 15 KM/Hr
Coordinates: 11.57607, 77.58841

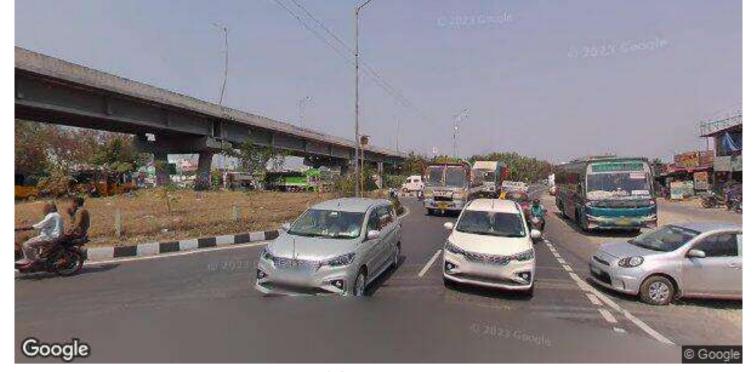
Risk Type: Turn
Risk Level: High
Speed Limit: 15 KM/Hr
Coordinates: 11.43001, 77.67575

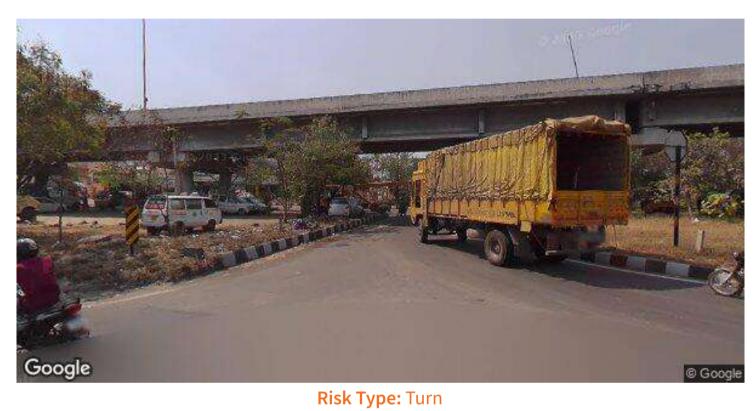
Risk Level: Medium
Speed Limit: 30 KM/Hr
Coordinates: 11.43000, 77.67564

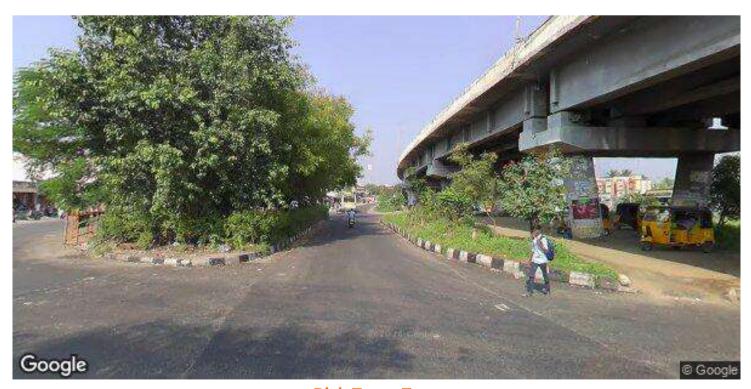
Risk Type: Turn
Risk Level: Medium

Speed Limit: 30 KM/Hr Coordinates: 11.43009, 77.67540

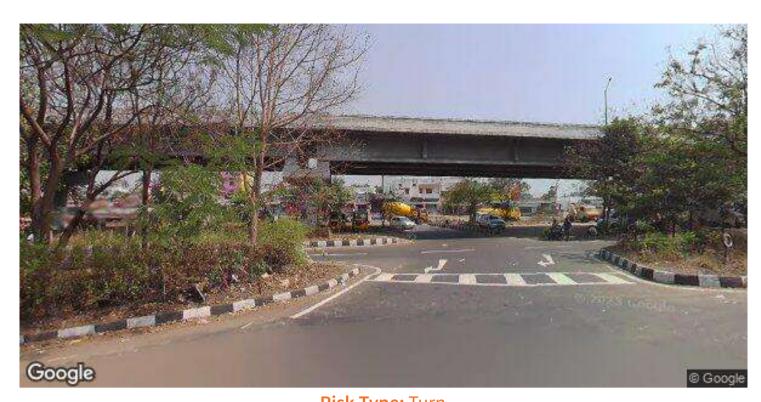
Risk Type: Turn
Risk Level: High
Speed Limit: 15 KM/Hr
Coordinates: 11.43026, 77.67525

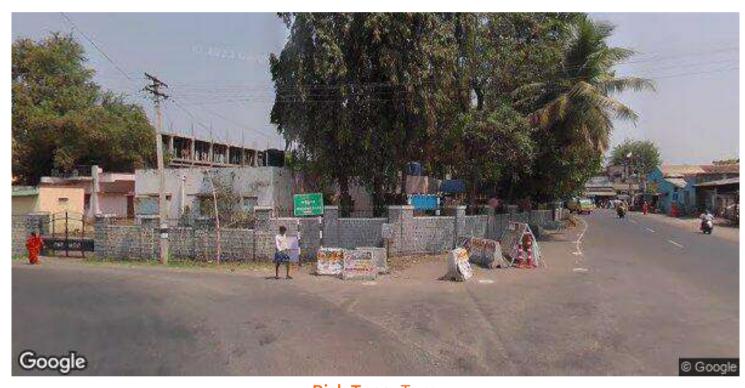
Risk Type: Turn
Risk Level: High
Speed Limit: 15 KM/Hr
Coordinates: 11.43864, 77.68225

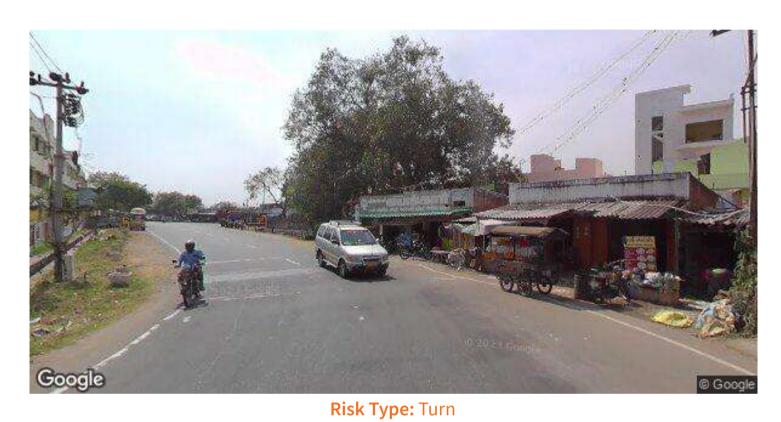
Risk Level: High
Speed Limit: 15 KM/Hr
Coordinates: 11.44105, 77.68188

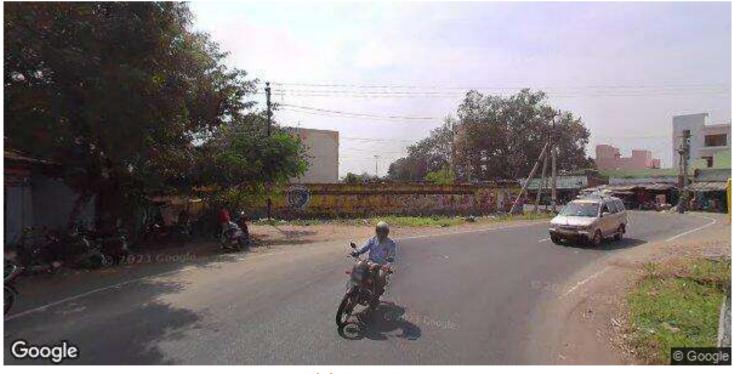
Risk Type: Turn Risk Level: High

Speed Limit: 15 KM/Hr Coordinates: 11.44120, 77.68218

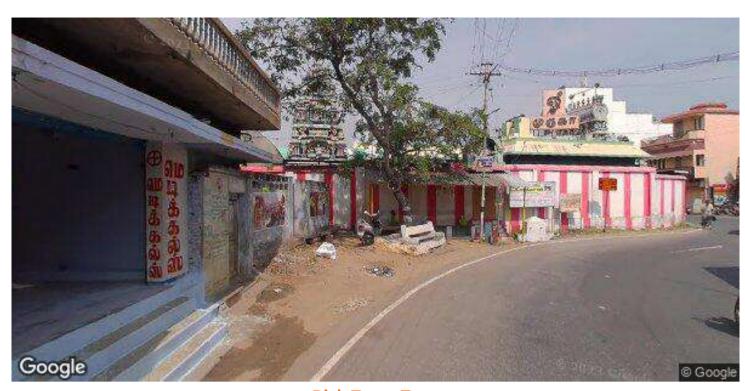
Risk Type: Turn
Risk Level: High
Speed Limit: 15 KM/Hr
Coordinates: 11.44288, 77.68254

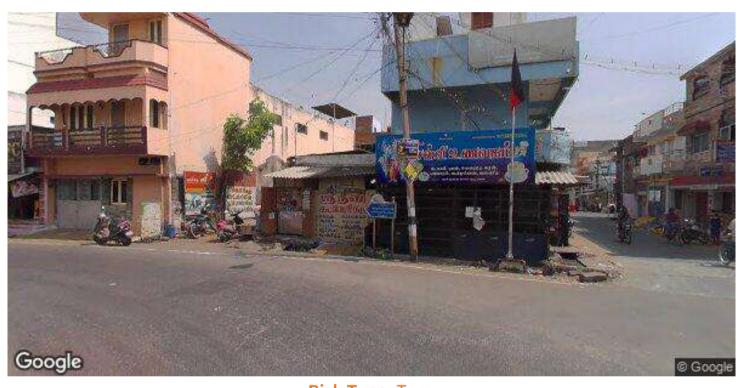
Risk Type: Turn
Risk Level: High
Speed Limit: 15 KM/Hr
Coordinates: 11.44298, 77.68273

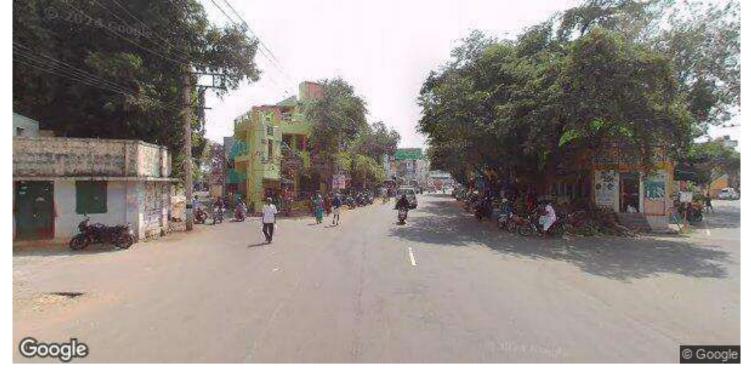
Risk Type: Turn
Risk Level: High
Speed Limit: 15 KM/Hr

Coordinates: 11.44858, 77.68333

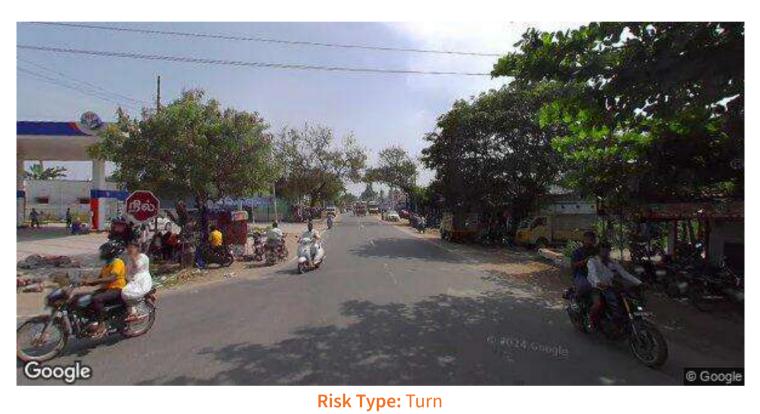
Risk Level: High
Speed Limit: 15 KM/Hr
Coordinates: 11.45649, 77.67621

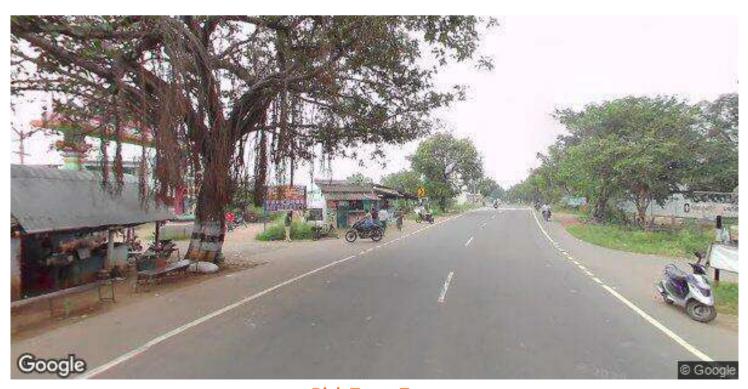
Risk Type: Turn
Risk Level: Medium

Speed Limit: 30 KM/Hr Coordinates: 11.54439, 77.61209

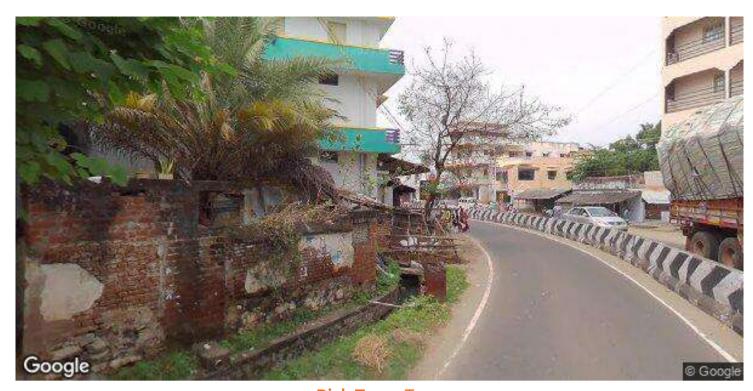
Risk Type: Turn
Risk Level: Medium
Speed Limit: 30 KM/Hr
Coordinates: 11.58067, 77.58800

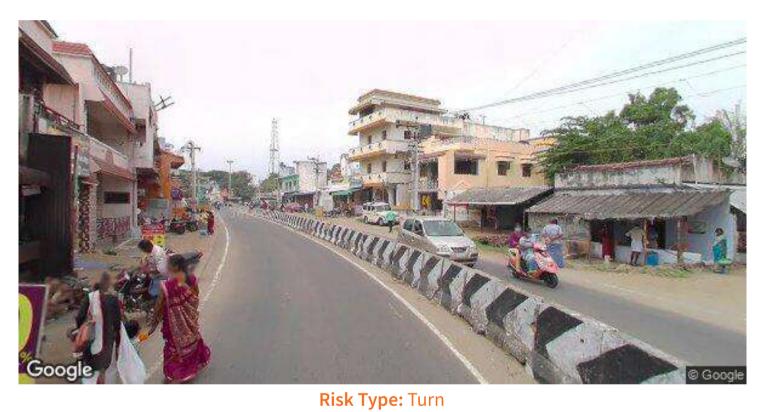
Risk Level: Medium
Speed Limit: 30 KM/Hr
Coordinates: 11.58080, 77.58786

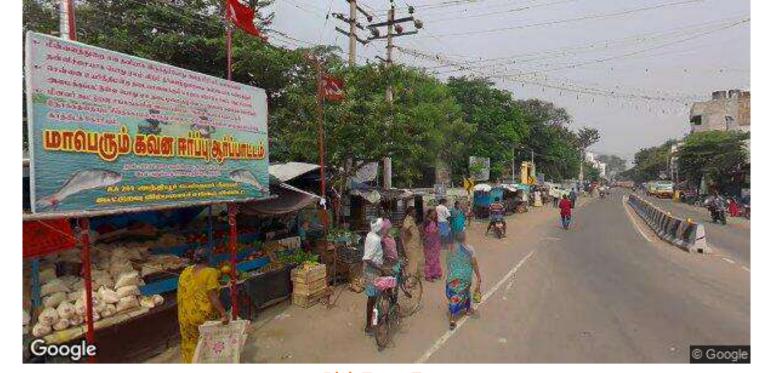
Risk Type: Turn
Risk Level: High
Speed Limit: 15 KM/Hr

Coordinates: 11.58103, 77.58704
