JOURNEY RISK MANAGEMENT (JRM) STUDY

Salem Terminal TO HARSITA FUELS

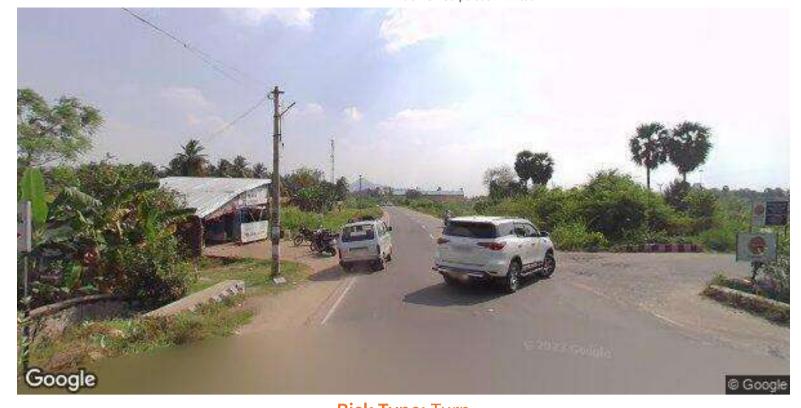
Risk Type: Turn
Risk Level: High
Speed Limit: 15 KM/Hr
Coordinates: 11.44029, 77.87544

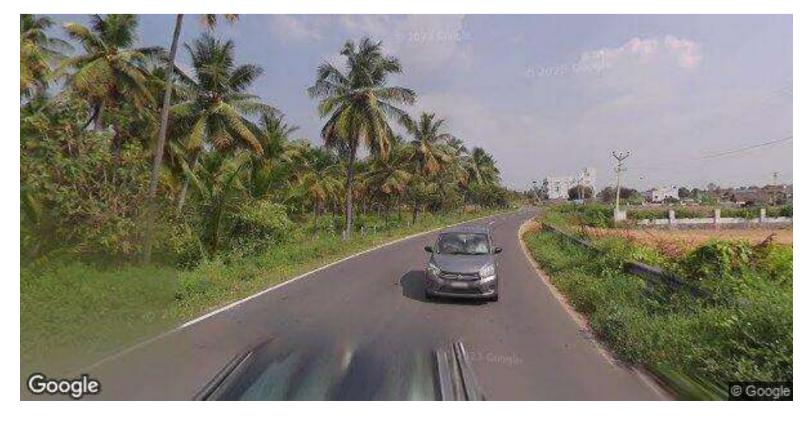
Coordinates: 11.45357, 77.85789

Risk Type: Turn
Risk Level: Medium
Speed Limit: 30 KM/Hr

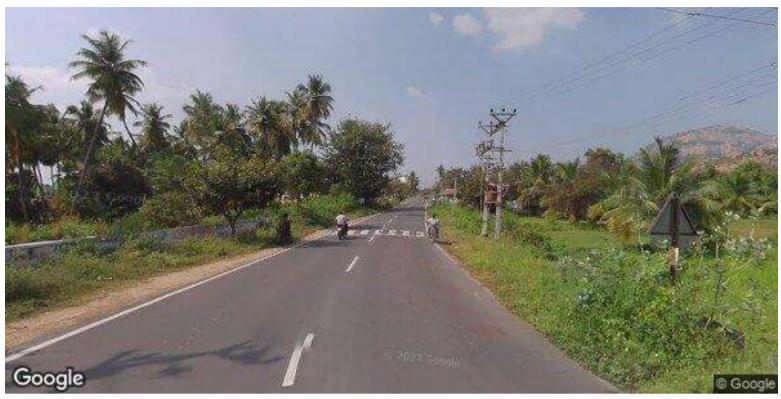
Coordinates: 11.45352, 77.85698

Risk Type: Turn
Risk Level: High
Speed Limit: 15 KM/Hr

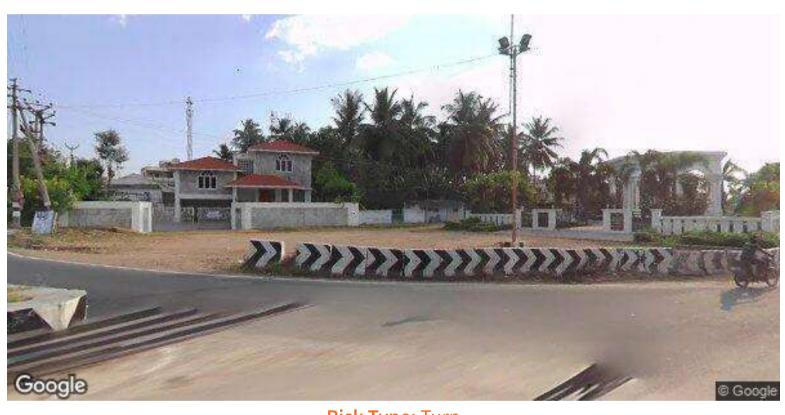
Risk Type: Turn
Risk Level: Medium
Speed Limit: 30 KM/Hr
Coordinates: 11.46314, 77.84928

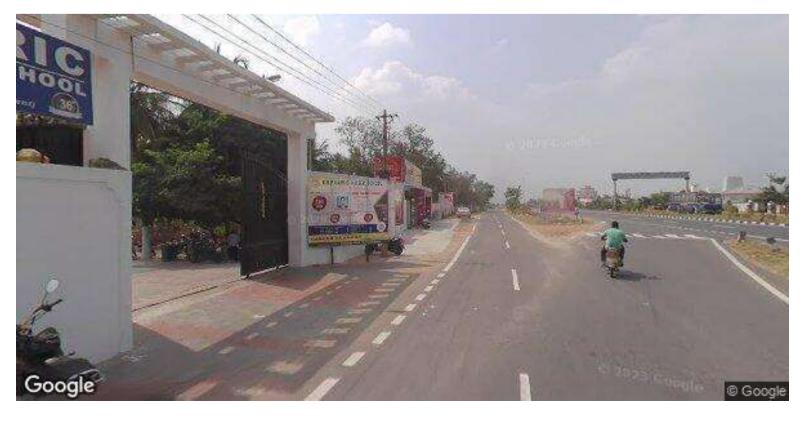
Coordinates: 11.45509, 77.81383

Risk Type: Turn
Risk Level: Medium
Speed Limit: 30 KM/Hr

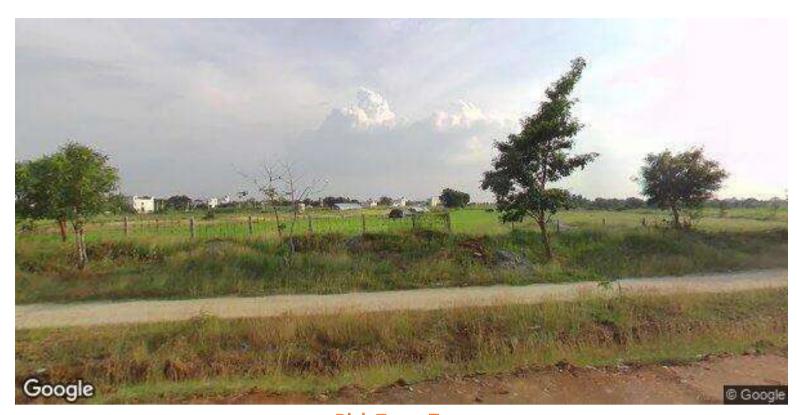
Risk Type: Turn
Risk Level: Medium
Speed Limit: 30 KM/Hr
Coordinates: 11.29288, 77.59029

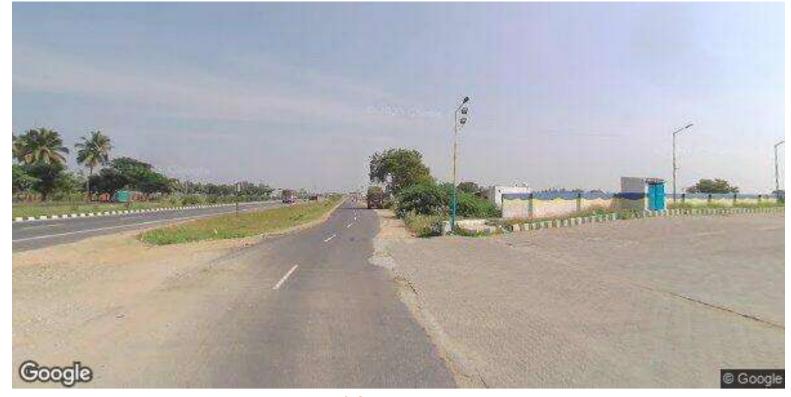
Risk Type: Turn
Risk Level: High
Speed Limit: 15 KM/Hr
Coordinates: 11.20335, 77.42730

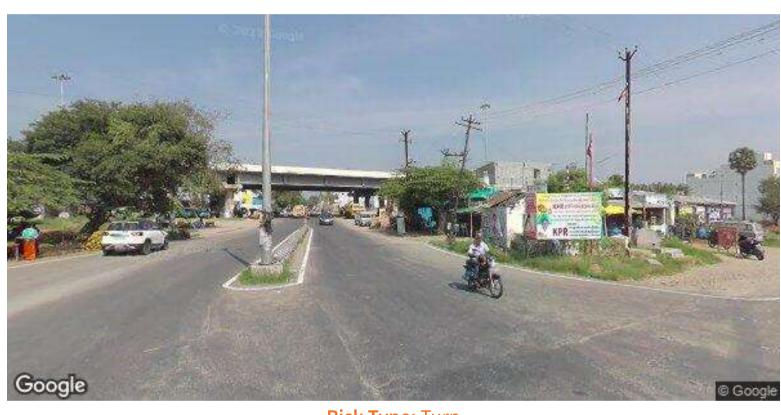
Risk Type: Turn
Risk Level: High
Speed Limit: 15 KM/Hr
Coordinates: 11.19962, 77.42240

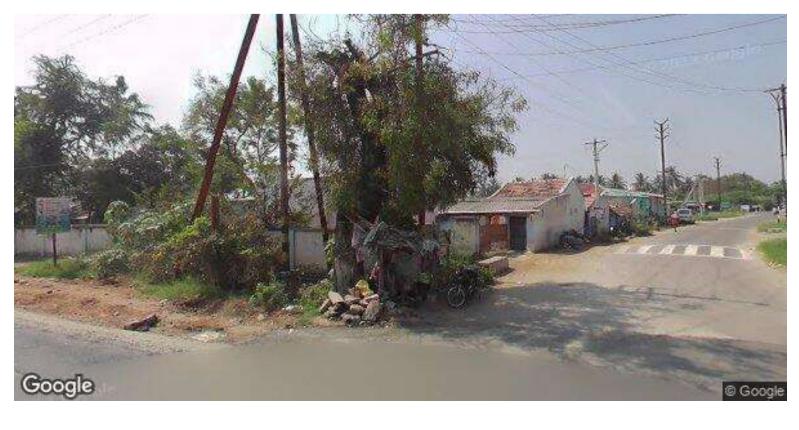
Coordinates: 11.19748, 77.42349

Risk Type: Blind Spot Risk Level: Blind Spot Speed Limit: 10 KM/Hr

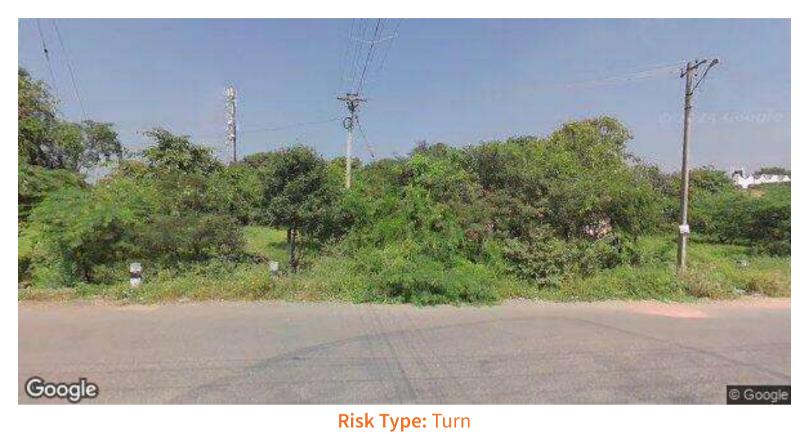
Coordinates: 11.19731, 77.42240

Risk Level: High

Speed Limit: 15 KM/Hr

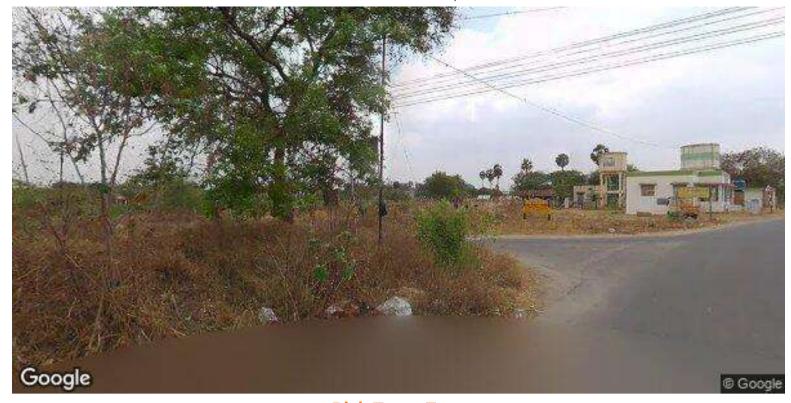
Risk Type: Turn
Risk Level: High
Speed Limit: 15 KM/Hr
Coordinates: 11.15927, 77.42044

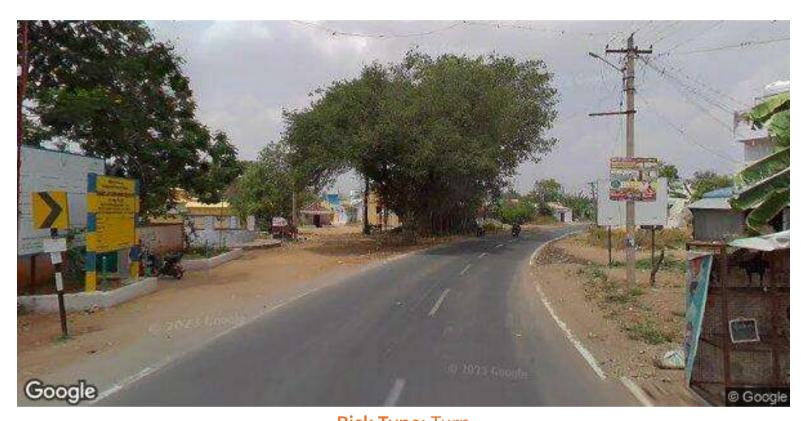
Risk Type: Turn
Risk Level: Medium
Speed Limit: 30 KM/Hr
Coordinates: 11.15930, 77.41866

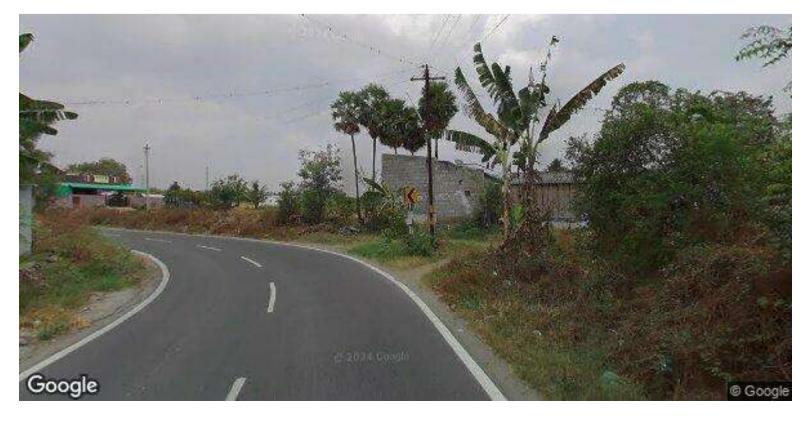
Coordinates: 11.15996, 77.41806

Risk Type: Turn
Risk Level: Medium
Speed Limit: 30 KM/Hr

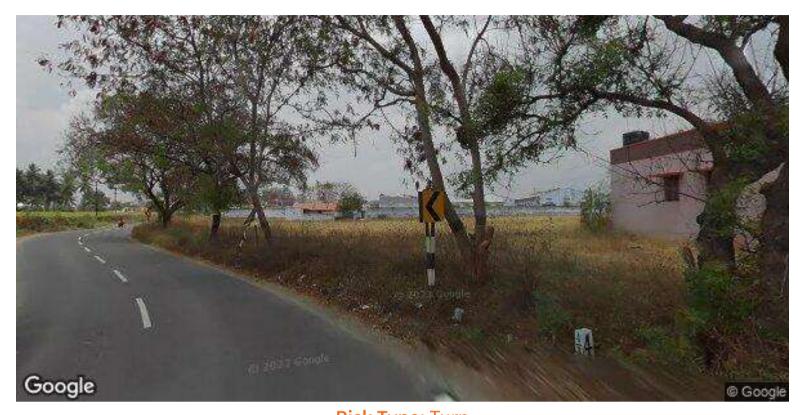
Risk Type: Turn
Risk Level: Medium
Speed Limit: 30 KM/Hr
Coordinates: 11.16004, 77.41760

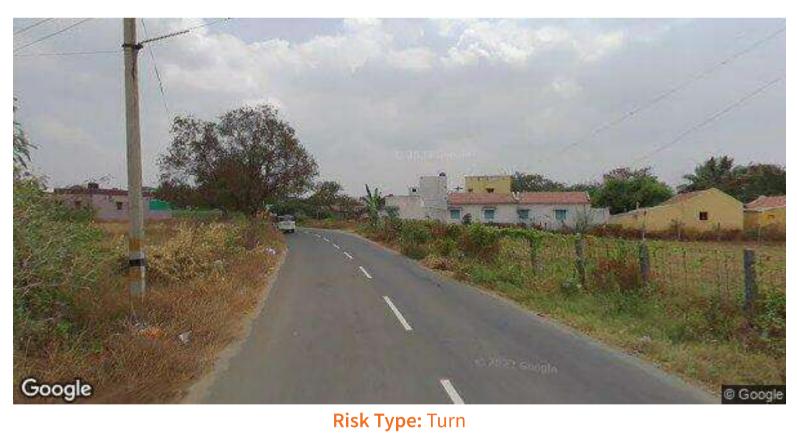
Risk Level: Medium
Speed Limit: 30 KM/Hr
Coordinates: 11.15963, 77.41700
