# JOURNEY RISK MANAGEMENT (JRM) STUDY

# IOCL Coimbatore Terminal to India Land Tech Park Pvt Ltd

Route Safety Analysis: Athappagoundenpudur to India Land Tech Park, Coimbatore

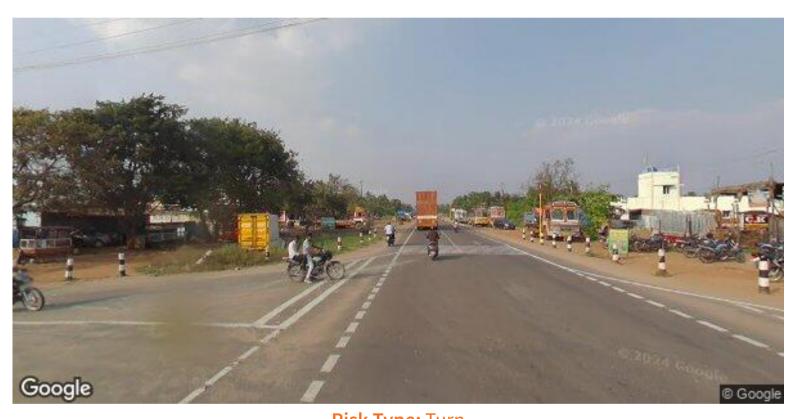
**Coordinates:** 11.03211, 77.07640

Risk Type: Turn
Risk Level: High
Speed Limit: 15 KM/Hr

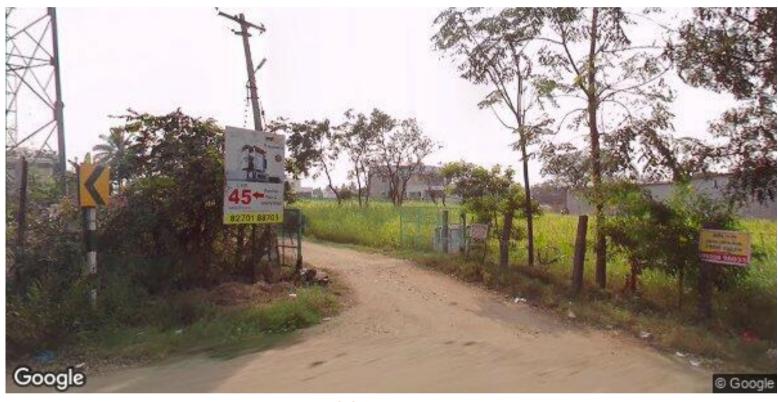
Risk Type: Turn
Risk Level: Medium
Speed Limit: 30 KM/Hr
Coordinates: 11.05181, 77.07696

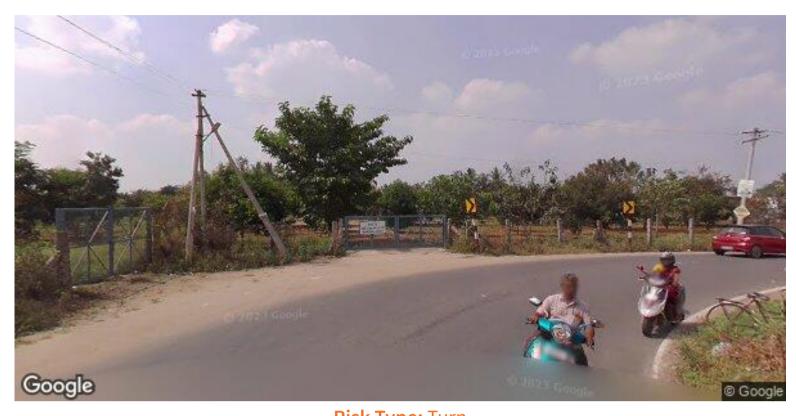
Risk Type: Turn
Risk Level: Medium
Speed Limit: 30 KM/Hr
Coordinates: 11.05343, 77.07106

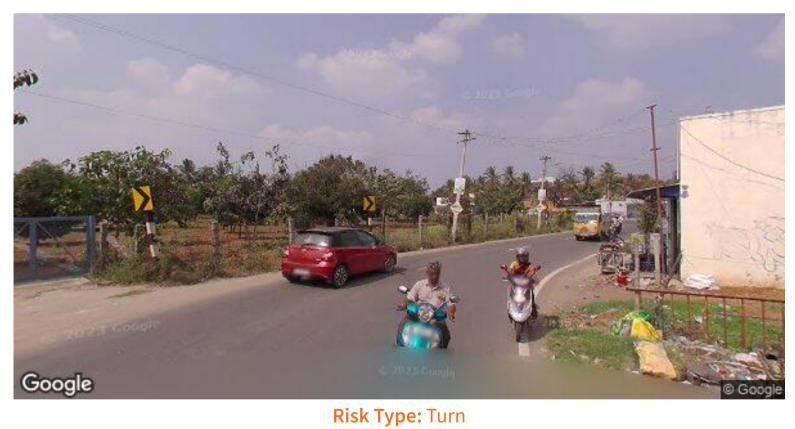
Risk Level: Medium
Speed Limit: 30 KM/Hr
Coordinates: 11.05351, 77.07099

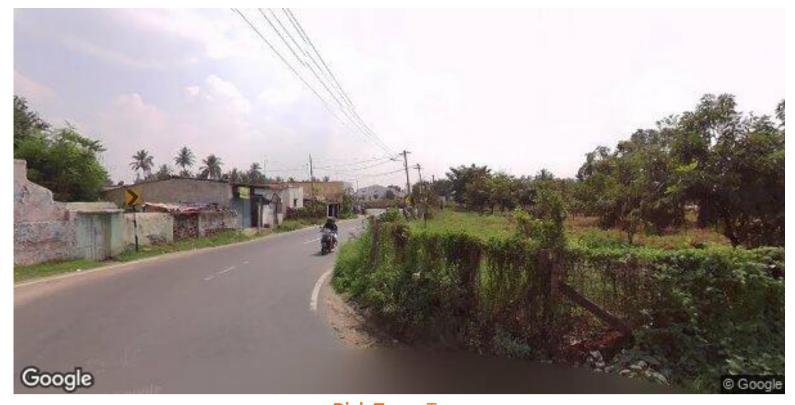
Risk Type: Turn
Risk Level: Medium
Speed Limit: 30 KM/Hr
Coordinates: 11.05411, 77.07097

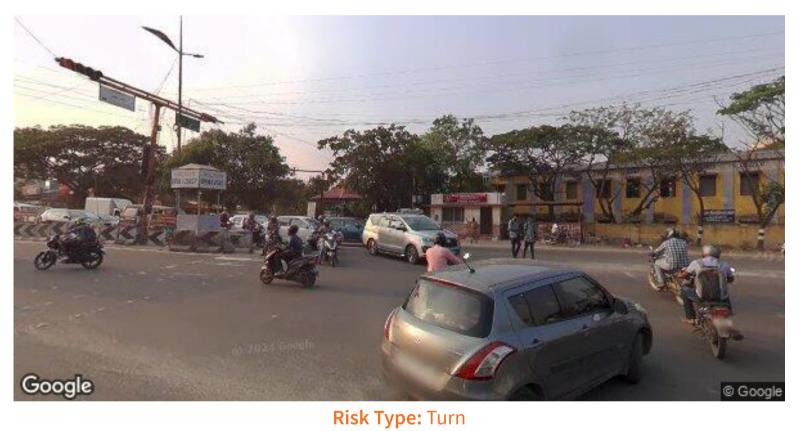
Risk Level: High
Speed Limit: 15 KM/Hr
Coordinates: 11.05529, 77.06566

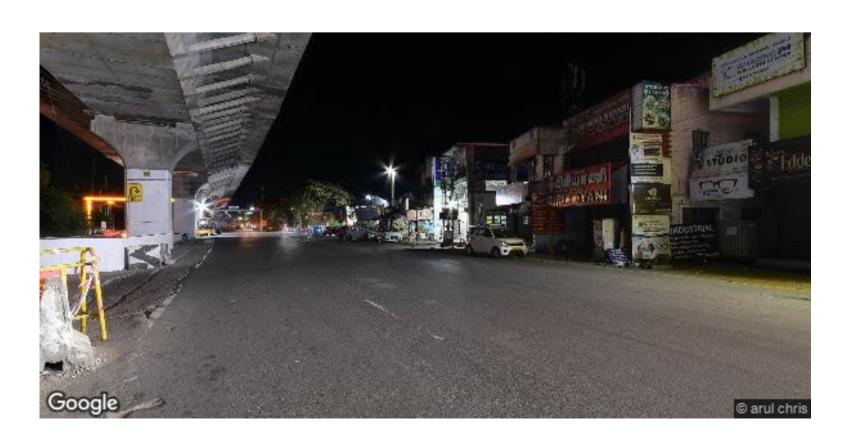
**Coordinates:** 11.03735, 77.03672

Risk Type: Blind Spot Risk Level: Blind Spot Speed Limit: 10 KM/Hr

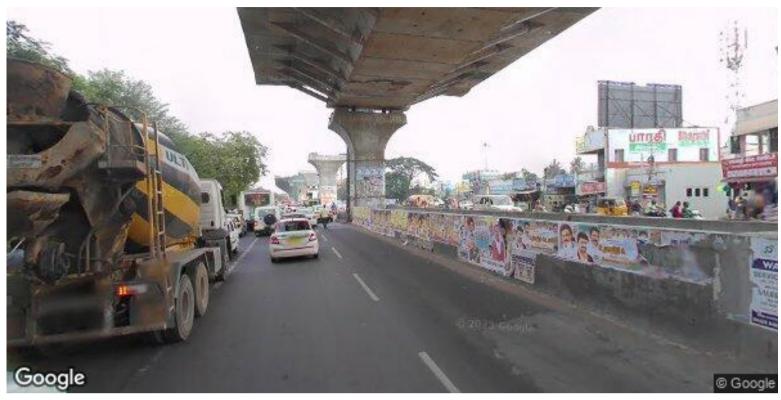
**Coordinates:** 11.03746, 77.03666

Risk Type: Turn
Risk Level: High
Speed Limit: 15 KM/Hr

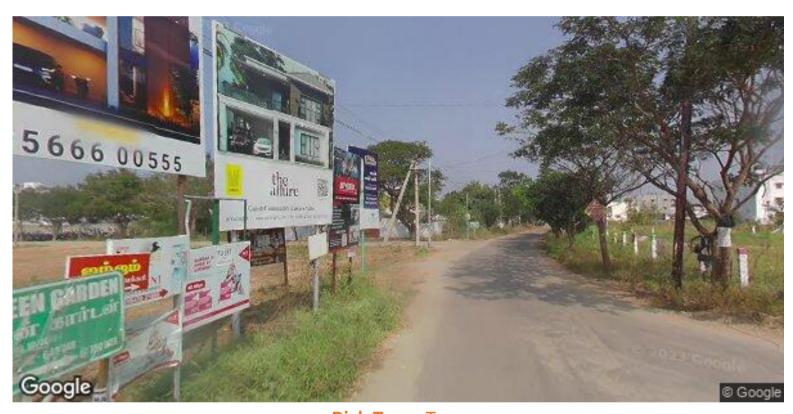
Risk Type: Turn
Risk Level: High
Speed Limit: 15 KM/Hr
Coordinates: 11.06387, 77.03223

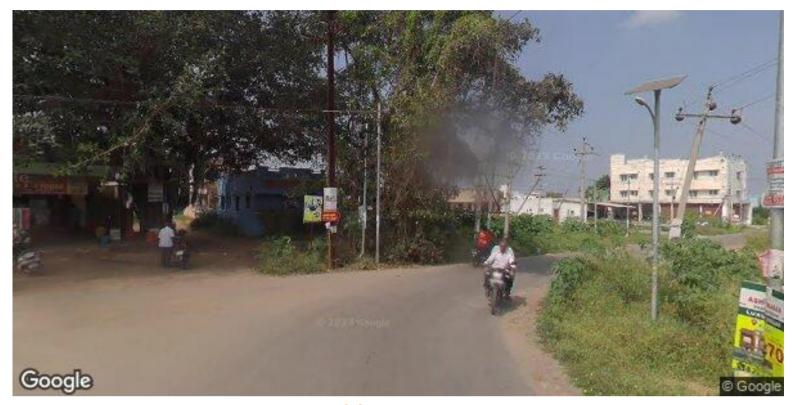
Risk Type: Turn
Risk Level: Medium
Speed Limit: 30 KM/Hr
Coordinates: 11.06257, 77.02744

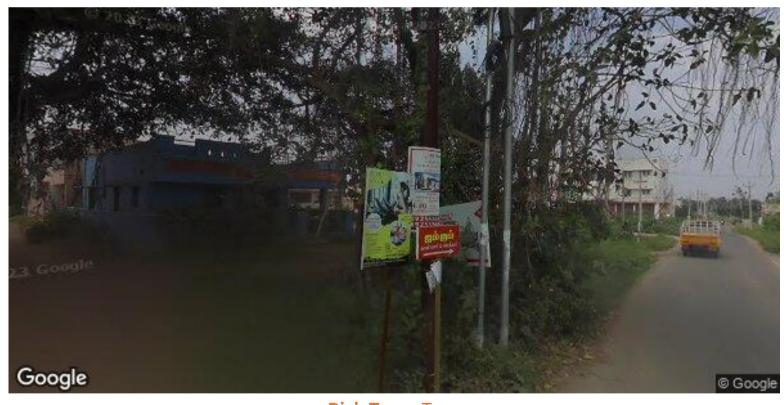
Risk Type: Turn
Risk Level: High
Speed Limit: 15 KM/Hr
Coordinates: 11.06262, 77.02734

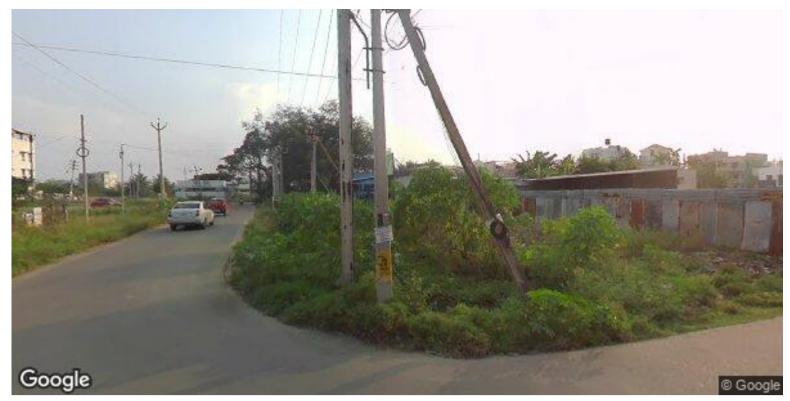
Risk Type: Turn
Risk Level: High
Speed Limit: 15 KM/Hr
Coordinates: 11.06325, 77.02732

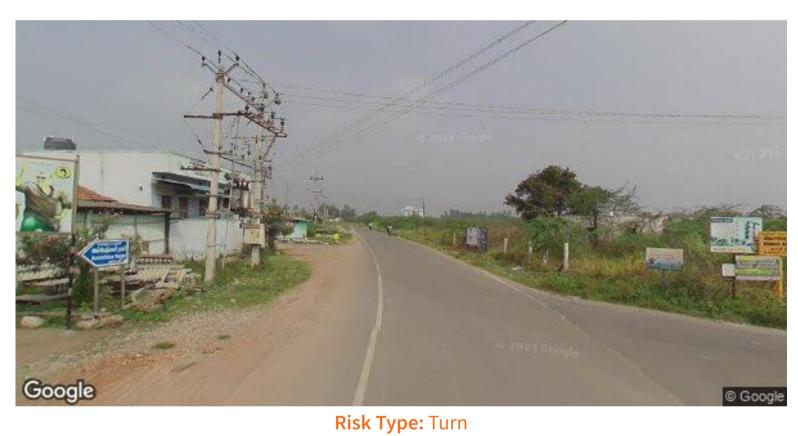
Risk Level: High
Speed Limit: 15 KM/Hr
Coordinates: 11.06322, 77.02449

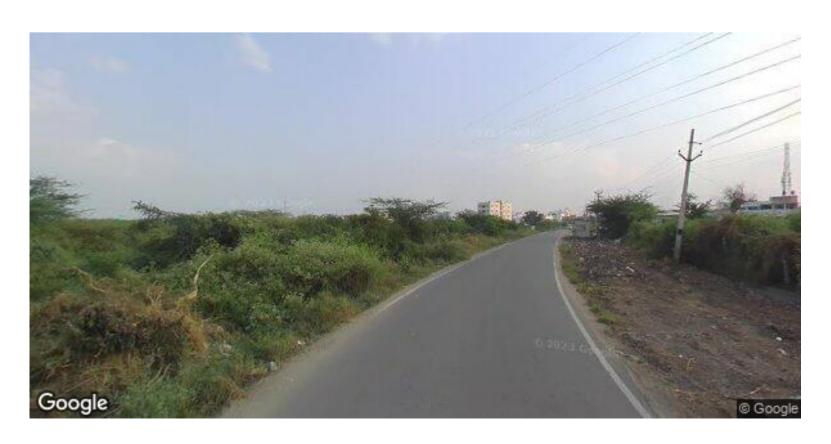
**Coordinates:** 11.06531, 77.02379

Risk Type: Turn
Risk Level: Medium
Speed Limit: 30 KM/Hr

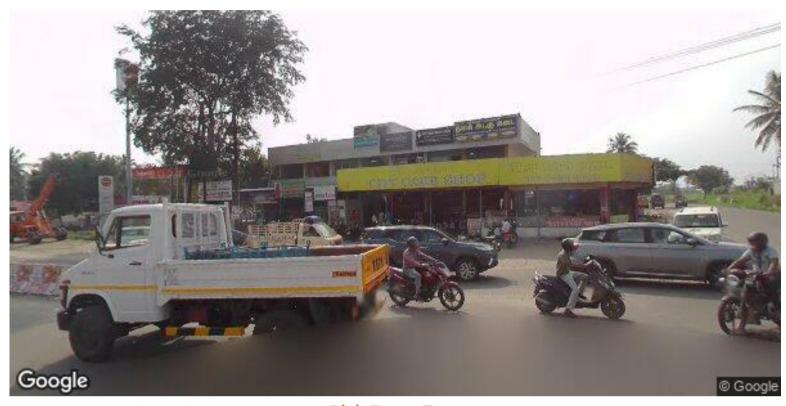
**Coordinates:** 11.07368, 77.01680

Risk Type: Turn
Risk Level: Medium
Speed Limit: 30 KM/Hr

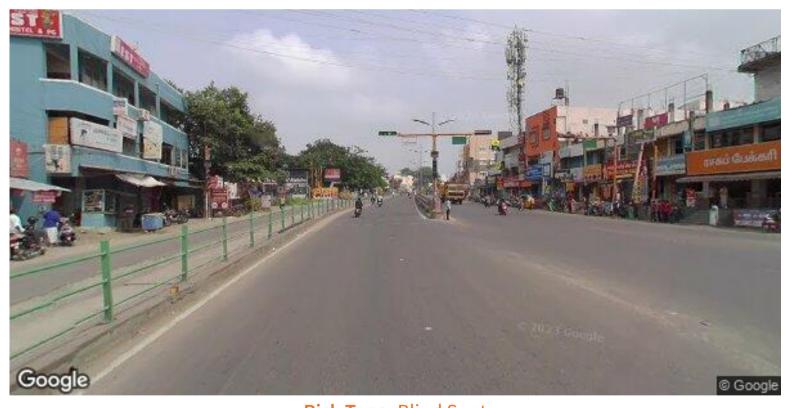
**Coordinates:** 11.07496, 77.00208

Risk Type: Blind Spot
Risk Level: Blind Spot
Speed Limit: 10 KM/Hr

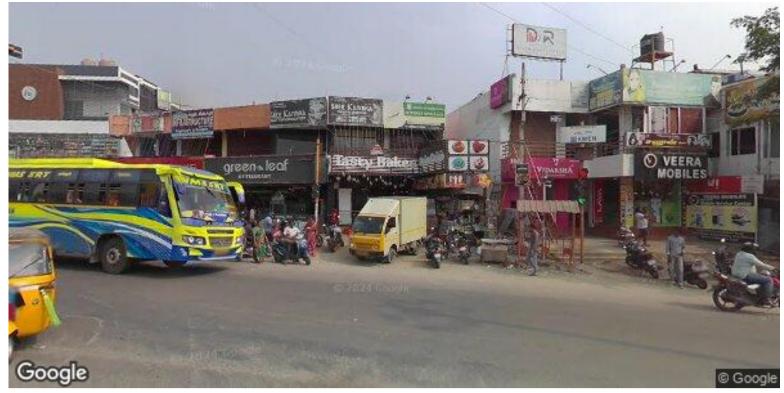
Risk Type: Turn
Risk Level: High
Speed Limit: 15 KM/Hr
Coordinates: 11.07859, 77.00367

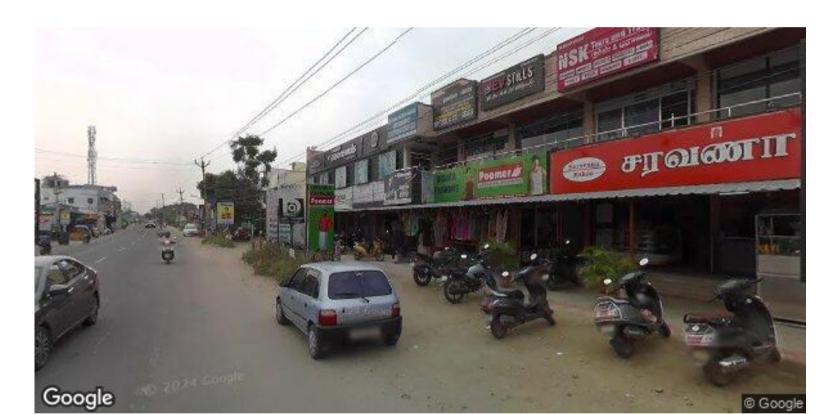
Risk Type: Turn
Risk Level: High
Speed Limit: 15 KM/Hr
Coordinates: 11.07948, 77.00249

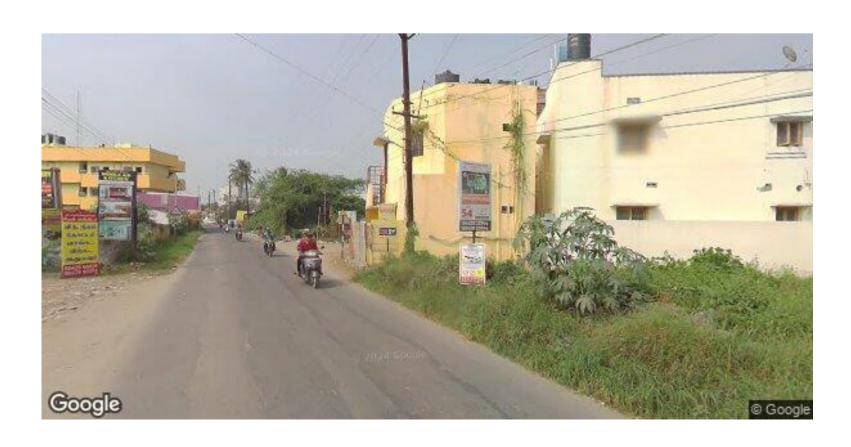
**Coordinates:** 11.08072, 77.00238

Risk Type: Turn
Risk Level: Medium
Speed Limit: 30 KM/Hr

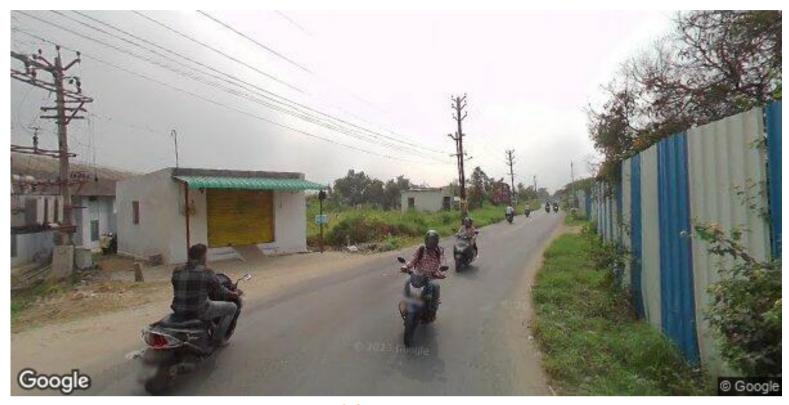
Risk Type: Turn
Risk Level: High
Speed Limit: 15 KM/Hr
Coordinates: 11.08604, 76.99845

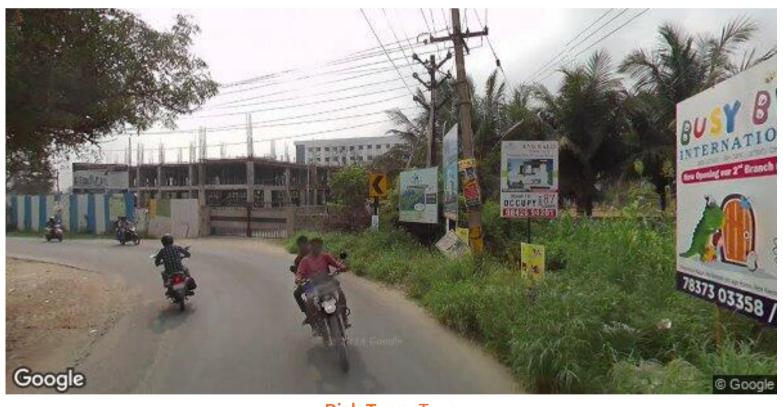
Risk Type: Turn
Risk Level: Medium
Speed Limit: 30 KM/Hr
Coordinates: 11.08616, 76.99773

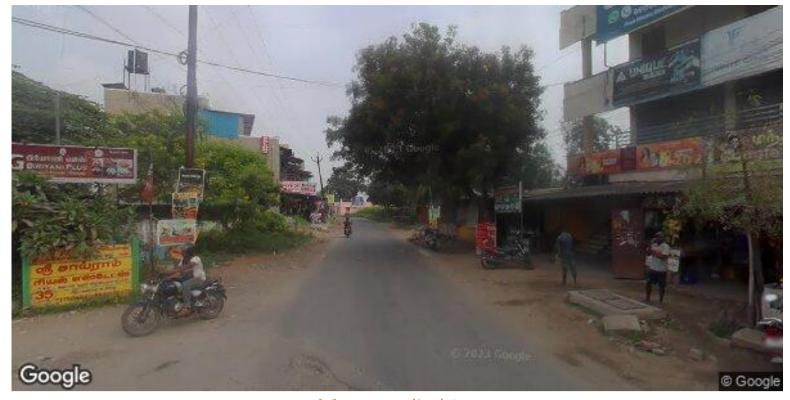
**Coordinates:** 11.10176, 76.99644

Risk Type: Blind Spot Risk Level: Blind Spot Speed Limit: 10 KM/Hr

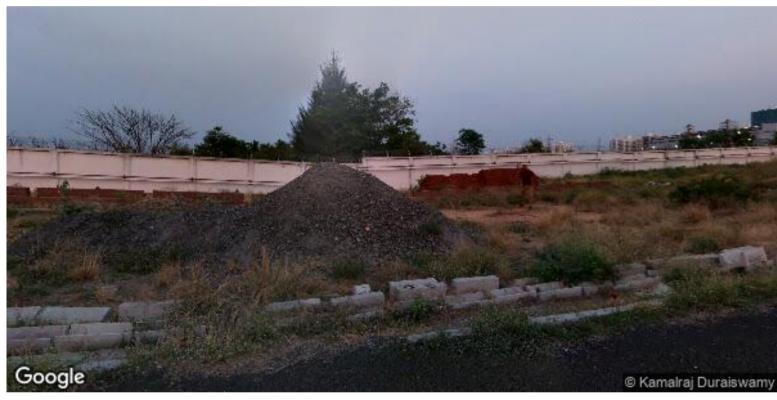
**Coordinates:** 11.10373, 76.98516

Risk Type: Turn
Risk Level: High
Speed Limit: 15 KM/Hr
