JOURNEY RISK MANAGEMENT (JRM) STUDY

Salem Terminal to ACMS COOPERATIVE PETROL BUNK

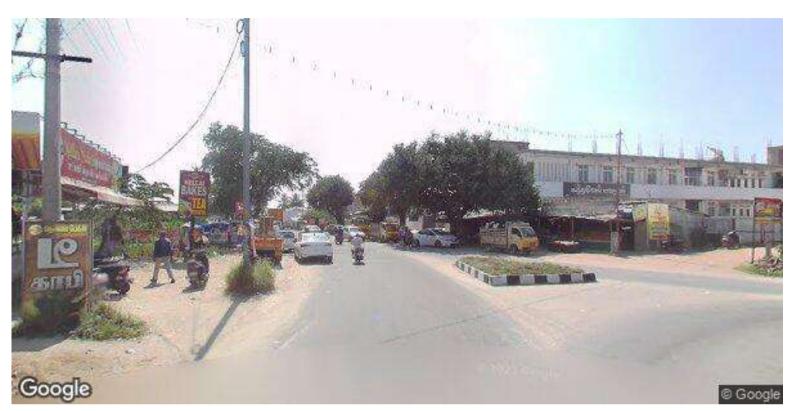
Coordinates: 11.17250, 77.26863

Risk Type: Roundabout
Risk Level: High
Speed Limit: 15 KM/Hr

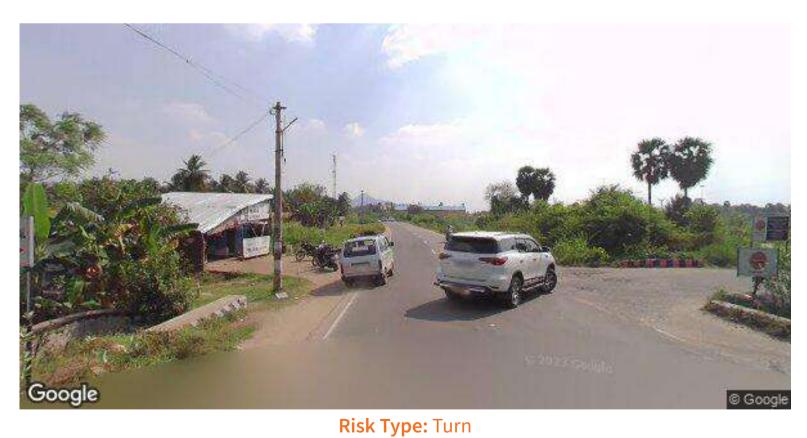
Risk Type: Turn
Risk Level: High
Speed Limit: 15 KM/Hr
Coordinates: 11.44029, 77.87544

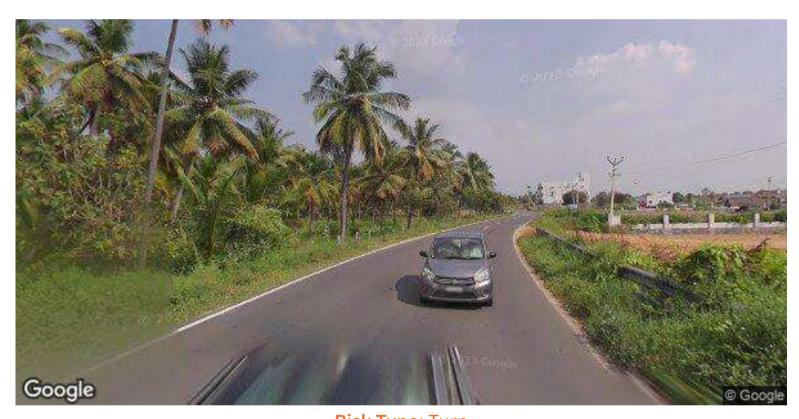
Risk Type: Turn
Risk Level: Medium
Speed Limit: 30 KM/Hr
Coordinates: 11.45357, 77.85789

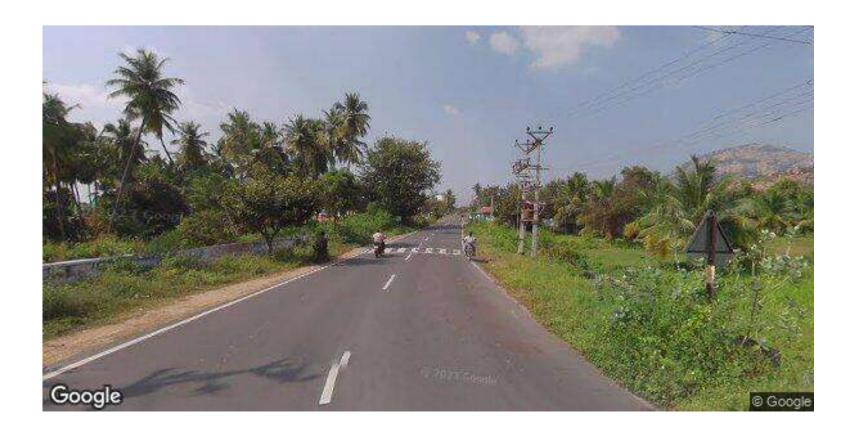
Coordinates: 11.45352, 77.85698

Risk Type: Turn Risk Level: High **Speed Limit:** 15 KM/Hr

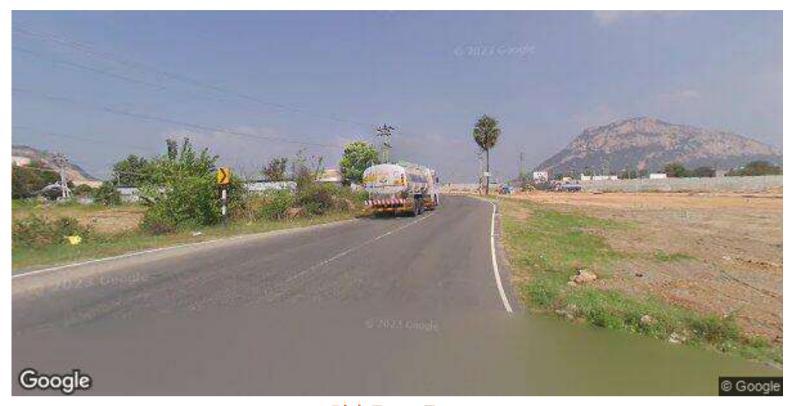
Risk Type: Turn Risk Level: Medium Speed Limit: 30 KM/Hr **Coordinates:** 11.45847, 77.85140

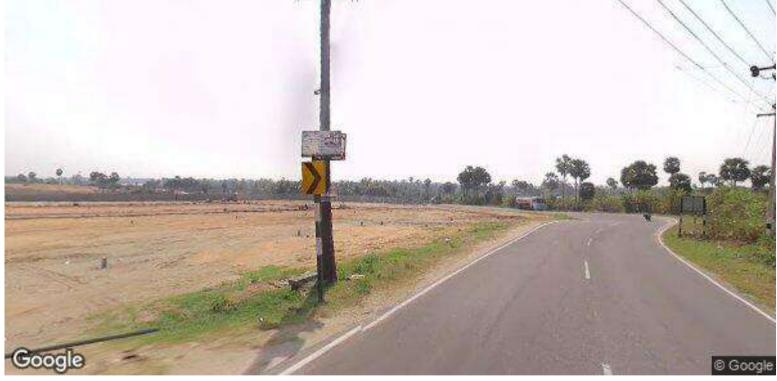
Coordinates: 11.45898, 77.85135

Risk Type: Turn Risk Level: Medium **Speed Limit:** 30 KM/Hr

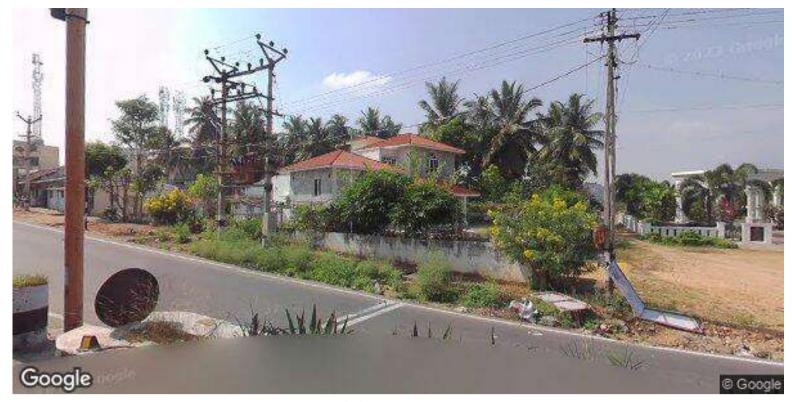
Risk Type: Turn
Risk Level: Medium
Speed Limit: 30 KM/Hr
Coordinates: 11.46303, 77.84945

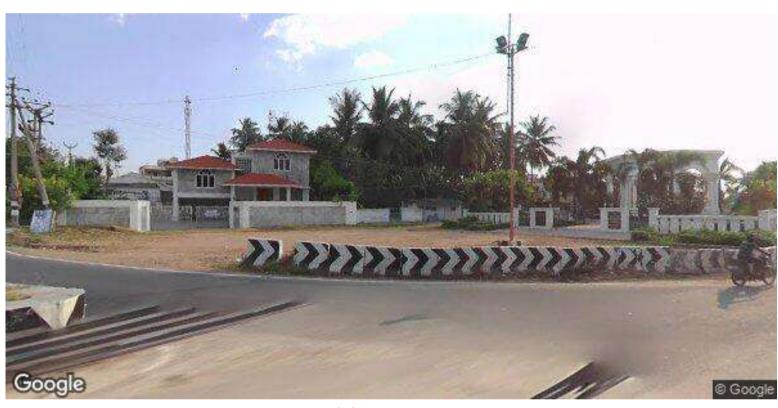
Risk Type: Turn
Risk Level: Medium
Speed Limit: 30 KM/Hr
Coordinates: 11.46314, 77.84928

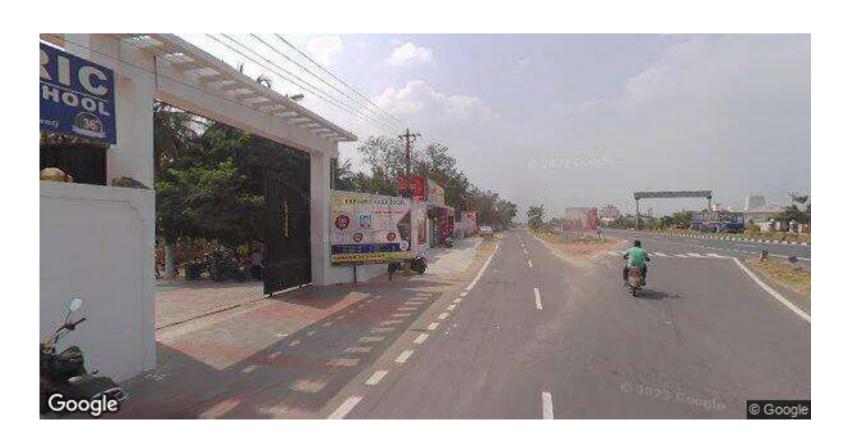
Coordinates: 11.45509, 77.81383

Risk Type: Turn
Risk Level: Medium
Speed Limit: 30 KM/Hr
