JOURNEY RISK MANAGEMENT (JRM) STUDY

Salem Terminal TO DURAISAMY SONS

Route Safety Analysis Report

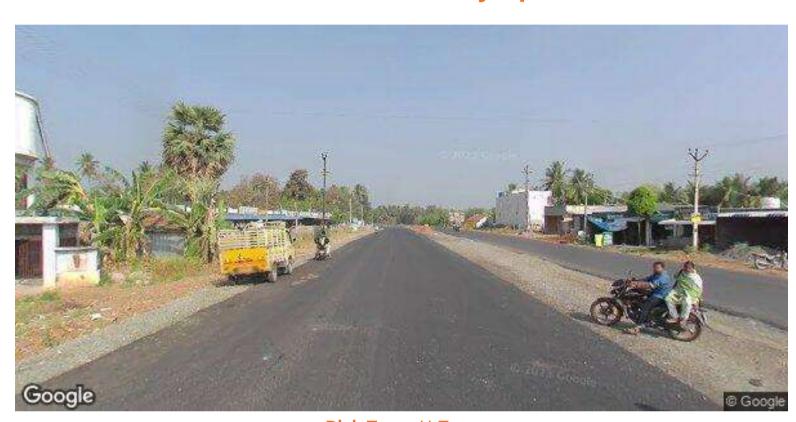
Coordinates: 11.4287655, 77.537661

Risk Type: U-Turn
Risk Level: High
Speed Limit: 10 KM/Hr

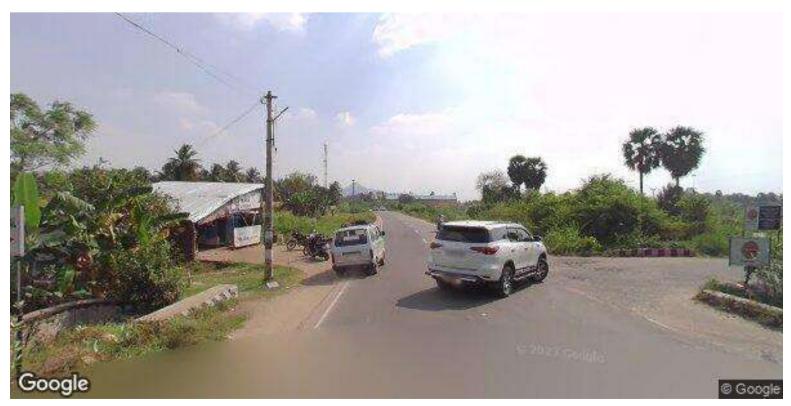
Risk Type: Turn Risk Level: High Speed Limit: 15 KM/Hr Coordinates: 11.44029, 77.87544

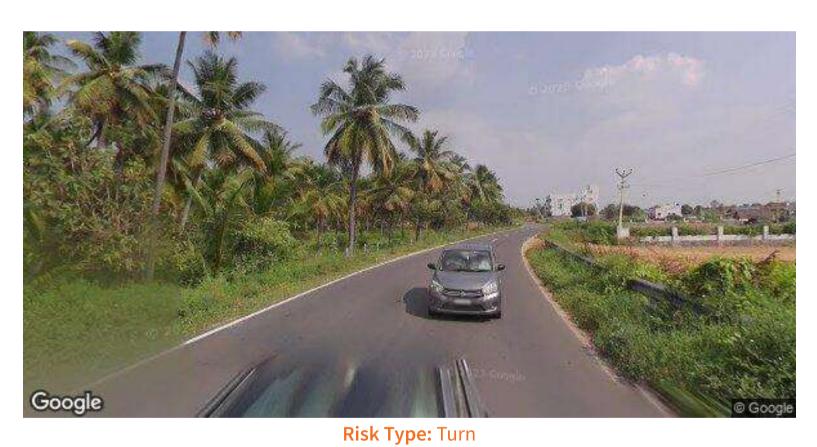
Risk Level: Medium
Speed Limit: 30 KM/Hr
Coordinates: 11.45357, 77.85789

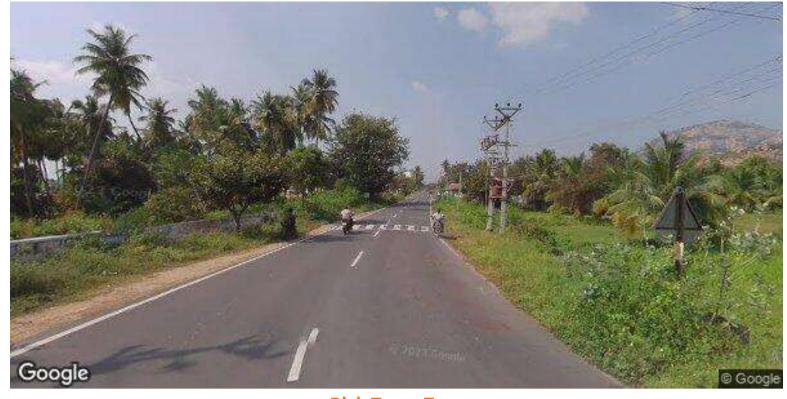
Risk Type: Turn
Risk Level: Medium
Speed Limit: 30 KM/Hr
Coordinates: 11.45352, 77.85698

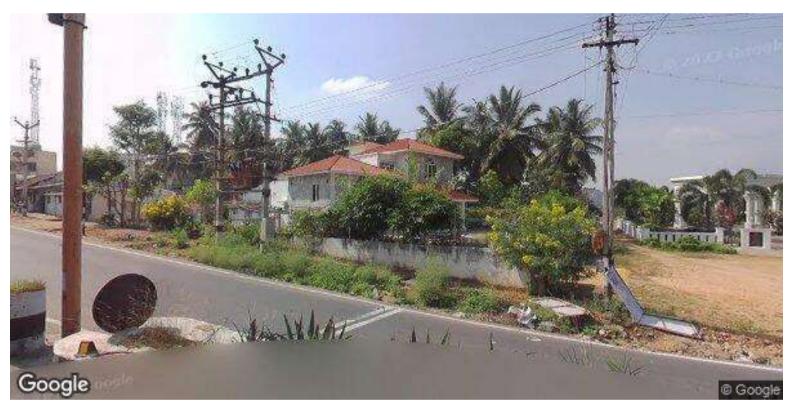
Risk Type: Turn
Risk Level: Medium
Speed Limit: 30 KM/Hr
Coordinates: 11.46303, 77.84945

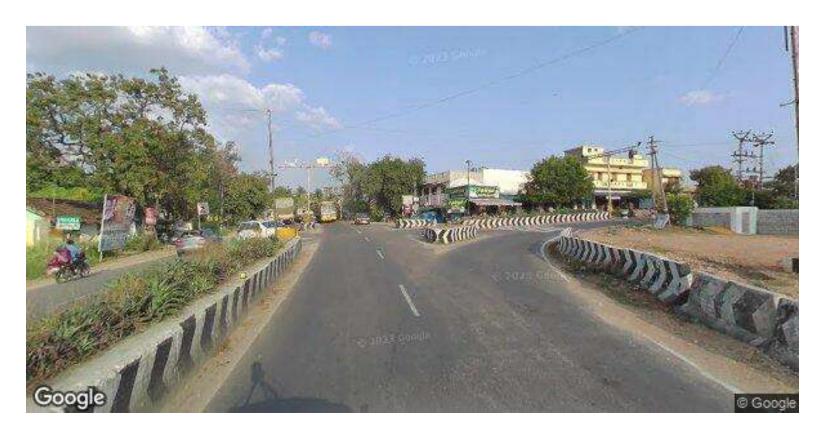
Coordinates: 11.46318, 77.84913

Risk Type: Turn
Risk Level: Medium
Speed Limit: 30 KM/Hr

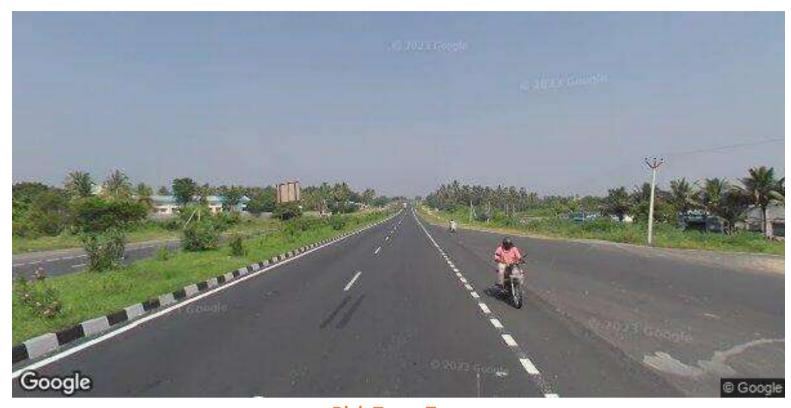
Coordinates: 11.40046, 77.65371

Risk Type: Turn
Risk Level: High
Speed Limit: 15 KM/Hr

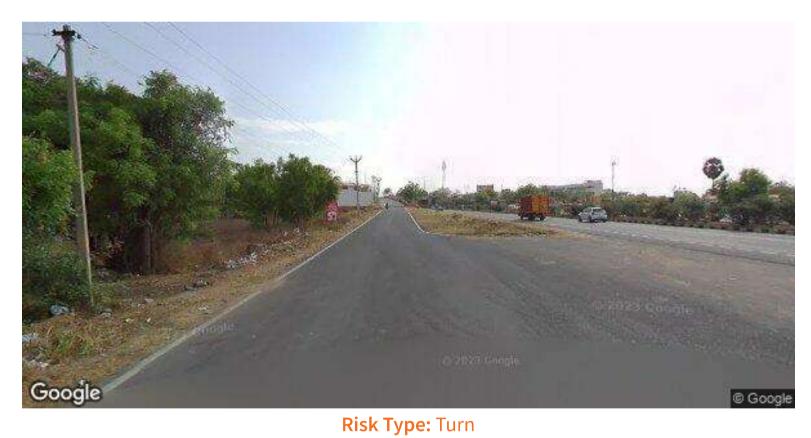
Coordinates: 11.40035, 77.65383

Risk Level: High
Speed Limit: 15 KM/Hr

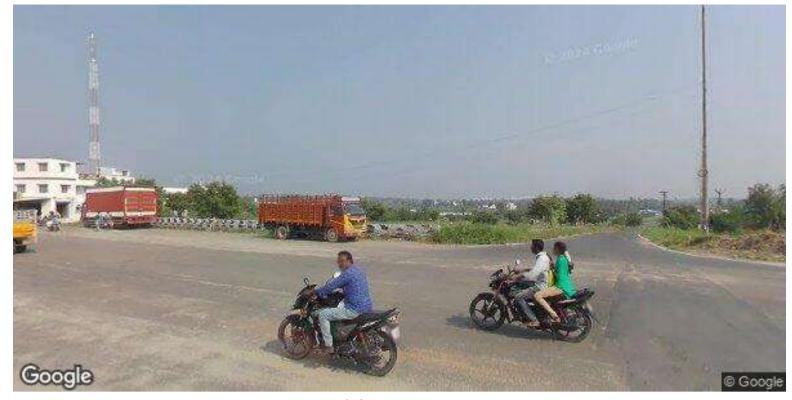
Risk Type: Turn
Risk Level: High
Speed Limit: 15 KM/Hr
Coordinates: 11.39827, 77.65237

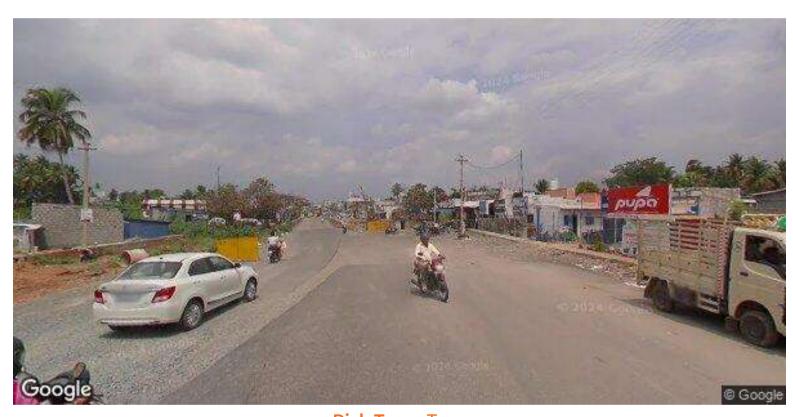
Risk Type: Turn
Risk Level: Medium
Speed Limit: 30 KM/Hr
Coordinates: 11.42079, 77.56127

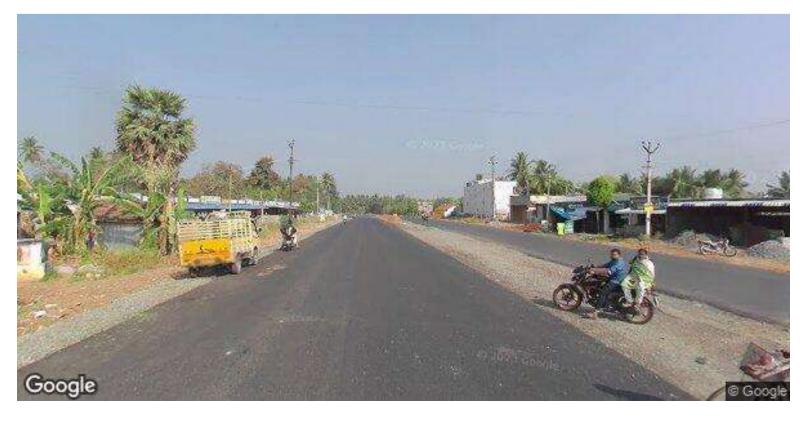
Coordinates: 11.42877, 77.53766

Risk Type: Blind Spot Risk Level: Blind Spot Speed Limit: 10 KM/Hr

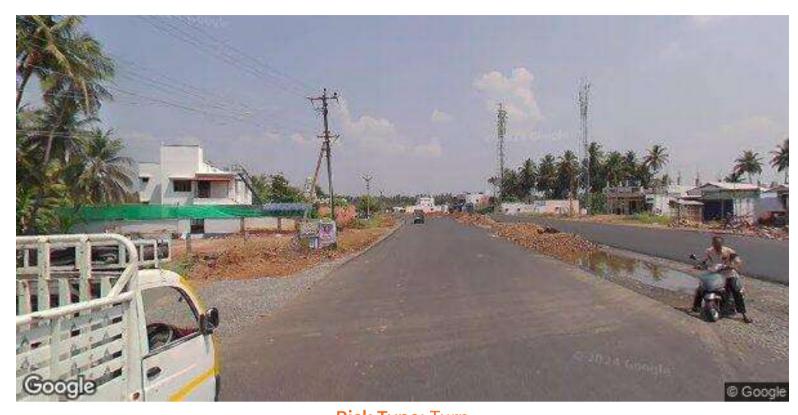
Coordinates: 11.42885, 77.53775

Risk Type: Turn
Risk Level: High
Speed Limit: 15 KM/Hr
