JOURNEY RISK MANAGEMENT (JRM) STUDY

Salem Terminal to AANJANEYA FUELS

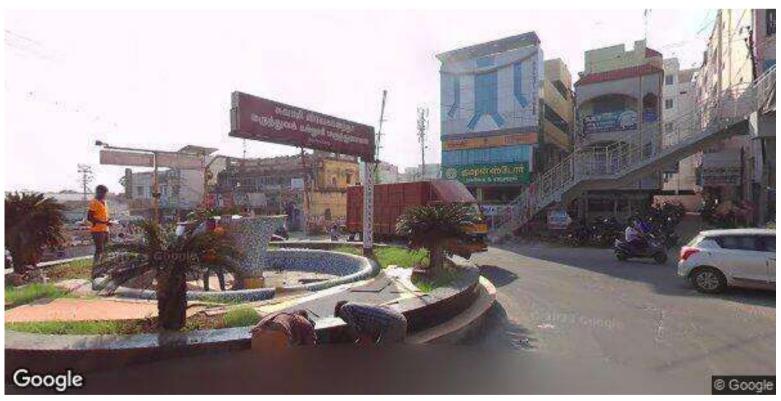
Coordinates: 11.38395, 77.89480

Risk Type: Roundabout

Risk Level: High
Speed Limit: 15 KM/Hr

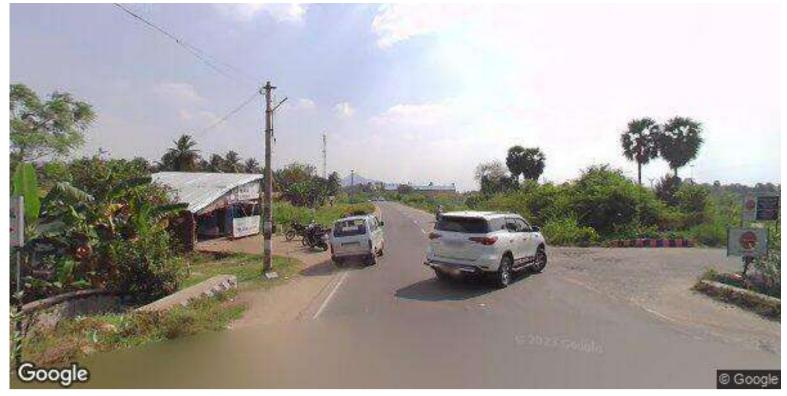
Risk Type: Blind Spot
Risk Level: Blind Spot
Speed Limit: 10 KM/Hr
Coordinates: 11.44029, 77.87544

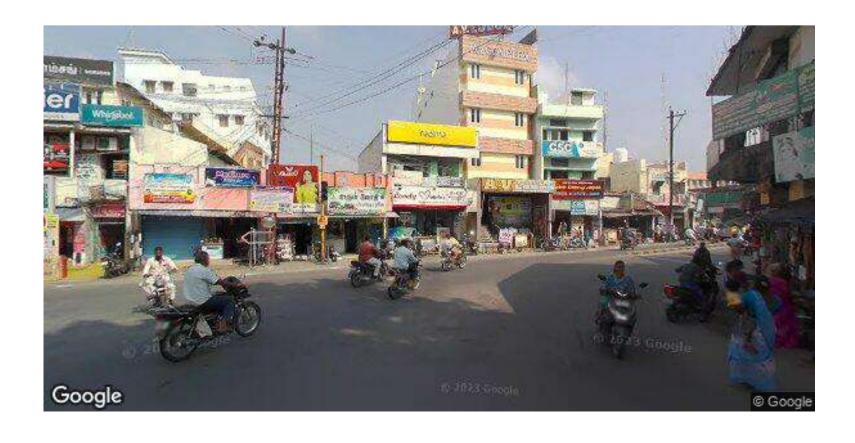
Coordinates: 11.37842, 77.89452

Risk Type: Turn
Risk Level: Medium
Speed Limit: 30 KM/Hr

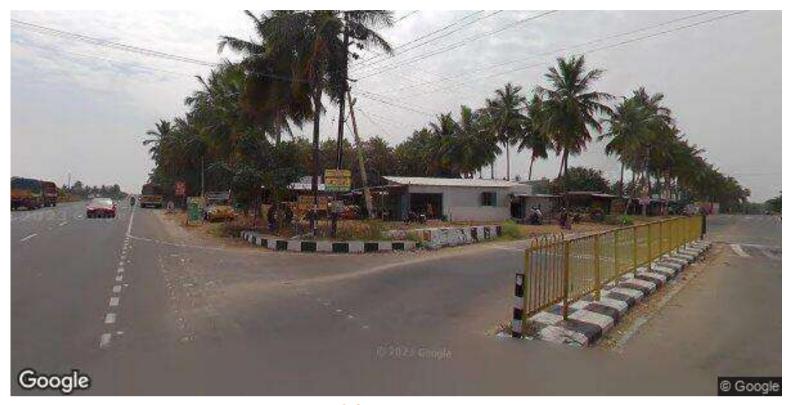
Risk Type: Turn
Risk Level: High
Speed Limit: 15 KM/Hr
Coordinates: 11.30859, 77.92918

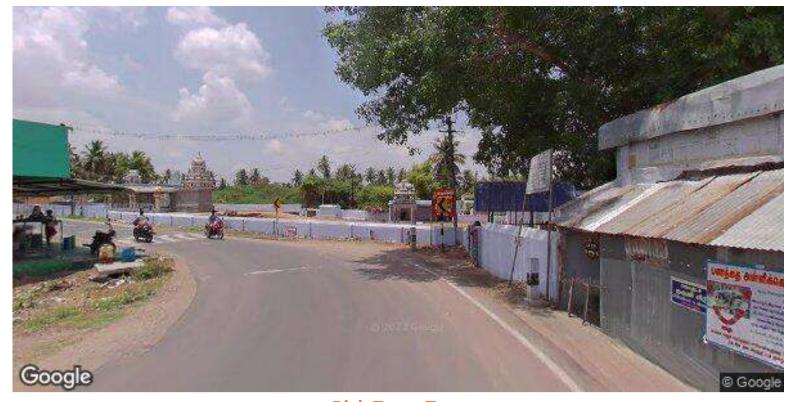
Risk Type: Turn
Risk Level: Medium
Speed Limit: 30 KM/Hr
Coordinates: 11.24053, 77.86902

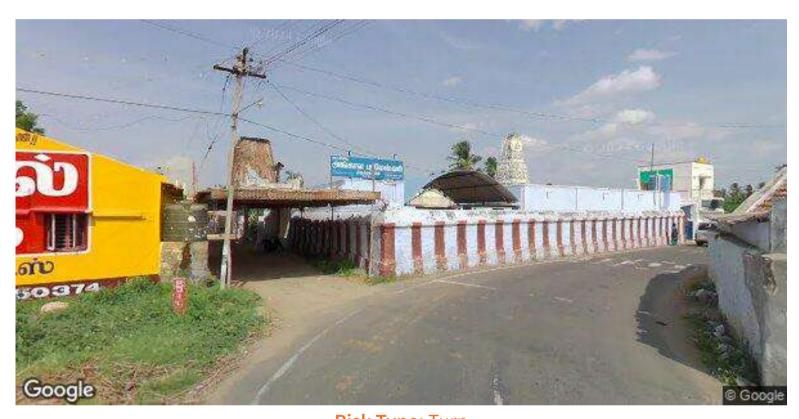
Risk Type: Turn
Risk Level: Medium
Speed Limit: 30 KM/Hr
Coordinates: 11.24115, 77.86891

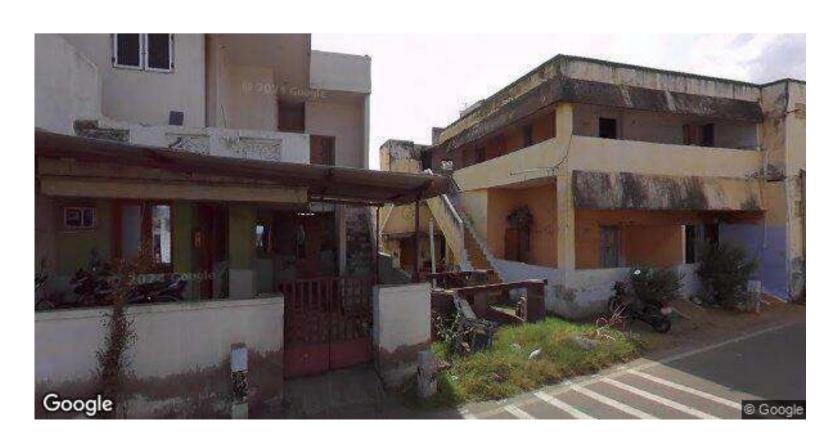
Coordinates: 11.24122, 77.86883

Risk Type: Turn
Risk Level: Medium
Speed Limit: 30 KM/Hr

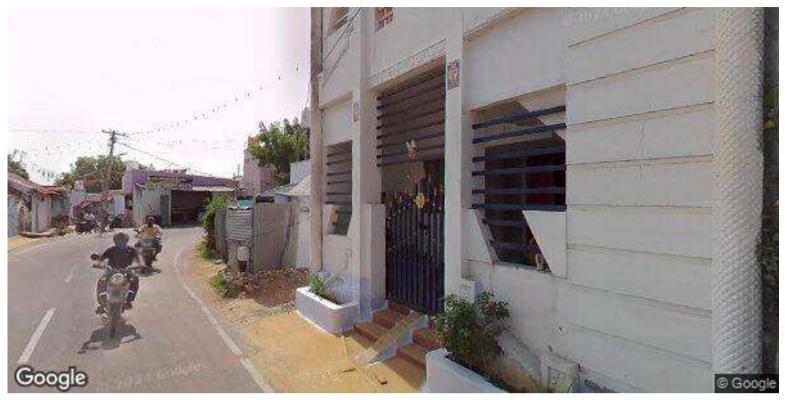
Coordinates: 11.24159, 77.86874

Risk Type: Turn
Risk Level: High
Speed Limit: 15 KM/Hr

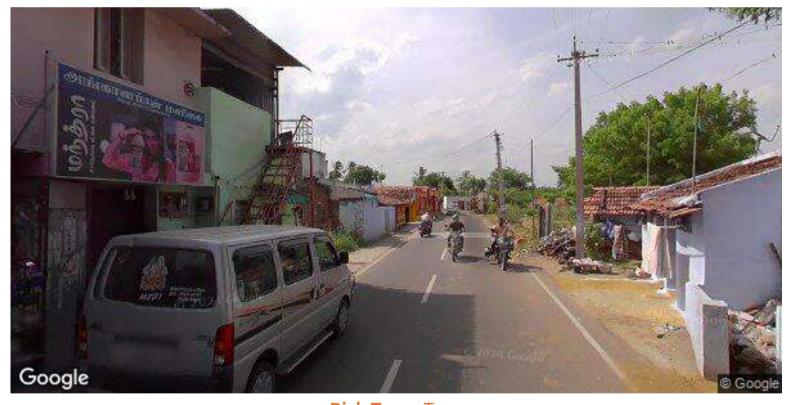
Risk Type: Turn
Risk Level: High
Speed Limit: 15 KM/Hr
Coordinates: 11.24170, 77.86842

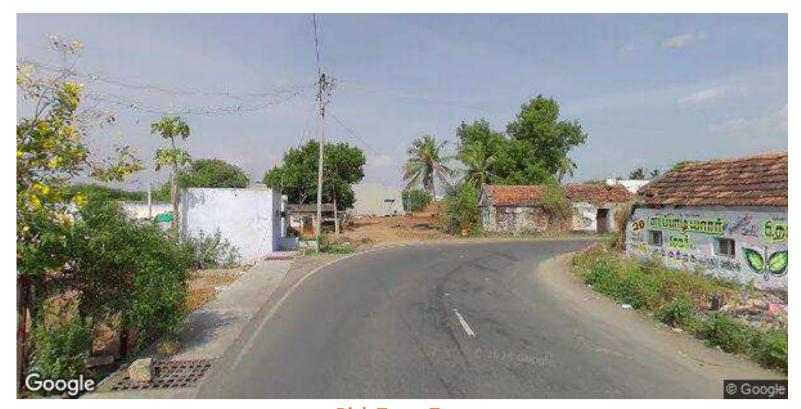
Risk Type: Turn
Risk Level: High
Speed Limit: 15 KM/Hr
Coordinates: 11.24248, 77.86829

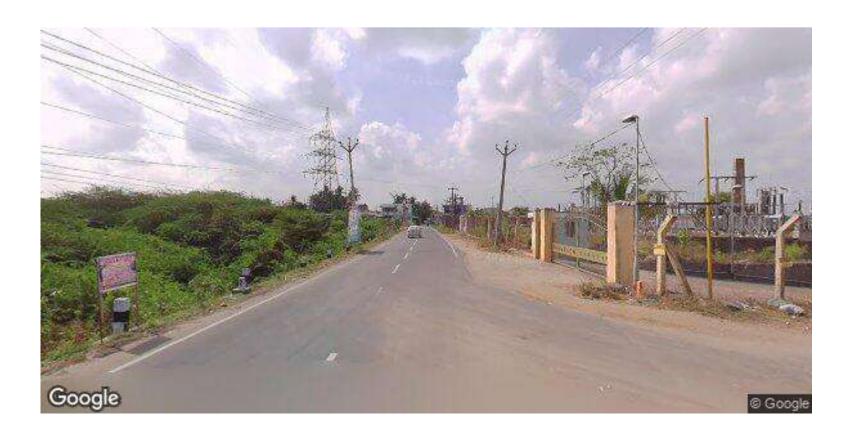
Coordinates: 11.24384, 77.86689

Risk Type: Blind Spot
Risk Level: Blind Spot
Speed Limit: 10 KM/Hr

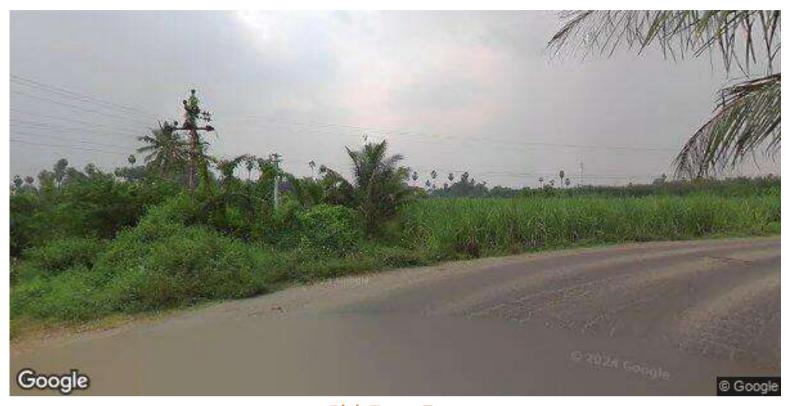
Coordinates: 11.24101, 77.86034

Risk Type: Turn
Risk Level: Medium
Speed Limit: 30 KM/Hr

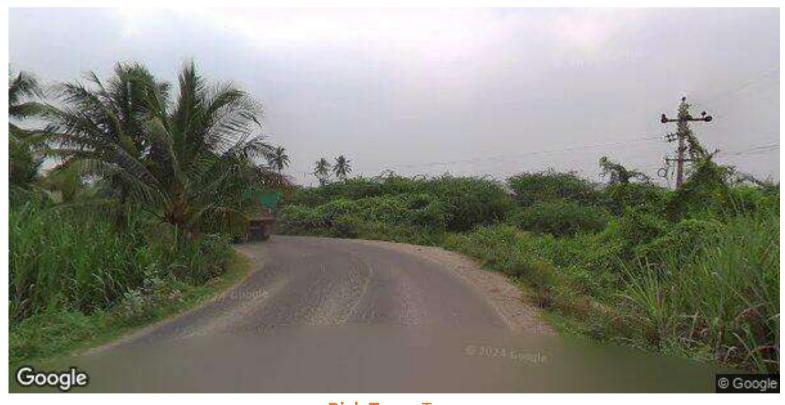
Risk Type: Turn
Risk Level: Medium
Speed Limit: 30 KM/Hr
Coordinates: 11.24103, 77.86020

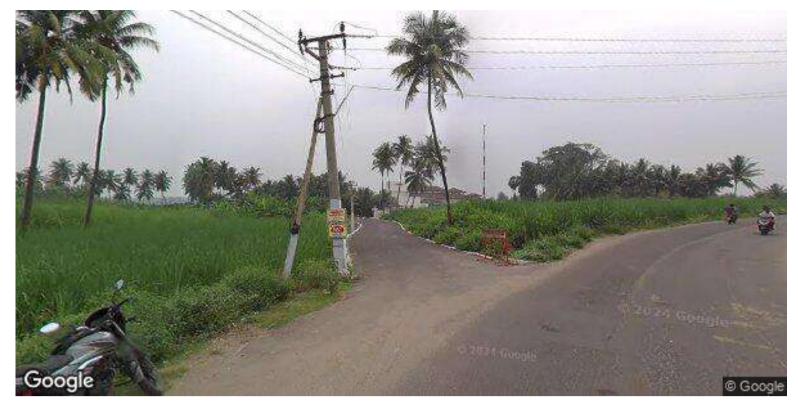
Risk Type: Turn
Risk Level: Medium
Speed Limit: 30 KM/Hr
Coordinates: 11.24197, 77.85905

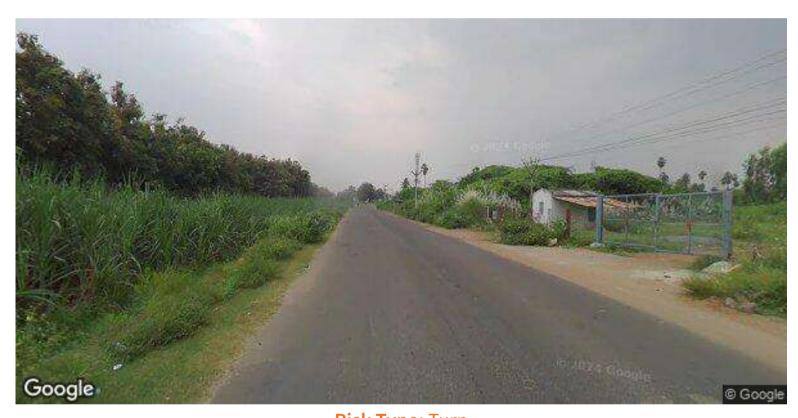
Risk Type: Turn
Risk Level: Medium
Speed Limit: 30 KM/Hr
Coordinates: 11.24196, 77.85856

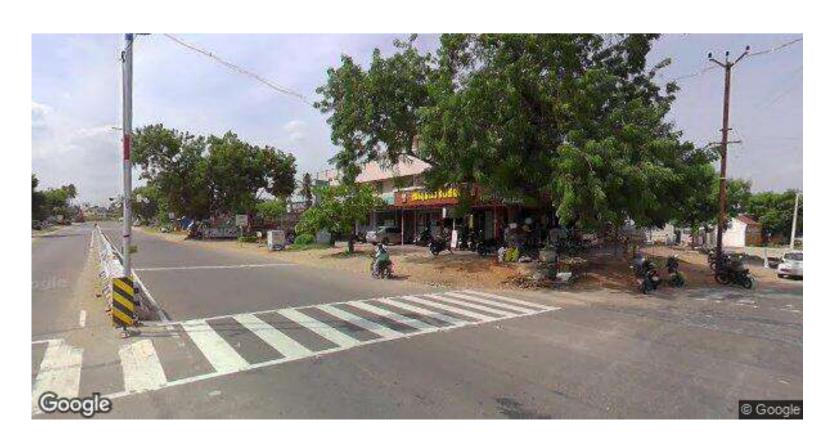
Coordinates: 11.22377, 77.83980

Risk Type: Turn
Risk Level: High
Speed Limit: 15 KM/Hr

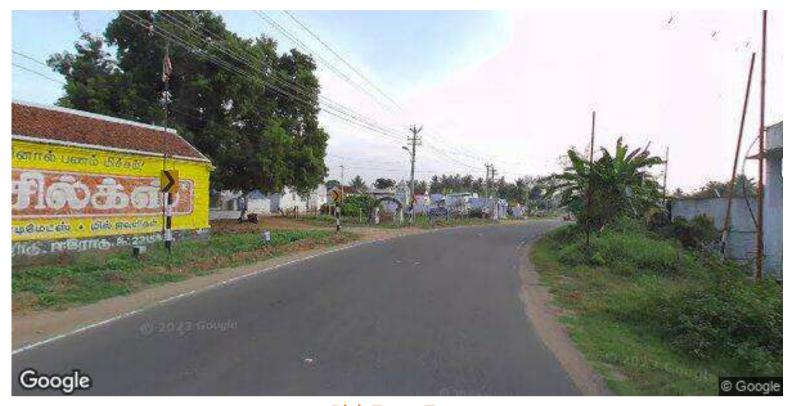
Coordinates: 11.14839, 77.84954

Risk Type: Turn
Risk Level: Medium
Speed Limit: 30 KM/Hr
