# JOURNEY RISK MANAGEMENT (JRM) STUDY

# **IOCL Coimbatore Terminal to Tanfed Udumalpet**

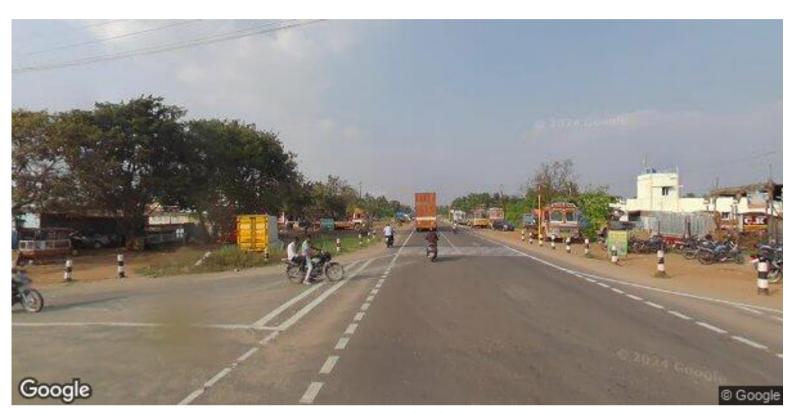
**Coordinates:** 11.03211, 77.07640

Risk Type: Blind Spot Risk Level: Blind Spot Speed Limit: 10 KM/Hr

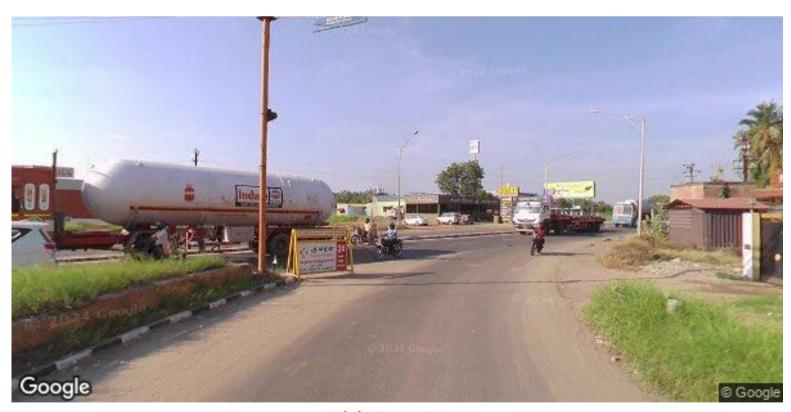
**Coordinates:** 11.00787, 77.07082

Risk Type: Turn
Risk Level: Medium
Speed Limit: 30 KM/Hr

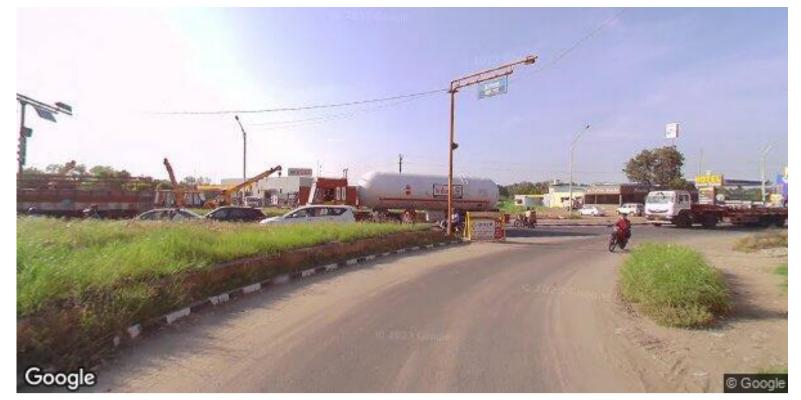
**Coordinates:** 11.00778, 77.07085

Risk Type: Turn
Risk Level: High
Speed Limit: 15 KM/Hr

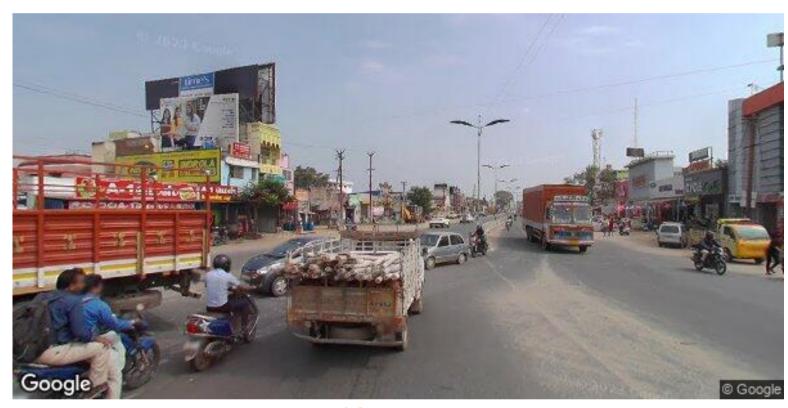
Risk Type: Turn
Risk Level: Medium
Speed Limit: 30 KM/Hr
Coordinates: 11.02774, 77.12761

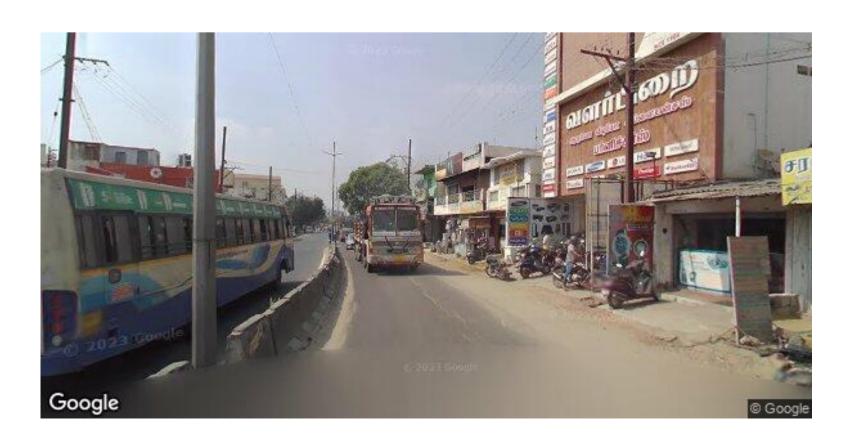
**Coordinates:** 10.99570, 77.28153

Risk Type: Turn
Risk Level: Medium
Speed Limit: 30 KM/Hr

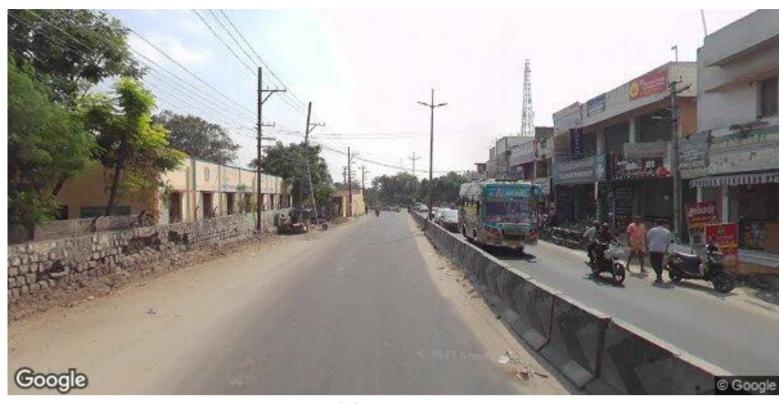
Risk Type: Turn
Risk Level: Medium
Speed Limit: 30 KM/Hr
Coordinates: 10.99535, 77.28179

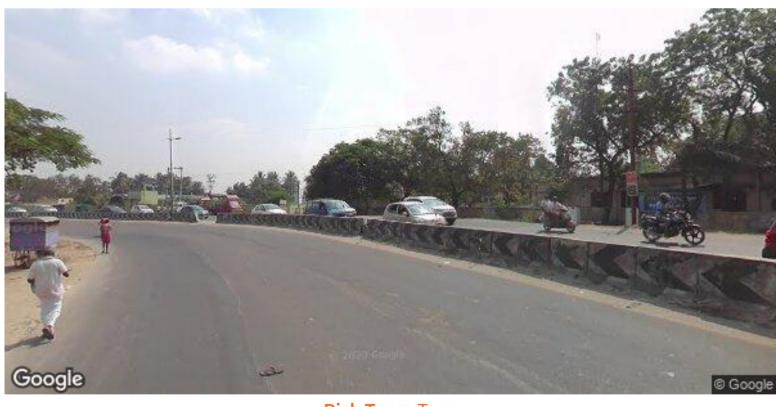
Risk Type: Turn
Risk Level: Medium
Speed Limit: 30 KM/Hr
Coordinates: 10.99436, 77.28183

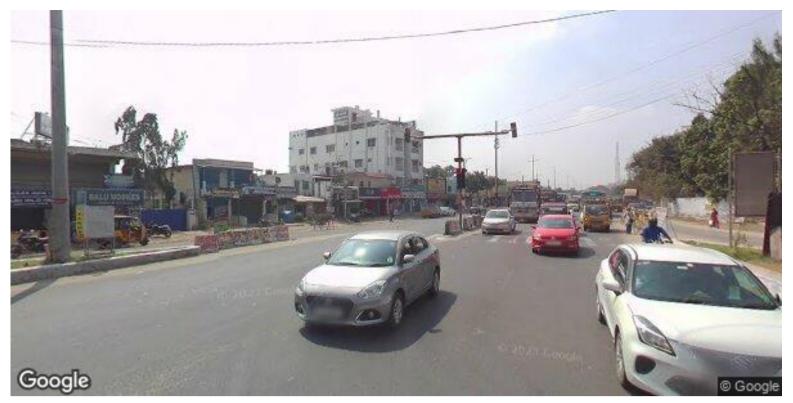
Risk Type: Turn
Risk Level: High
Speed Limit: 15 KM/Hr
Coordinates: 10.99400, 77.28557

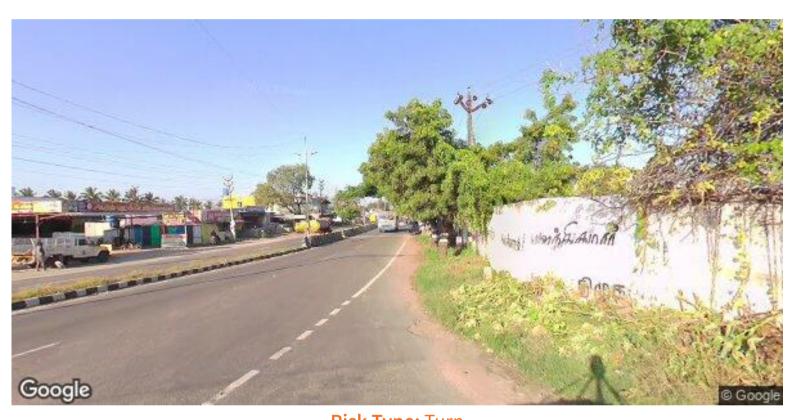
Risk Type: Turn
Risk Level: Medium
Speed Limit: 30 KM/Hr
Coordinates: 10.98116, 77.27933

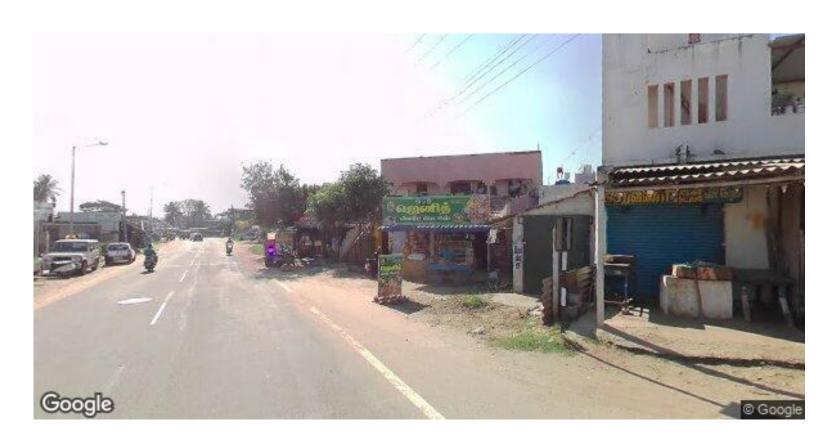
**Coordinates:** 10.59638, 77.24639

Risk Type: Turn
Risk Level: Medium
Speed Limit: 30 KM/Hr

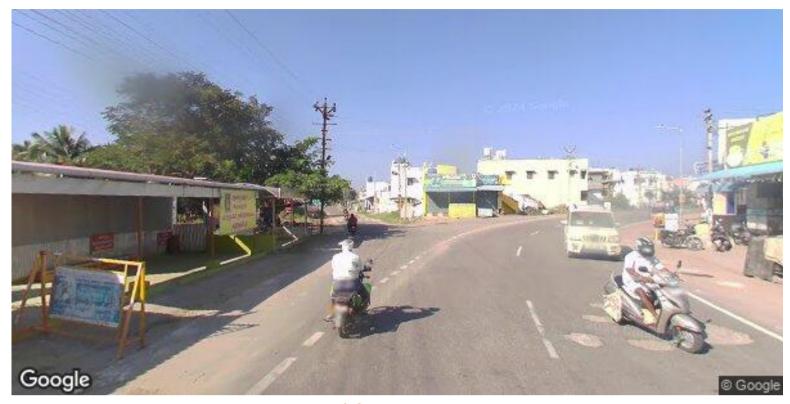
Risk Type: Turn
Risk Level: Medium
Speed Limit: 30 KM/Hr
Coordinates: 10.59541, 77.24546

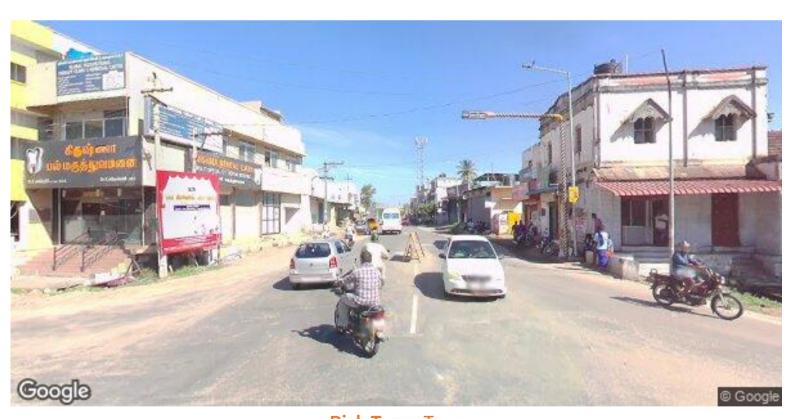
**Coordinates:** 10.58828, 77.24496

Risk Type: Turn
Risk Level: High
Speed Limit: 15 KM/Hr

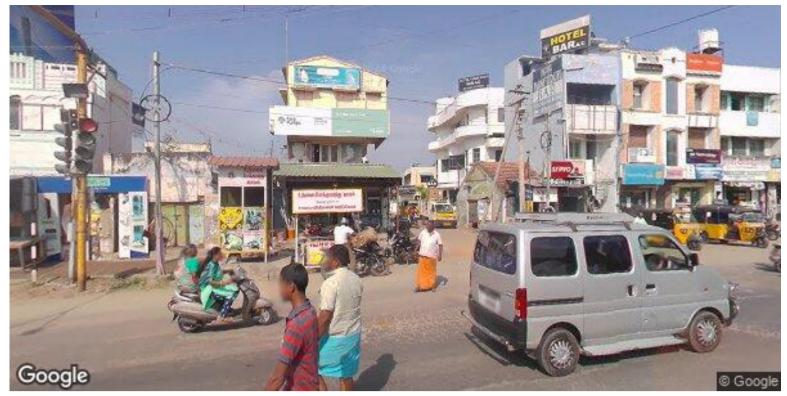
Risk Type: Turn
Risk Level: High
Speed Limit: 15 KM/Hr
Coordinates: 10.58790, 77.24599

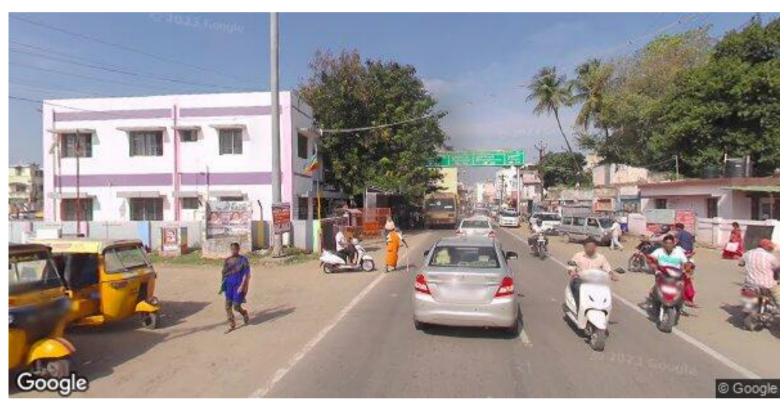
Risk Type: Blind Spot
Risk Level: Blind Spot
Speed Limit: 10 KM/Hr
Coordinates: 10.58455, 77.24482

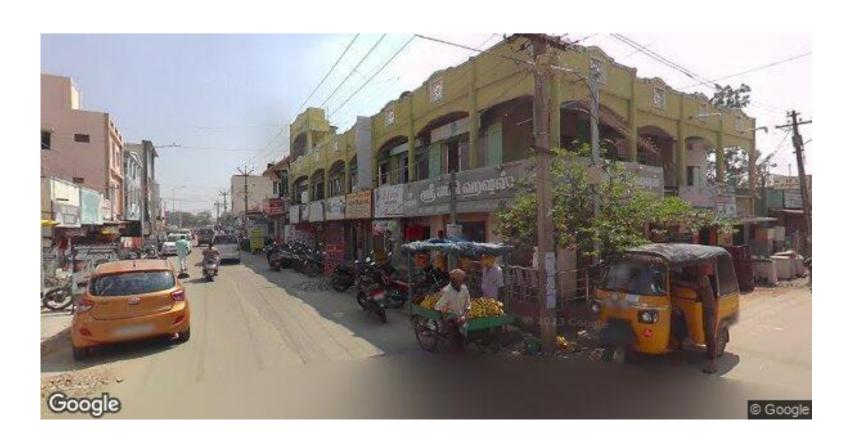
**Coordinates:** 10.58420, 77.24845

Risk Type: Blind Spot Risk Level: Blind Spot Speed Limit: 10 KM/Hr

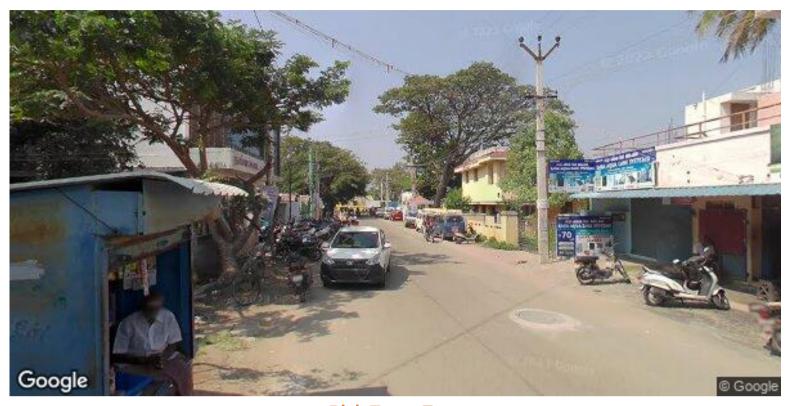
**Coordinates:** 10.58331, 77.24837

Risk Type: Turn
Risk Level: High
Speed Limit: 15 KM/Hr
