JOURNEY RISK MANAGEMENT (JRM) STUDY

IOCL Coimbatore Terminal to Somu Petro Fuels

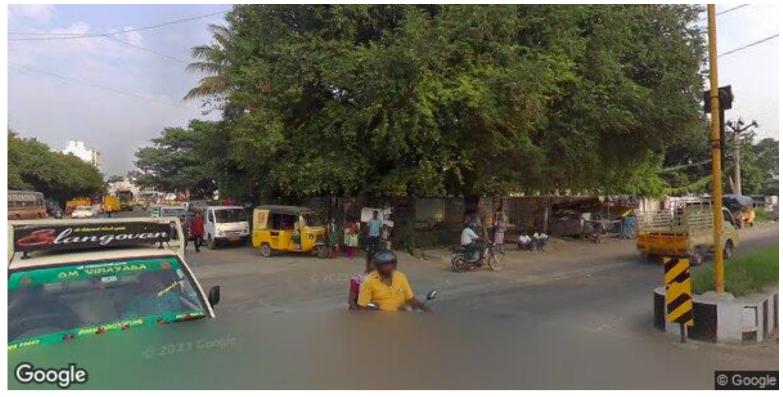
Coordinates: 11.07800, 77.03707

Risk Type: Roundabout
Risk Level: High
Speed Limit: 15 KM/Hr

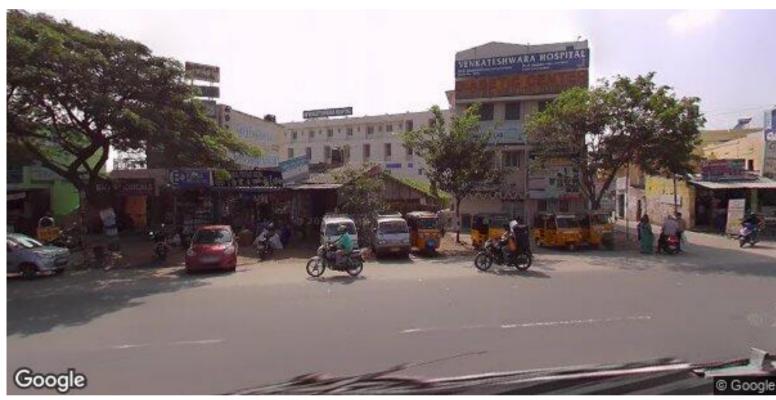
Coordinates: 11.0549503, 77.0650284

Risk Type: U-Turn
Risk Level: High
Speed Limit: 10 KM/Hr

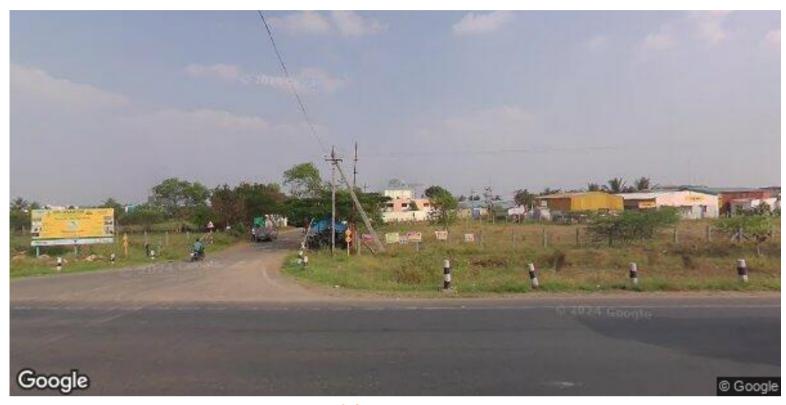
Coordinates: 11.05129, 77.07919

Risk Type: Turn
Risk Level: High
Speed Limit: 15 KM/Hr

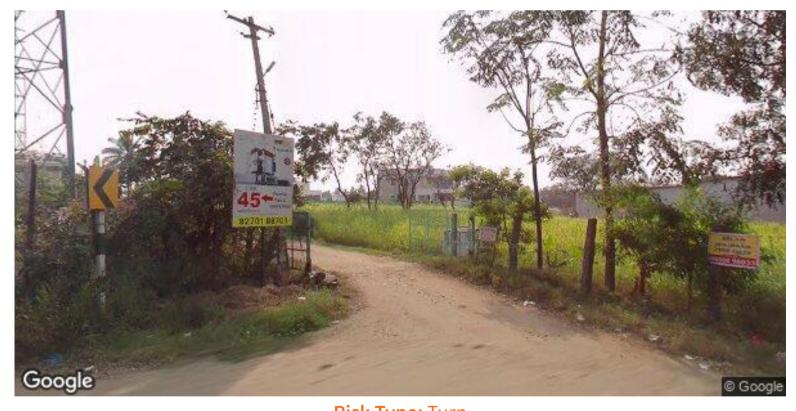
Coordinates: 11.05181, 77.07696

Risk Type: Turn
Risk Level: High
Speed Limit: 15 KM/Hr

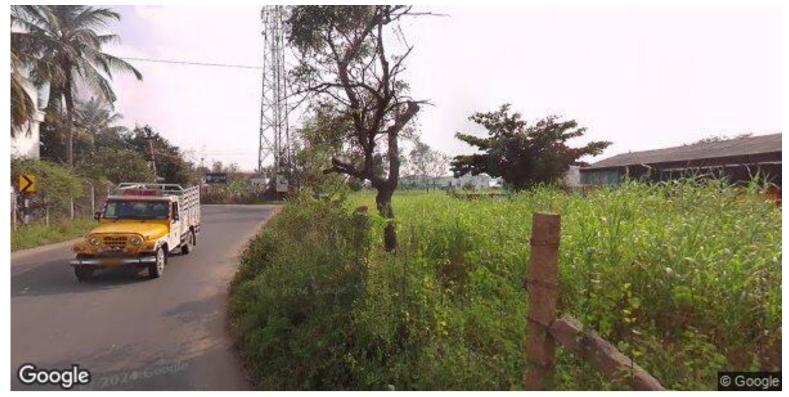
Risk Type: Turn
Risk Level: High
Speed Limit: 15 KM/Hr
Coordinates: 11.05218, 77.07692

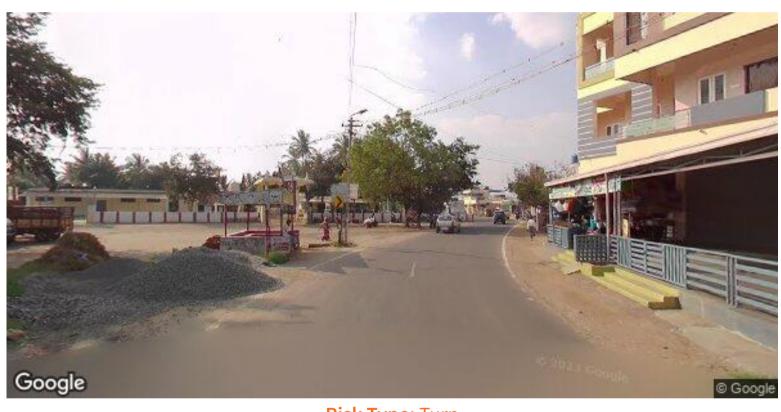
Risk Type: Turn
Risk Level: Medium
Speed Limit: 30 KM/Hr
Coordinates: 11.05281, 77.07261

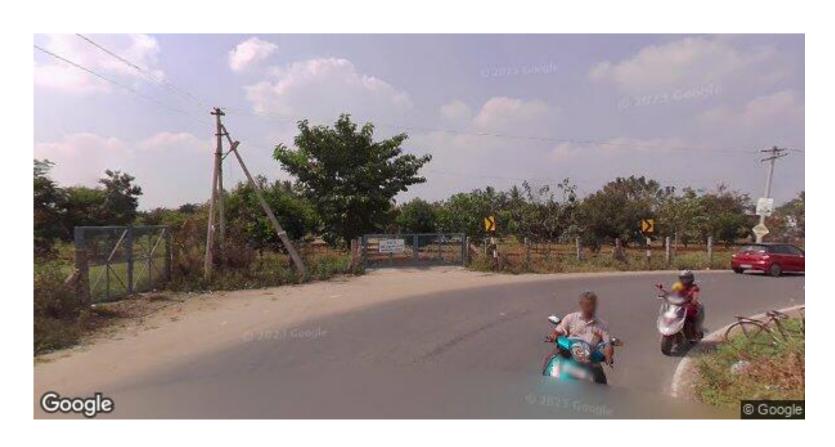
Coordinates: 11.05343, 77.07106

Risk Type: Turn
Risk Level: Medium
Speed Limit: 30 KM/Hr

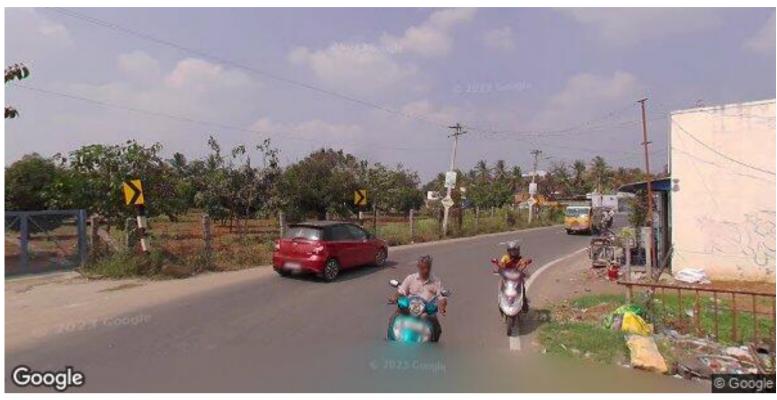
Coordinates: 11.05351, 77.07099

Risk Type: Turn
Risk Level: High
Speed Limit: 15 KM/Hr

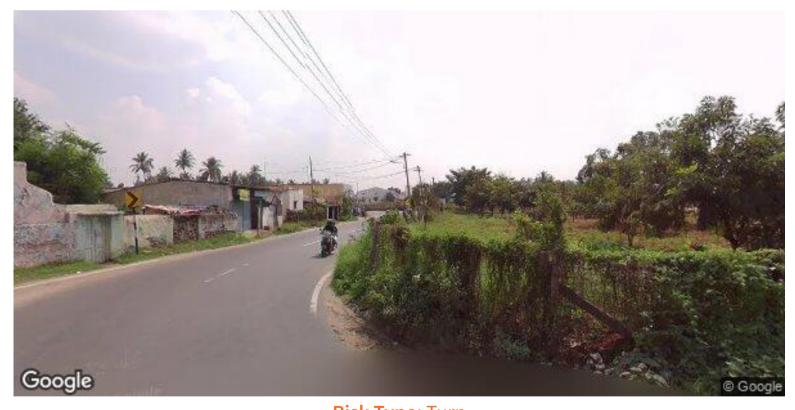
Coordinates: 11.05411, 77.07097

Risk Type: Turn
Risk Level: High
Speed Limit: 15 KM/Hr

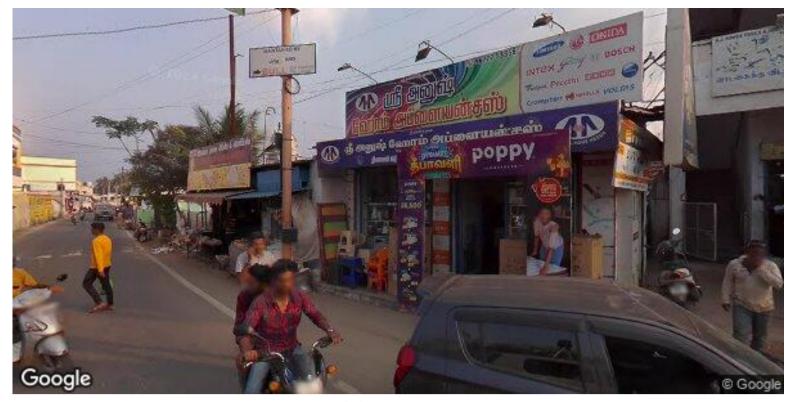
Risk Type: Turn
Risk Level: Medium
Speed Limit: 30 KM/Hr
Coordinates: 11.05527, 77.06568

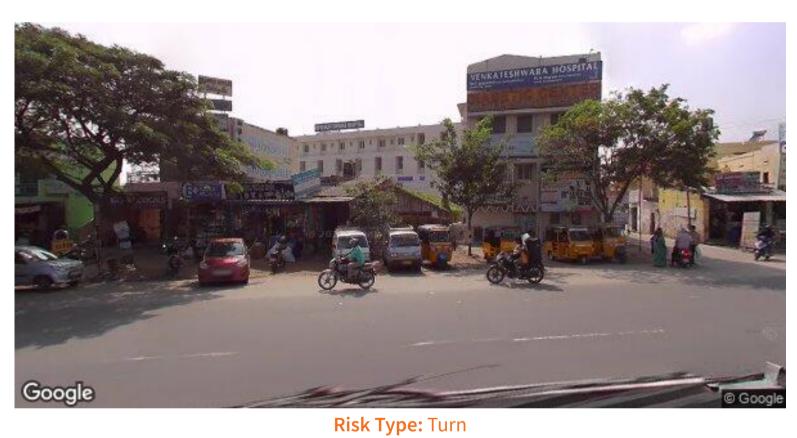
Risk Level: High
Speed Limit: 15 KM/Hr
Coordinates: 11.05495, 77.06503

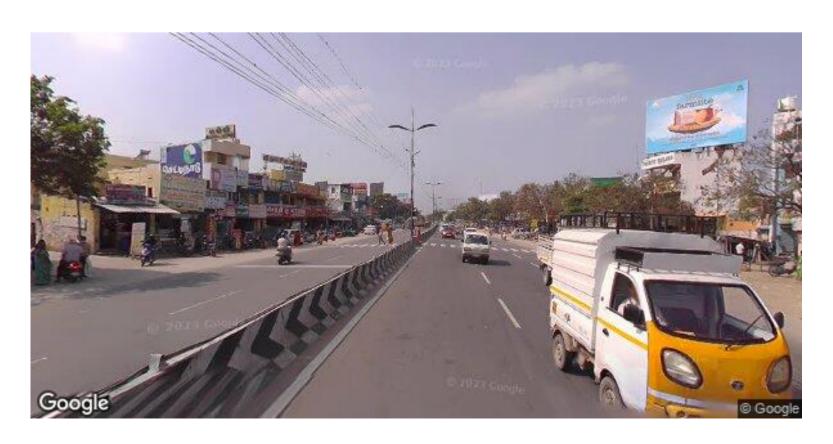
Coordinates: 11.05507, 77.06496

Risk Type: Blind Spot Risk Level: Blind Spot Speed Limit: 10 KM/Hr

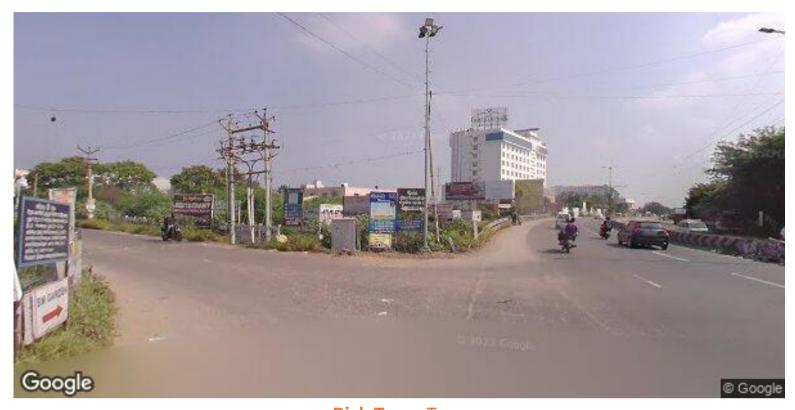
Risk Type: Turn
Risk Level: High
Speed Limit: 15 KM/Hr
Coordinates: 11.05751, 77.06875

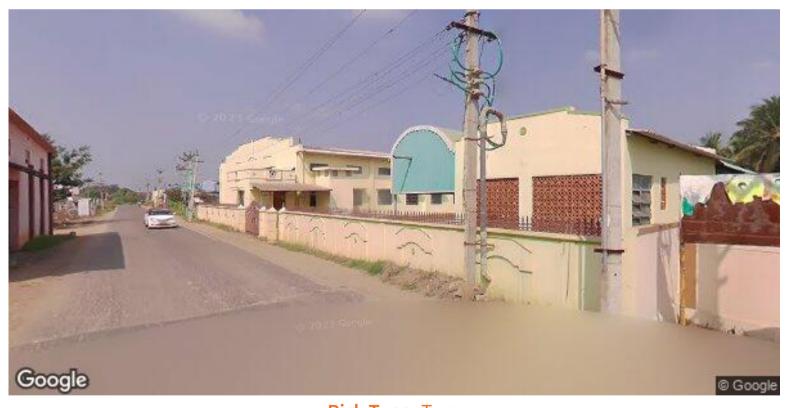
Coordinates: 11.06437, 77.06865

Risk Type: Turn
Risk Level: High
Speed Limit: 15 KM/Hr

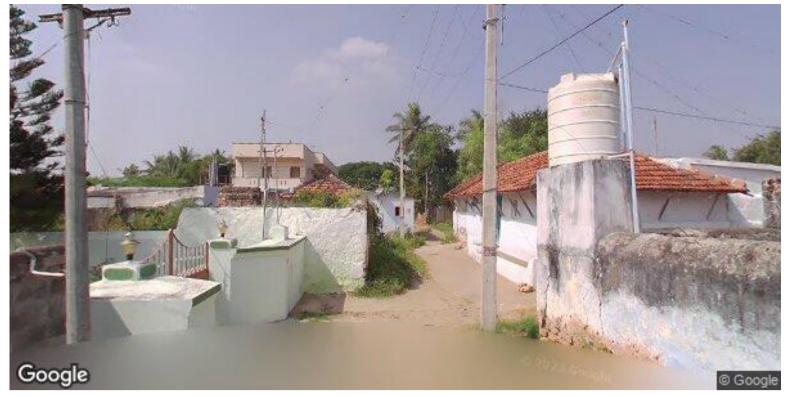
Coordinates: 11.06510, 77.06256

Risk Type: Blind Spot Risk Level: Blind Spot Speed Limit: 10 KM/Hr

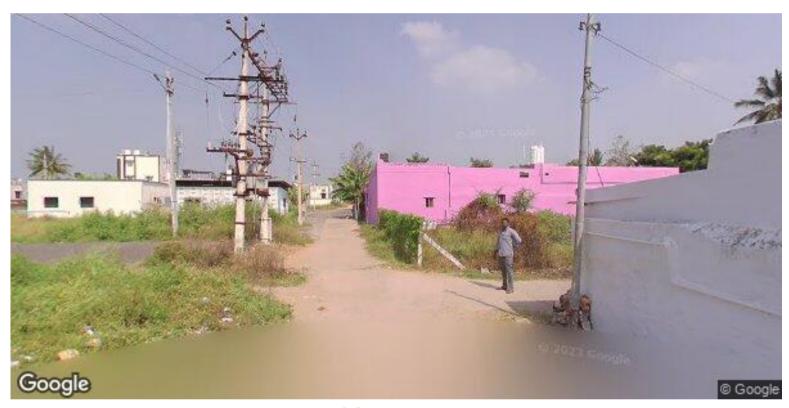
Risk Type: Turn
Risk Level: High
Speed Limit: 15 KM/Hr
Coordinates: 11.06612, 77.06275

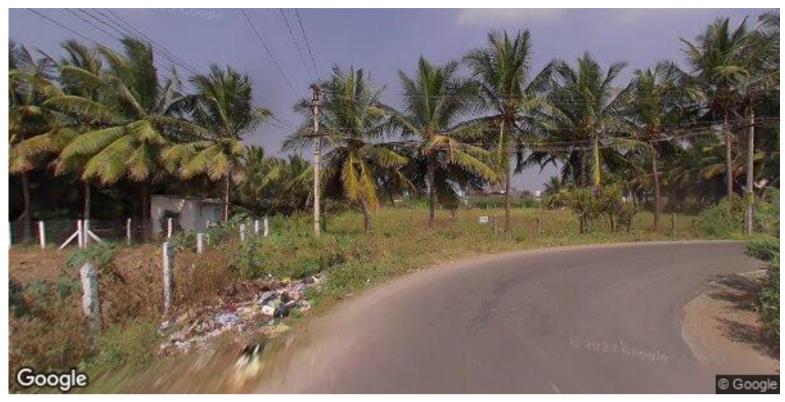
Coordinates: 11.07198, 77.06365

Risk Type: Turn
Risk Level: Medium
Speed Limit: 30 KM/Hr

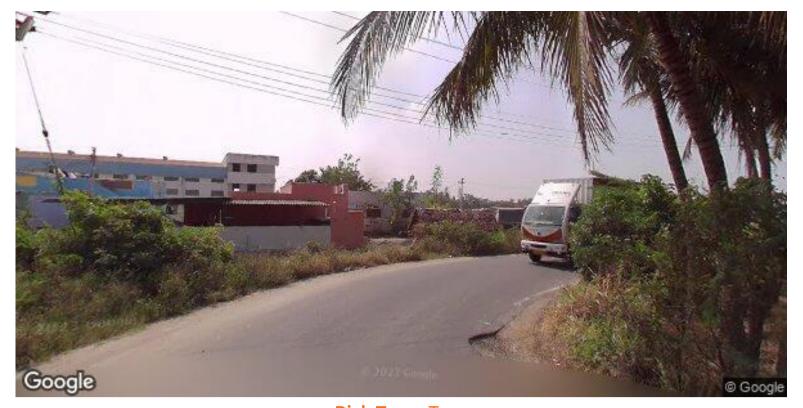
Risk Type: Turn
Risk Level: Medium
Speed Limit: 30 KM/Hr
Coordinates: 11.07228, 77.06399

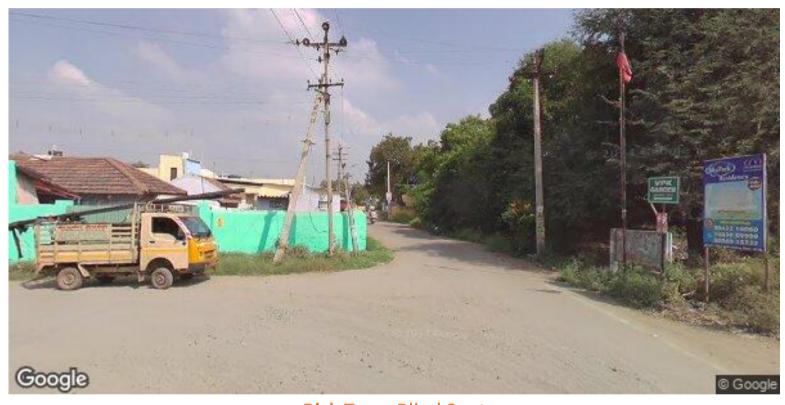
Risk Type: Blind Spot
Risk Level: Blind Spot
Speed Limit: 10 KM/Hr
Coordinates: 11.07865, 77.06377

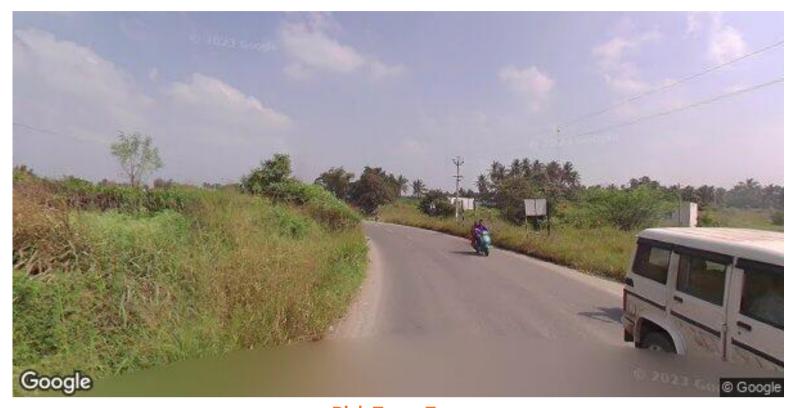
Risk Type: Turn
Risk Level: Medium
Speed Limit: 30 KM/Hr
Coordinates: 11.07667, 77.05838

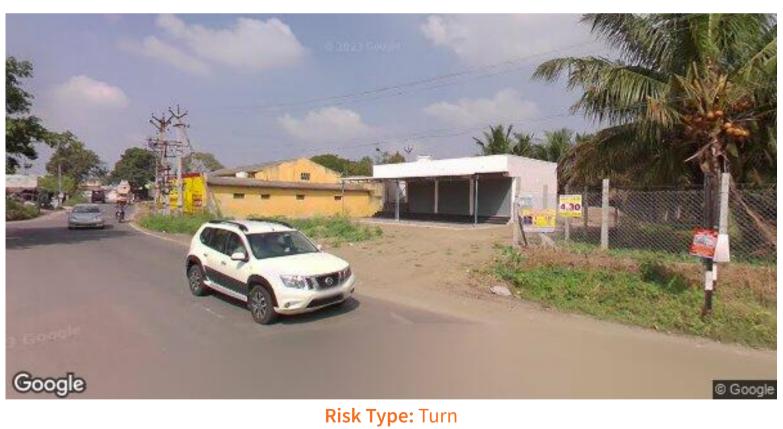
Risk Type. Turn
Risk Level: Medium
Speed Limit: 30 KM/Hr
Coordinates: 11.07650, 77.05803

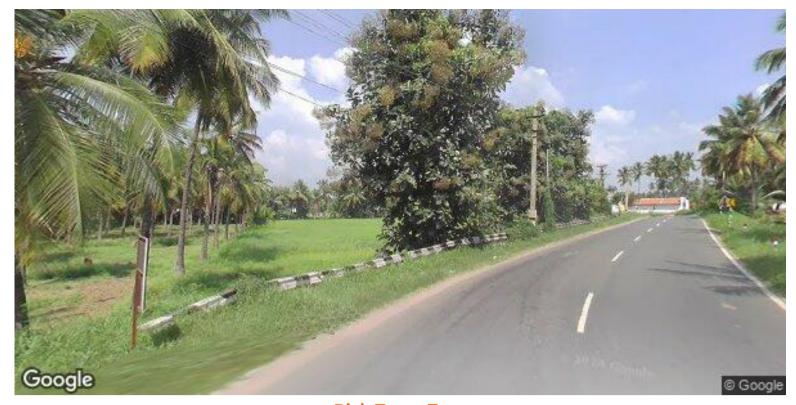
Risk Type: Turn
Risk Level: Medium
Speed Limit: 30 KM/Hr
Coordinates: 11.09599, 77.03170

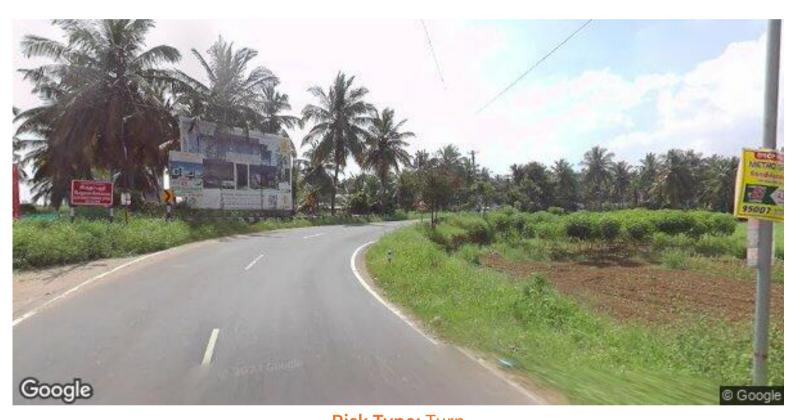
Risk Type: Turn
Risk Level: Medium
Speed Limit: 30 KM/Hr
Coordinates: 11.09663, 77.03241

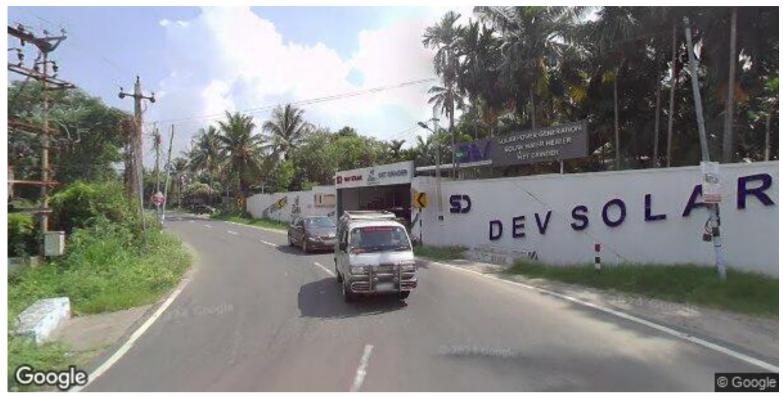
Coordinates: 11.09879, 77.03095

Risk Type: Turn
Risk Level: High
Speed Limit: 15 KM/Hr

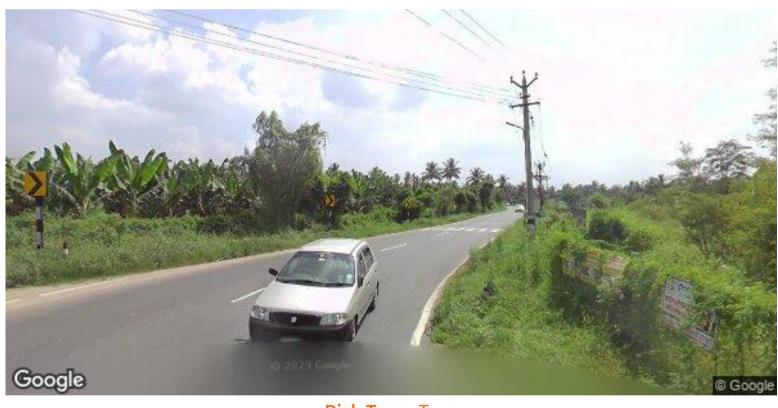
Risk Type: Turn
Risk Level: Medium
Speed Limit: 30 KM/Hr
Coordinates: 11.10295, 77.03049

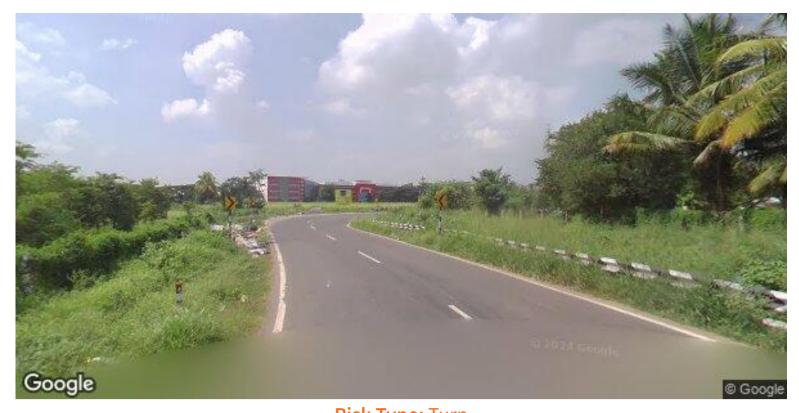
Risk Type: Turn
Risk Level: Medium
Speed Limit: 30 KM/Hr
Coordinates: 11.10306, 77.03040

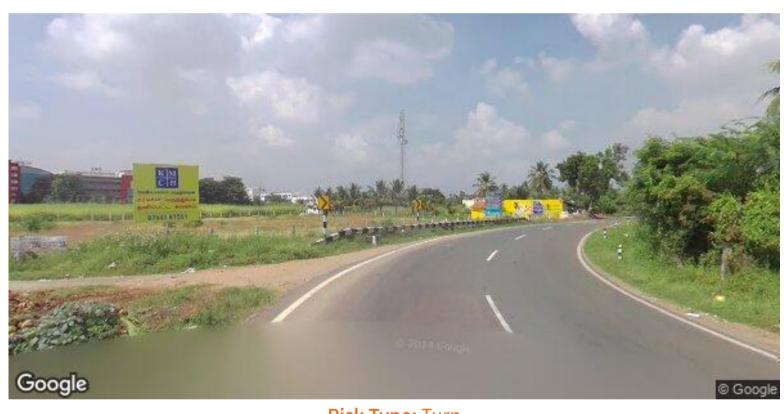
Risk Type: Turn
Risk Level: Medium
Speed Limit: 30 KM/Hr
Coordinates: 11.10315, 77.02995

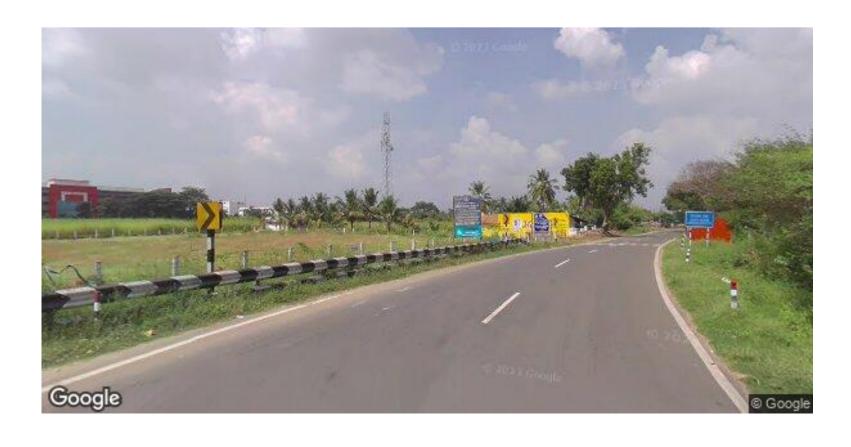
Coordinates: 11.10326, 77.02986

Risk Type: Turn
Risk Level: Medium
Speed Limit: 30 KM/Hr

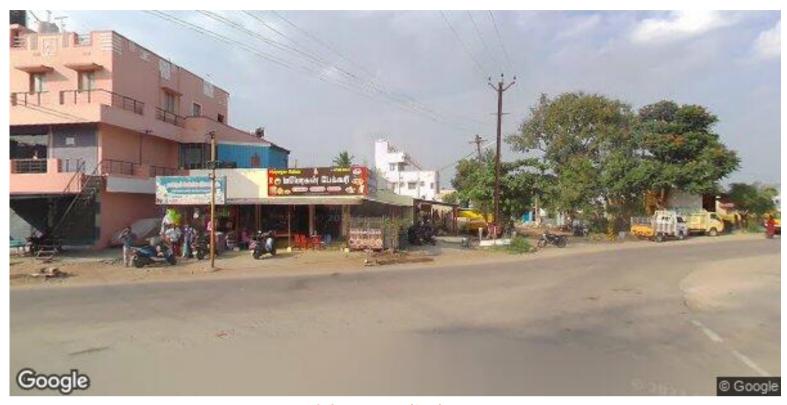
Coordinates: 11.11250, 77.03030

Risk Type: Blind Spot Risk Level: Blind Spot Speed Limit: 10 KM/Hr

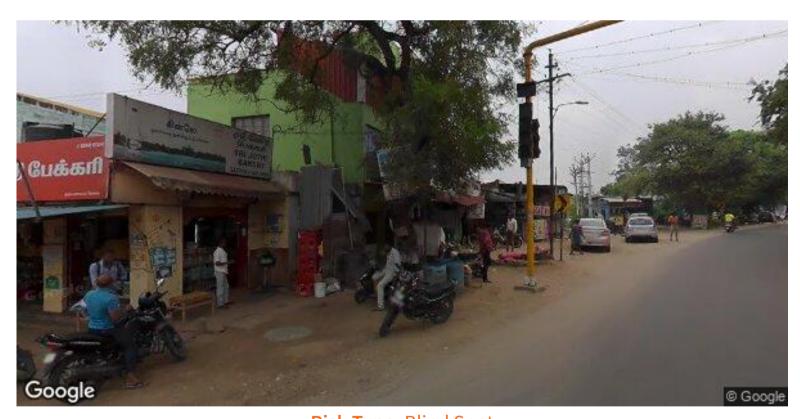
Coordinates: 11.11256, 77.02901

Risk Type: Blind Spot
Risk Level: Blind Spot
Speed Limit: 10 KM/Hr

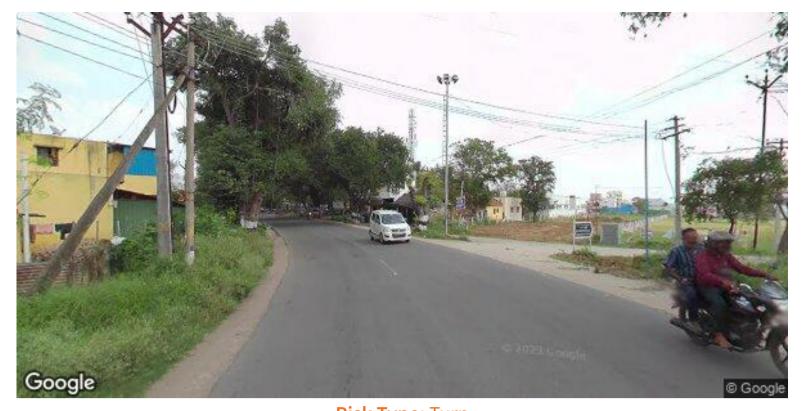
Risk Type: Turn
Risk Level: Medium
Speed Limit: 30 KM/Hr
Coordinates: 11.14340, 77.04107

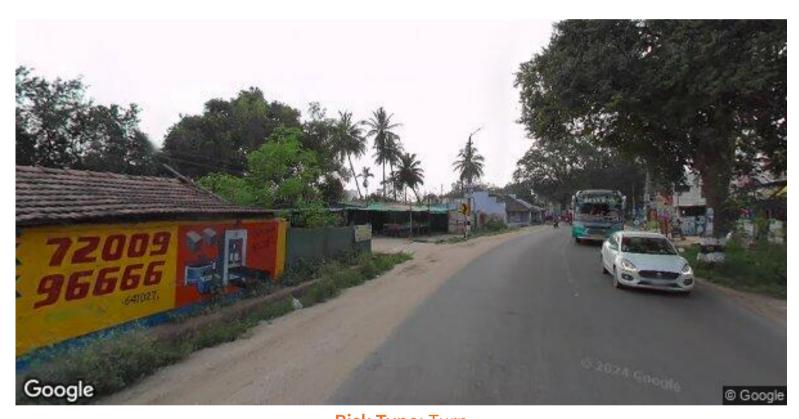
Risk Type: Turn
Risk Level: Medium
Speed Limit: 30 KM/Hr
Coordinates: 11.15207, 77.04890

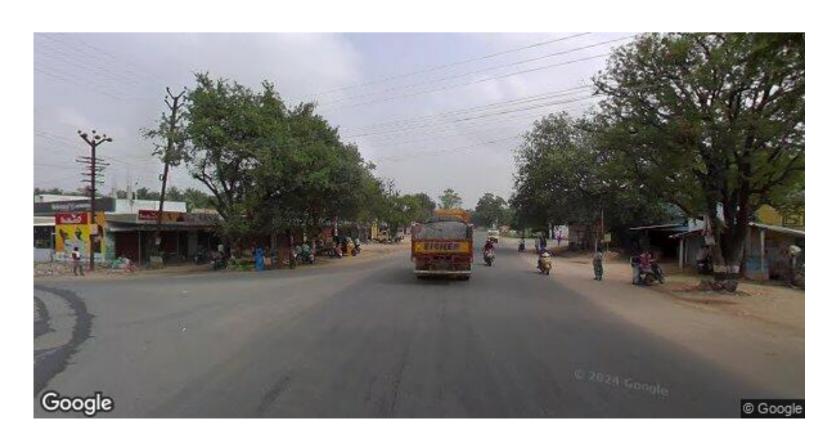
Coordinates: 11.20175, 77.07779

Risk Type: Turn
Risk Level: Medium
Speed Limit: 30 KM/Hr

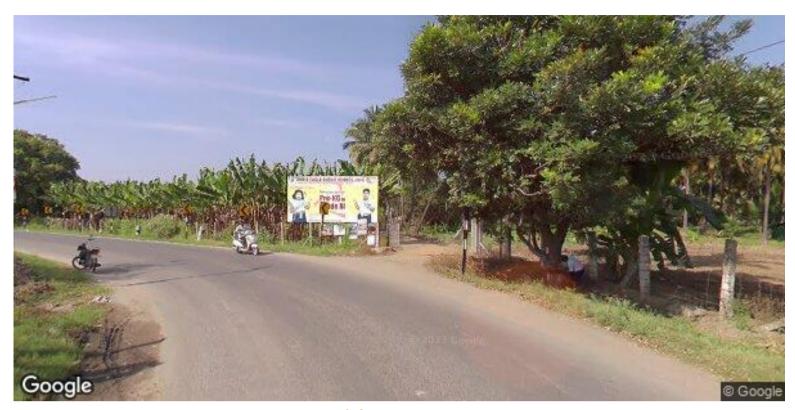
Coordinates: 11.20302, 77.07758

Risk Type: Turn
Risk Level: Medium
Speed Limit: 30 KM/Hr

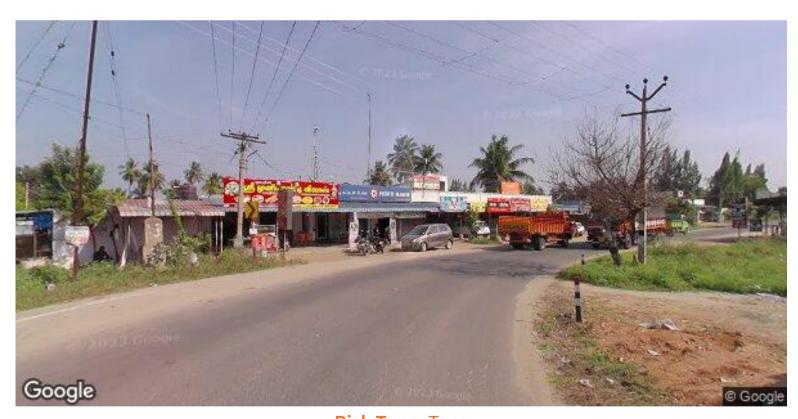
Coordinates: 11.20708, 77.07457

Risk Type: Turn
Risk Level: Medium
Speed Limit: 30 KM/Hr

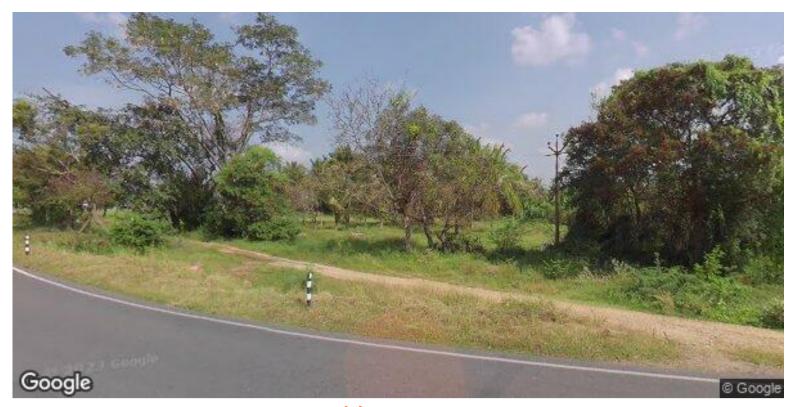
Risk Type: Turn
Risk Level: Medium
Speed Limit: 30 KM/Hr
Coordinates: 11.21292, 77.04042

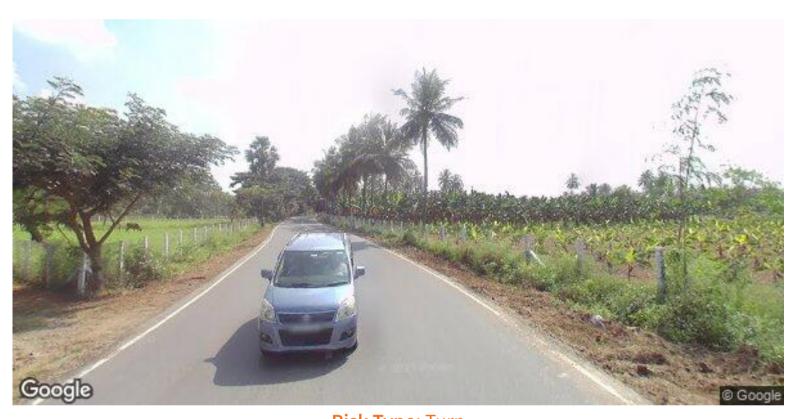
Risk Type: Turn
Risk Level: Medium
Speed Limit: 30 KM/Hr
Coordinates: 11.22243, 77.03203

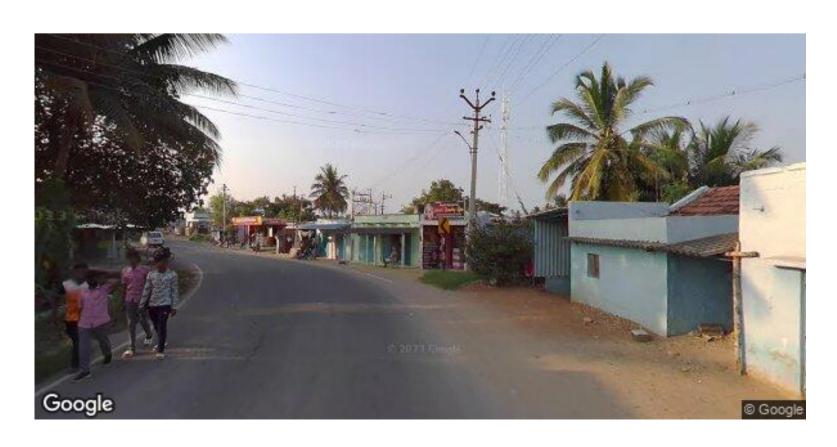
Coordinates: 11.22802, 77.02934

Risk Type: Turn
Risk Level: Medium
Speed Limit: 30 KM/Hr

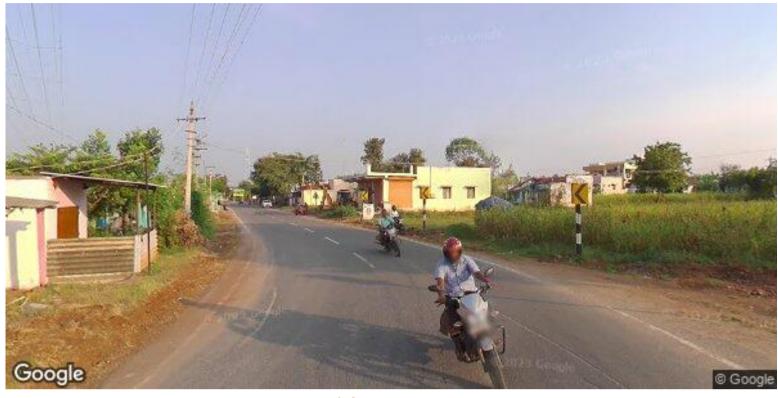
Coordinates: 11.22931, 77.02630

Risk Type: Turn
Risk Level: High
Speed Limit: 15 KM/Hr

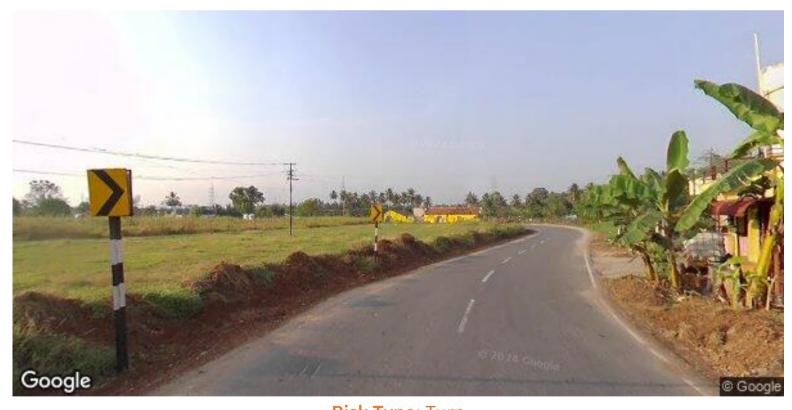
Risk Type: Turn
Risk Level: Medium
Speed Limit: 30 KM/Hr
Coordinates: 11.22943, 77.02622

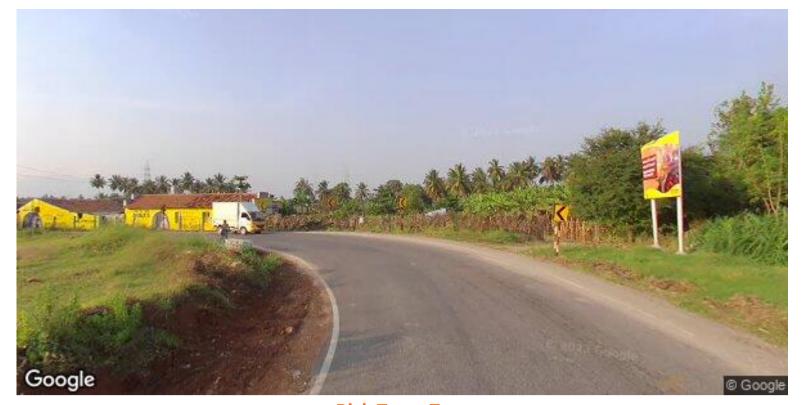
Risk Type: Turn
Risk Level: Medium
Speed Limit: 30 KM/Hr
Coordinates: 11.22994, 77.02623
