JOURNEY RISK MANAGEMENT (JRM) STUDY

Salem Terminal to AKR FUELS

Route Safety Analysis: Sangagiri (CVQF+23W) to Mylambadi (GMGG+PWM)

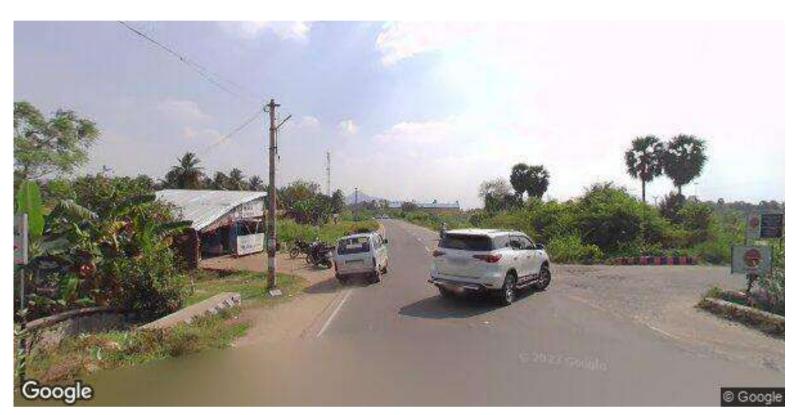
Risk Type: Turn
Risk Level: High
Speed Limit: 15 KM/Hr
Coordinates: 11.44029, 77.87544

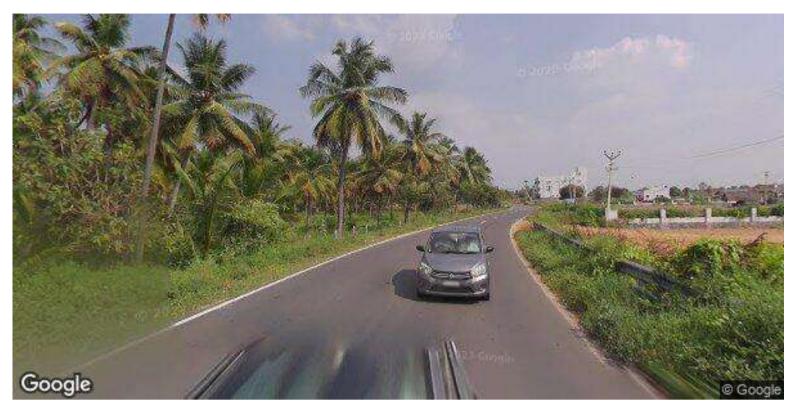
Risk Type: Turn
Risk Level: Medium
Speed Limit: 30 KM/Hr
Coordinates: 11.45357, 77.85789

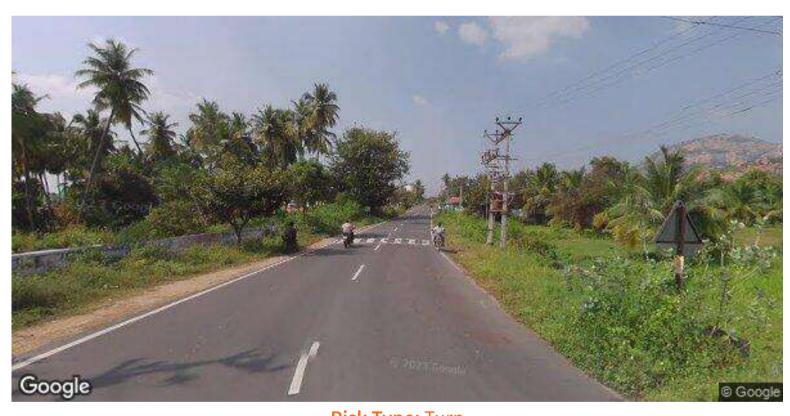
Risk Type: Turn
Risk Level: Medium
Speed Limit: 30 KM/Hr
Coordinates: 11.45352, 77.85698

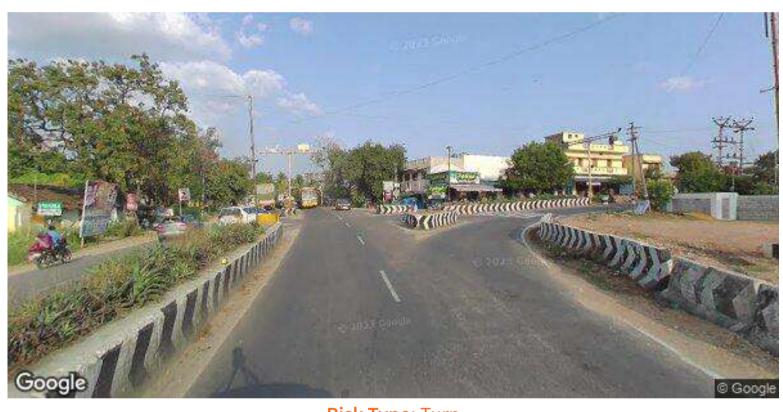
Risk Type: Turn
Risk Level: Medium
Speed Limit: 30 KM/Hr
Coordinates: 11.46318, 77.84913

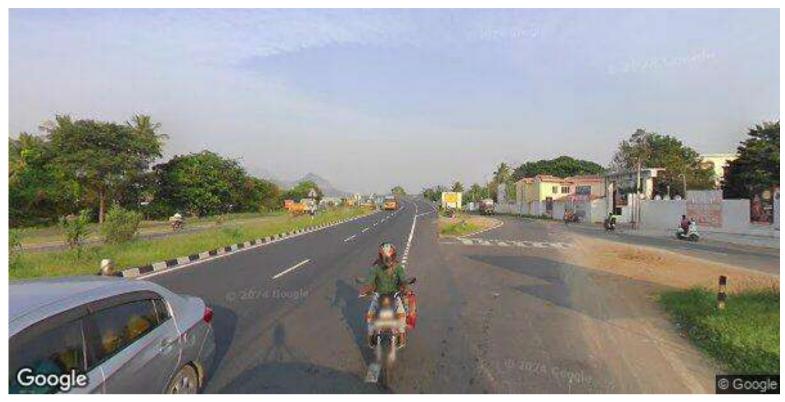
Risk Type: Turn
Risk Level: High
Speed Limit: 15 KM/Hr
Coordinates: 11.45521, 77.81343

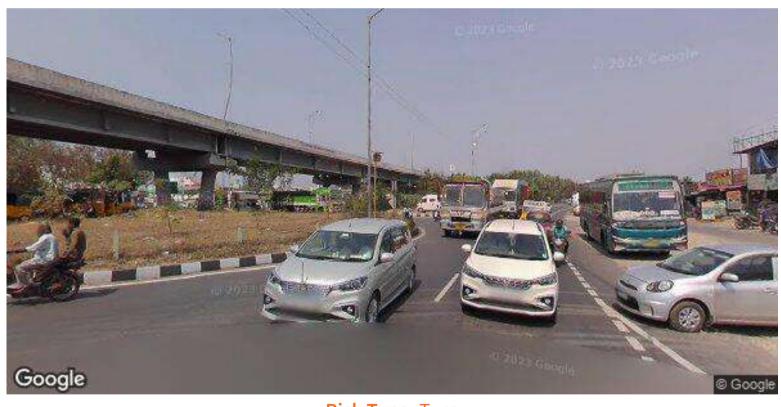
Risk Type: Turn
Risk Level: High
Speed Limit: 15 KM/Hr
Coordinates: 11.43001, 77.67575

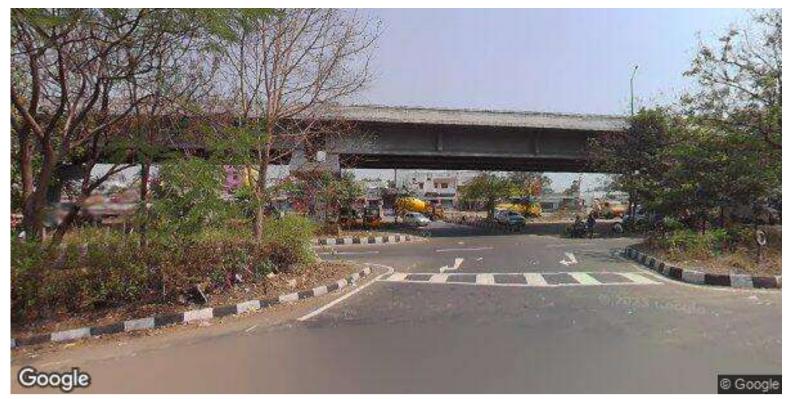
Risk Type: Turn
Risk Level: High
Speed Limit: 15 KM/Hr
Coordinates: 11.43026, 77.67525

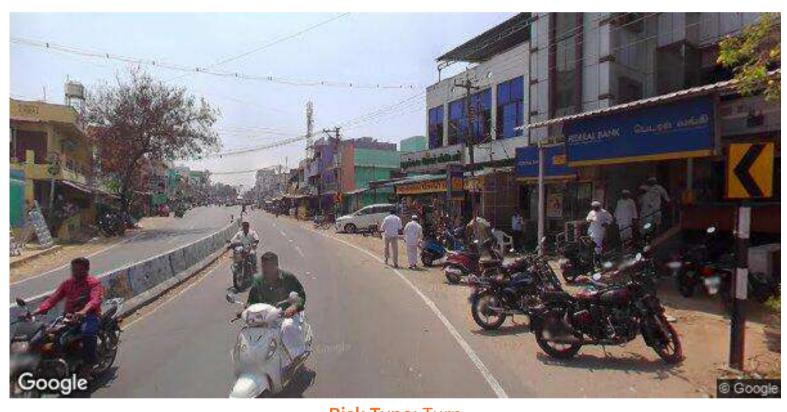
Risk Type: Turn
Risk Level: Medium
Speed Limit: 30 KM/Hr
Coordinates: 11.43769, 77.67810

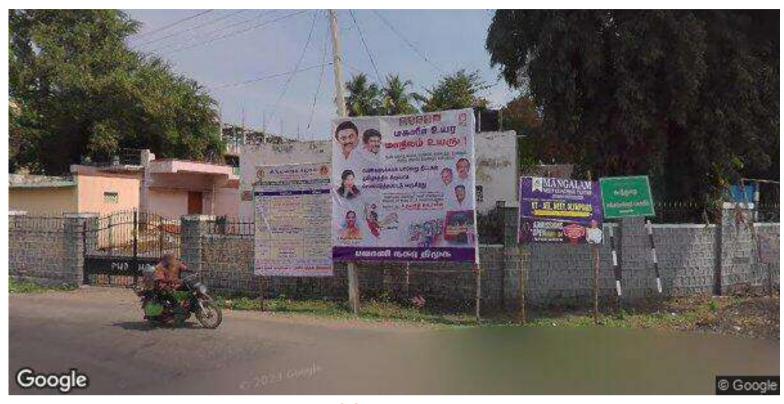
Risk Type: Turn
Risk Level: Medium
Speed Limit: 30 KM/Hr
Coordinates: 11.43871, 77.68228

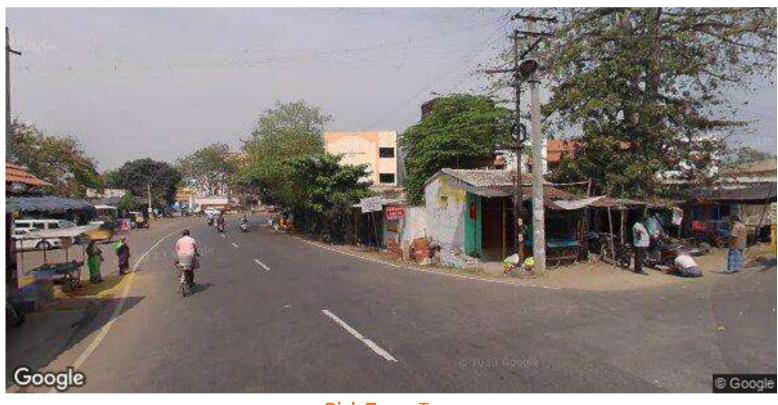
Risk Type: Turn
Risk Level: Medium
Speed Limit: 30 KM/Hr
Coordinates: 11.43965, 77.68224

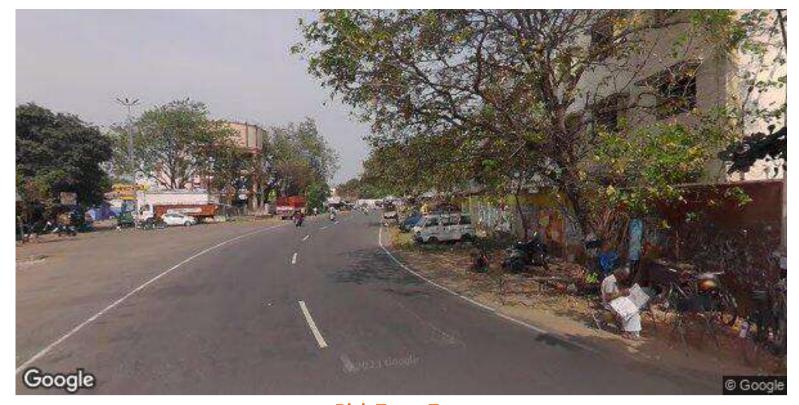
Risk Type: Turn
Risk Level: Medium
Speed Limit: 30 KM/Hr
Coordinates: 11.43997, 77.68198

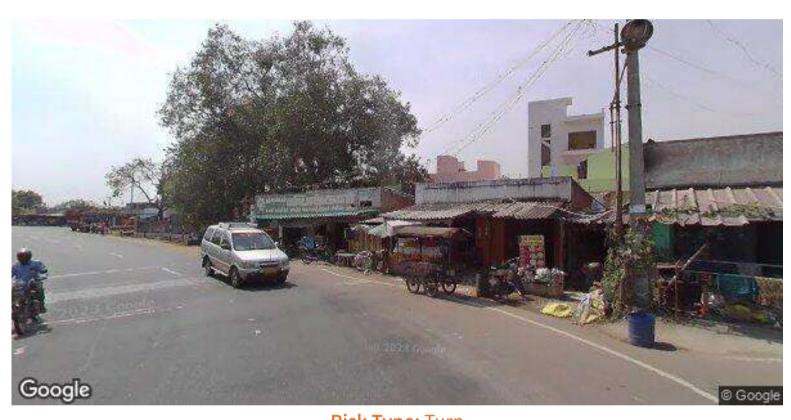
Risk Type: Turn
Risk Level: High
Speed Limit: 15 KM/Hr
Coordinates: 11.44105, 77.68187

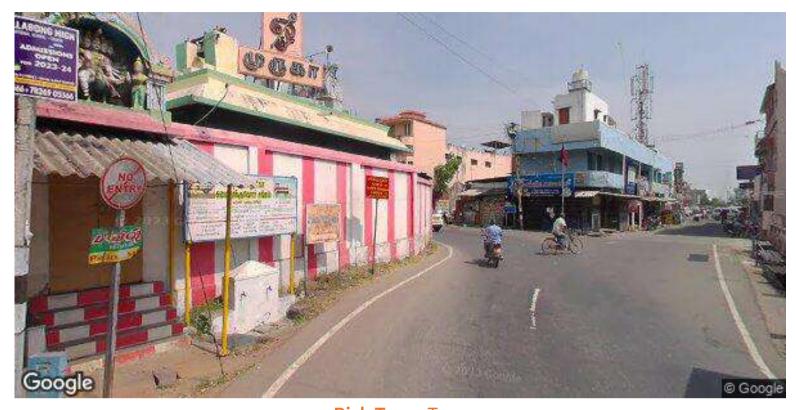
Risk Type: Turn
Risk Level: Medium
Speed Limit: 30 KM/Hr
Coordinates: 11.44295, 77.68261

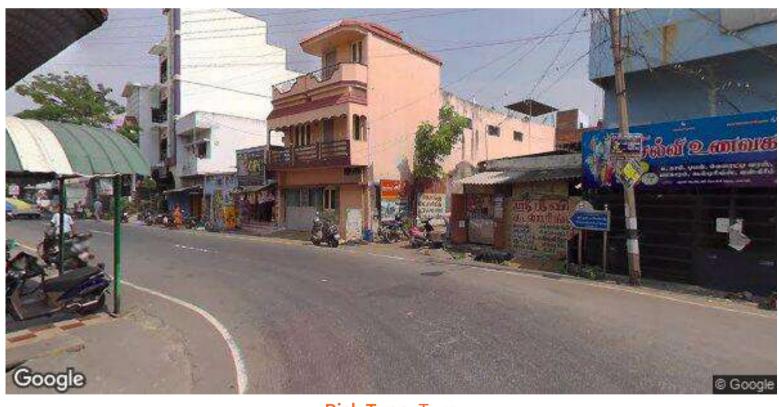
Risk Type: Turn
Risk Level: High
Speed Limit: 15 KM/Hr
Coordinates: 11.44300, 77.68275

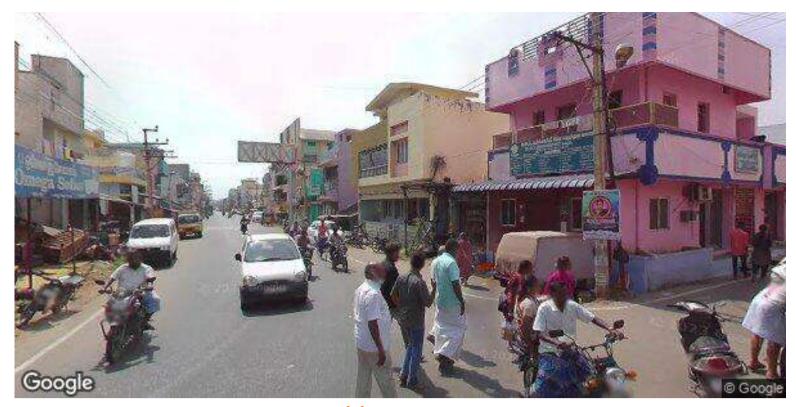
Risk Type: Turn
Risk Level: High
Speed Limit: 15 KM/Hr
Coordinates: 11.44715, 77.68304

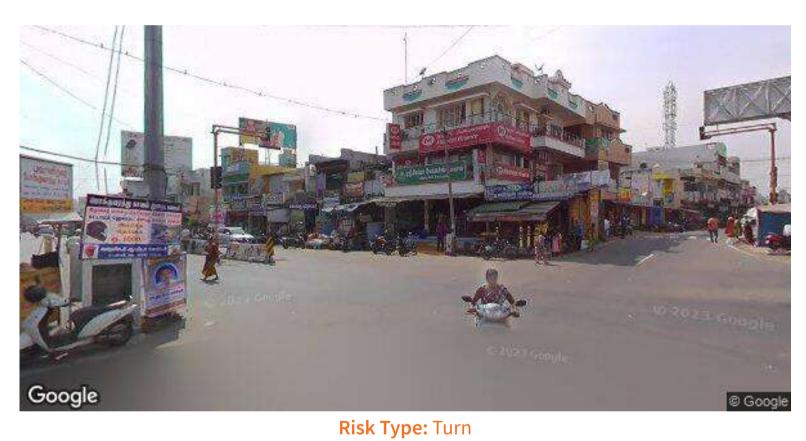
Risk Level: Medium
Speed Limit: 30 KM/Hr
Coordinates: 11.44714, 77.68402

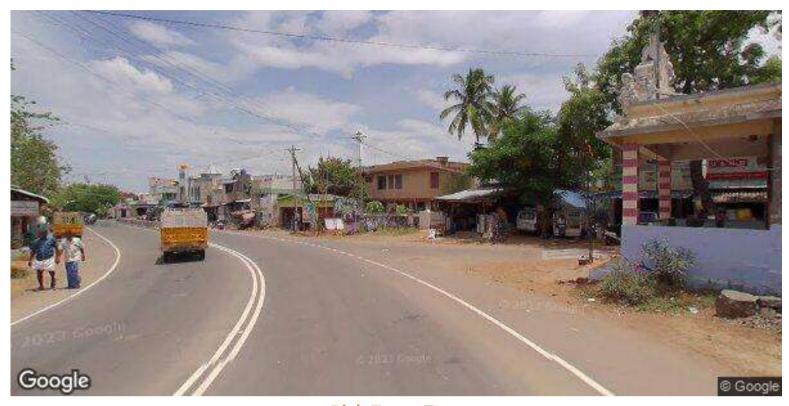
Coordinates: 11.52464, 77.67958

Risk Type: Turn
Risk Level: Medium
Speed Limit: 30 KM/Hr

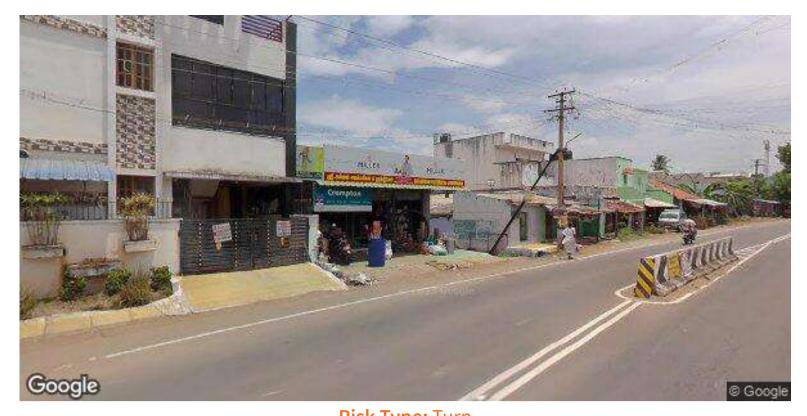
Coordinates: 11.52468, 77.67849

Risk Type: Turn
Risk Level: Medium
Speed Limit: 30 KM/Hr
