JOURNEY RISK MANAGEMENT (JRM) STUDY

Salem Terminal TO EDCCWS ERODE RING ROAD

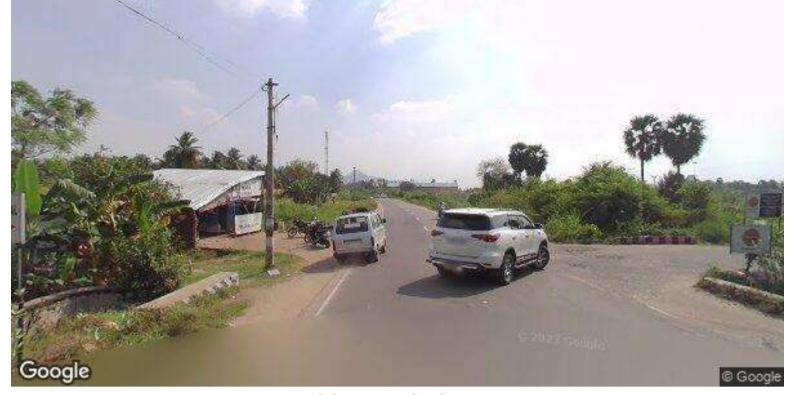
Risk Type: Blind Spot
Risk Level: Blind Spot
Speed Limit: 10 KM/Hr
Coordinates: 11.44029, 77.87544

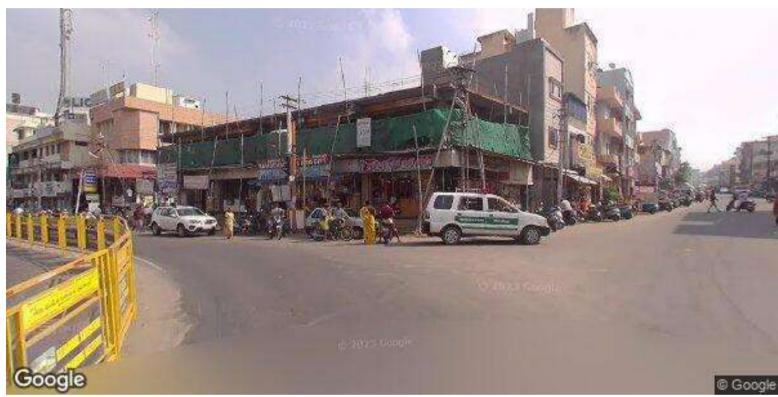
Coordinates: 11.37868, 77.89498

Risk Type: Turn
Risk Level: High
Speed Limit: 15 KM/Hr

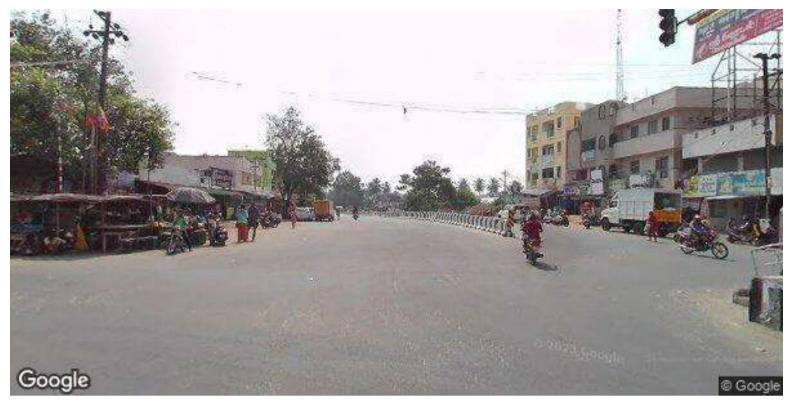
Coordinates: 11.36604, 77.88887

Risk Type: Turn
Risk Level: High
Speed Limit: 15 KM/Hr

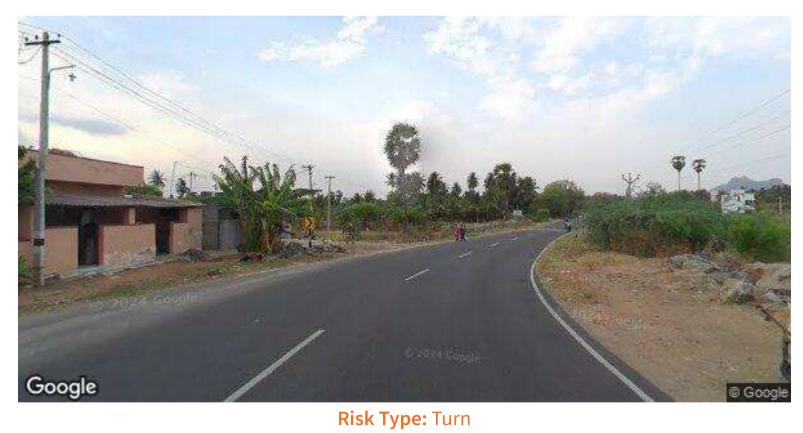
Coordinates: 11.33882, 77.86218

Risk Type. Turn
Risk Level: Medium
Speed Limit: 30 KM/Hr
