JOURNEY RISK MANAGEMENT (JRM) STUDY

Salem Terminal To SK FUELS

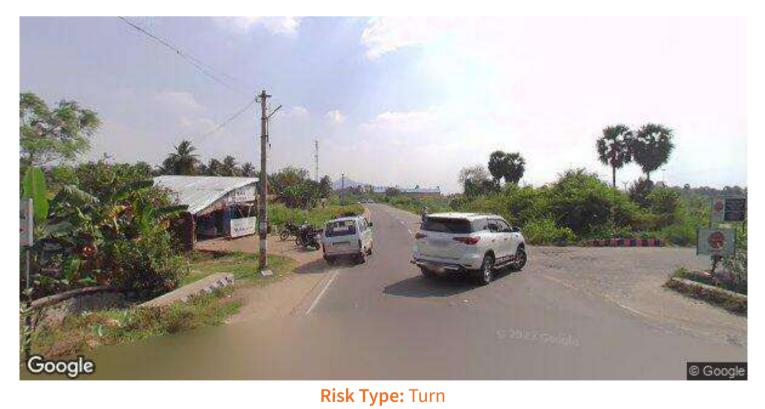
Risk Level: High
Speed Limit: 15 KM/Hr
Coordinates: 11.44029, 77.87544

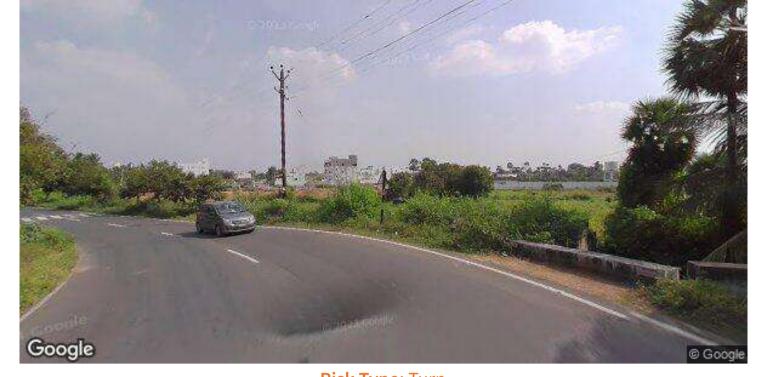
Risk Type: Turn
Risk Level: Medium
Speed Limit: 30 KM/Hr
Coordinates: 11.45350, 77.85700

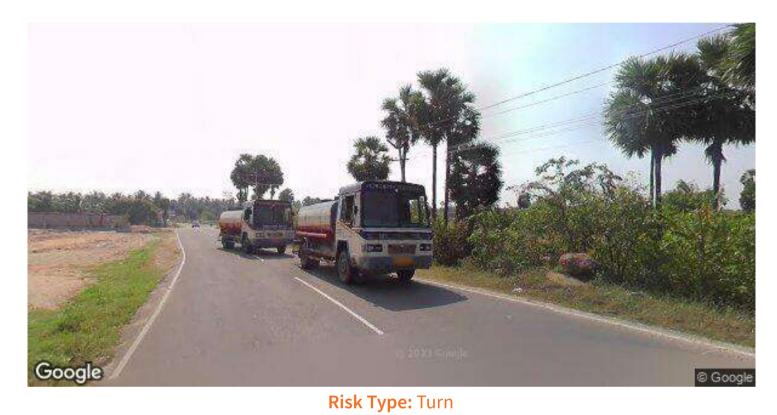
Risk Level: Medium
Speed Limit: 30 KM/Hr
Coordinates: 11.45833, 77.85146

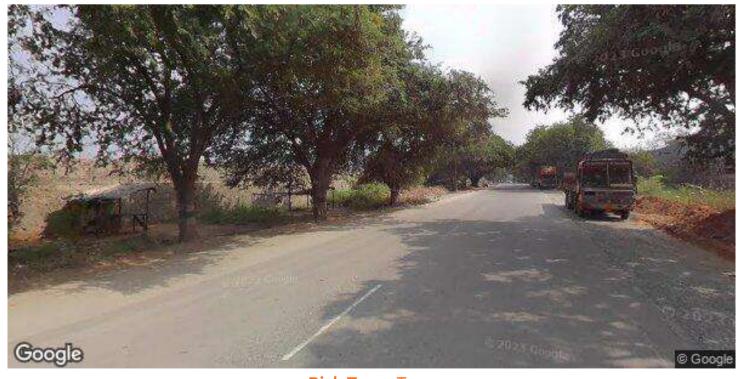
Risk Type: Turn
Risk Level: Medium

Speed Limit: 30 KM/Hr Coordinates: 11.45697, 77.82719

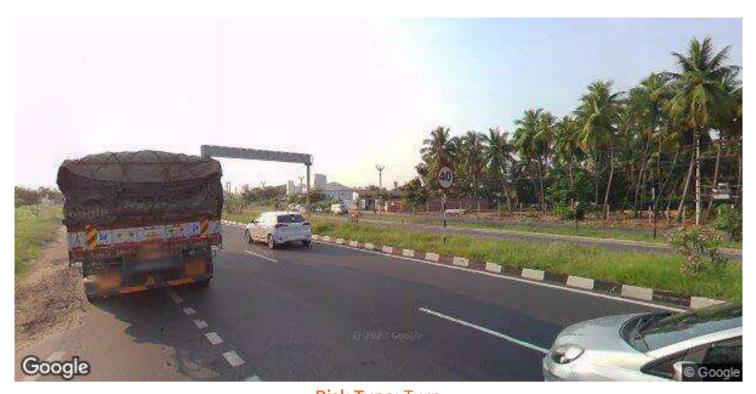
Risk Type: Turn
Risk Level: High
Speed Limit: 15 KM/Hr
Coordinates: 11.45518, 77.81344

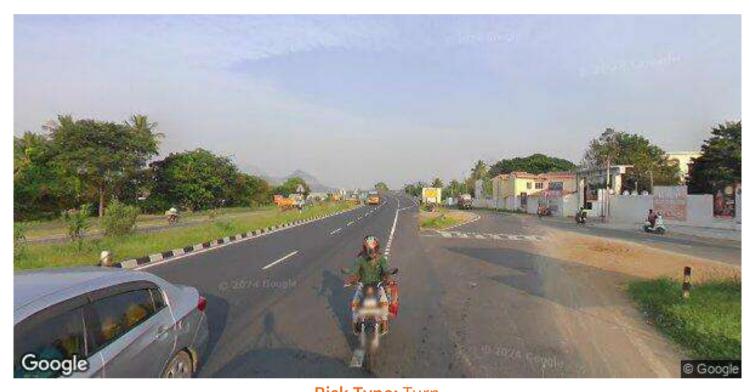
Risk Type: Turn
Risk Level: High
Speed Limit: 15 KM/Hr
Coordinates: 11.45521, 77.81343

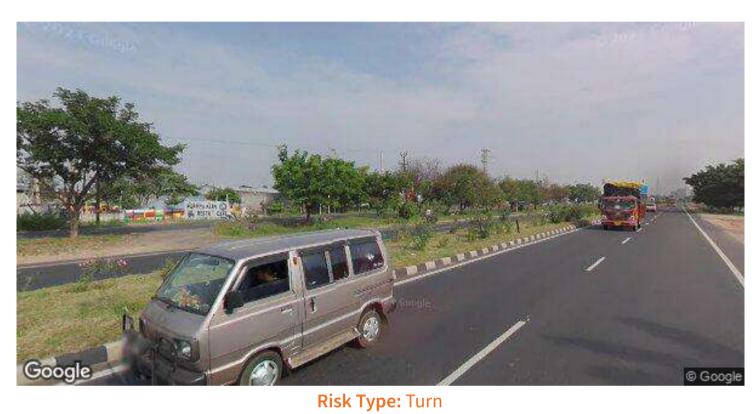
Risk Level: Medium
Speed Limit: 30 KM/Hr
Coordinates: 11.43982, 77.71084

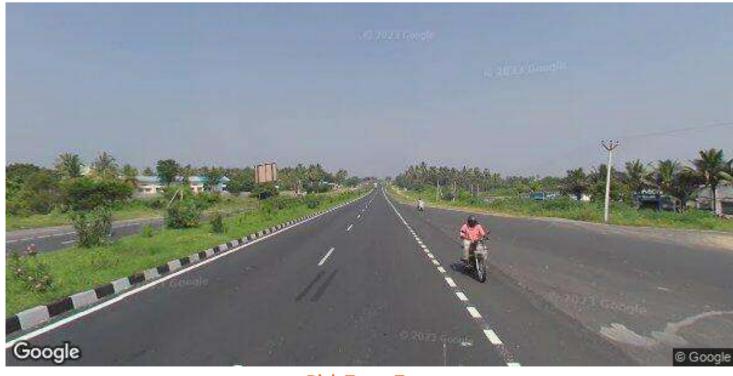
Risk Type: Turn Risk Level: High

Speed Limit: 15 KM/Hr Coordinates: 11.40046, 77.65371

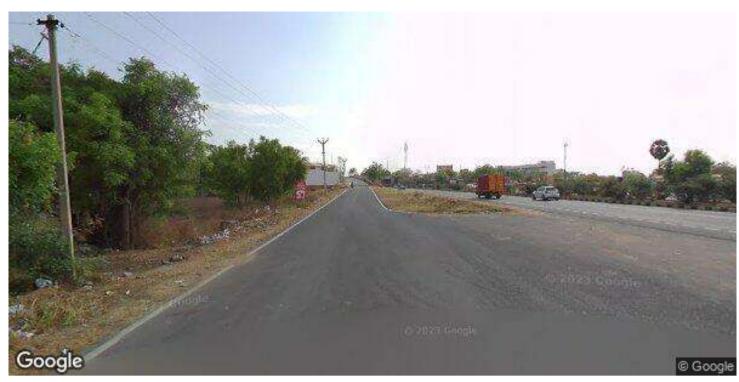
Risk Type: Turn
Risk Level: High
Speed Limit: 15 KM/Hr
Coordinates: 11.40035, 77.65383

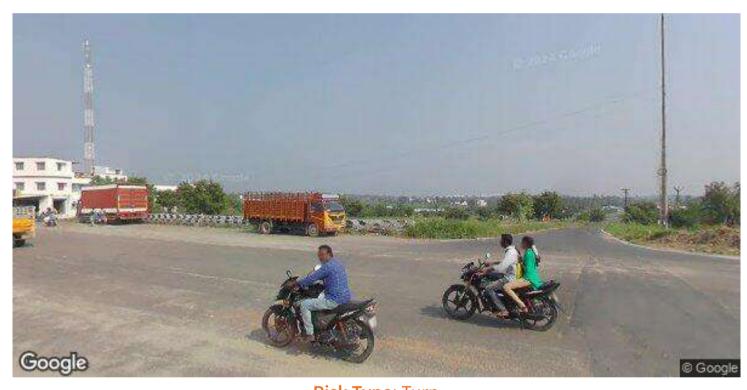
Risk Type: Turn
Risk Level: High
Speed Limit: 15 KM/Hr
Coordinates: 11.39827, 77.65237

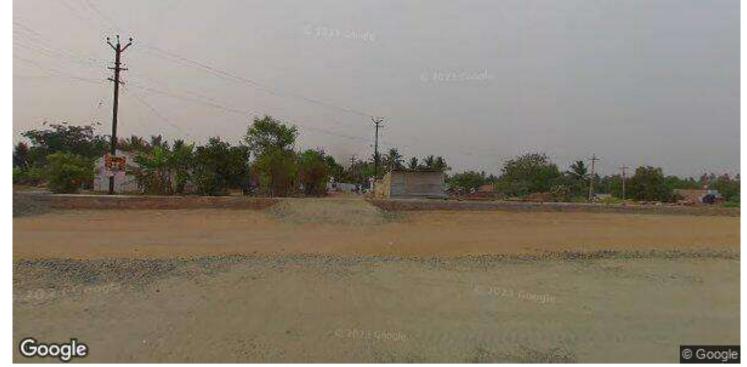
Risk Type: Turn
Risk Level: High
Speed Limit: 15 KM/Hr
Coordinates: 11.39972, 77.64797

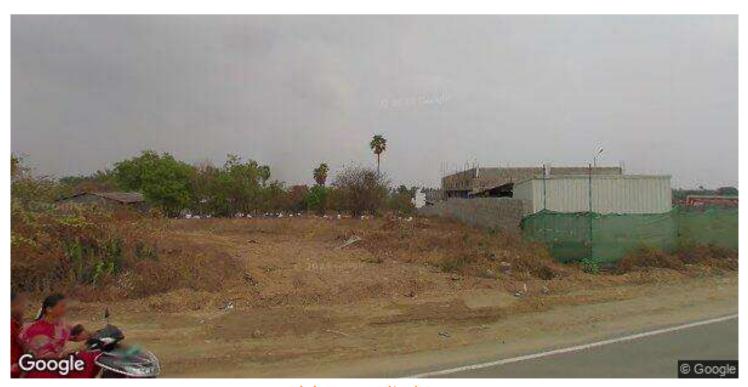
Risk Type: Blind Spot Risk Level: Blind Spot Speed Limit: 10 KM/Hr

Coordinates: 11.39995, 77.64214
