JOURNEY RISK MANAGEMENT (JRM) STUDY

Salem Terminal TO GOUNDER AGENCIES

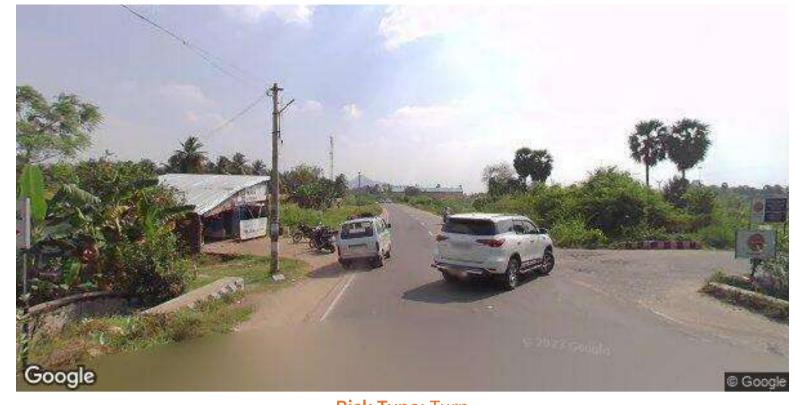
Risk Type: Turn
Risk Level: High
Speed Limit: 15 KM/Hr
Coordinates: 11.44029, 77.87544

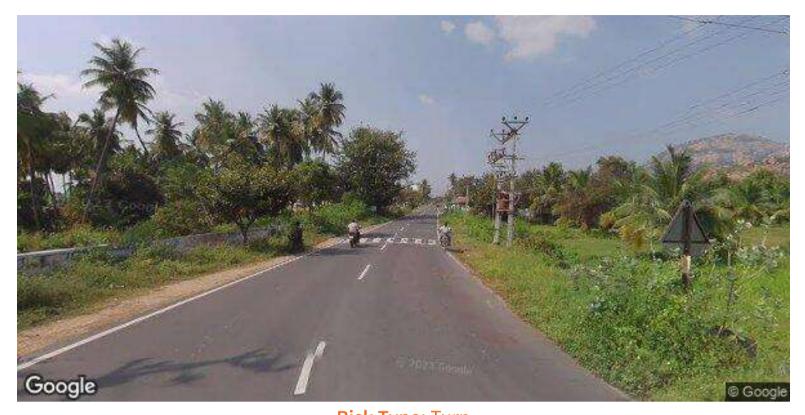
Risk Type: Turn
Risk Level: Medium
Speed Limit: 30 KM/Hr
Coordinates: 11.45352, 77.85698

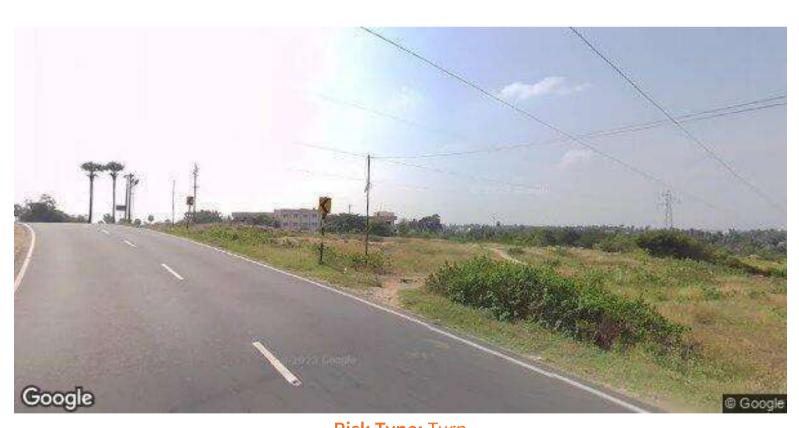
Coordinates: 11.46048, 77.85036

Risk Type: Turn
Risk Level: Medium
Speed Limit: 30 KM/Hr

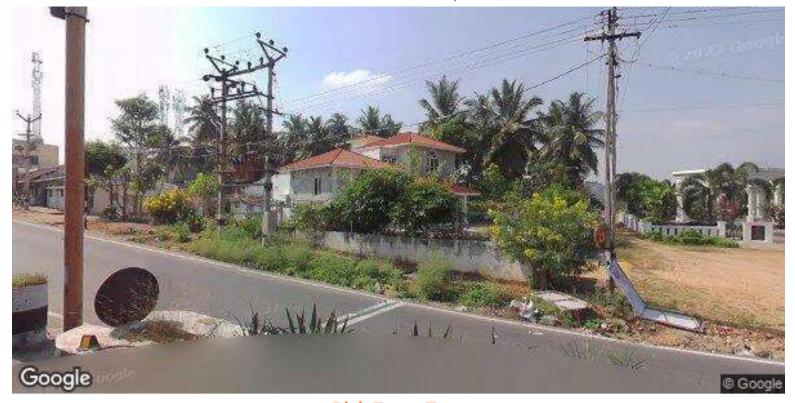
Risk Type: Turn
Risk Level: Medium
Speed Limit: 30 KM/Hr
Coordinates: 11.46303, 77.84945

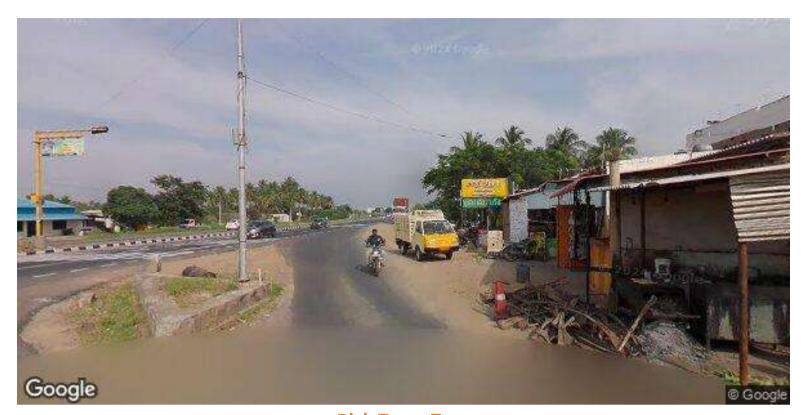
Risk Type: Turn
Risk Level: Medium
Speed Limit: 30 KM/Hr
Coordinates: 11.29164, 77.58610

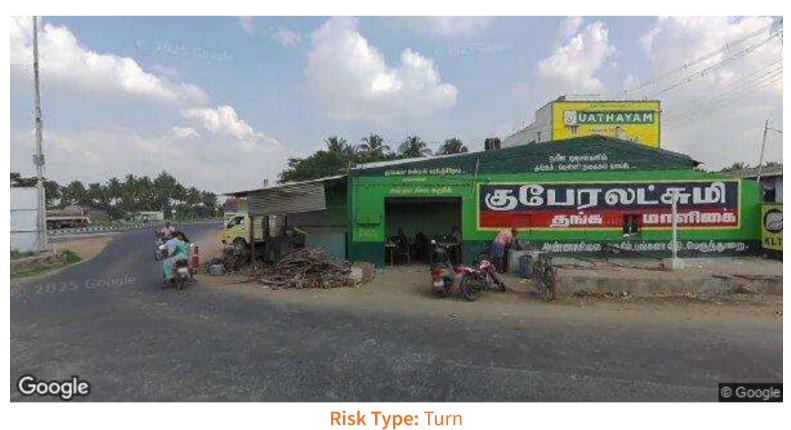
Coordinates: 11.29158, 77.58600

Risk Level: High
Speed Limit: 15 KM/Hr

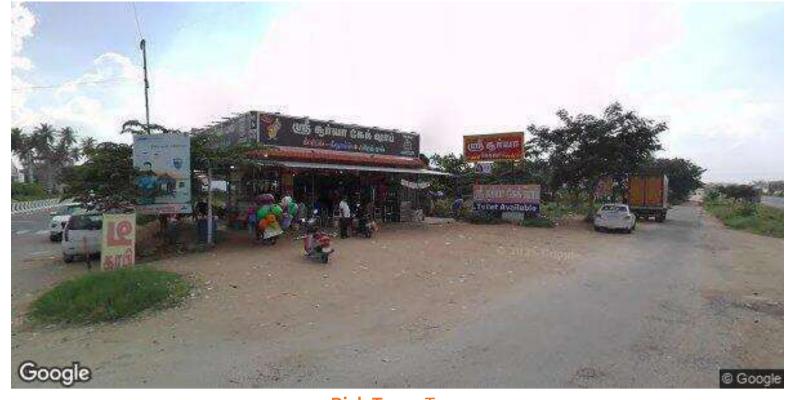
Risk Type: Turn
Risk Level: Medium
Speed Limit: 30 KM/Hr
Coordinates: 11.29163, 77.58591

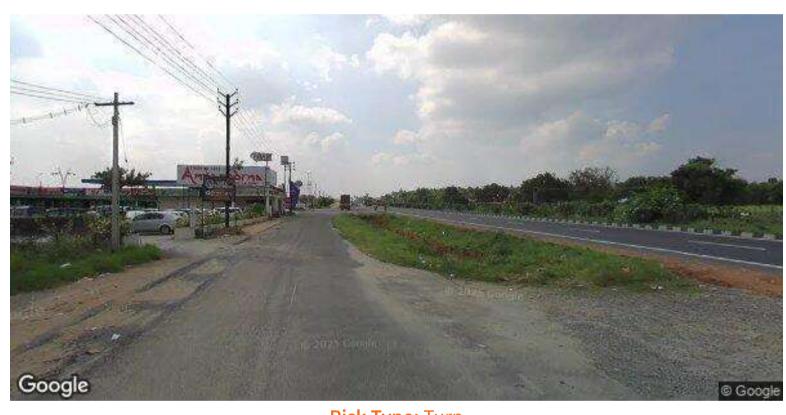
Risk Type: Turn
Risk Level: Medium
Speed Limit: 30 KM/Hr
Coordinates: 11.29140, 77.58253

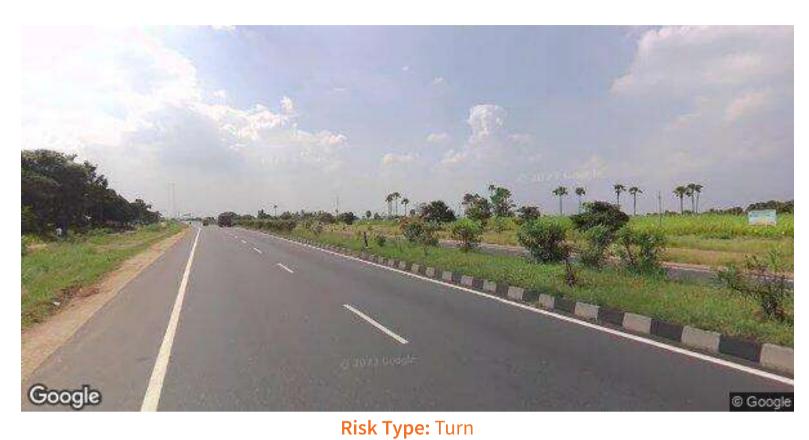
Risk Type. Turn
Risk Level: Medium
Speed Limit: 30 KM/Hr
Coordinates: 11.29012, 77.56873

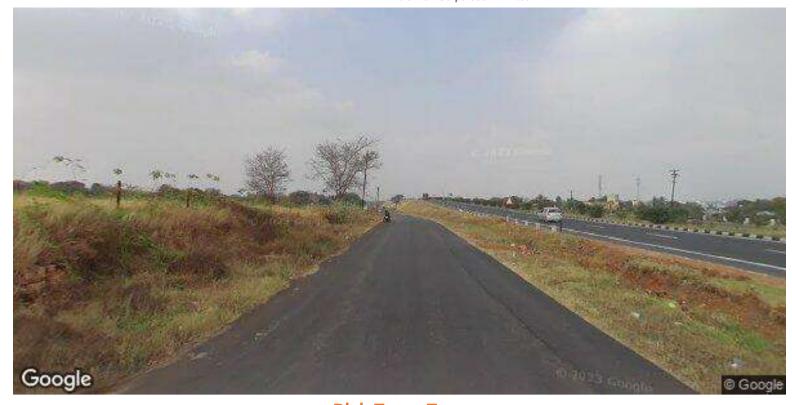
Risk Type: Turn
Risk Level: Medium
Speed Limit: 30 KM/Hr
Coordinates: 11.28713, 77.56216
