JOURNEY RISK MANAGEMENT (JRM) STUDY

Salem Terminal To SRI MAHA FUELS

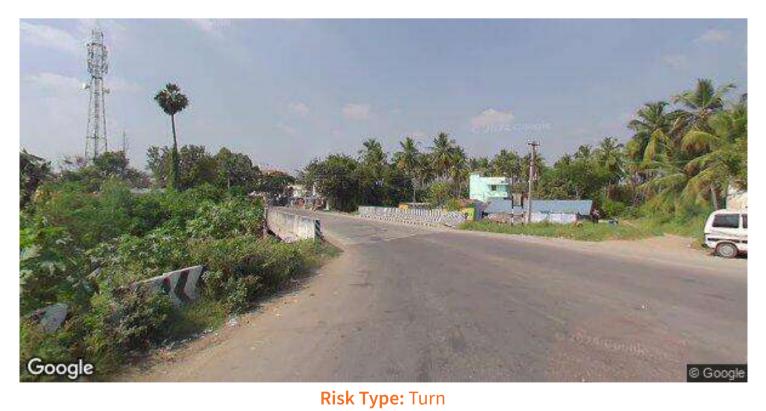
Risk Level: High
Speed Limit: 15 KM/Hr
Coordinates: 11.44893, 77.87413

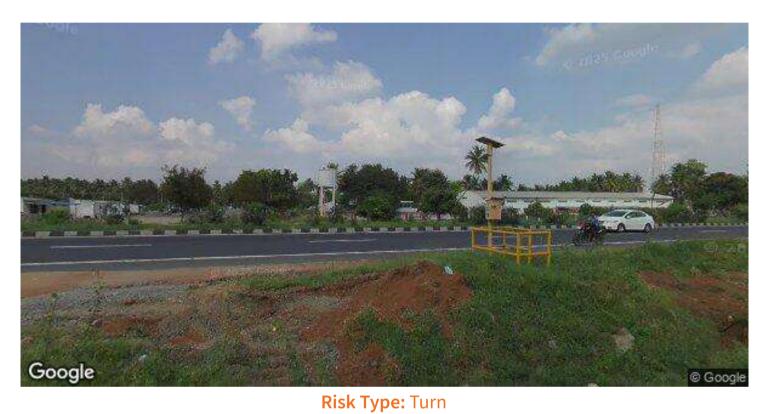
Risk Level: Medium
Speed Limit: 30 KM/Hr
Coordinates: 11.29141, 77.58266

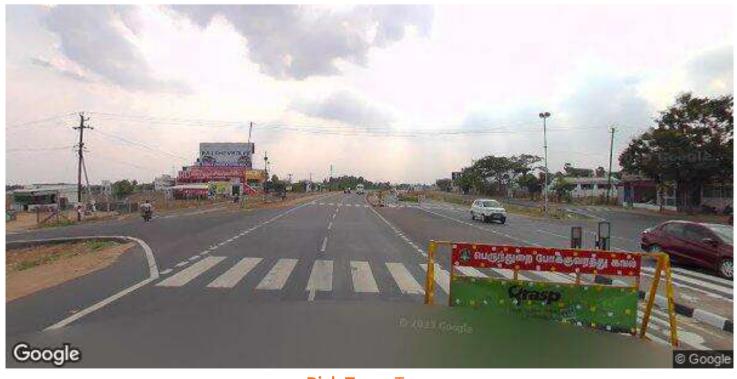
Risk Type: Turn
Risk Level: Medium

Speed Limit: 30 KM/Hr Coordinates: 11.23724, 77.50686

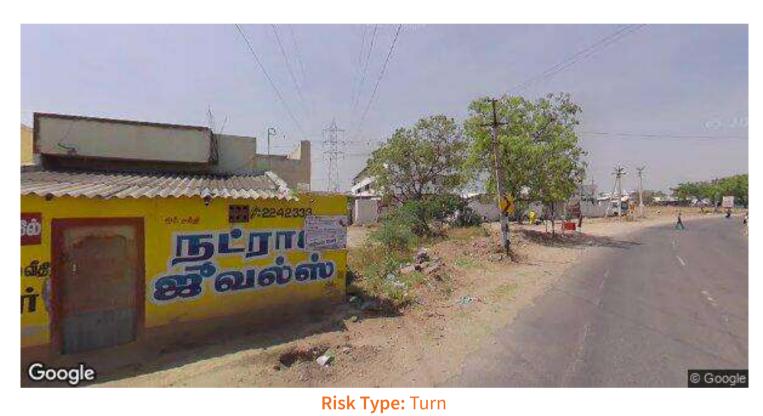
Risk Level: Medium
Speed Limit: 30 KM/Hr
Coordinates: 11.13578, 77.41299

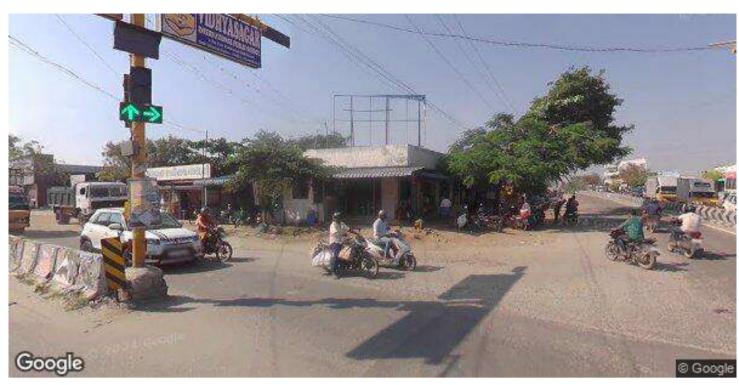
Risk Type: Turn
Risk Level: High
Speed Limit: 15 KM/Hr
Coordinates: 11.12775, 77.39347

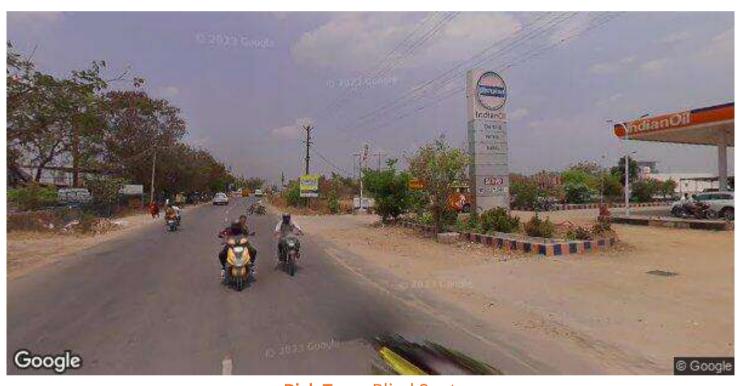
Risk Type: Blind Spot
Risk Level: Blind Spot
Speed Limit: 10 KM/Hr
Coordinates: 11.12333, 77.39381
