# JOURNEY RISK MANAGEMENT (JRM) STUDY

### **IOCL Coimbatore Terminal to Gowripriya Agencies**

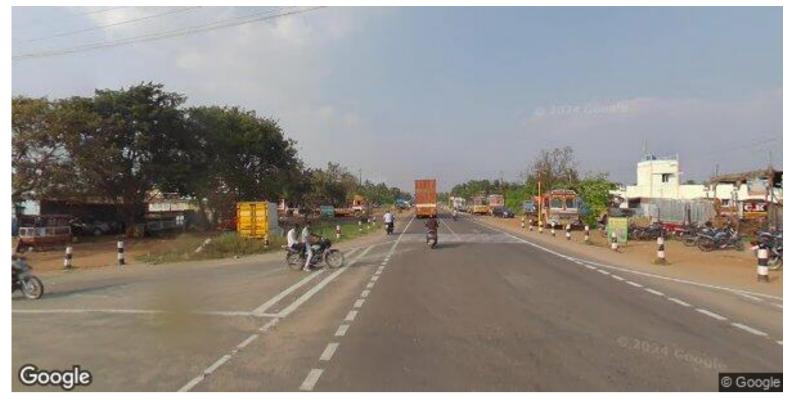
**Coordinates:** 11.03211, 77.07640

Risk Type: Turn
Risk Level: High
Speed Limit: 15 KM/Hr

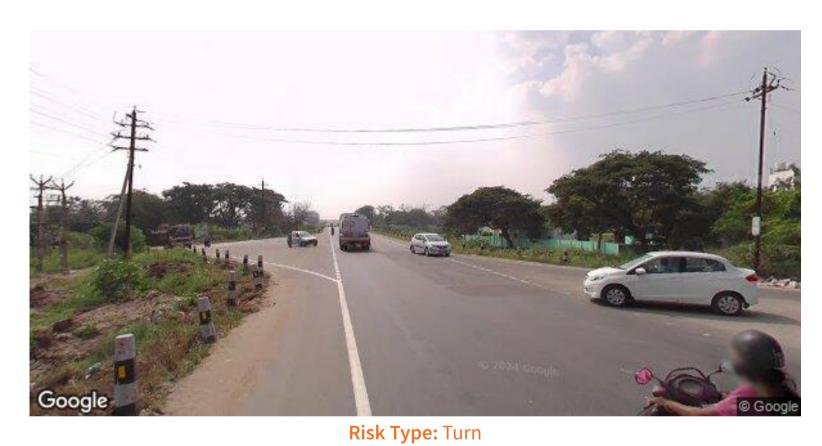
Risk Level: High
Speed Limit: 15 KM/Hr
Coordinates: 11.05950, 77.08744

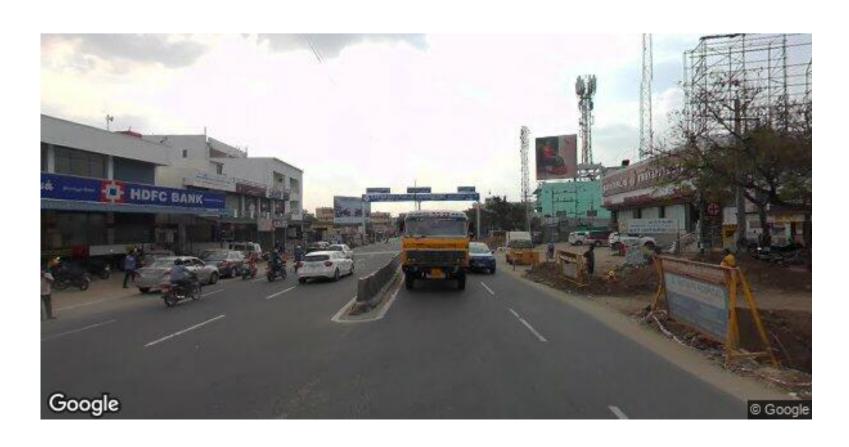
**Coordinates:** 11.06138, 77.08700

Risk Type: Blind Spot Risk Level: Blind Spot Speed Limit: 10 KM/Hr

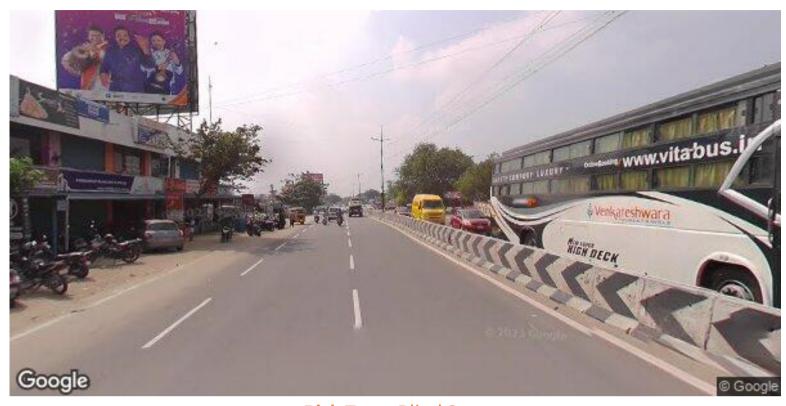
**Coordinates:** 11.06017, 77.08395

Risk Type: Blind Spot Risk Level: Blind Spot Speed Limit: 10 KM/Hr

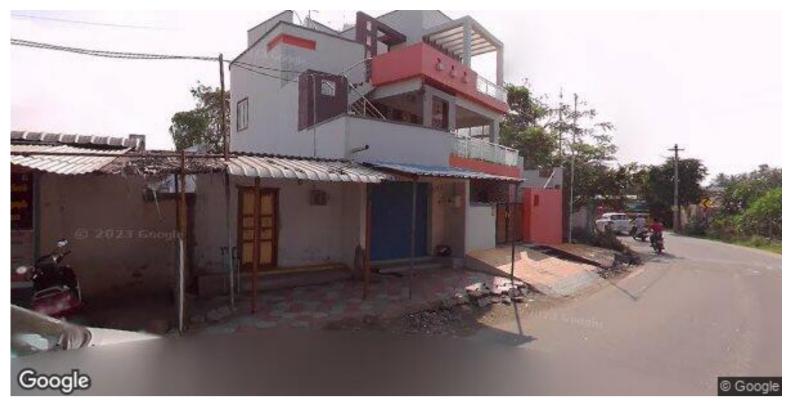
Risk Type: Turn
Risk Level: High
Speed Limit: 15 KM/Hr
Coordinates: 11.09692, 77.06915

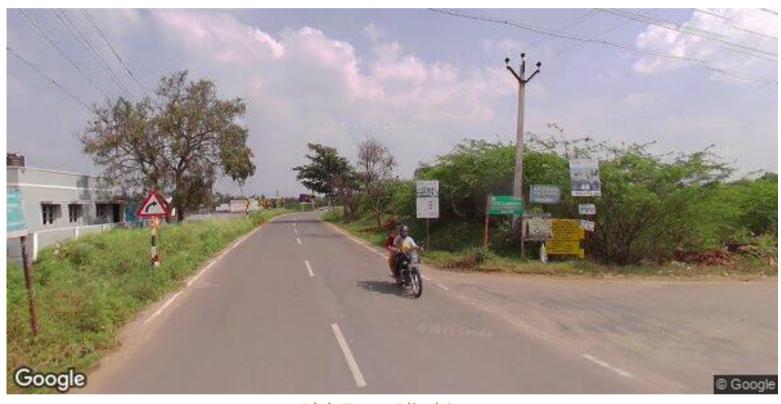
Risk Type: Blind Spot
Risk Level: Blind Spot
Speed Limit: 10 KM/Hr
Coordinates: 11.11531, 77.06799

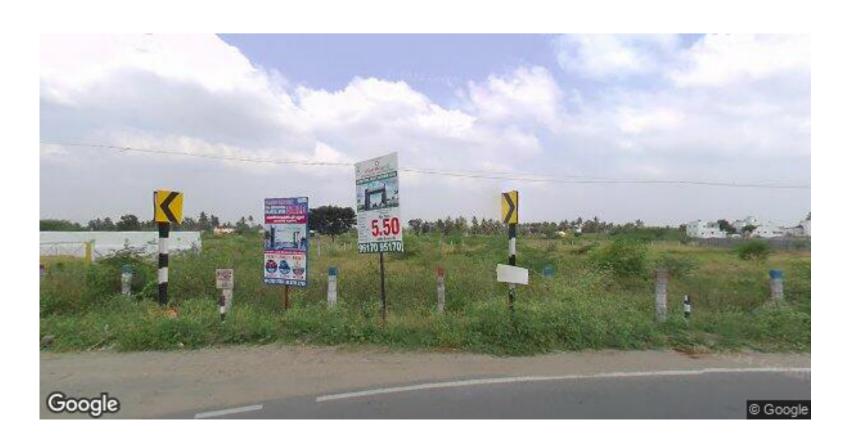
**Coordinates:** 11.11581, 77.05929

Risk Type: Turn
Risk Level: Medium
Speed Limit: 30 KM/Hr

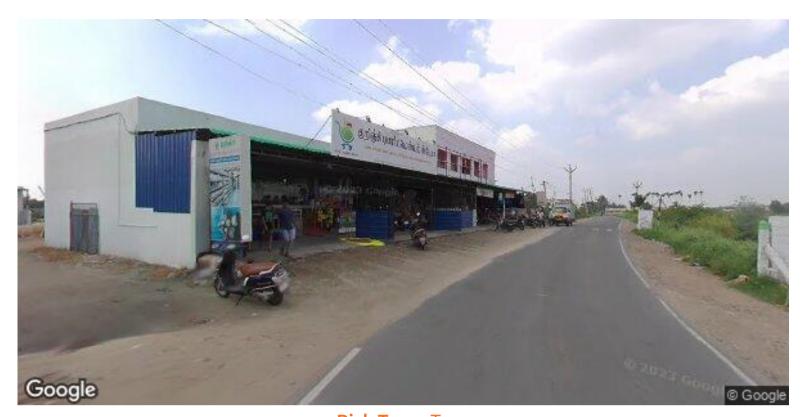
Risk Type: Turn
Risk Level: Medium
Speed Limit: 30 KM/Hr
Coordinates: 11.11555, 77.05876

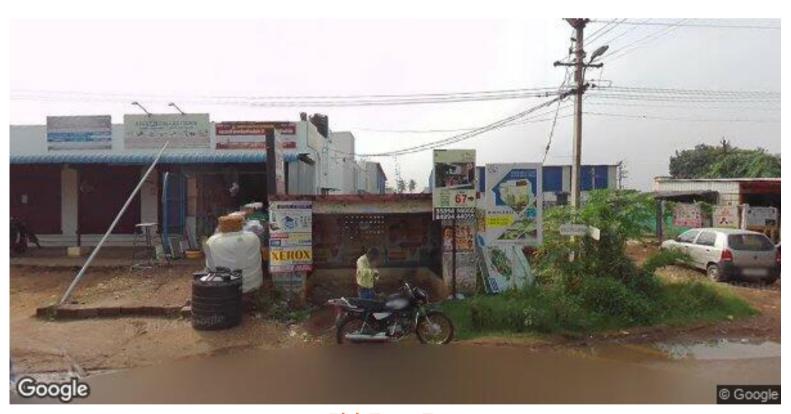
Risk Type: Turn
Risk Level: High
Speed Limit: 15 KM/Hr
Coordinates: 11.11590, 77.04318

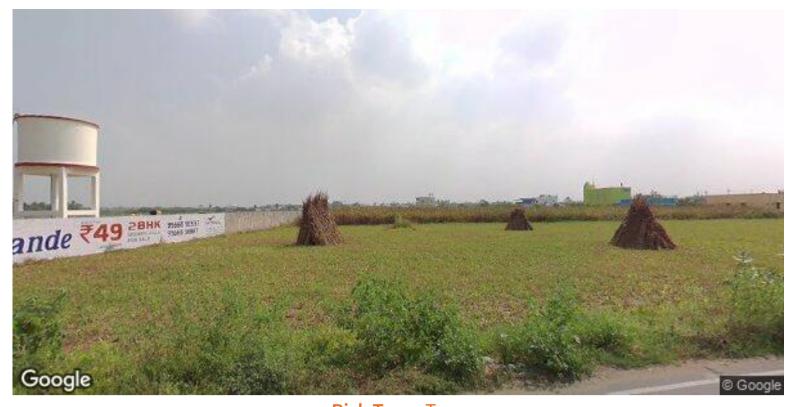
**Coordinates:** 11.12352, 77.04304

Risk Type: Turn
Risk Level: Medium
Speed Limit: 30 KM/Hr

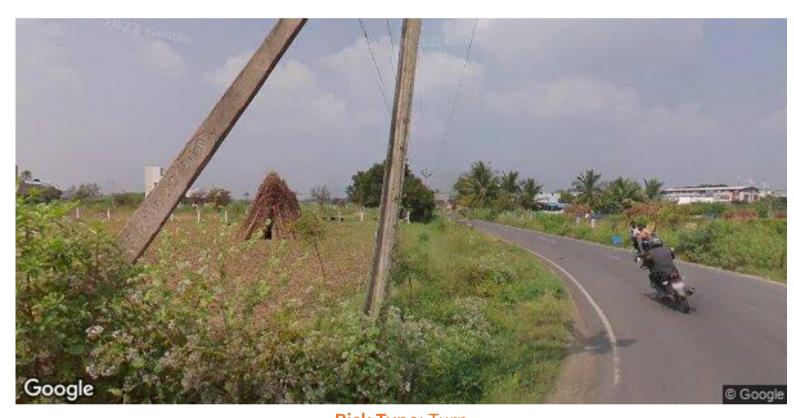
Risk Type: Turn
Risk Level: Medium
Speed Limit: 30 KM/Hr
Coordinates: 11.12361, 77.04301

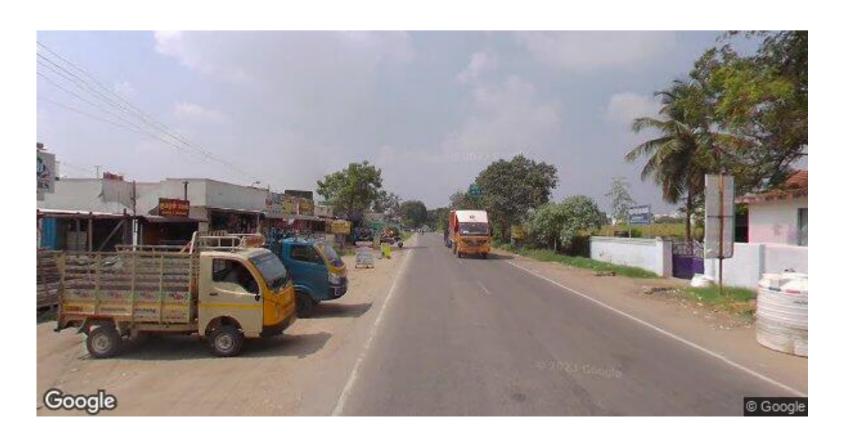
**Coordinates:** 11.13291, 77.04230

Risk Type: Turn
Risk Level: High
Speed Limit: 15 KM/Hr

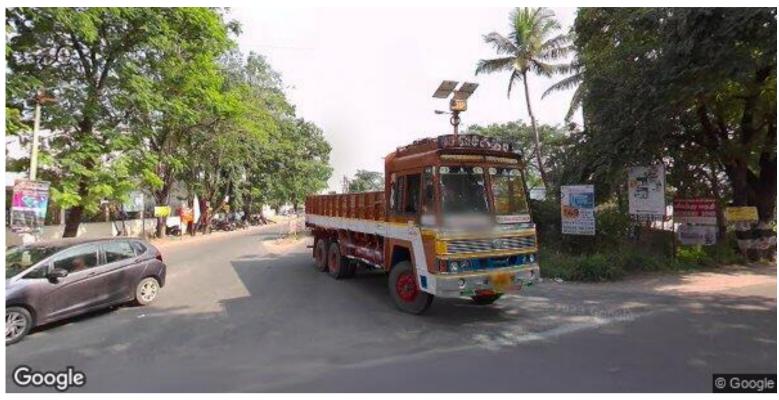
**Coordinates:** 11.13350, 77.03352

Risk Type: Turn
Risk Level: High
Speed Limit: 15 KM/Hr

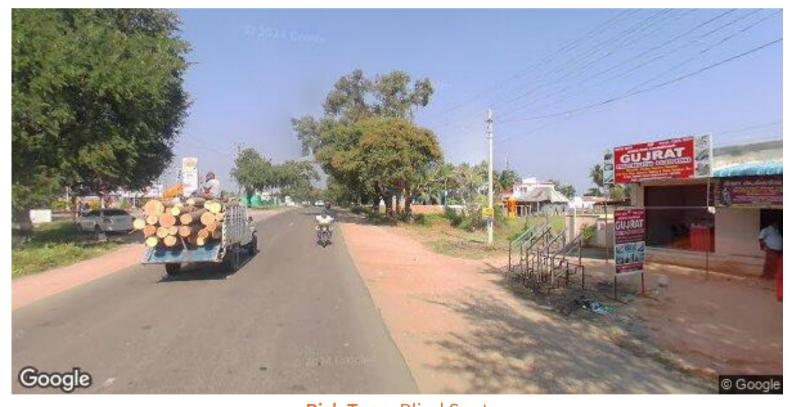
**Coordinates:** 11.21577, 77.08522

Risk Type: Blind Spot Risk Level: Blind Spot Speed Limit: 10 KM/Hr

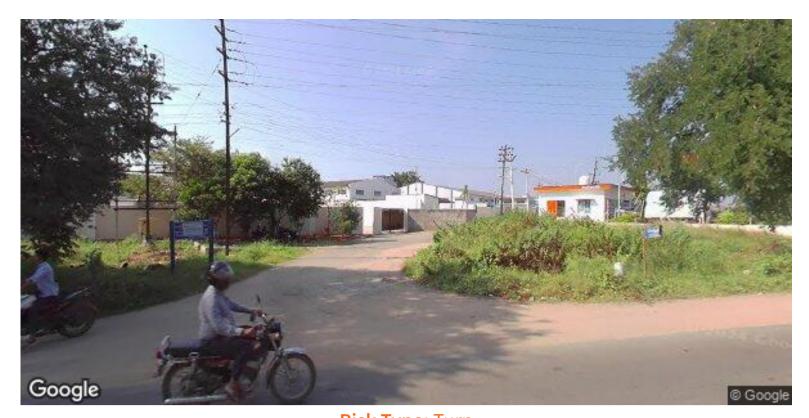
**Coordinates:** 11.21592, 77.08509

Risk Type: Turn
Risk Level: Medium
Speed Limit: 30 KM/Hr
