JOURNEY RISK MANAGEMENT (JRM) STUDY

IOCL Coimbatore Terminal to Karpaga Shasthaa Fuels

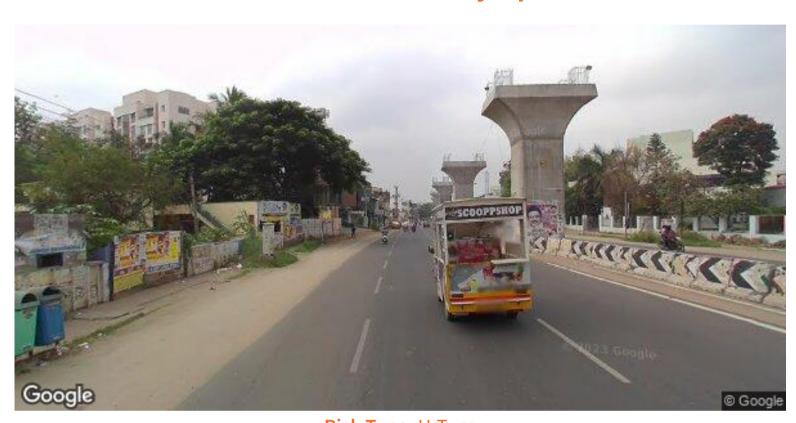
Coordinates: 11.0161282, 76.9896128

Risk Type: U-Turn
Risk Level: High
Speed Limit: 10 KM/Hr

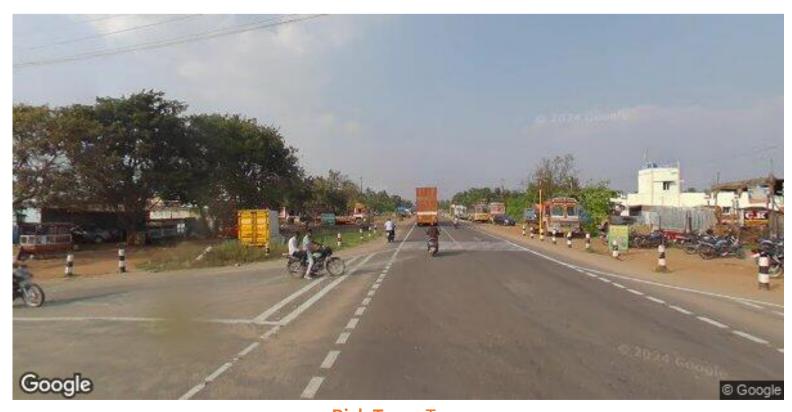
Risk Type: Turn Risk Level: High Speed Limit: 15 KM/Hr Coordinates: 11.03211, 77.07640

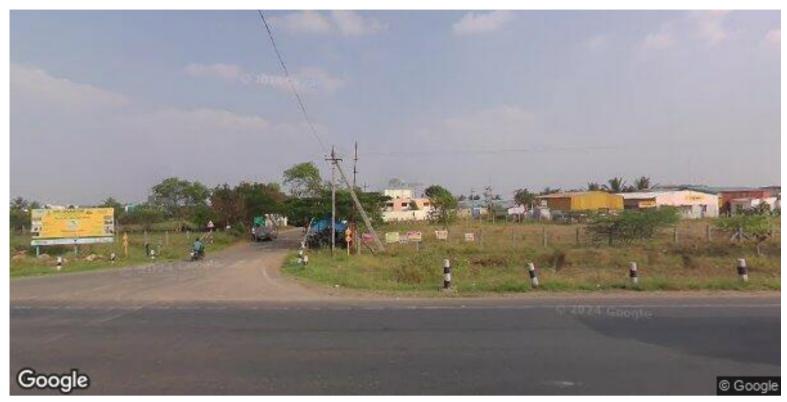
Risk Type: Turn
Risk Level: High
Speed Limit: 15 KM/Hr
Coordinates: 11.05129, 77.07919

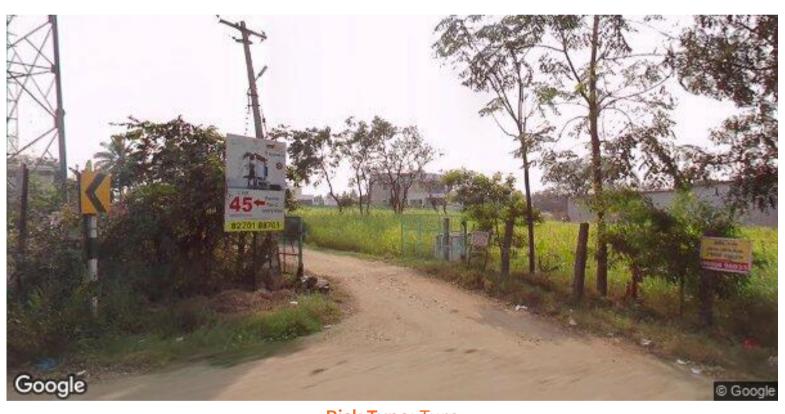
Risk Type: Turn
Risk Level: Medium
Speed Limit: 30 KM/Hr
Coordinates: 11.05181, 77.07696

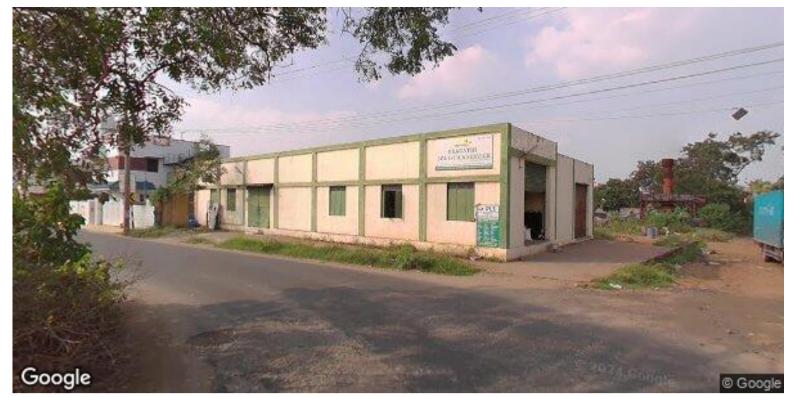
Risk Type: Turn
Risk Level: High
Speed Limit: 15 KM/Hr
Coordinates: 11.05222, 77.07690

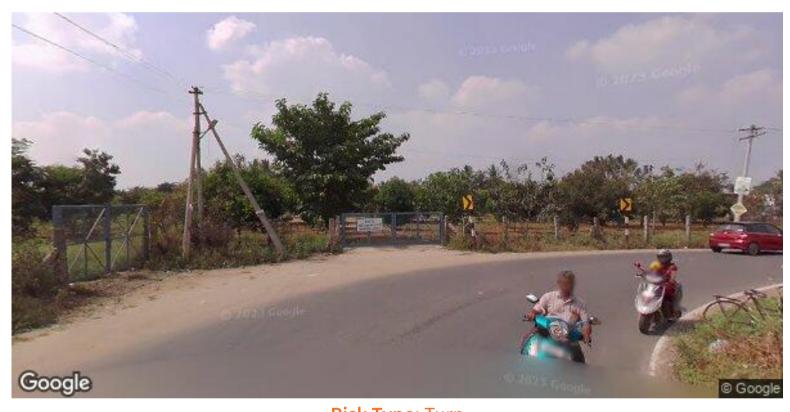
Risk Type: Turn
Risk Level: Medium
Speed Limit: 30 KM/Hr
Coordinates: 11.05343, 77.07106

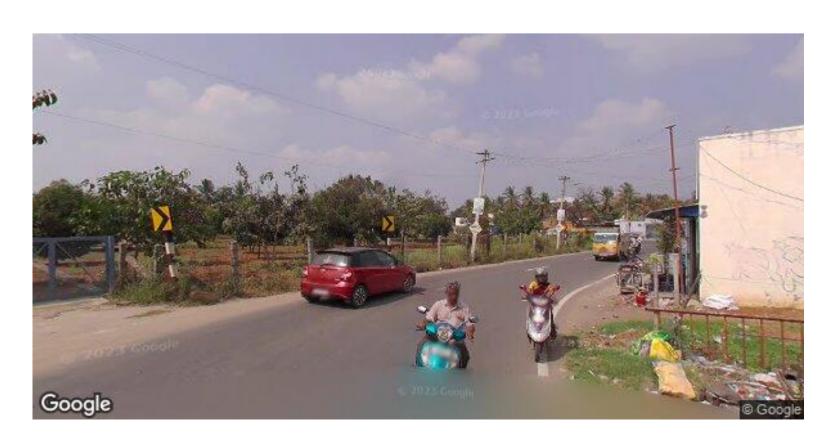
Coordinates: 11.05351, 77.07099

Risk Type: Turn
Risk Level: Medium
Speed Limit: 30 KM/Hr

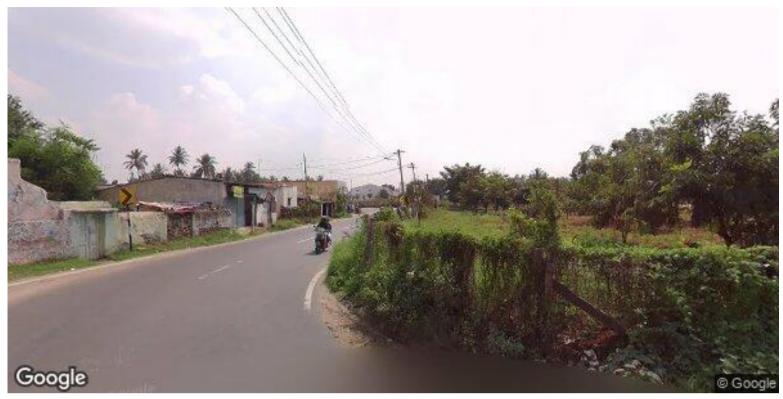
Risk Type: Turn
Risk Level: Medium
Speed Limit: 30 KM/Hr
Coordinates: 11.05411, 77.07097

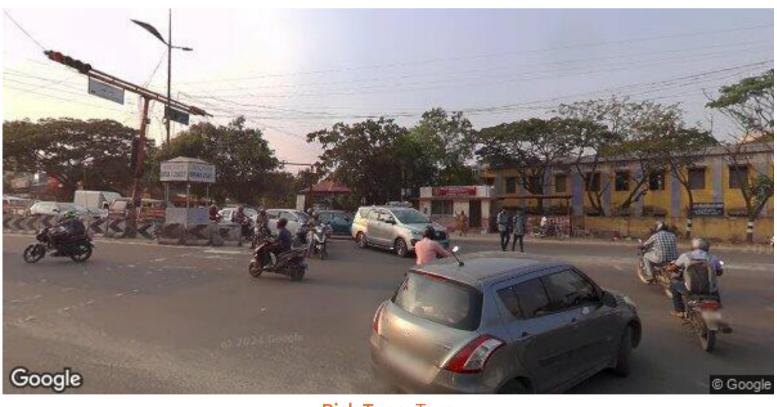
Risk Type: Turn
Risk Level: High
Speed Limit: 15 KM/Hr
Coordinates: 11.05529, 77.06566

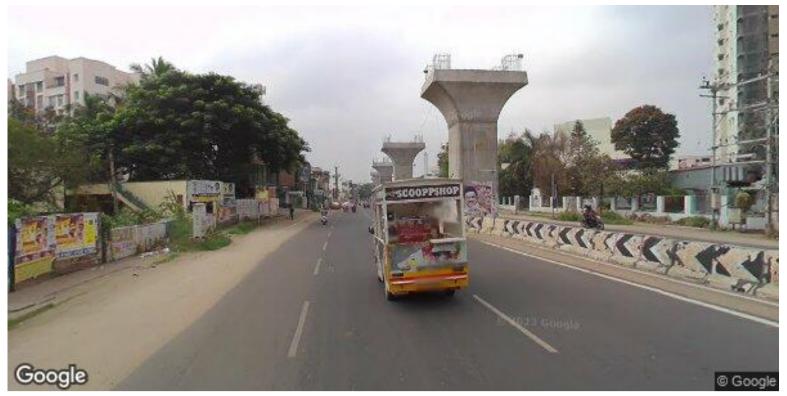
Risk Type: Turn
Risk Level: High
Speed Limit: 15 KM/Hr
Coordinates: 11.01613, 76.98961

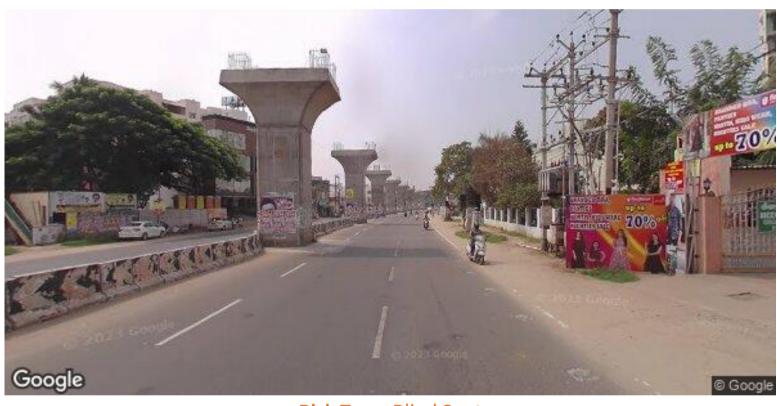
Risk Type: Blind Spot
Risk Level: Blind Spot
Speed Limit: 10 KM/Hr
Coordinates: 11.01618, 76.98951

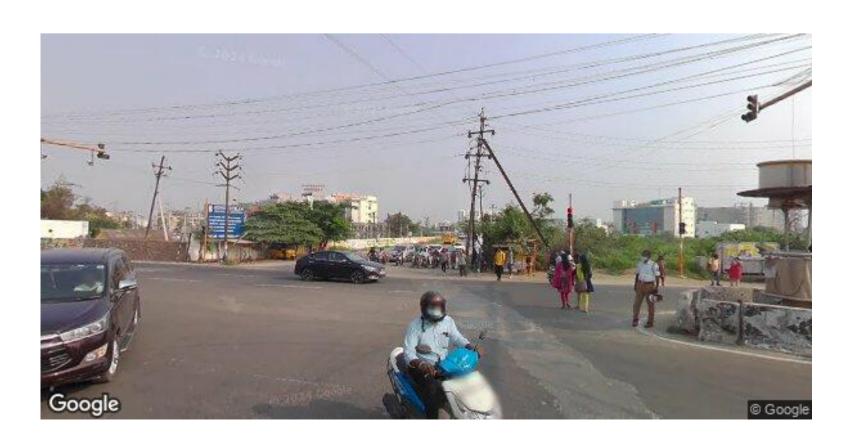
Coordinates: 11.02014, 76.99212

Risk Type: Turn
Risk Level: High
Speed Limit: 15 KM/Hr

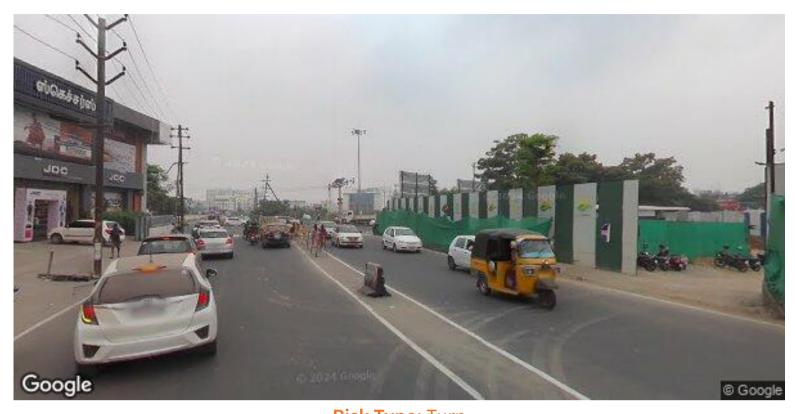
Coordinates: 11.02051, 76.99177

Risk Type: Turn
Risk Level: Medium
Speed Limit: 30 KM/Hr

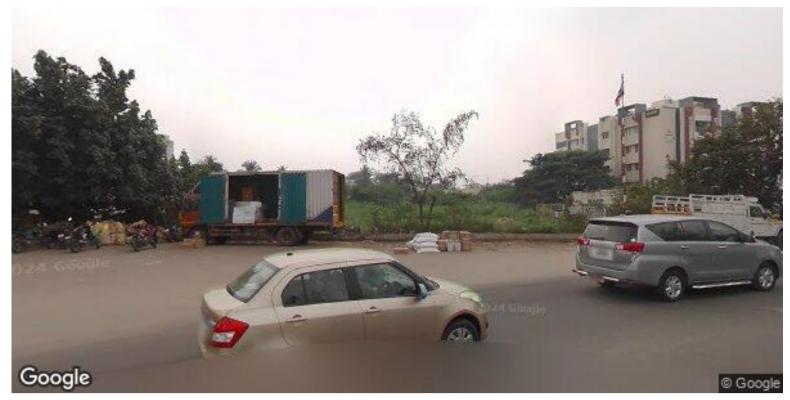
Coordinates: 11.02097, 76.98650

Risk Type: Turn
Risk Level: High
Speed Limit: 15 KM/Hr

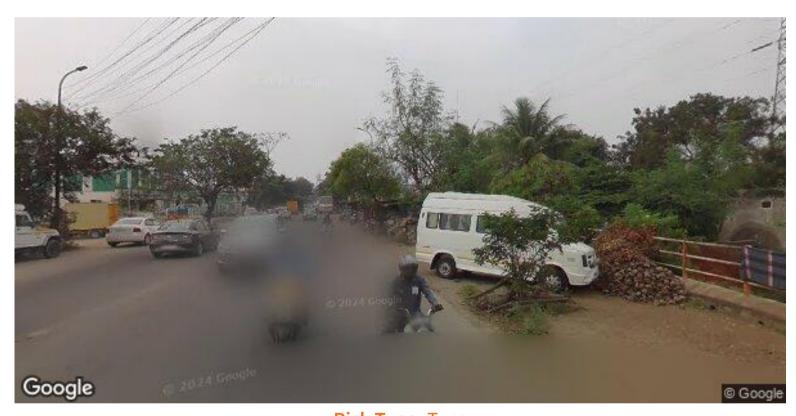
Risk Type: Turn
Risk Level: Medium
Speed Limit: 30 KM/Hr
Coordinates: 11.02095, 76.98644

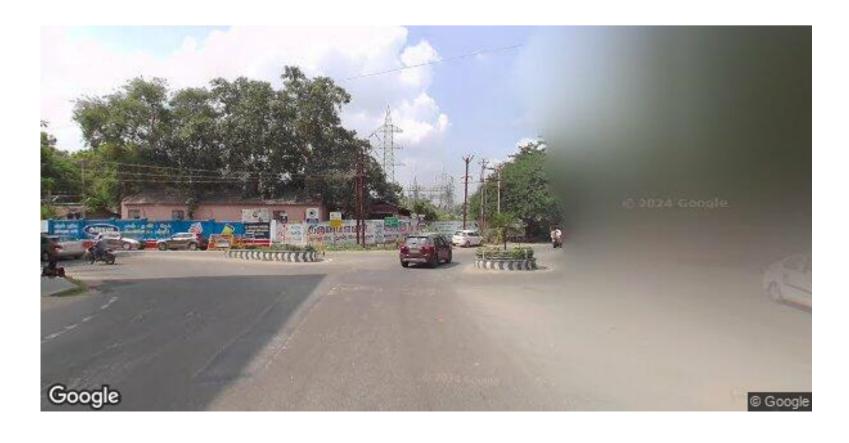
Coordinates: 11.01886, 76.96047

Risk Type: Turn
Risk Level: Medium
Speed Limit: 30 KM/Hr

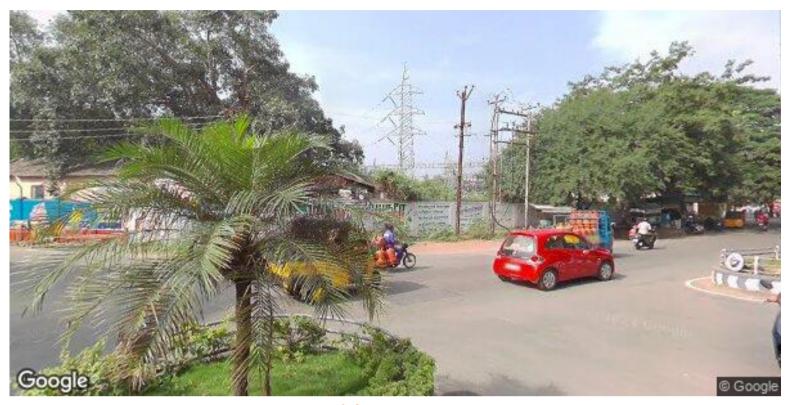
Coordinates: 11.01891, 76.96036

Risk Type: Turn
Risk Level: High
Speed Limit: 15 KM/Hr

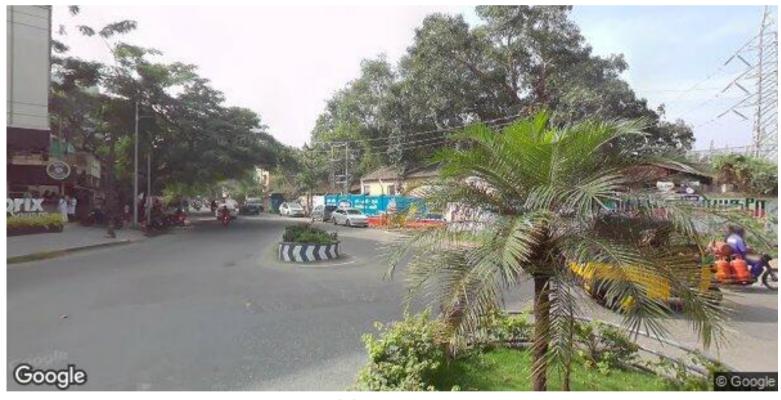
Coordinates: 11.01889, 76.96035

Risk Type: Turn
Risk Level: High
Speed Limit: 15 KM/Hr

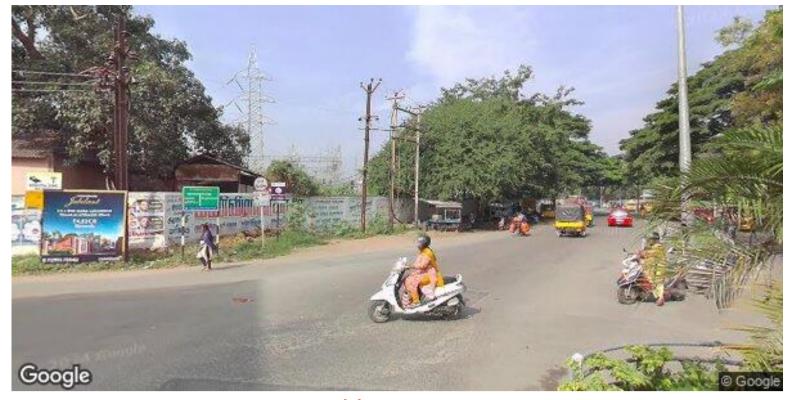
Risk Type: Turn
Risk Level: Medium
Speed Limit: 30 KM/Hr
Coordinates: 11.01889, 76.96029

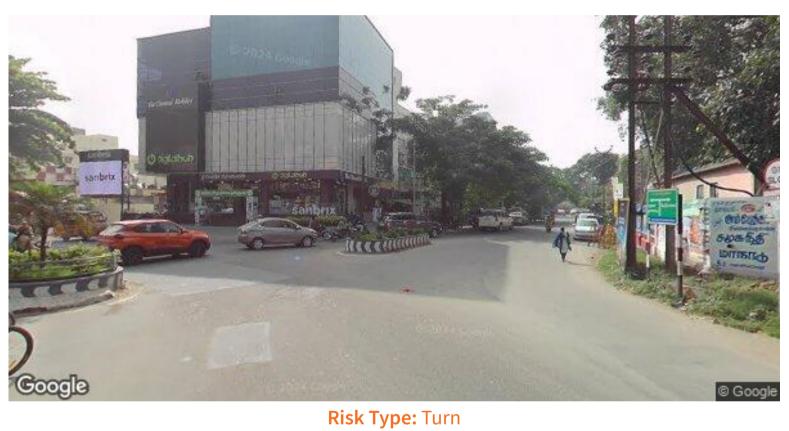
Risk Level: High
Speed Limit: 15 KM/Hr
Coordinates: 11.01893, 76.96023

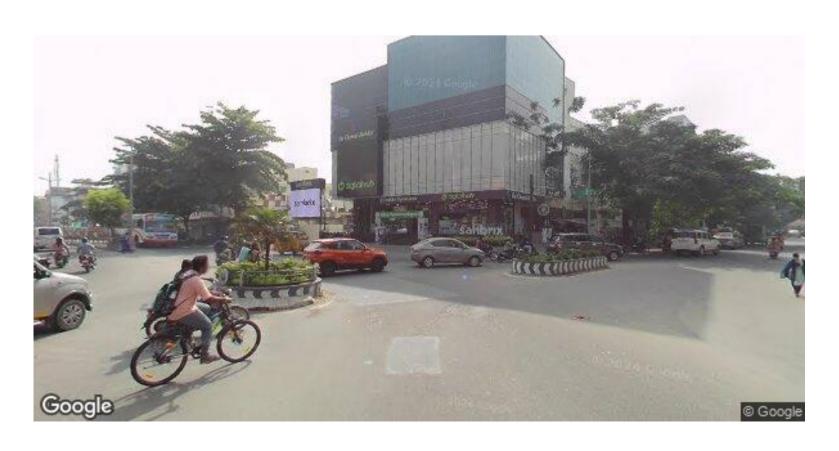
Coordinates: 11.01895, 76.96023

Risk Type: Turn
Risk Level: High
Speed Limit: 15 KM/Hr

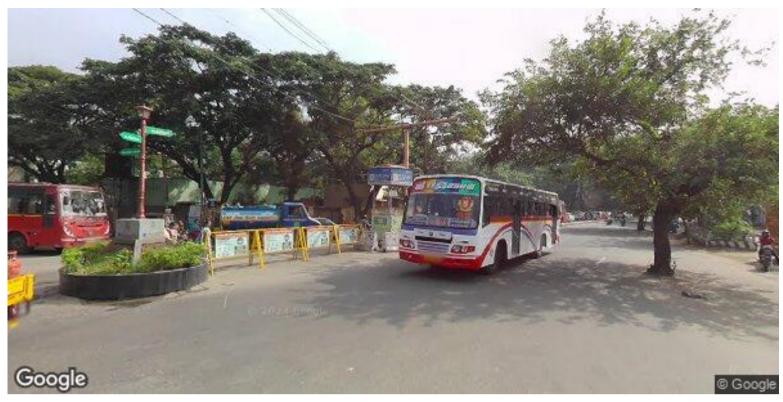
Coordinates: 11.01944, 76.95923

Risk Type: Turn
Risk Level: High
Speed Limit: 15 KM/Hr

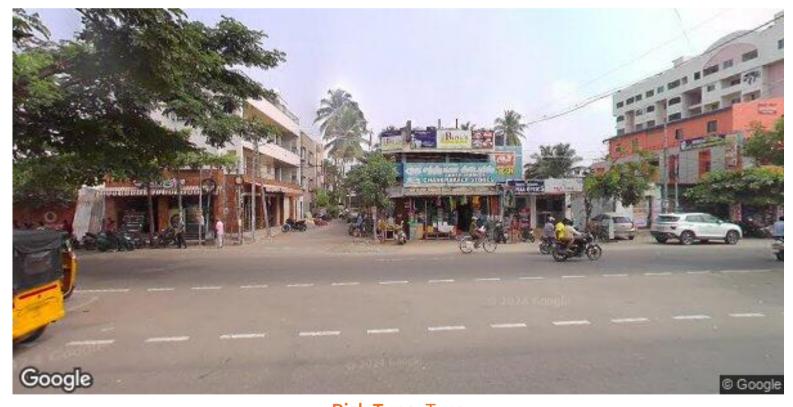
Coordinates: 11.02444, 76.95905

Risk Type: Turn
Risk Level: High
Speed Limit: 15 KM/Hr

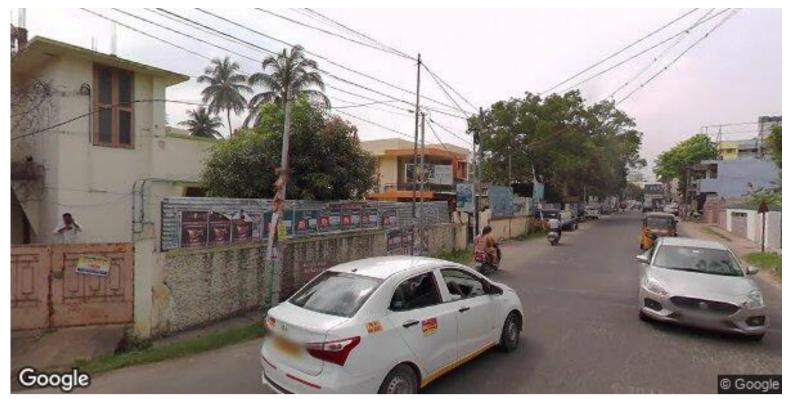
Risk Type: Turn
Risk Level: High
Speed Limit: 15 KM/Hr
Coordinates: 11.02504, 76.95710

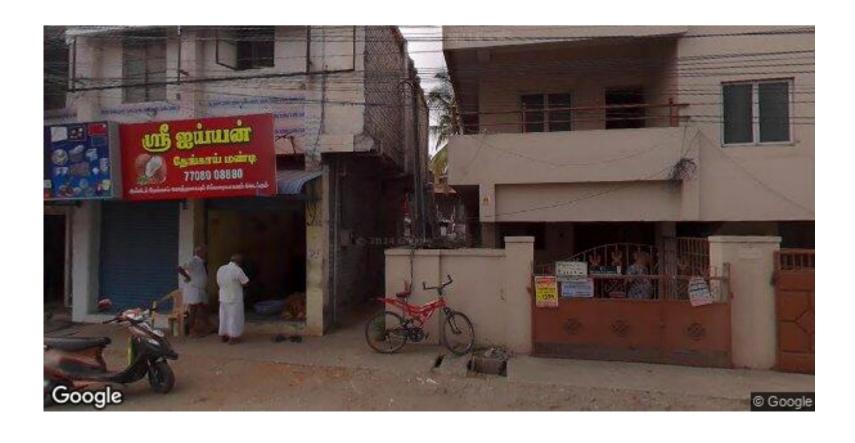
Coordinates: 11.02510, 76.95543

Risk Type: Turn
Risk Level: Medium
Speed Limit: 30 KM/Hr

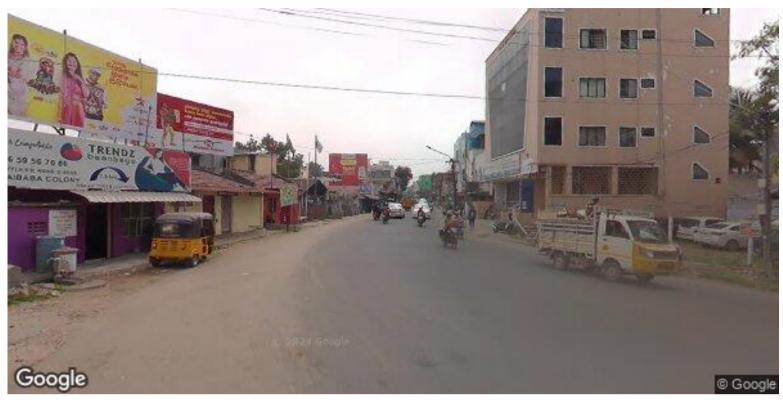
Coordinates: 11.02696, 76.95577

Risk Type: Turn
Risk Level: High
Speed Limit: 15 KM/Hr

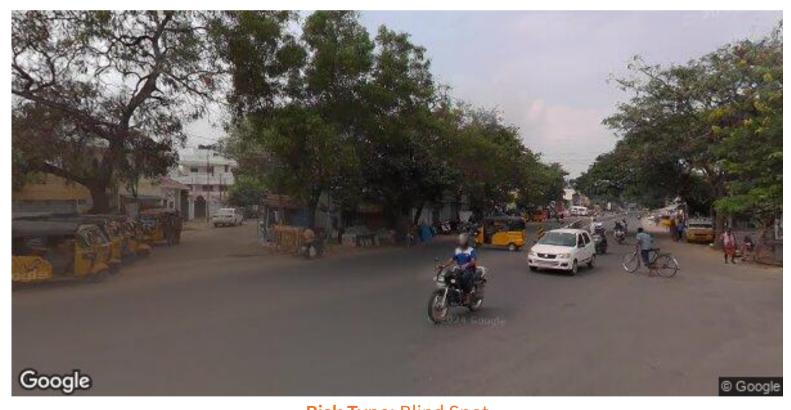
Coordinates: 11.02700, 76.95569

Risk Type: Blind Spot Risk Level: Blind Spot Speed Limit: 10 KM/Hr

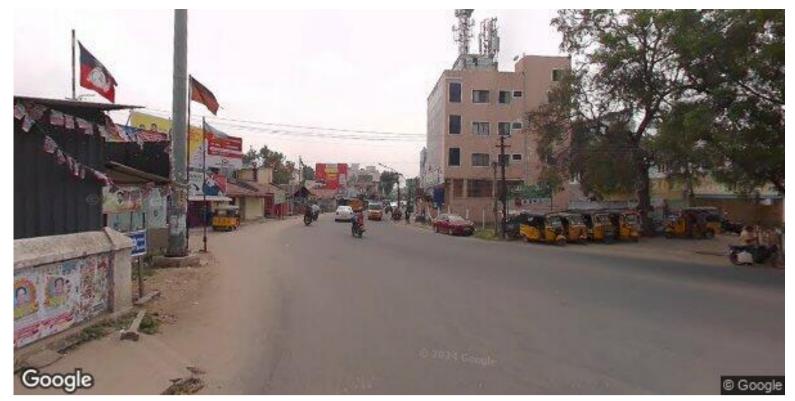
Risk Type: Turn
Risk Level: High
Speed Limit: 15 KM/Hr
Coordinates: 11.02705, 76.95578

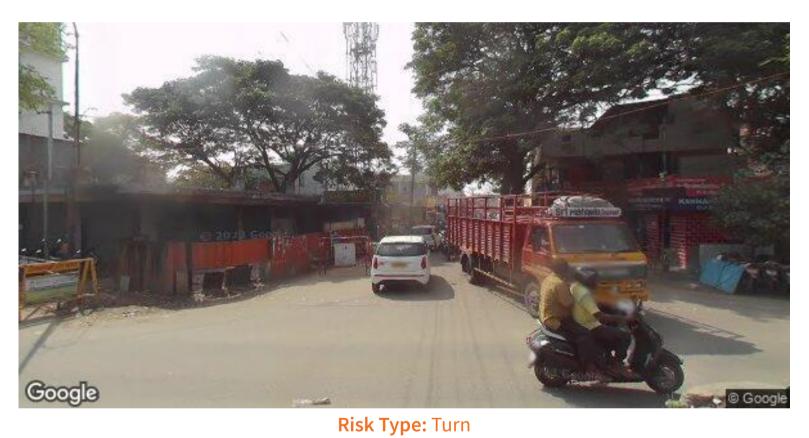
Risk Level: High
Speed Limit: 15 KM/Hr
Coordinates: 11.03571, 76.95557

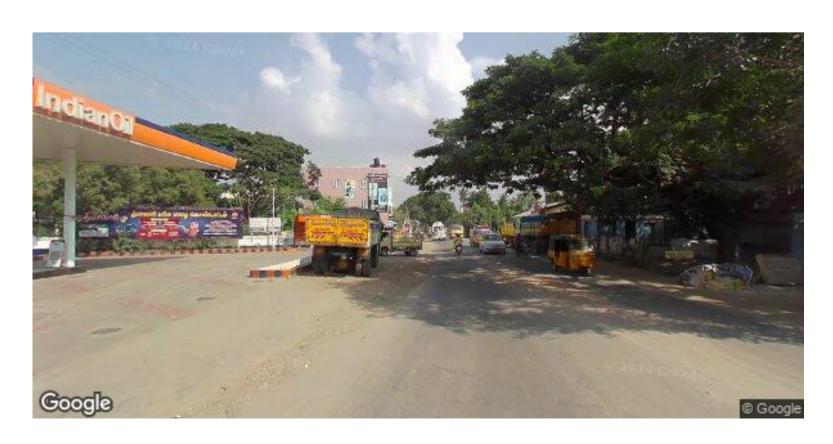
Coordinates: 11.03688, 76.95079

Risk Type: Blind Spot Risk Level: Blind Spot Speed Limit: 10 KM/Hr
