JOURNEY RISK MANAGEMENT (JRM) STUDY

Salem Terminal to THE VELAN PETROLEIUM AGENCIES

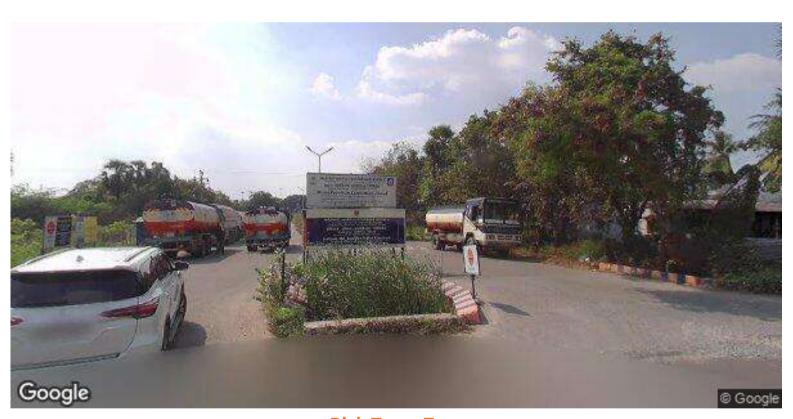
Coordinates: 11.44024, 77.87528

Risk Type: Turn
Risk Level: High
Speed Limit: 15 KM/Hr

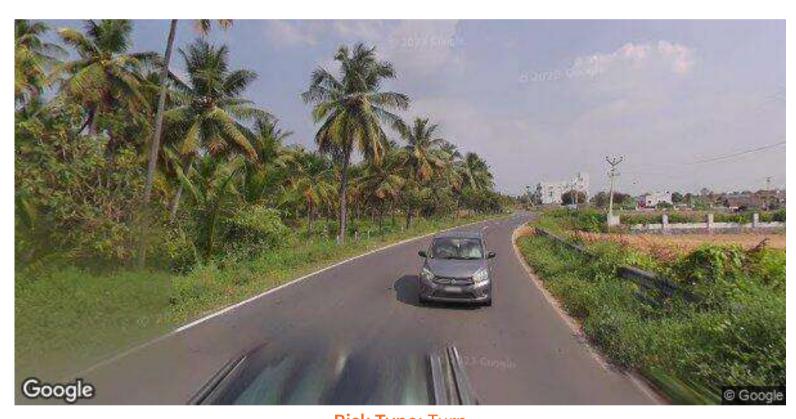
Risk Type: Turn
Risk Level: Medium
Speed Limit: 30 KM/Hr
Coordinates: 11.45357, 77.85789

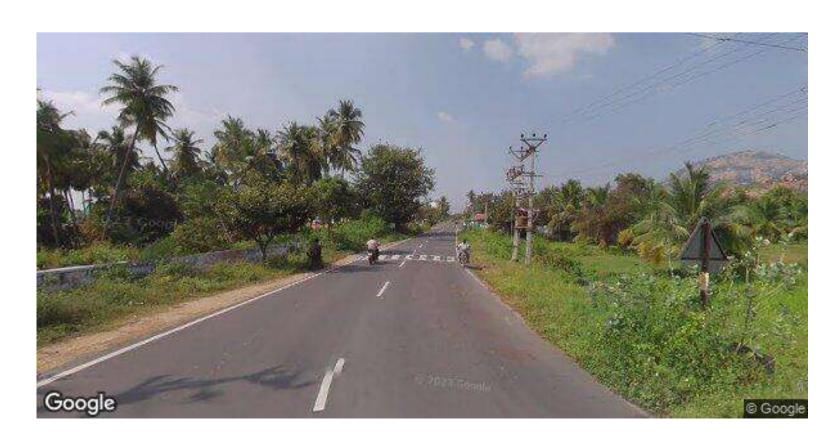
Coordinates: 11.45352, 77.85698

Risk Type: Turn
Risk Level: High
Speed Limit: 15 KM/Hr

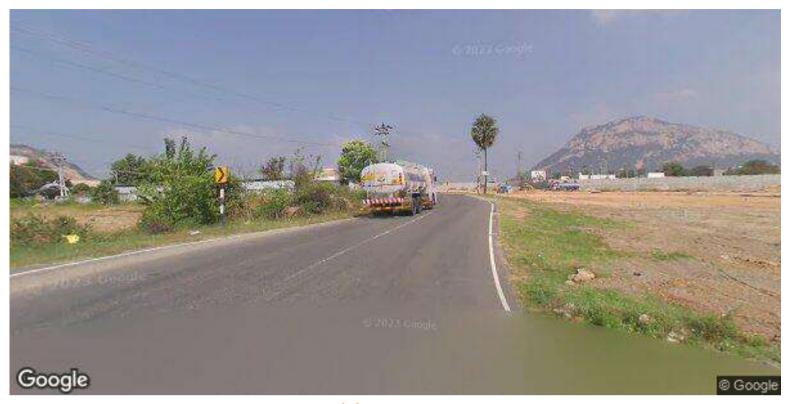
Risk Type: Turn
Risk Level: Medium
Speed Limit: 30 KM/Hr
Coordinates: 11.45847, 77.85140

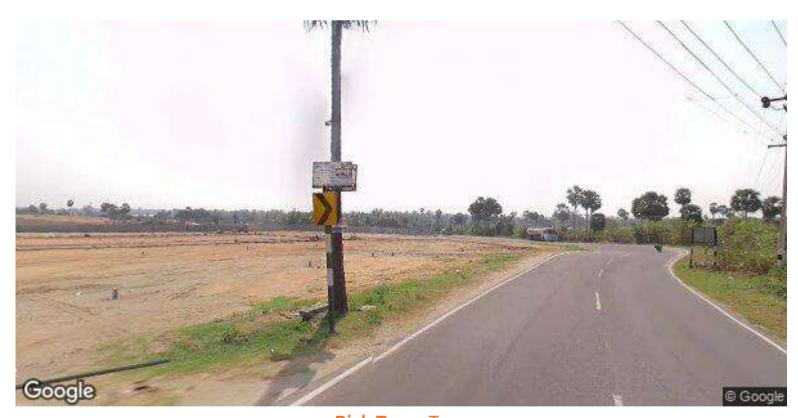
Risk Type: Turn
Risk Level: Medium
Speed Limit: 30 KM/Hr
Coordinates: 11.45898, 77.85135

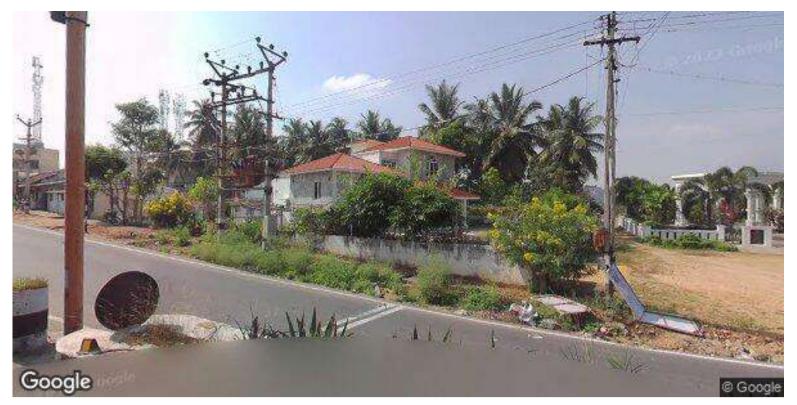
Risk Type: Turn
Risk Level: High
Speed Limit: 15 KM/Hr
Coordinates: 11.46303, 77.84945

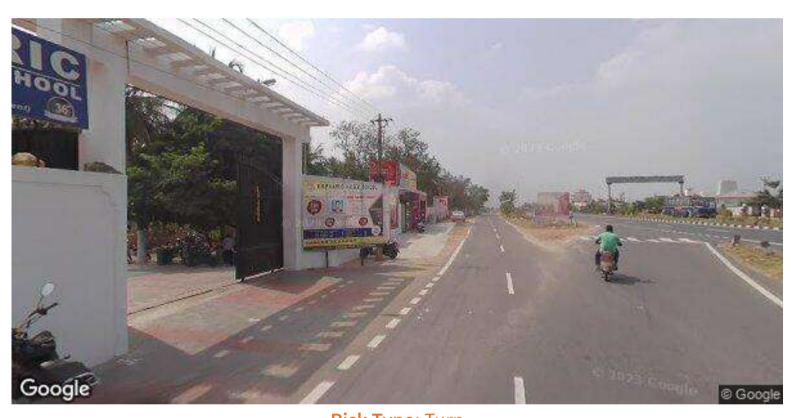
Risk Type: Turn
Risk Level: Medium
Speed Limit: 30 KM/Hr
Coordinates: 11.45509, 77.81383

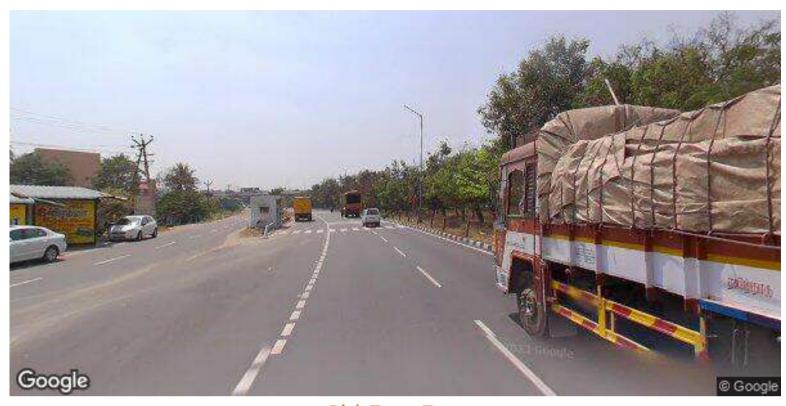
Coordinates: 11.43165, 77.67734

Risk Type: Turn
Risk Level: Medium
Speed Limit: 30 KM/Hr

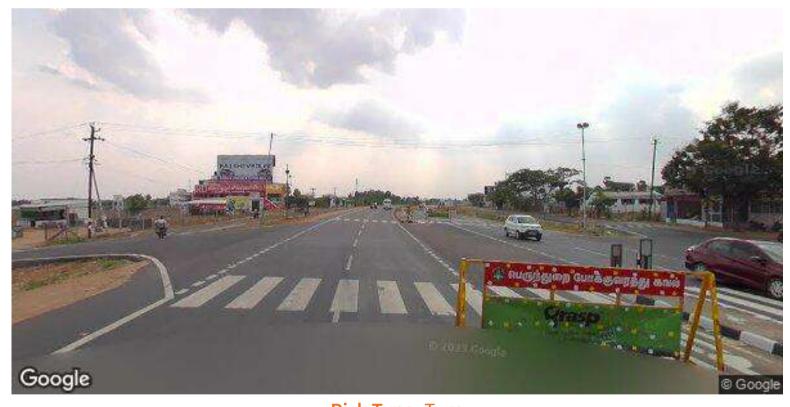
Risk Type: Turn
Risk Level: Medium
Speed Limit: 30 KM/Hr
Coordinates: 11.23724, 77.50686

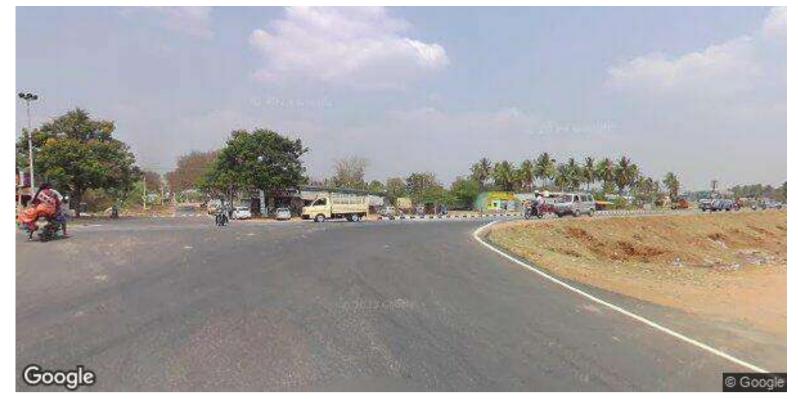
Risk Type: Turn
Risk Level: High
Speed Limit: 15 KM/Hr
Coordinates: 11.23704, 77.50676

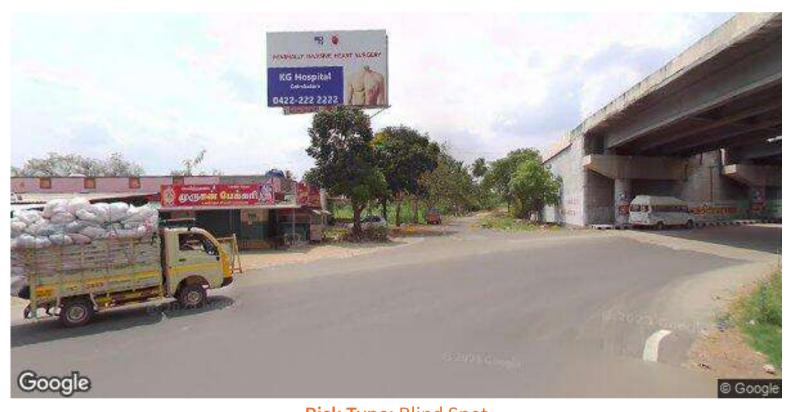
Risk Type: Blind Spot
Risk Level: Blind Spot
Speed Limit: 10 KM/Hr
Coordinates: 11.23686, 77.50216

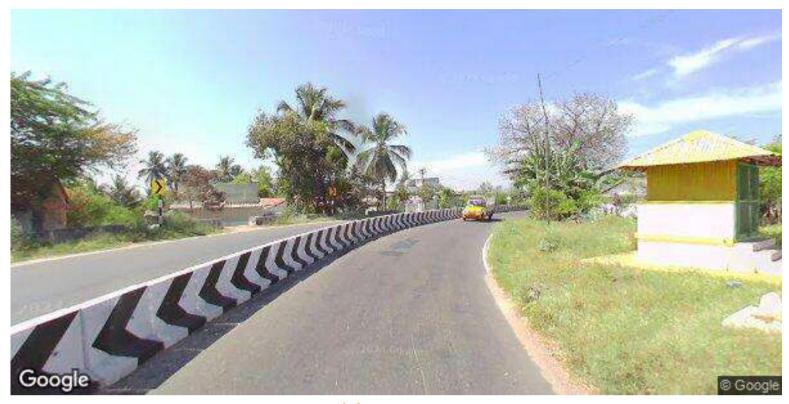
Coordinates: 11.23396, 77.50105

Risk Type: Turn
Risk Level: High
Speed Limit: 15 KM/Hr

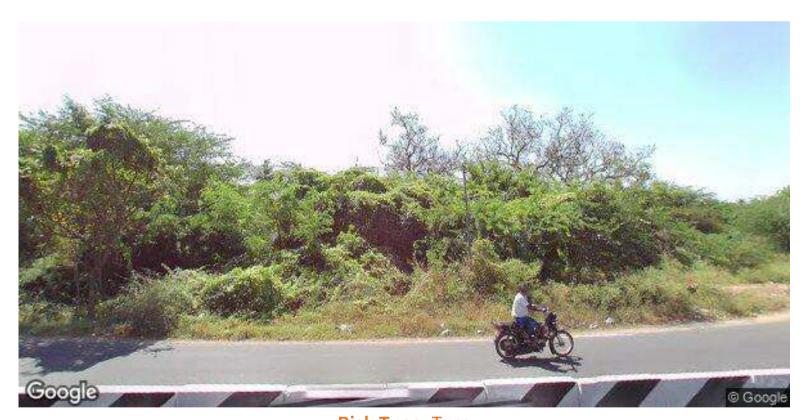
Coordinates: 11.23329, 77.49966

Risk Type: Turn
Risk Level: Medium
Speed Limit: 30 KM/Hr

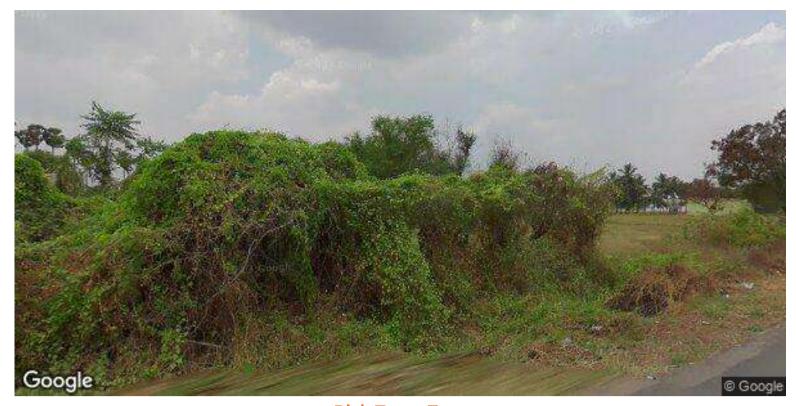
Risk Type: Turn
Risk Level: Medium
Speed Limit: 30 KM/Hr
Coordinates: 11.17851, 77.46169

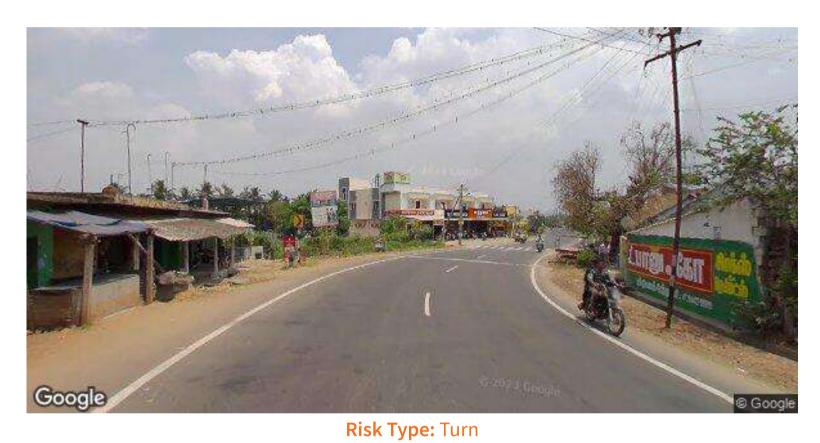
Risk Level: Medium
Speed Limit: 30 KM/Hr
Coordinates: 11.17368, 77.45730

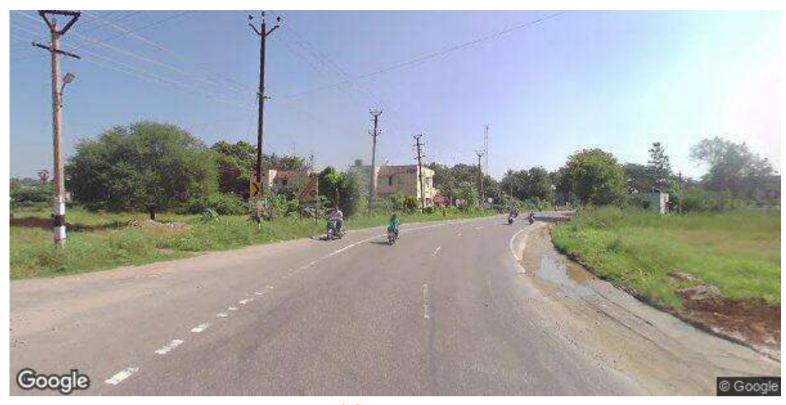
Coordinates: 11.16959, 77.44396

Risk Type: Turn
Risk Level: High
Speed Limit: 15 KM/Hr

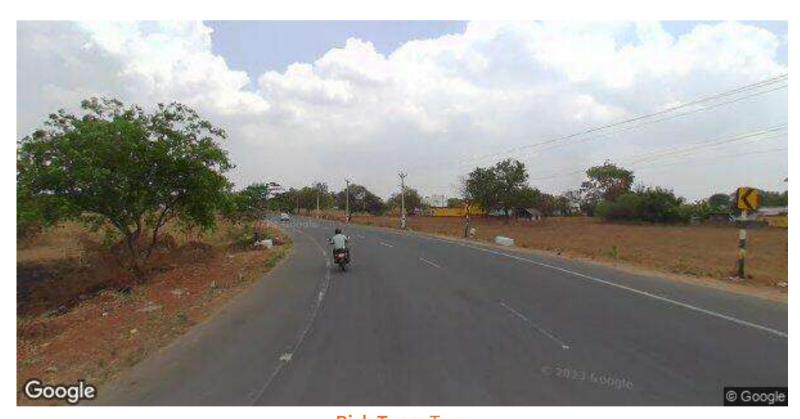
Risk Type: Turn
Risk Level: Medium
Speed Limit: 30 KM/Hr
Coordinates: 11.16381, 77.43700

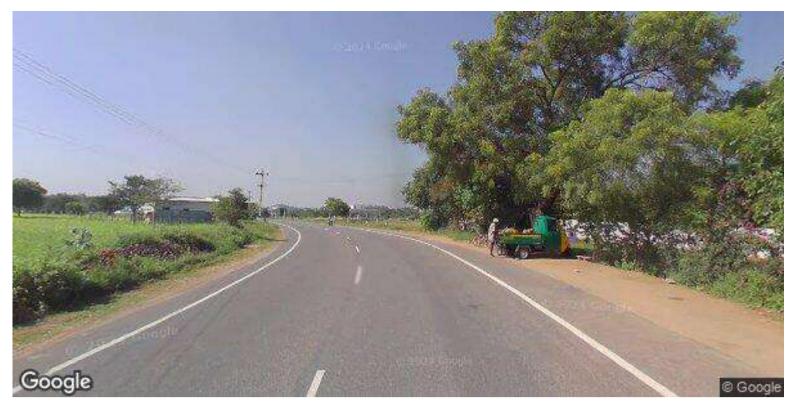
Risk Type: Turn
Risk Level: Medium
Speed Limit: 30 KM/Hr
Coordinates: 11.16280, 77.43139

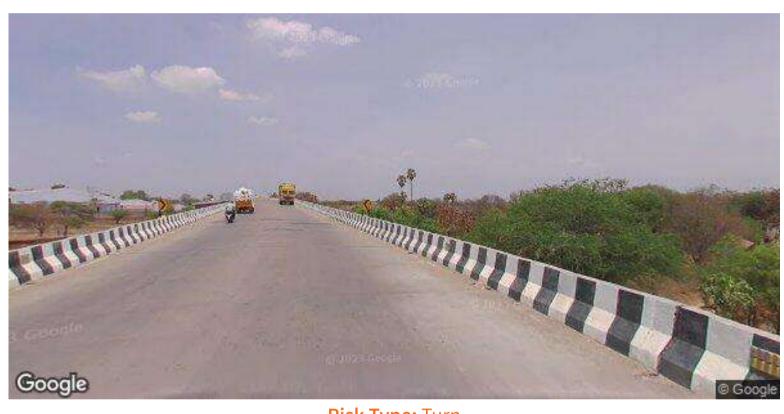
Risk Type: Turn
Risk Level: Medium
Speed Limit: 30 KM/Hr
Coordinates: 11.15217, 77.42418

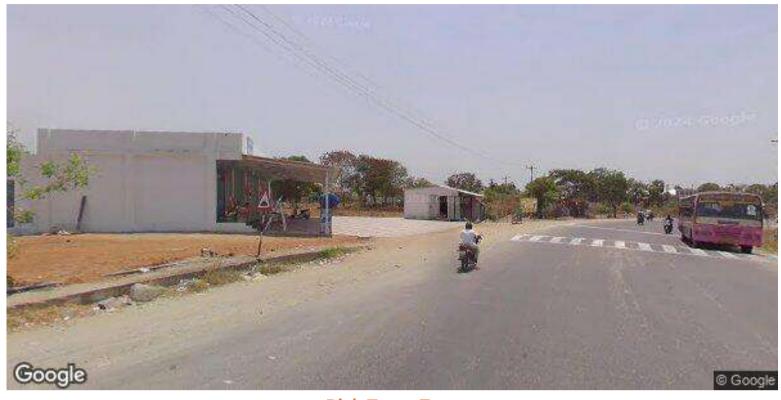
Risk Type: Turn
Risk Level: Medium
Speed Limit: 30 KM/Hr
Coordinates: 11.15023, 77.42247

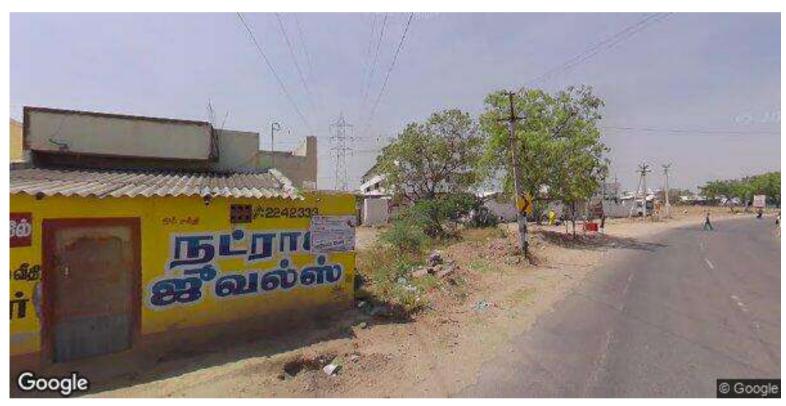
Risk Type: Turn
Risk Level: Medium
Speed Limit: 30 KM/Hr
Coordinates: 11.13578, 77.41299

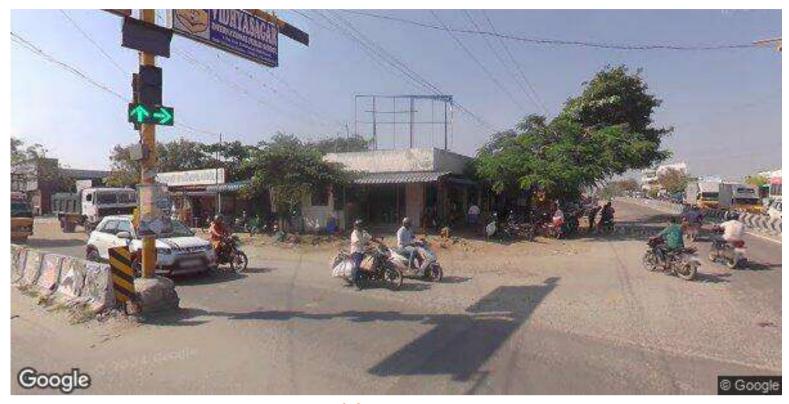
Coordinates: 11.12775, 77.39347

Risk Type: Turn
Risk Level: High
Speed Limit: 15 KM/Hr

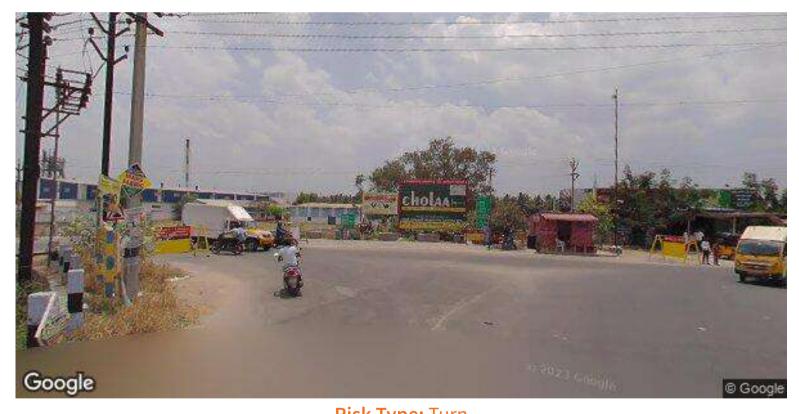
Coordinates: 11.11863, 77.39473

Risk Type: Turn
Risk Level: High
Speed Limit: 15 KM/Hr

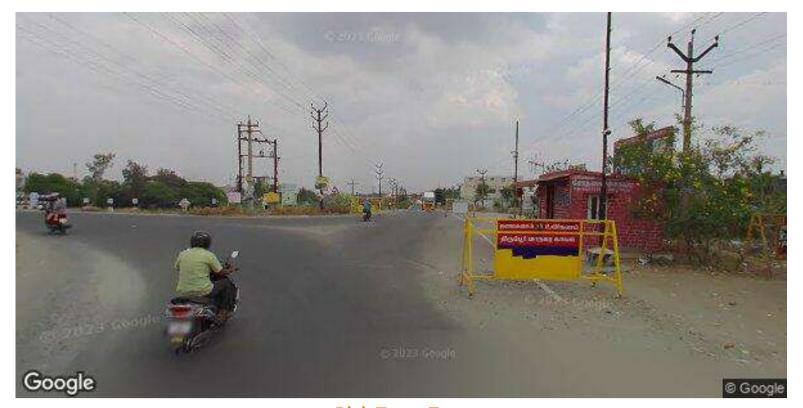
Risk Type: Turn
Risk Level: Medium
Speed Limit: 30 KM/Hr
Coordinates: 11.11846, 77.39460

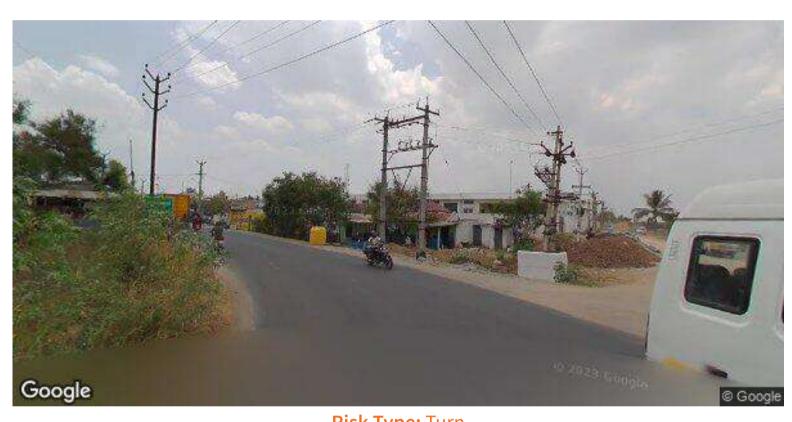
Risk Type: Turn
Risk Level: High
Speed Limit: 15 KM/Hr
Coordinates: 11.11833, 77.39390

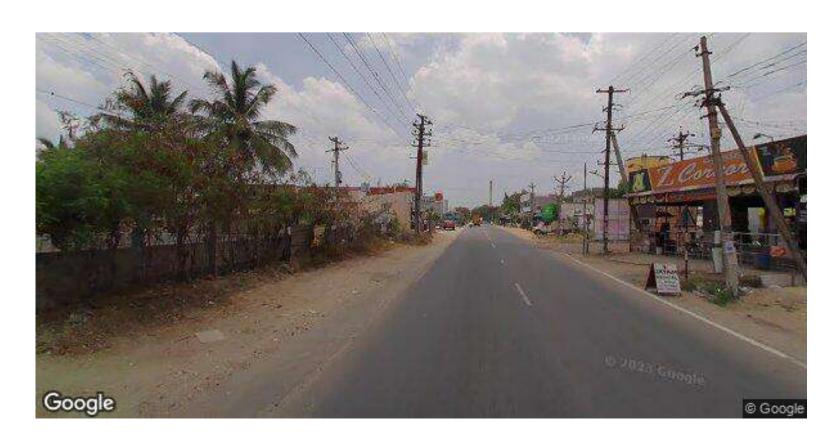
Coordinates: 11.11512, 77.39305

Risk Type: Turn
Risk Level: High
Speed Limit: 15 KM/Hr

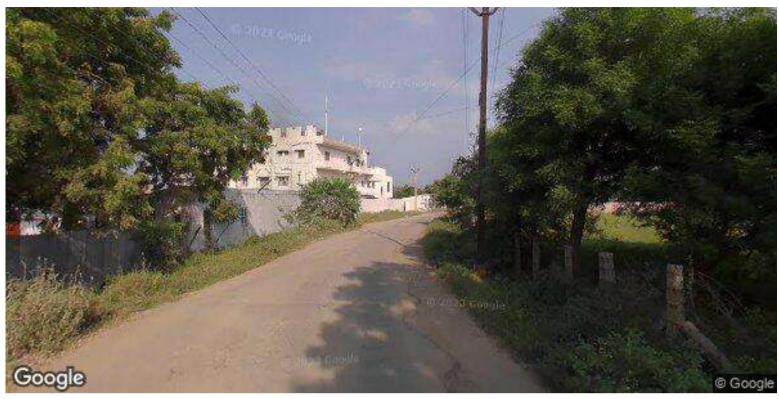
Risk Type: Turn
Risk Level: Medium
Speed Limit: 30 KM/Hr
Coordinates: 11.11497, 77.38987

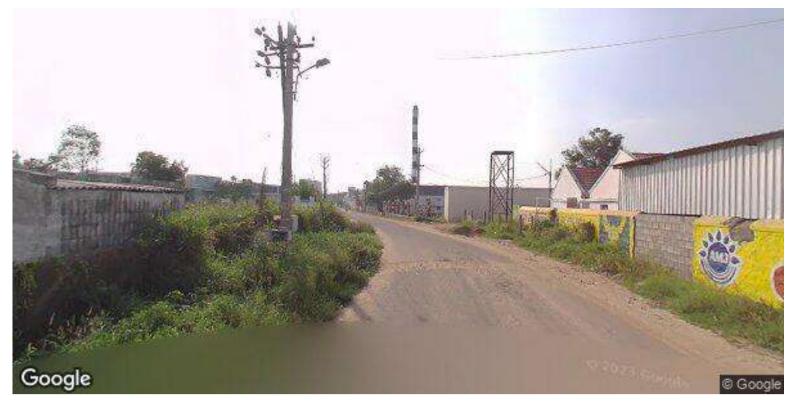
Risk Type: Turn
Risk Level: Medium
Speed Limit: 30 KM/Hr
Coordinates: 11.11539, 77.38469

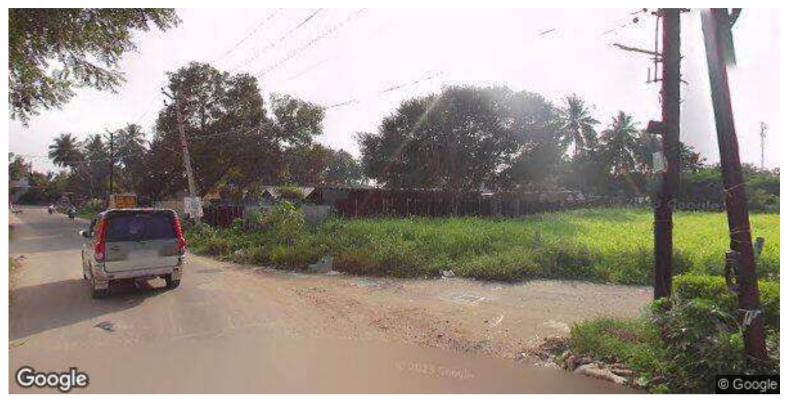
Coordinates: 11.11110, 77.37768

Risk Type: Turn
Risk Level: High
Speed Limit: 15 KM/Hr

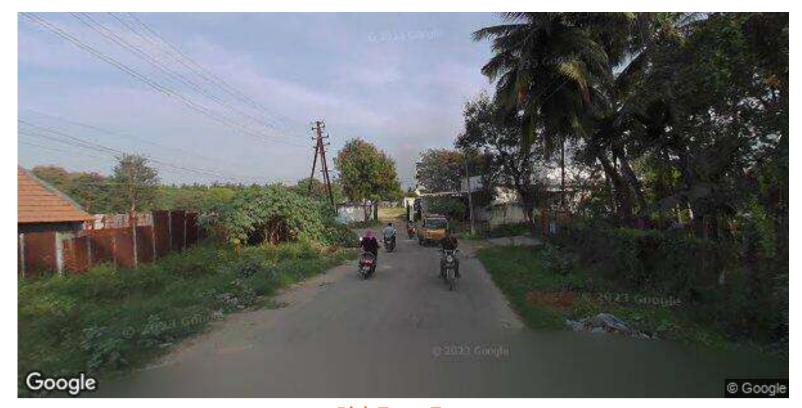
Risk Type: Turn
Risk Level: Medium
Speed Limit: 30 KM/Hr
Coordinates: 11.11013, 77.37747

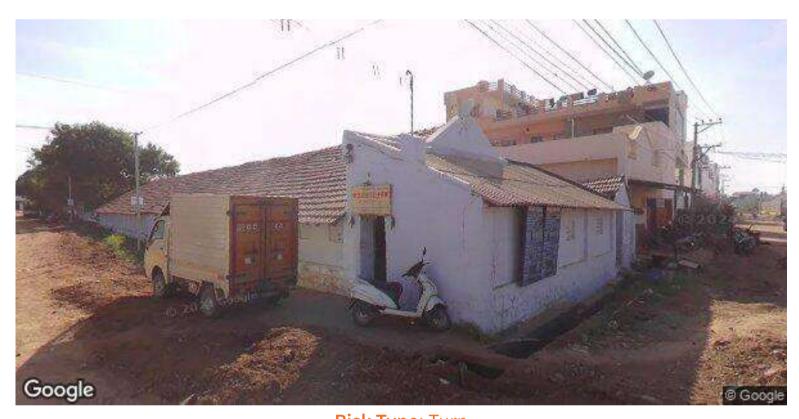
Risk Type: Turn
Risk Level: Medium
Speed Limit: 30 KM/Hr
Coordinates: 11.10613, 77.36798

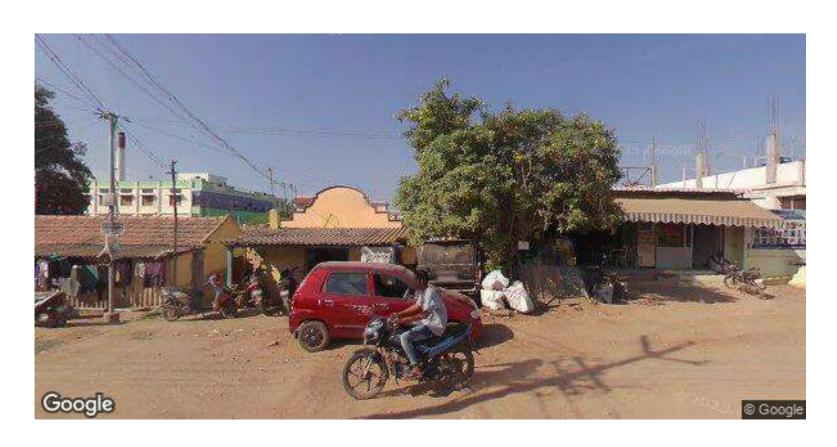
Coordinates: 11.10560, 77.36161

Risk Type: Turn
Risk Level: High
Speed Limit: 15 KM/Hr

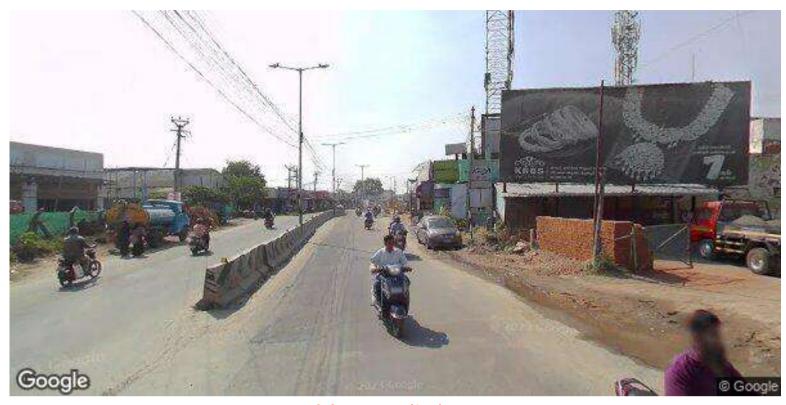
Coordinates: 11.10271, 77.36193

Risk Type: Blind Spot
Risk Level: Blind Spot
Speed Limit: 10 KM/Hr
