WELCOME TO JOURNEY
RISK MANAGEMENT
(JRM) STUDY USING
ARTIFICIAL
INTELLIGENCE (AI)
FOR IOCL TRICHY
TERMINAL

IOCL TIRCHY TERMINAL (10.7753, 78.8368) TO KPM AGENCY ,(10.37136, 78.81651), TOTAL DISTANCE -36 KM

* Route Safety Analysis Report

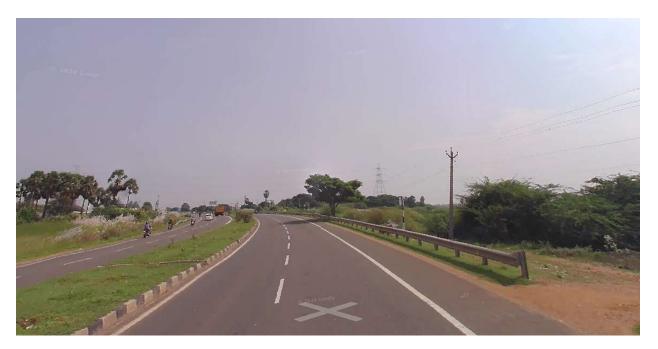
IMAGE :- SHARP TURN RISK LEVEL :- MEDIUM COORDI. 10.765497799294907, 78.83604620042777

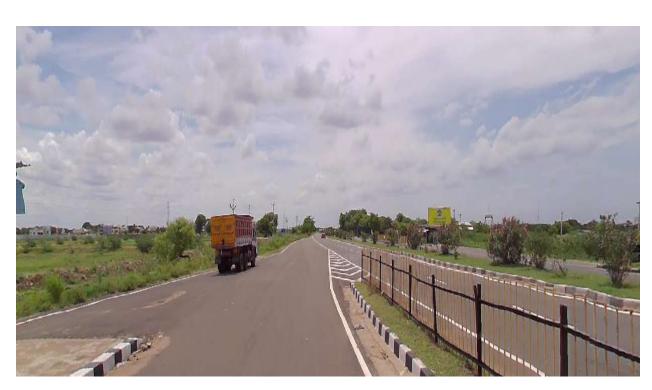
IMAGE:- SHARP TURN RISK LEVEL:- MEDIUM COORDI. 10.756122556562806, 78.83055889901199

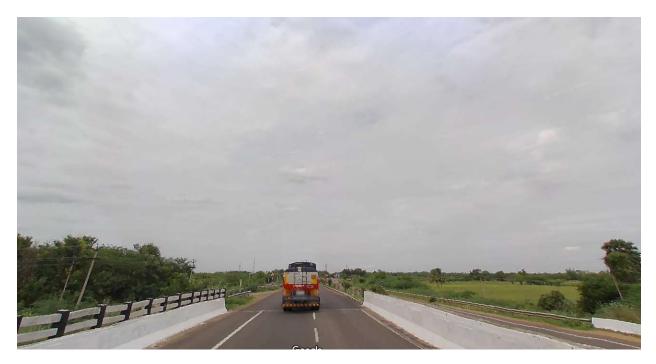
IMAGE :- SHARP TURN RISK LEVEL :- MEDIUM COORDI. 10.739011461069182, 78.83858885050212

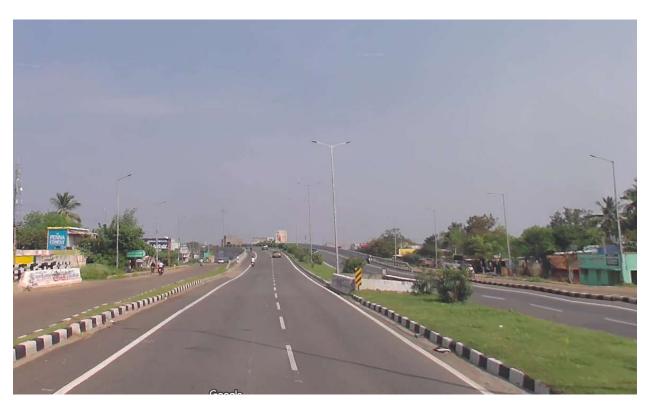
IMAGE:-SHARP TURN RISK LEVEL:-MEDIUM COORDI. 10.720753025938777, 78.96377618938521

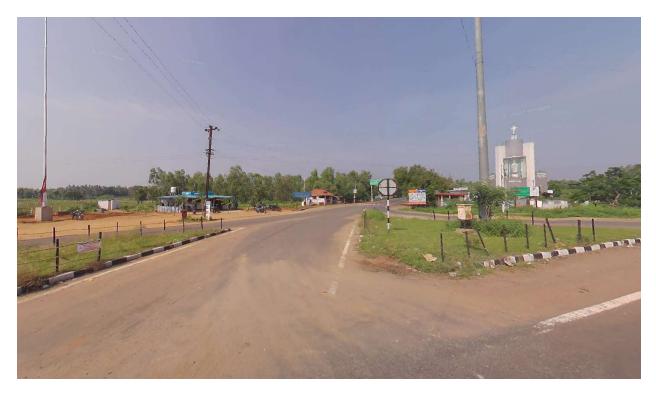
IMAGE :- SHARP TURN RISK LEVEL :- MEDIUM COORDI. 10.573492136690625, 79.01365840917202

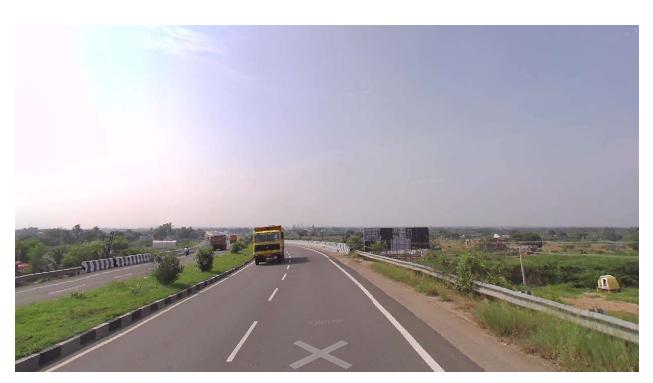
IMAGE :- SHARP TURN RISK LEVEL :- MEDIUM COORDI. 10.489673396392101, 78.97667721669097

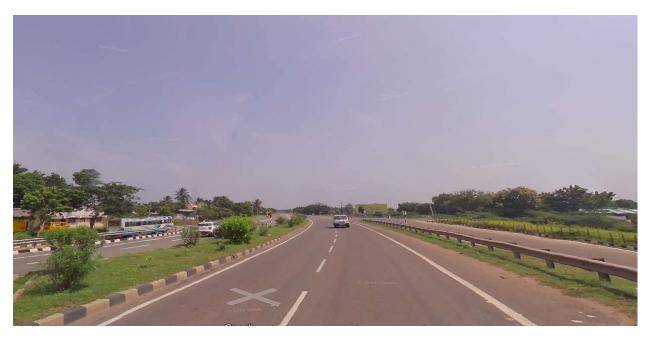
IMAGE:-SHARP TURN RISK LEVEL:-MEDIUM COORDI. 10.461719875337447, 78.98089783911972

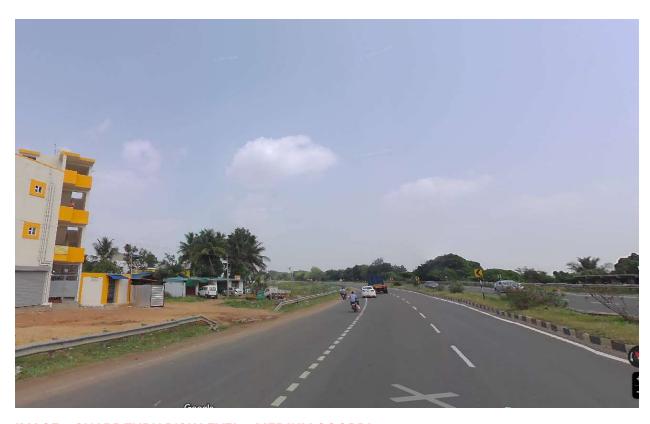
IMAGE :- SHARP TURN RISK LEVEL :- MEDIUM COORDI. 10.366911225762008, 78.9863942537038

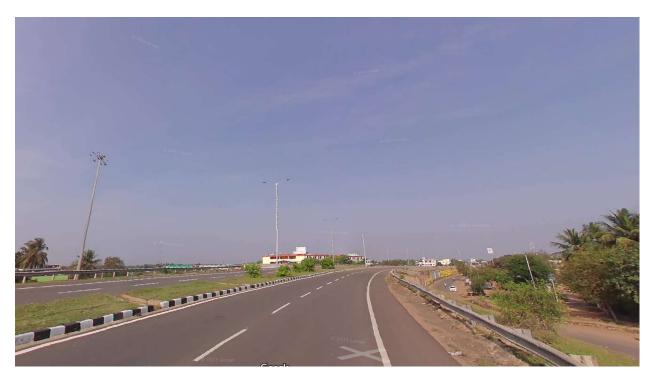
IMAGE :- SHARP TURN RISK LEVEL :- MEDIUM COORDI. 10.494374169846944, 78.97771872041729

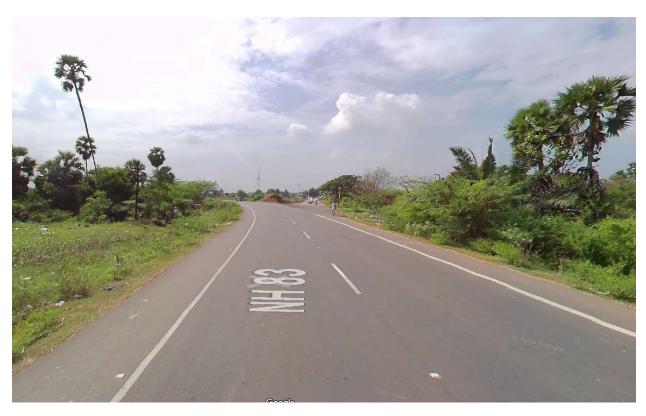
IMAGE:-SHARP TURN RISK LEVEL:-MEDIUM COORDI. 10.361143177391408, 78.98166916302662

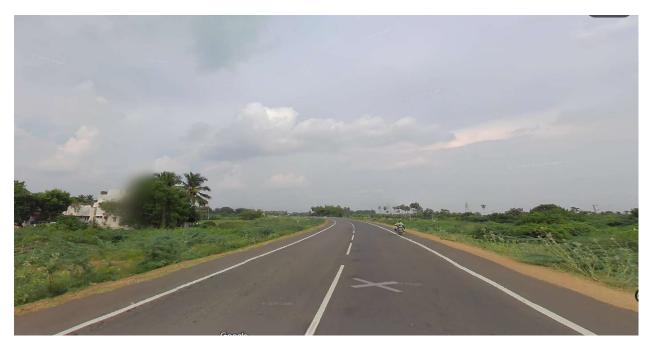
IMAGE :- SHARP TURN RISK LEVEL :- MEDIUM COORDI. 10.357266261057422, 78.98084609847567

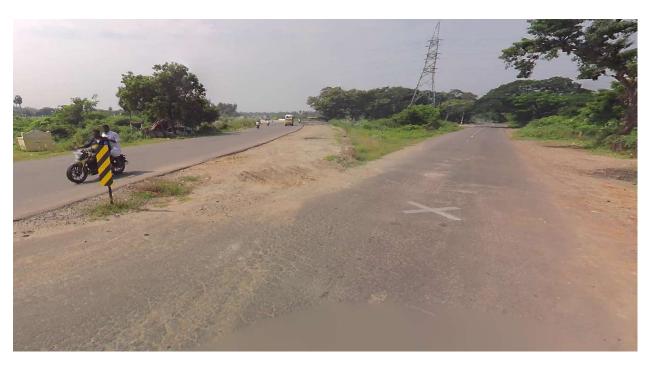
IMAGE :- SHARP TURN RISK LEVEL :- MEDIUM COORDI.23.423073831779945, 70.68656297849758

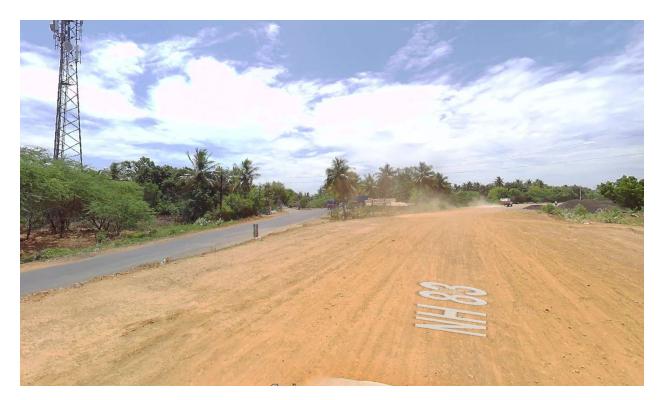
IMAGE :- SHARP TURN RISK LEVEL :- MEDIUM COORDI. 10.494374169846944, 78.97771872041729

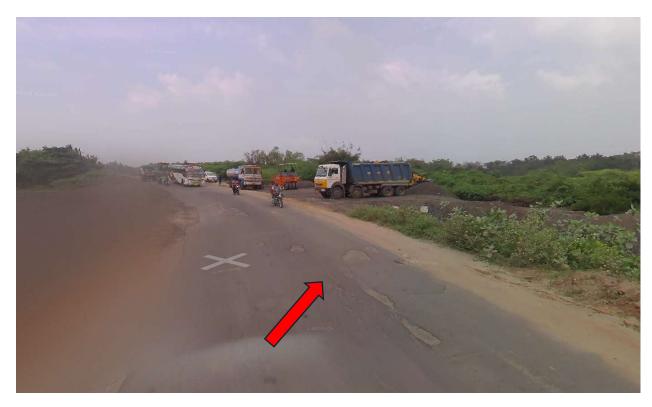
IMAGE :- SHARP TURN RISK LEVEL :- MEDIUM COORDI. 10.366911225762008, 78.9863942537038

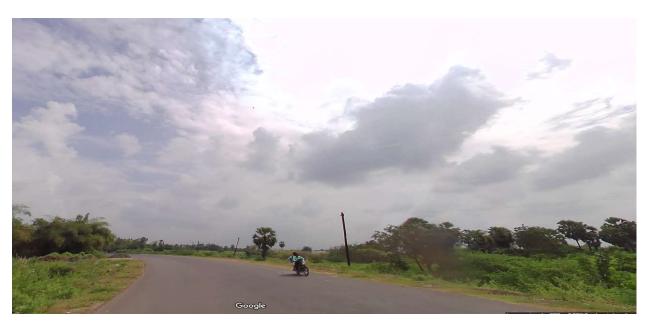
IMAGE :- SHARP TURN RISK LEVEL :- MEDIUM COORDI. 10.521018452488628, 78.9577791085502

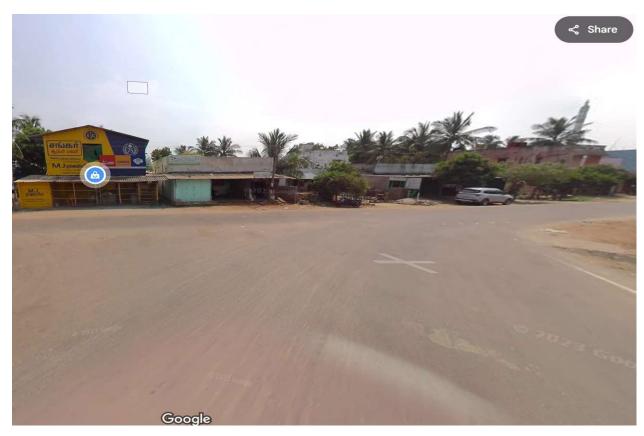
IMAGE :- SHARP TURN RISK LEVEL :- MEDIUM COORDI.10.75826994715787, 78.83326651420096

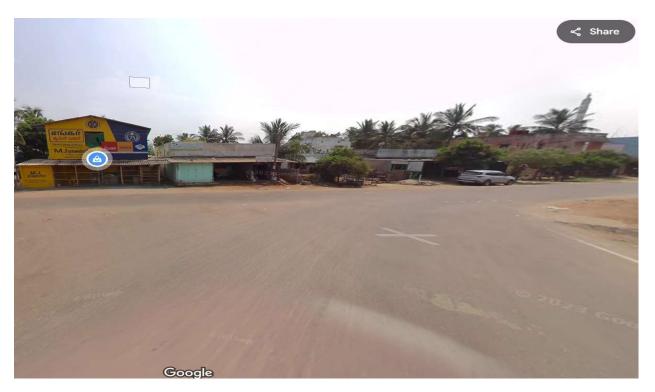
IMAGE :- SHARP TURN RISK LEVEL :- MEDIUM COORDI 10.75826994715787, 78.83326651420096

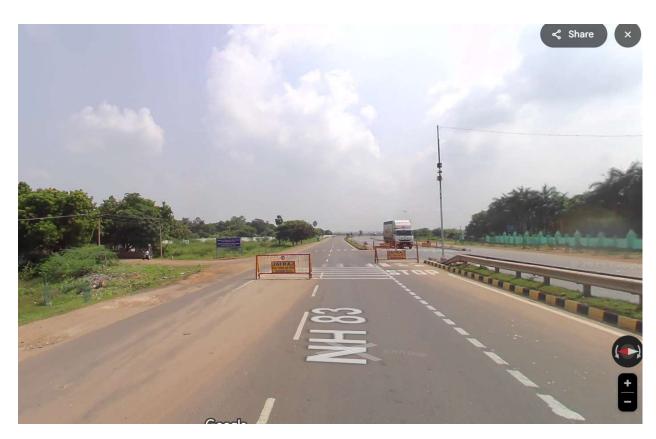
IMAGE :- SHARP TURN RISK LEVEL :- MEDIUM COORDI 10.750231129775111, 78.82811473719116

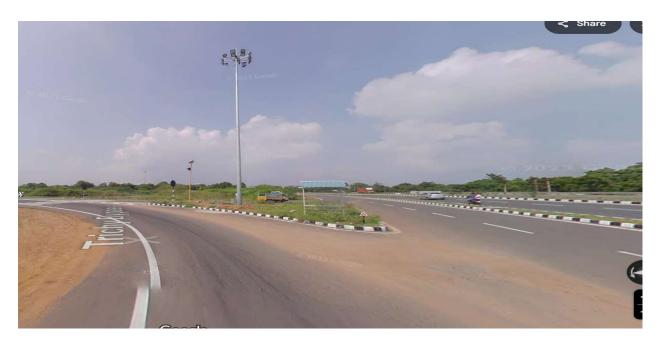
IMAGE :- SHARP TURN RISK LEVEL :- MEDIUM COORDI 10.74903839684931, 78.83067443431507

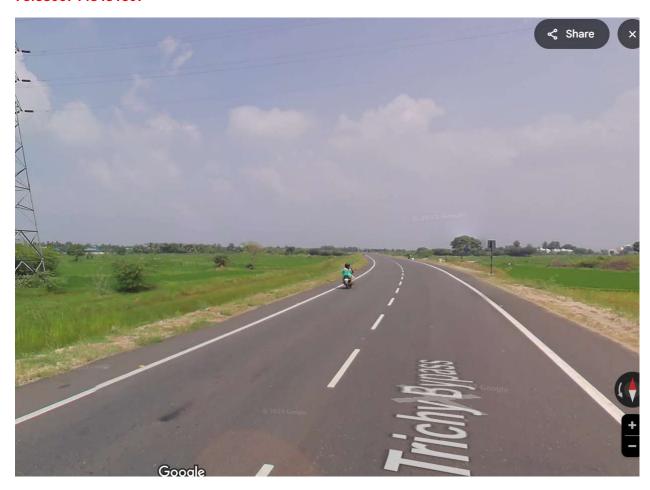
IMAGE :- SHARP TURN RISK LEVEL :- MEDIUM COORDI 10.742539235146788, 78.82757393279459

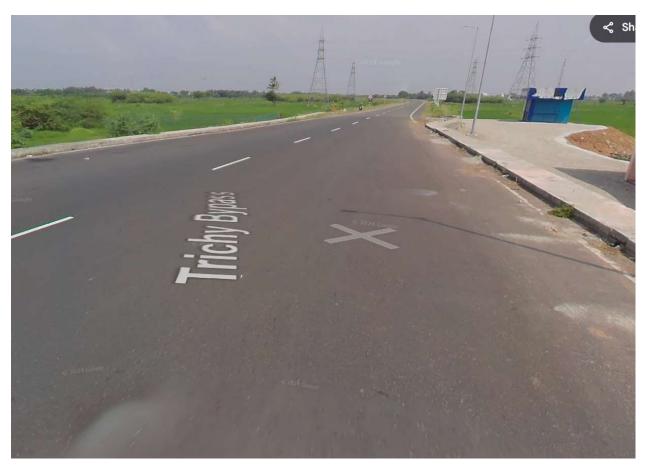
IMAGE :- SHARP TURN RISK LEVEL :- MEDIUM COORDI 10.73973556832621, 78.82562793774534

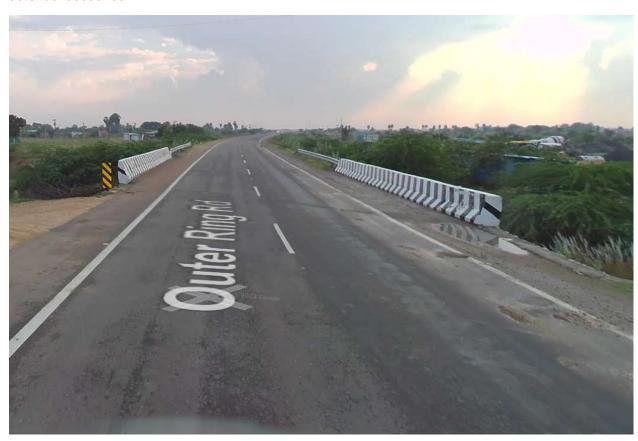
IMAGE :- SHARP TURN RISK LEVEL :- MEDIUM COORDI 10.72027477903802, 78.81393634911623

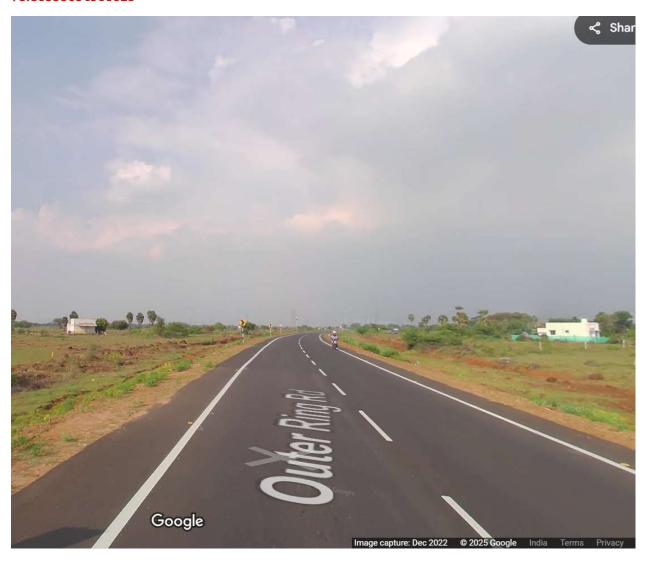
IMAGE :- SHARP TURN RISK LEVEL :- MEDIUM COORDI 10.7141676534269, 78.80978487855221

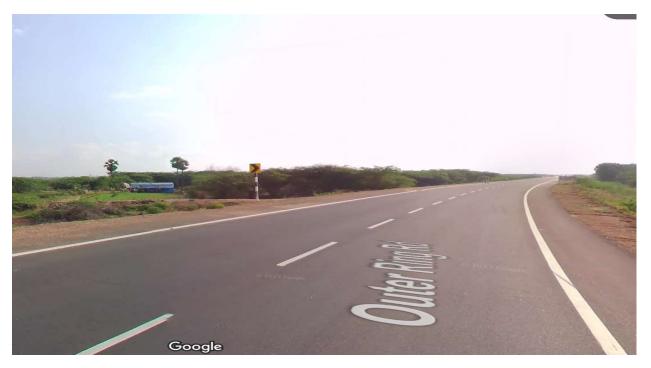
IMAGE:- SHARP TURN RISK LEVEL:- MEDIUM COORDI 10.706304240757193, 78.8074092846165

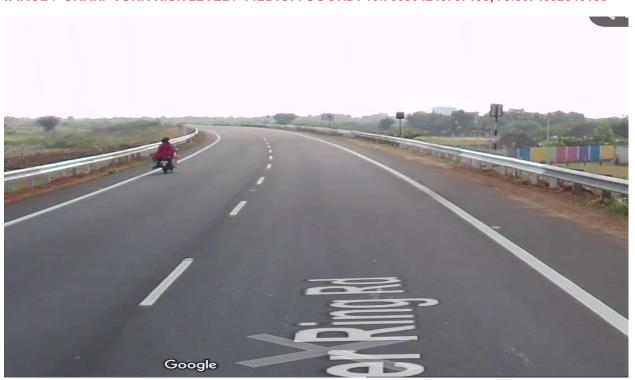
IMAGE :- SHARP TURN RISK LEVEL :- MEDIUM COORDI 10.69925365221937, 78.80013538152075

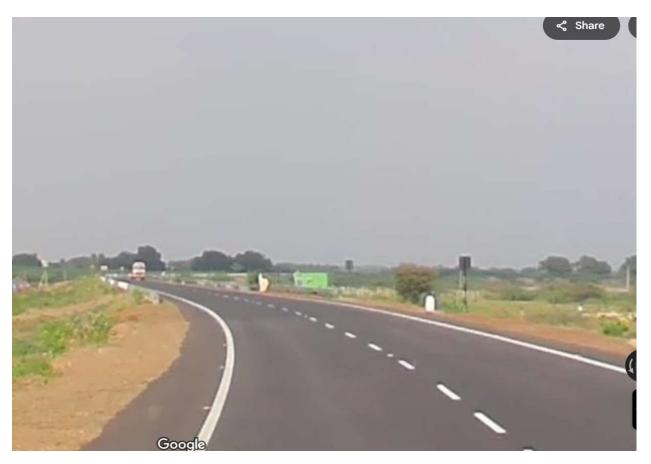
IMAGE :- SHARP TURN RISK LEVEL :- MEDIUM COORDI 10.695592180759466, 78.7972570109372

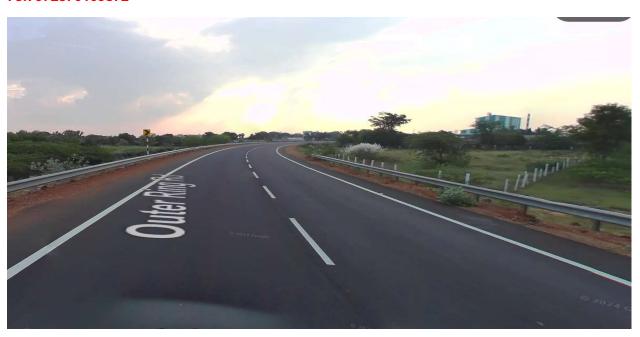
IMAGE :- SHARP TURN RISK LEVEL :- MEDIUM COORDI 10.69213724602102, 78.79365805599211

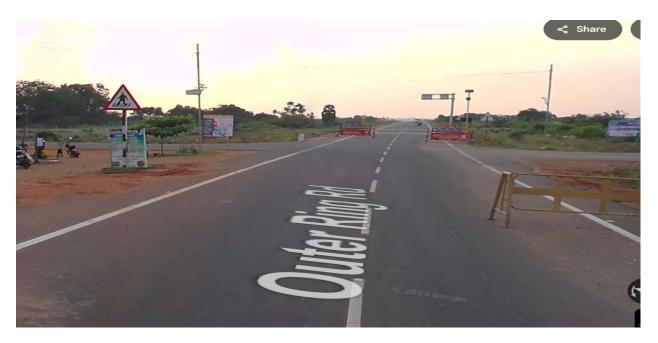
IMAGE:-SHARP TURN RISK LEVEL:-MEDIUM COORDI 10.691122538049239, 78.79072635315475

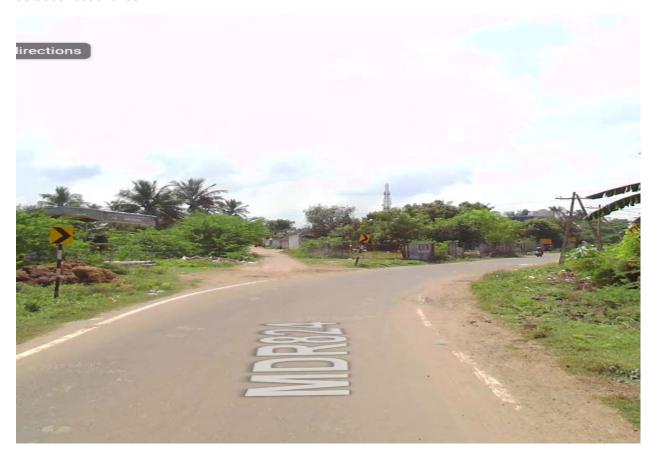
IMAGE :- SHARP TURN RISK LEVEL :- MEDIUM COORDI 10.642372204088872, 78.78787700005735
