JOURNEY RISK MANAGEMENT (JRM) STUDY

Salem Terminal to SRI SHANMUGA AGENCIES

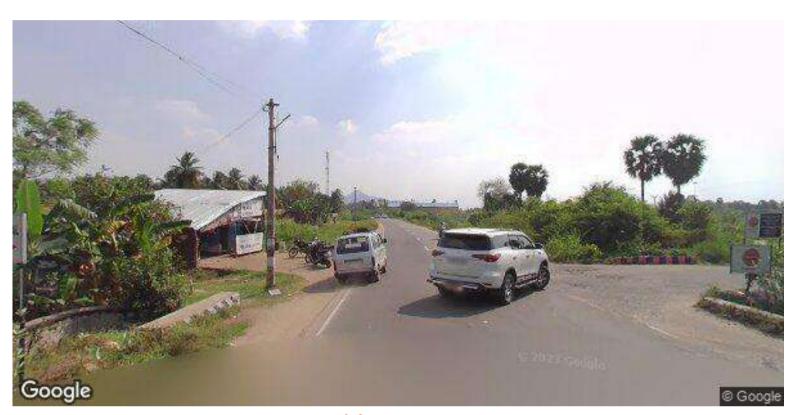
Risk Type: Turn
Risk Level: High
Speed Limit: 15 KM/Hr
Coordinates: 11.44029, 77.87544

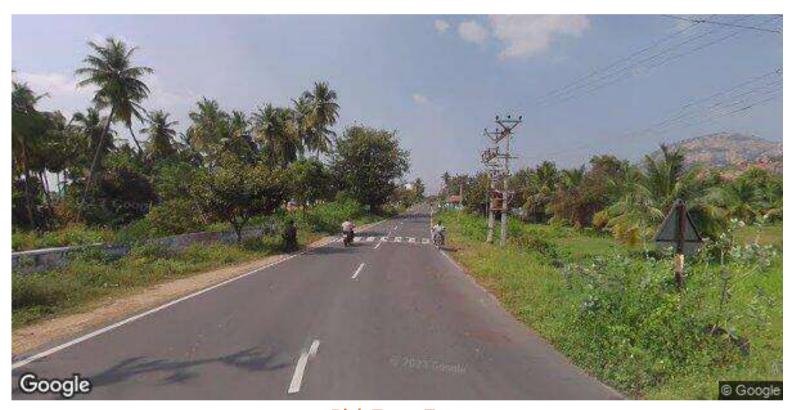
Risk Type: Turn
Risk Level: Medium
Speed Limit: 30 KM/Hr
Coordinates: 11.45352, 77.85698

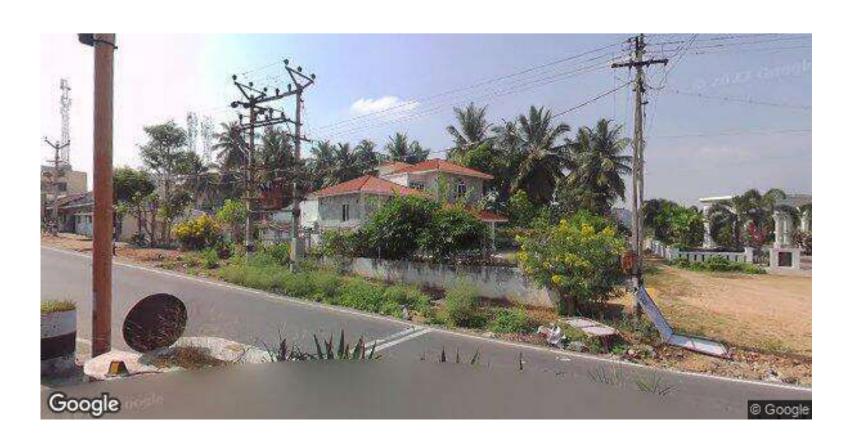
Coordinates: 11.46303, 77.84945

Risk Type: Turn
Risk Level: Medium
Speed Limit: 30 KM/Hr

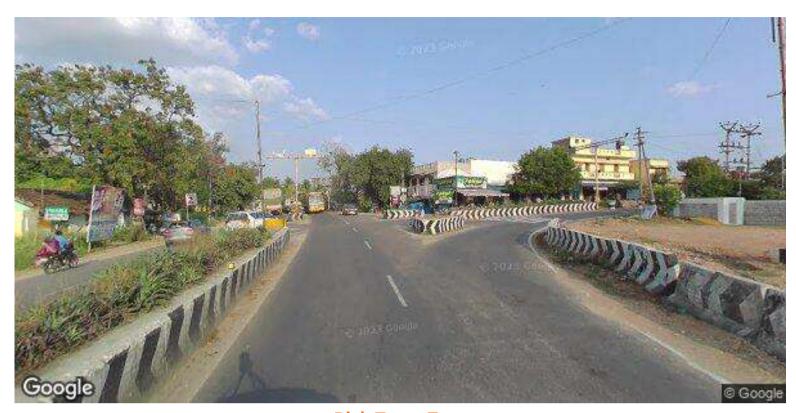
Coordinates: 11.46318, 77.84913

Risk Type: Turn
Risk Level: Medium
Speed Limit: 30 KM/Hr

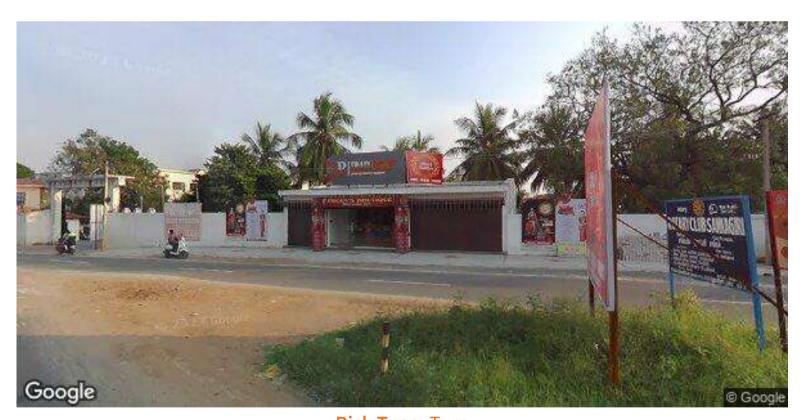
Coordinates: 11.45516, 77.81346

Risk Type: Turn
Risk Level: High
Speed Limit: 15 KM/Hr

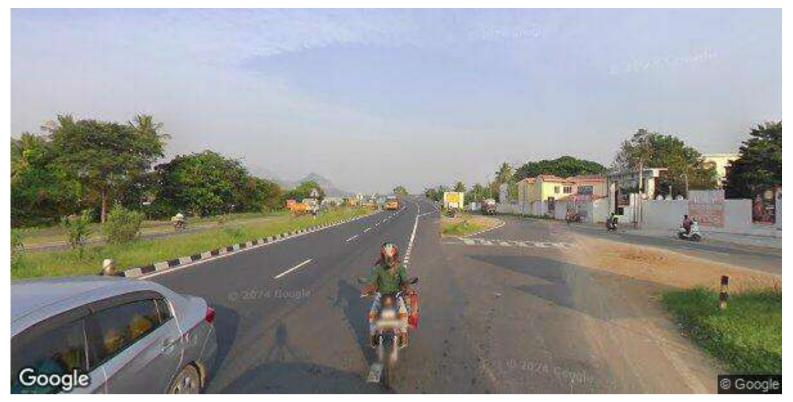
Risk Type: Turn
Risk Level: High
Speed Limit: 15 KM/Hr
Coordinates: 11.45521, 77.81343

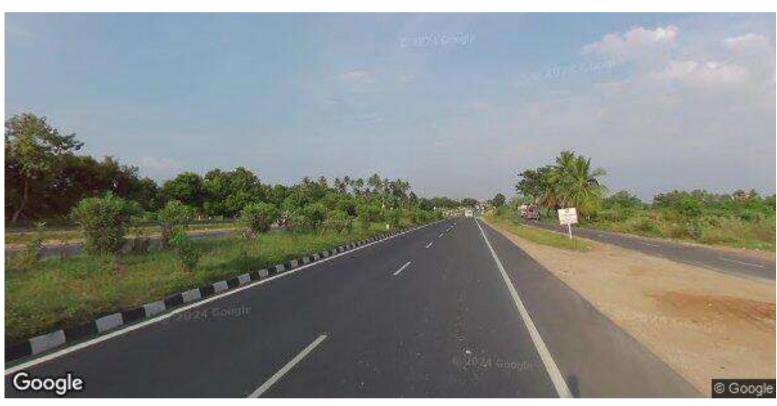
Risk Type: Blind Spot
Risk Level: Blind Spot
Speed Limit: 10 KM/Hr
Coordinates: 11.31301, 77.61186

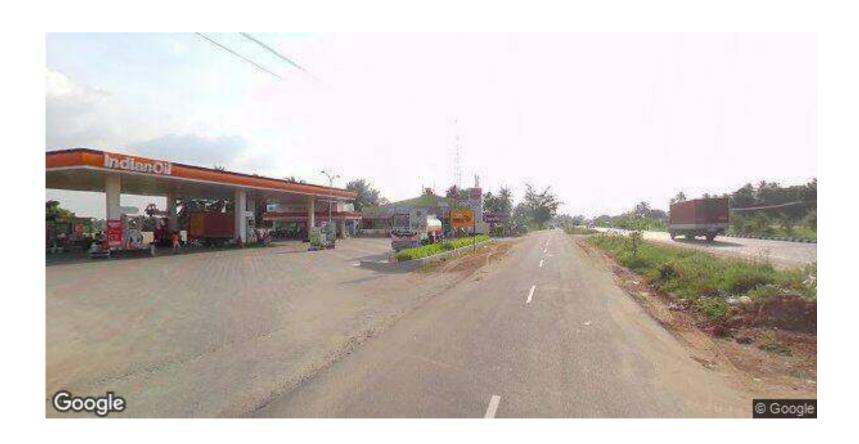
Coordinates: 11.31291, 77.61196

Risk Type: Blind Spot Risk Level: Blind Spot Speed Limit: 10 KM/Hr
