JOURNEY RISK MANAGEMENT (JRM) STUDY

IOCL Coimbatore Terminal to Pon Muthu Sivam Autos

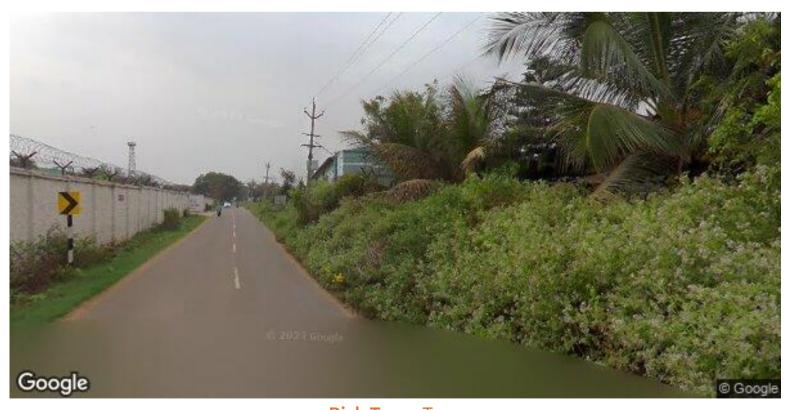
Coordinates: 11.03174, 77.08443

Risk Type: Turn
Risk Level: High
Speed Limit: 15 KM/Hr

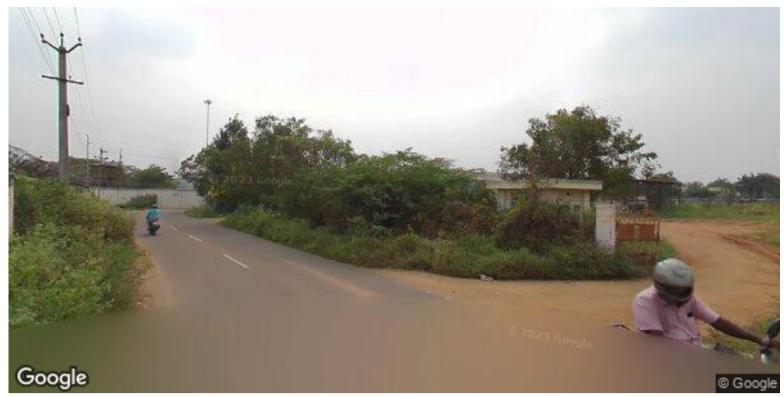
Risk Type: Turn
Risk Level: High
Speed Limit: 15 KM/Hr
Coordinates: 11.03231, 77.08448

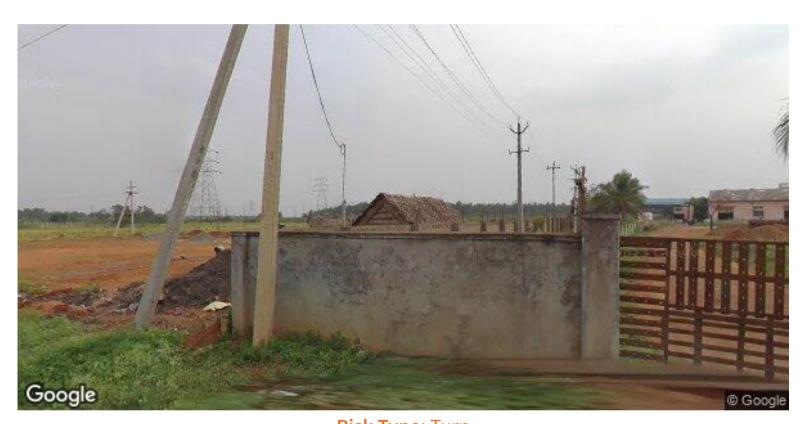
Risk Type: Turn
Risk Level: Medium
Speed Limit: 30 KM/Hr
Coordinates: 11.03306, 77.08758

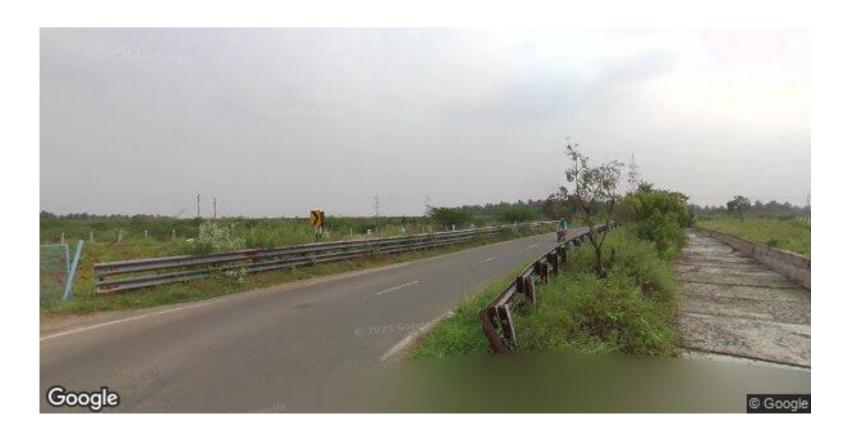
Coordinates: 11.03364, 77.08947

Risk Type: Blind Spot Risk Level: Blind Spot Speed Limit: 10 KM/Hr

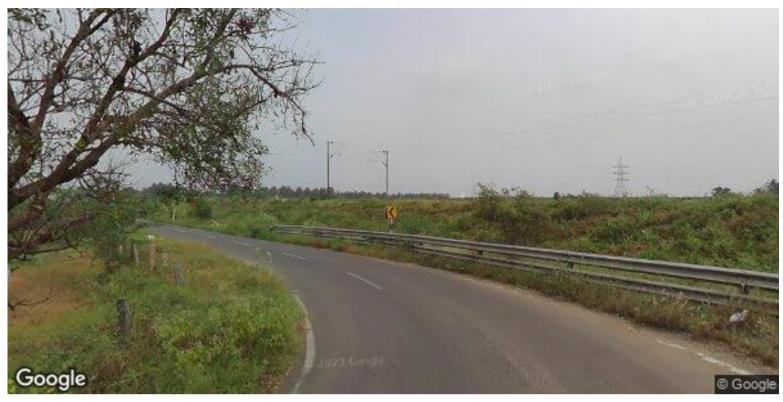
Risk Type: Blind Spot
Risk Level: Blind Spot
Speed Limit: 10 KM/Hr
Coordinates: 11.03267, 77.08951

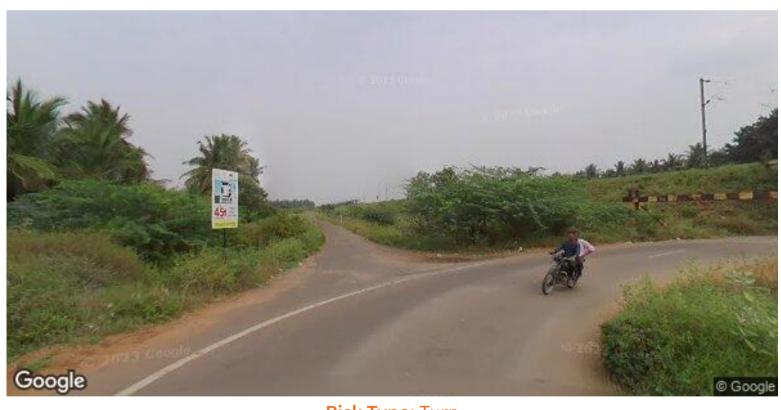
Coordinates: 11.03560, 77.09403

Risk Type: Turn
Risk Level: High
Speed Limit: 15 KM/Hr

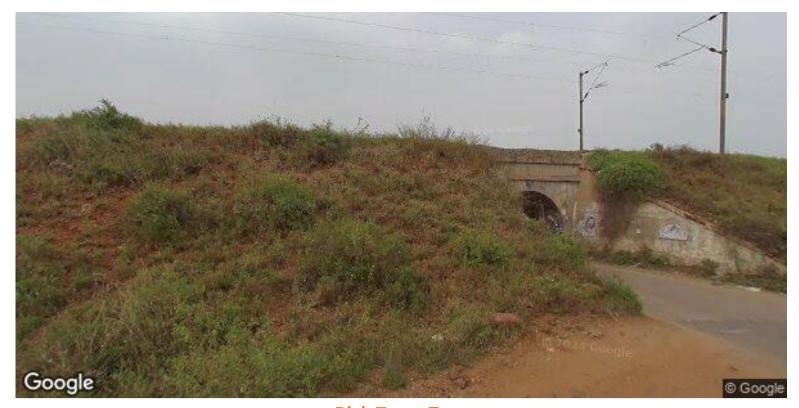
Risk Type: Turn
Risk Level: Medium
Speed Limit: 30 KM/Hr
Coordinates: 11.03521, 77.09439

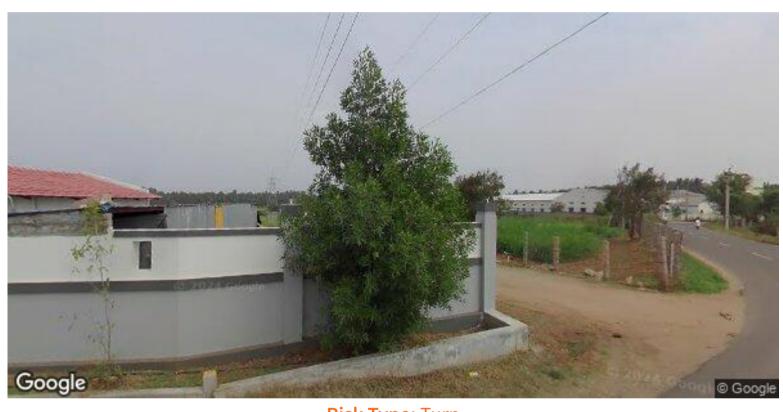
Risk Type: Turn
Risk Level: Medium
Speed Limit: 30 KM/Hr
Coordinates: 11.03106, 77.09486

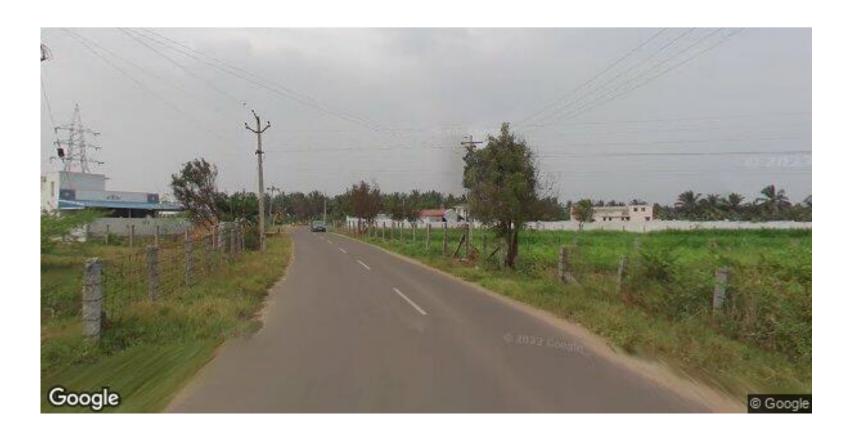
Coordinates: 11.03057, 77.09537

Risk Type: Turn
Risk Level: Medium
Speed Limit: 30 KM/Hr

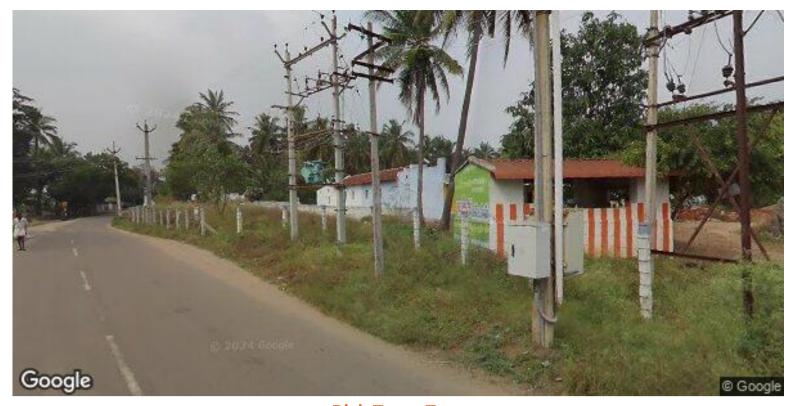
Risk Type: Turn
Risk Level: Medium
Speed Limit: 30 KM/Hr
Coordinates: 11.02777, 77.09694

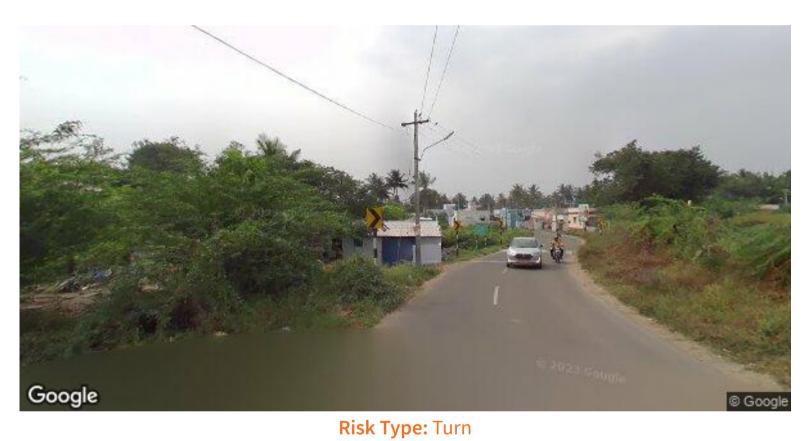
Risk Level: Medium
Speed Limit: 30 KM/Hr
Coordinates: 11.02727, 77.09847

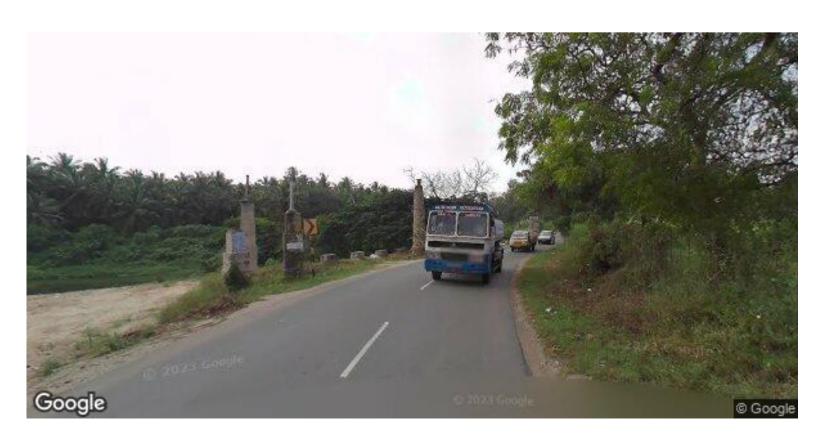
Coordinates: 11.03323, 77.11422

Risk Type: Turn
Risk Level: Medium
Speed Limit: 30 KM/Hr

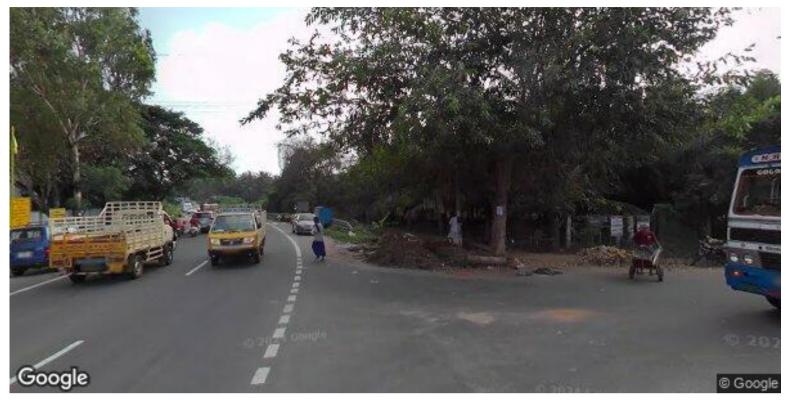
Coordinates: 11.03352, 77.11509

Risk Type: Turn
Risk Level: High
Speed Limit: 15 KM/Hr

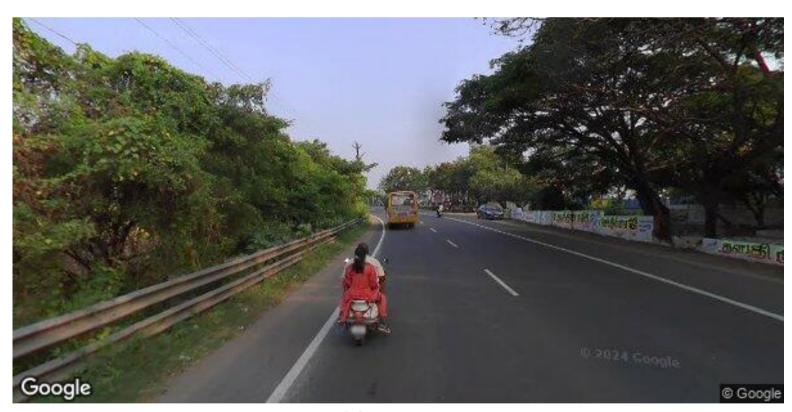
Coordinates: 11.03154, 77.11673

Risk Type: Turn
Risk Level: Medium
Speed Limit: 30 KM/Hr

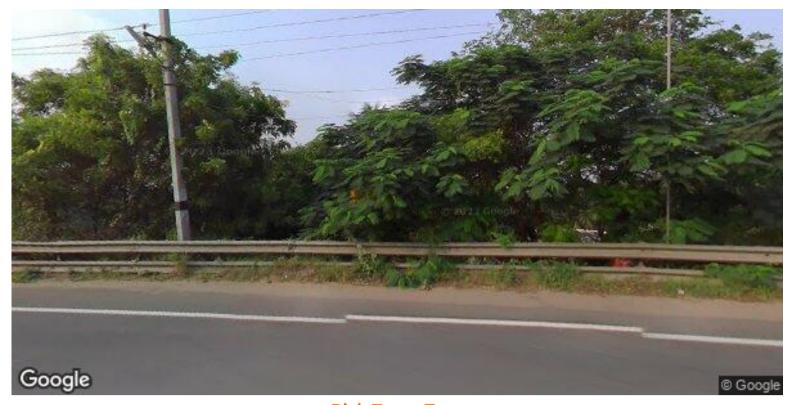
Risk Type: Turn
Risk Level: Medium
Speed Limit: 30 KM/Hr
Coordinates: 11.03146, 77.11854

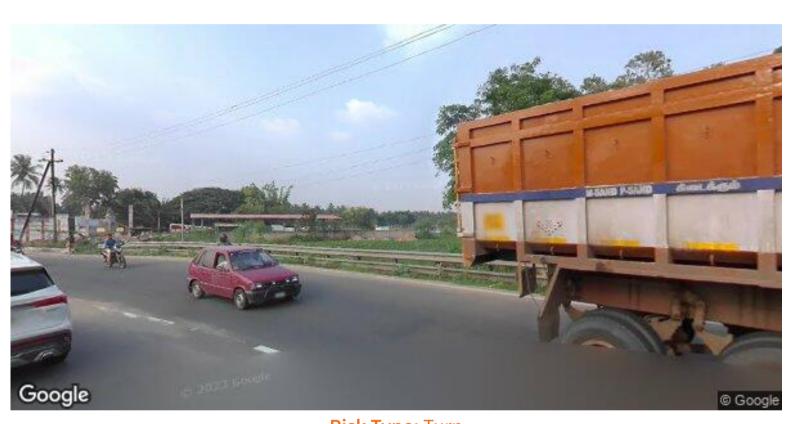
Risk Type: Turn
Risk Level: Medium
Speed Limit: 30 KM/Hr
Coordinates: 11.02970, 77.12192

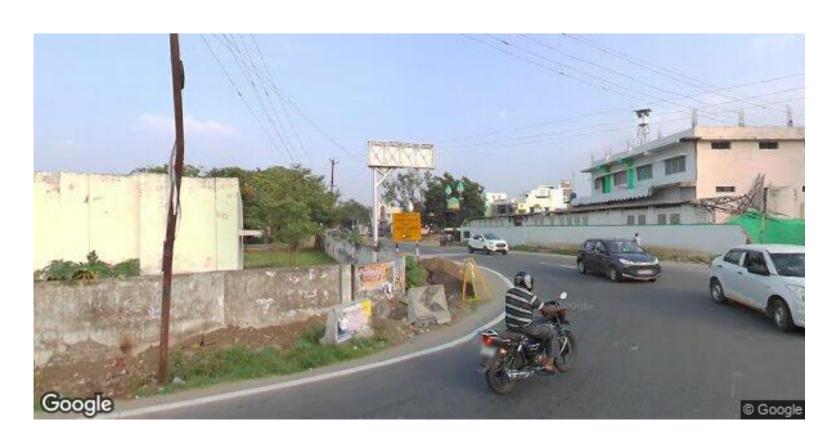
Coordinates: 11.02928, 77.12212

Risk Type: Turn
Risk Level: High
Speed Limit: 15 KM/Hr

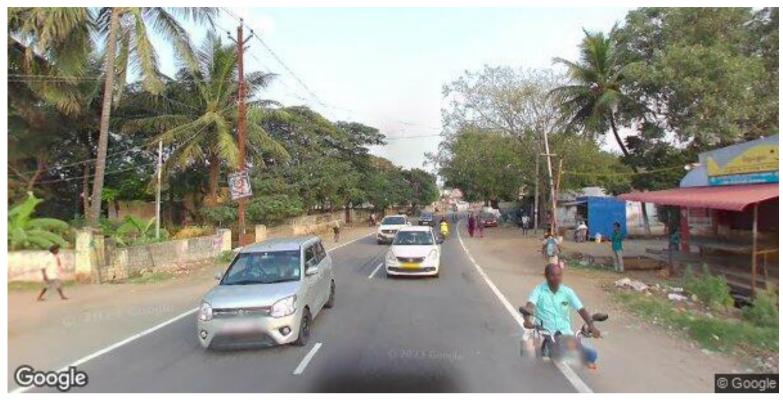
Coordinates: 11.02950, 77.12393

Risk Type: Turn
Risk Level: Medium
Speed Limit: 30 KM/Hr

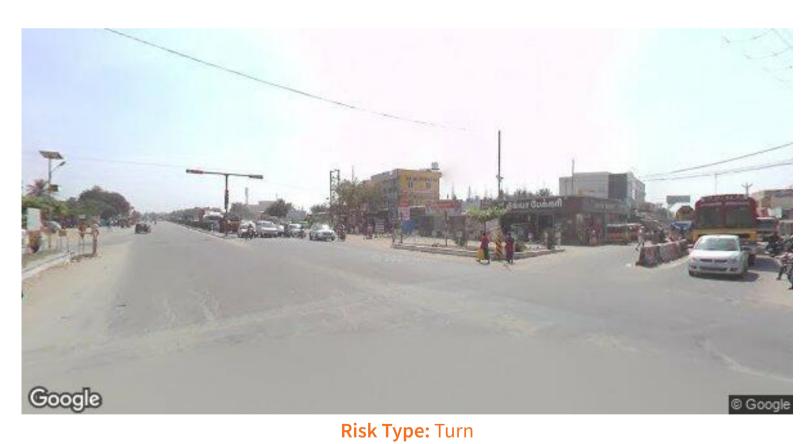
Coordinates: 11.01759, 77.18426

Risk Level: High
Speed Limit: 15 KM/Hr

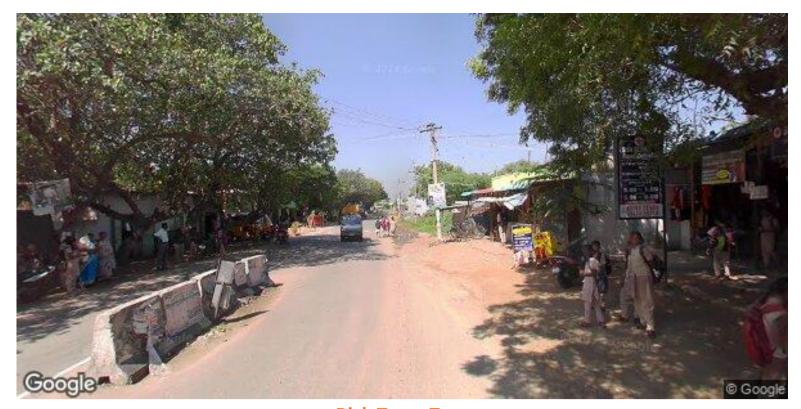
Risk Type: Turn
Risk Level: High
Speed Limit: 15 KM/Hr
Coordinates: 10.96625, 77.19239

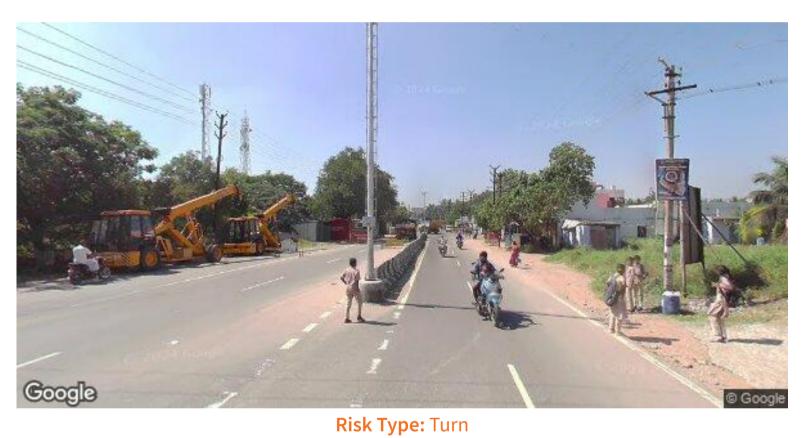
Risk Level: High
Speed Limit: 15 KM/Hr
Coordinates: 10.96628, 77.19310

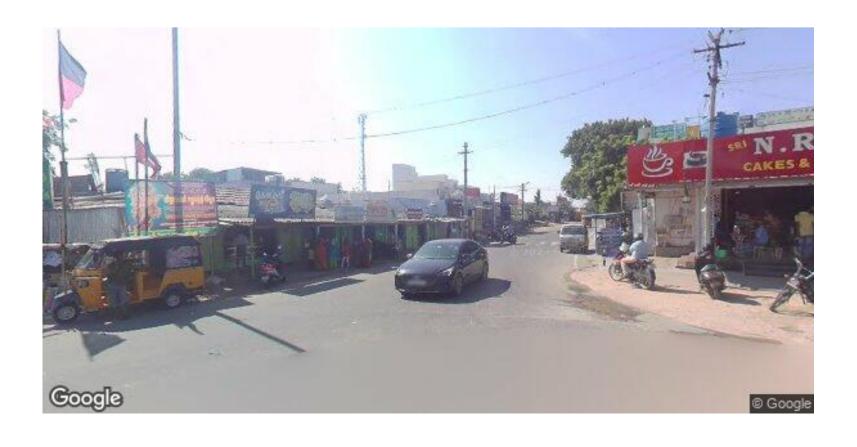
Coordinates: 10.90680, 77.21854

Risk Type: Blind Spot
Risk Level: Blind Spot
Speed Limit: 10 KM/Hr

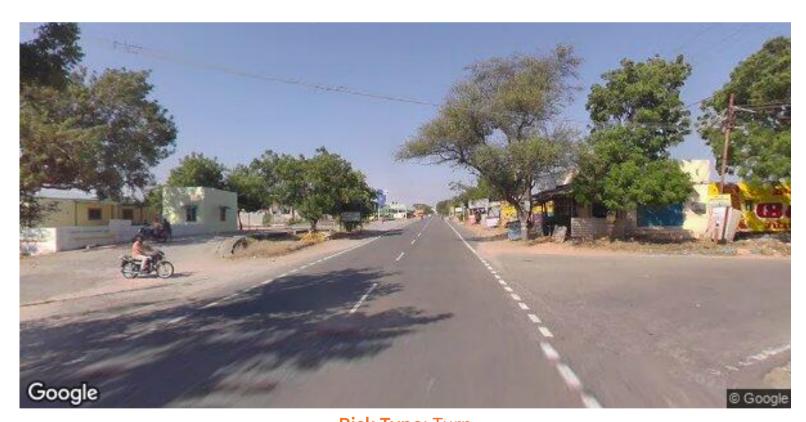
Risk Type: Turn
Risk Level: High
Speed Limit: 15 KM/Hr
Coordinates: 10.91679, 77.22642

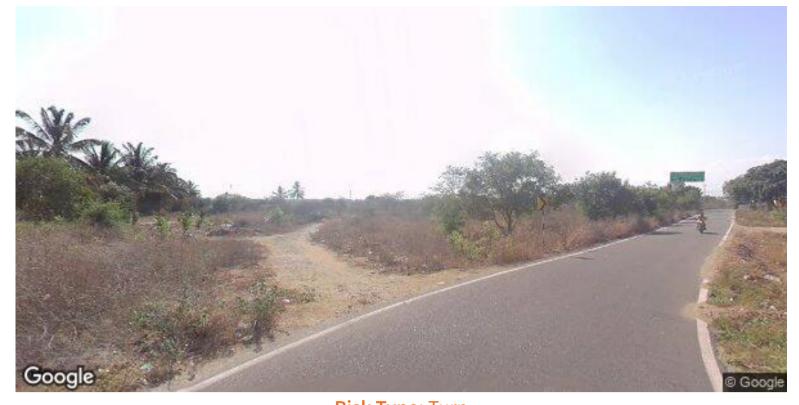
Risk Type: Turn
Risk Level: Medium
Speed Limit: 30 KM/Hr
Coordinates: 10.91599, 77.22755

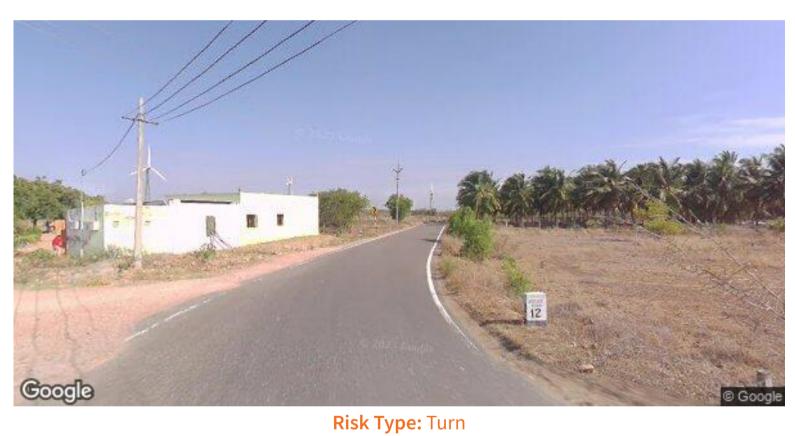
Risk Type: Turn
Risk Level: High
Speed Limit: 15 KM/Hr
Coordinates: 10.91570, 77.22991

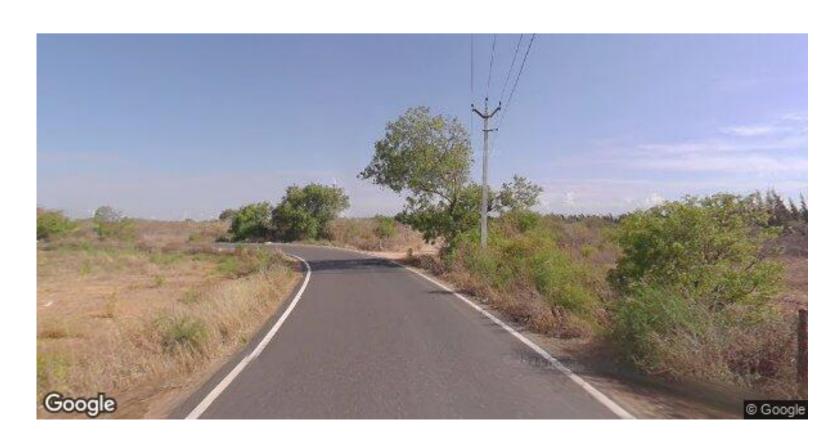
Coordinates: 10.91277, 77.23112

Risk Type: Turn
Risk Level: Medium
Speed Limit: 30 KM/Hr

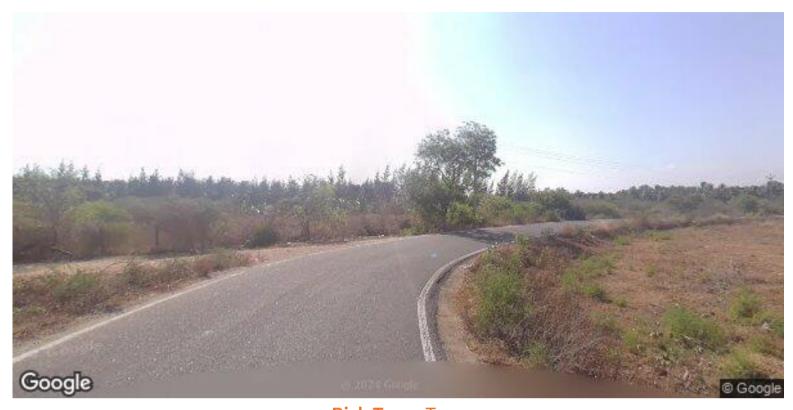
Coordinates: 10.91255, 77.23148

Risk Type: Turn
Risk Level: High
Speed Limit: 15 KM/Hr

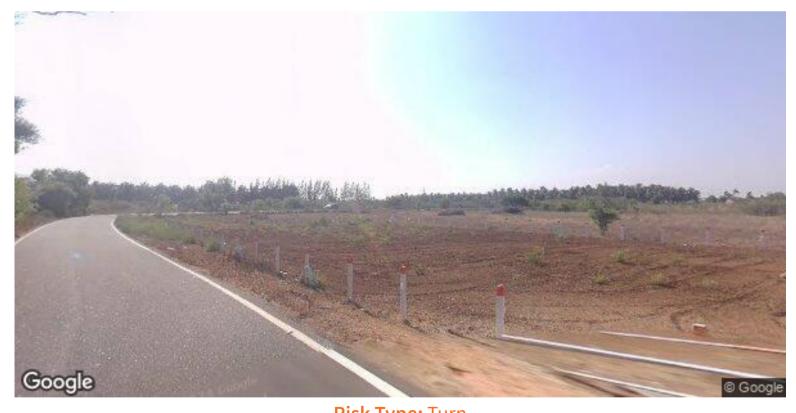
Coordinates: 10.91283, 77.23208

Risk Type: Turn
Risk Level: Medium
Speed Limit: 30 KM/Hr

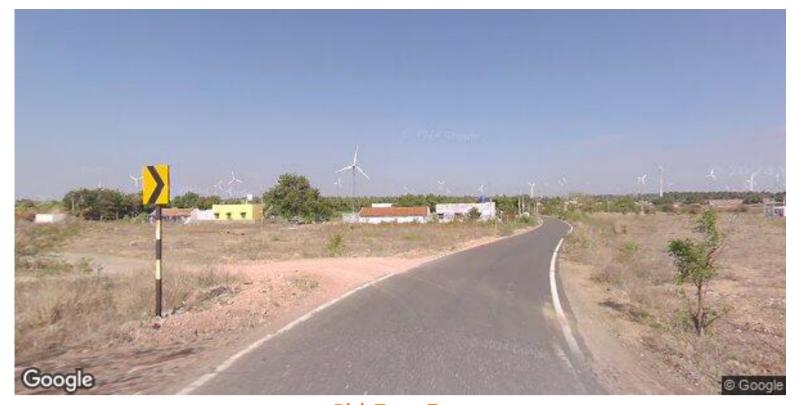
Risk Type: Turn
Risk Level: High
Speed Limit: 15 KM/Hr
Coordinates: 10.91412, 77.23606

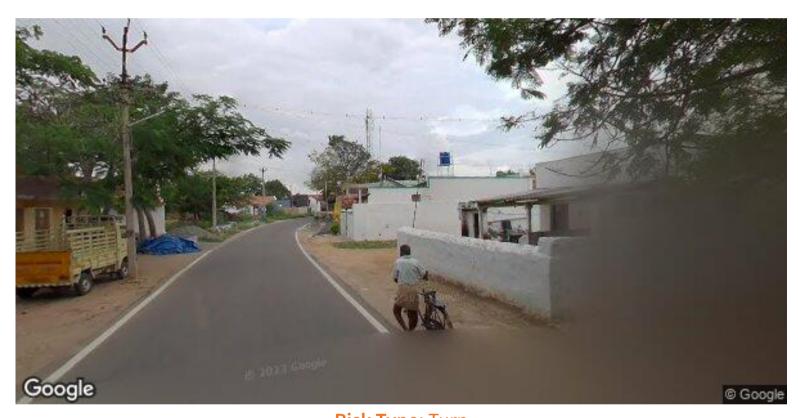
Risk Type: Turn
Risk Level: Medium
Speed Limit: 30 KM/Hr
Coordinates: 10.91382, 77.24112

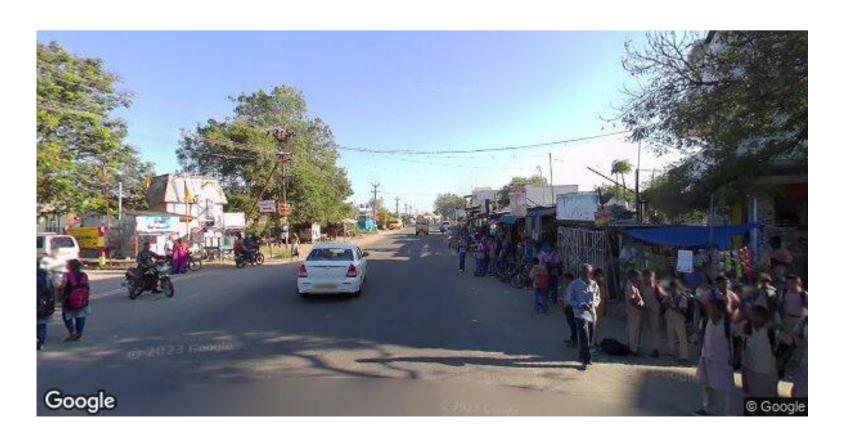
Coordinates: 10.91530, 77.26625

Risk Type: Turn
Risk Level: High
Speed Limit: 15 KM/Hr

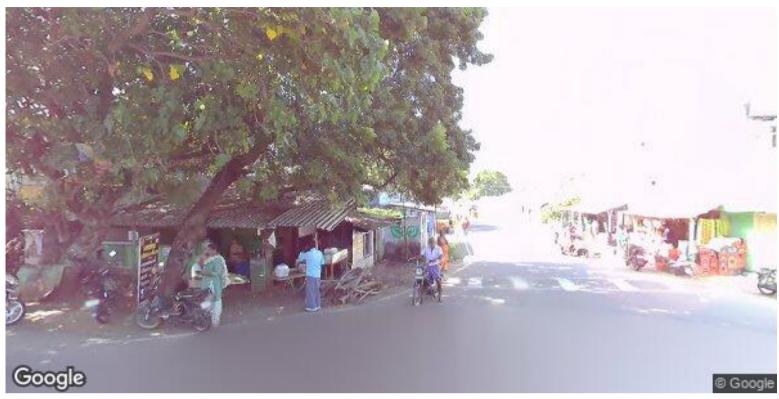
Coordinates: 10.65984, 77.27186

Risk Type: Turn
Risk Level: High
Speed Limit: 15 KM/Hr

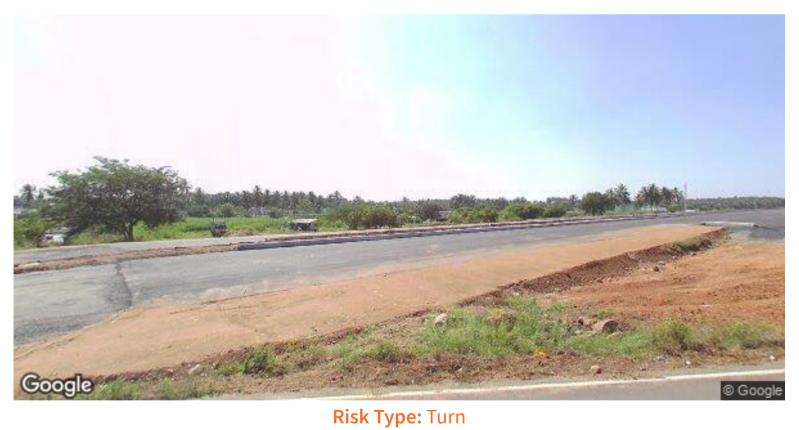
Coordinates: 10.56755, 77.36194

Risk Type: Turn
Risk Level: Medium
Speed Limit: 30 KM/Hr

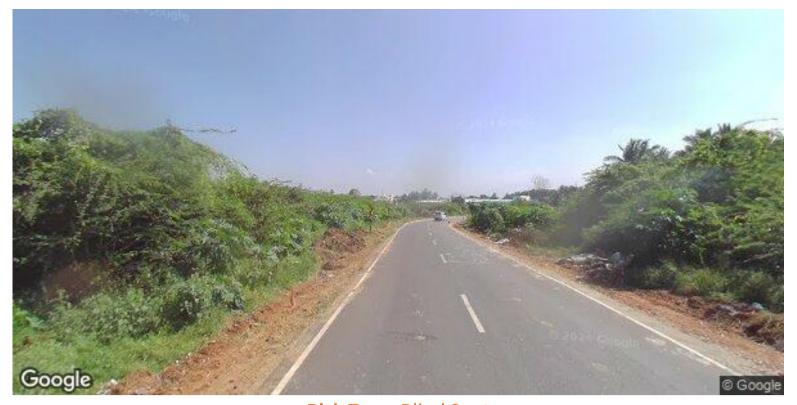
Coordinates: 10.56689, 77.36242

Risk Type: Blind Spot Risk Level: Blind Spot Speed Limit: 10 KM/Hr

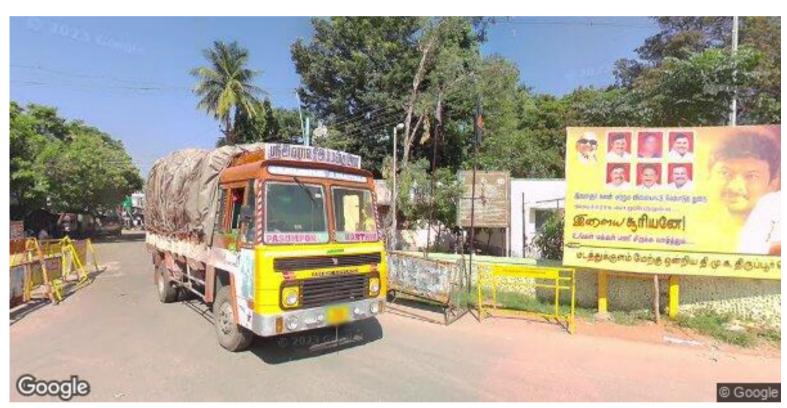
Coordinates: 10.55909, 77.36238

Risk Type: Turn
Risk Level: High
Speed Limit: 15 KM/Hr

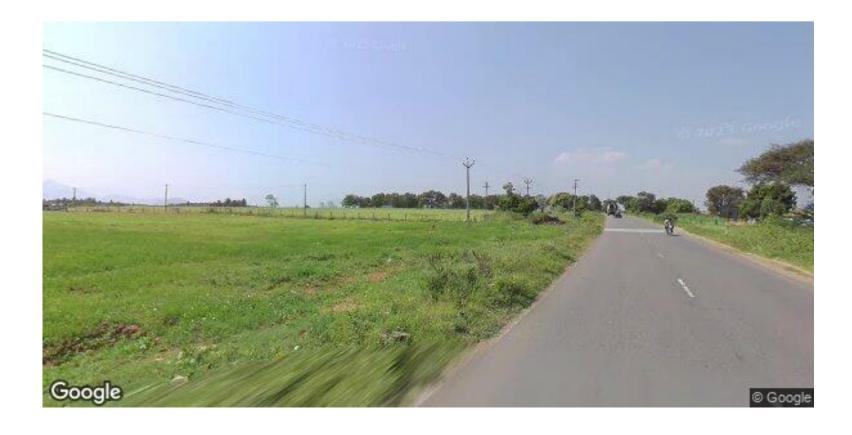
Coordinates: 10.54455, 77.40563

Risk Type: Turn
Risk Level: High
Speed Limit: 15 KM/Hr

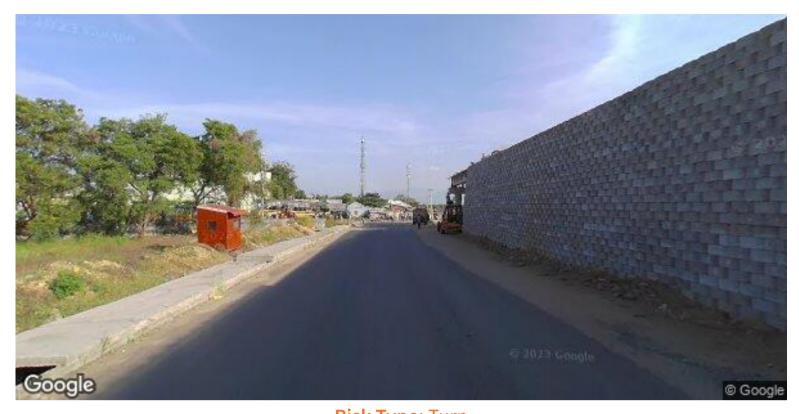
Risk Type: Turn
Risk Level: Medium
Speed Limit: 30 KM/Hr
Coordinates: 10.51951, 77.43664

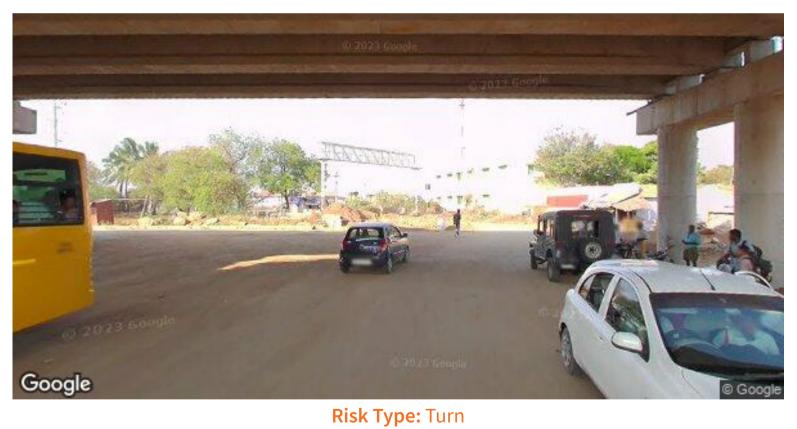
Risk Type. Turn
Risk Level: Medium
Speed Limit: 30 KM/Hr
Coordinates: 10.51911, 77.43693

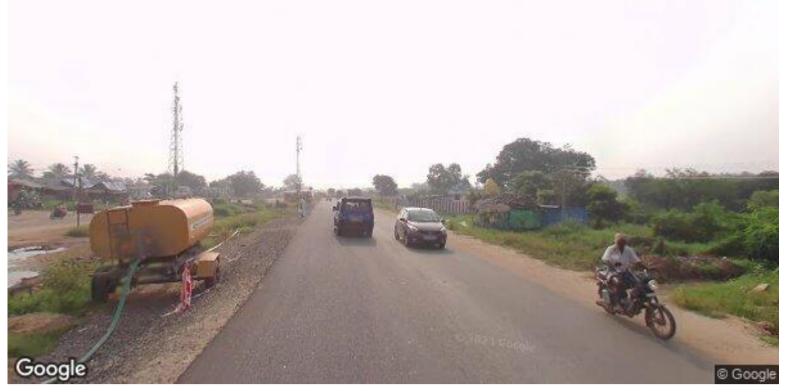
Risk Type: Turn
Risk Level: High
Speed Limit: 15 KM/Hr
Coordinates: 10.51884, 77.43690

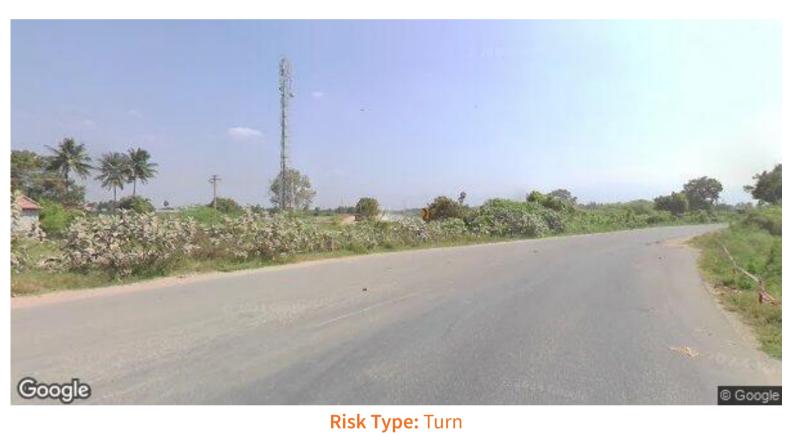
Risk Level: Medium
Speed Limit: 30 KM/Hr
Coordinates: 10.51816, 77.43823

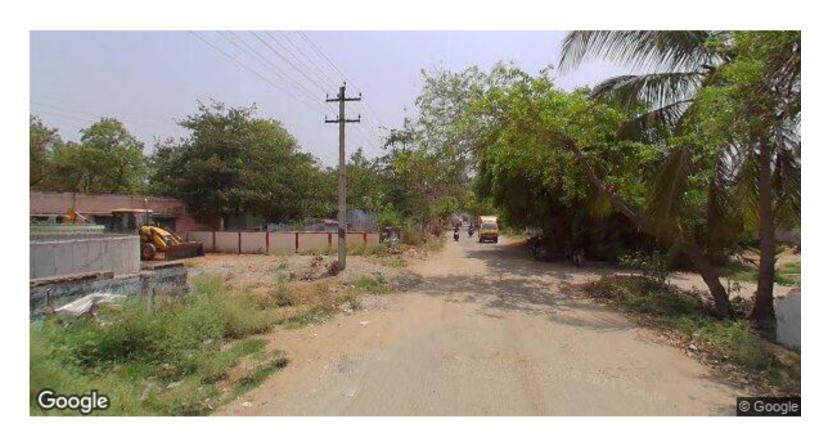
Coordinates: 10.46933, 77.46918

Risk Type: Turn
Risk Level: Medium
Speed Limit: 30 KM/Hr

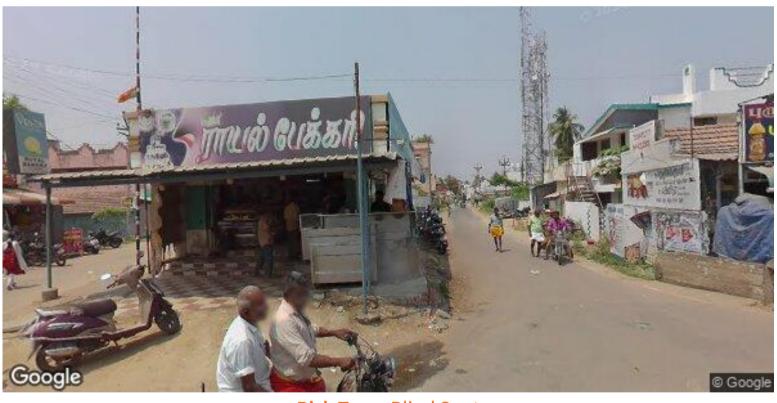
Coordinates: 10.44511, 77.46363

Risk Type: Blind Spot
Risk Level: Blind Spot
Speed Limit: 10 KM/Hr
