JOURNEY RISK MANAGEMENT (JRM) STUDY

Salem Terminal TO SBT ENTERPRISES

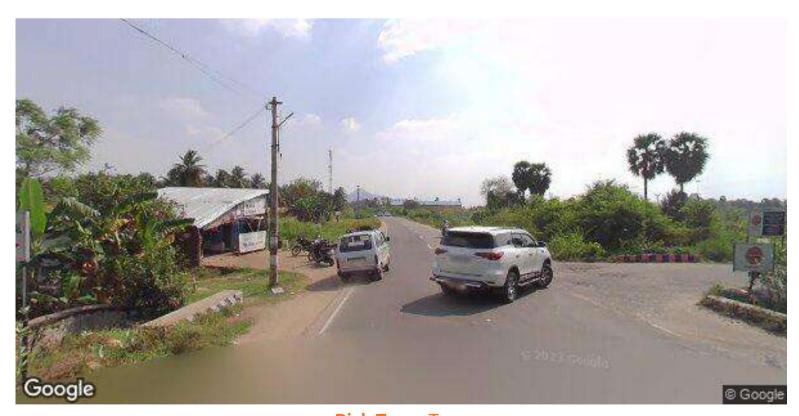
Risk Type: Turn
Risk Level: High
Speed Limit: 15 KM/Hr
Coordinates: 11.44029, 77.87544

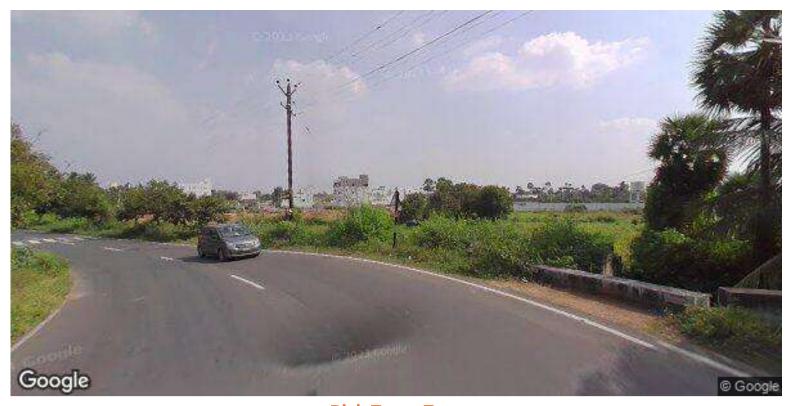
Risk Type: Turn
Risk Level: Medium
Speed Limit: 30 KM/Hr
Coordinates: 11.45350, 77.85700

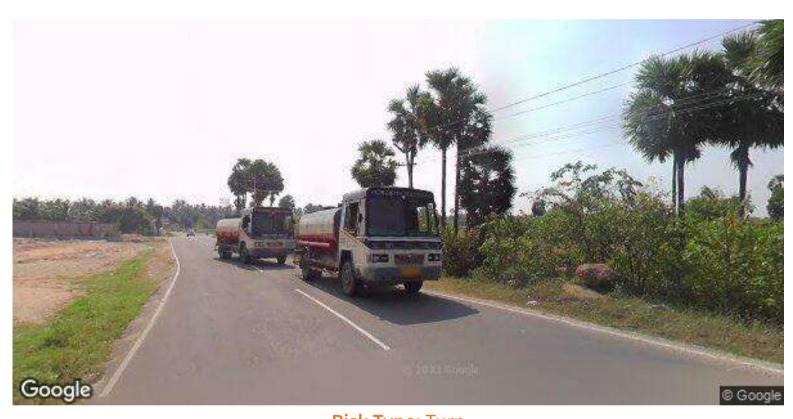
Risk Type: Turn
Risk Level: Medium
Speed Limit: 30 KM/Hr
Coordinates: 11.45833, 77.85146

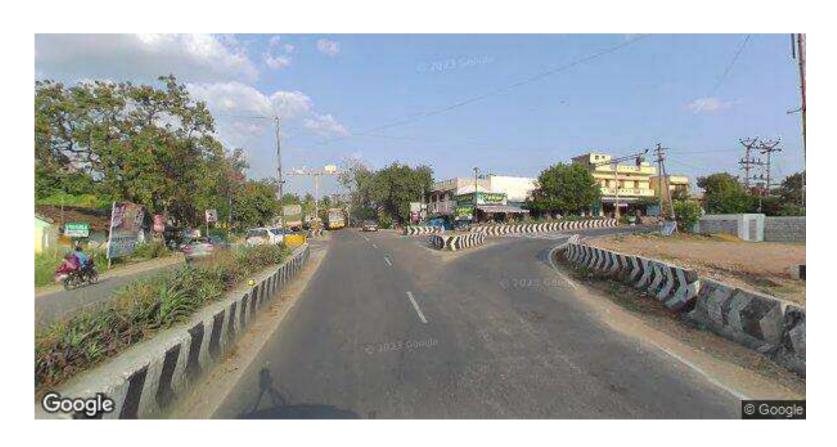
Coordinates: 11.46318, 77.84913

Risk Type: Turn
Risk Level: Medium
Speed Limit: 30 KM/Hr

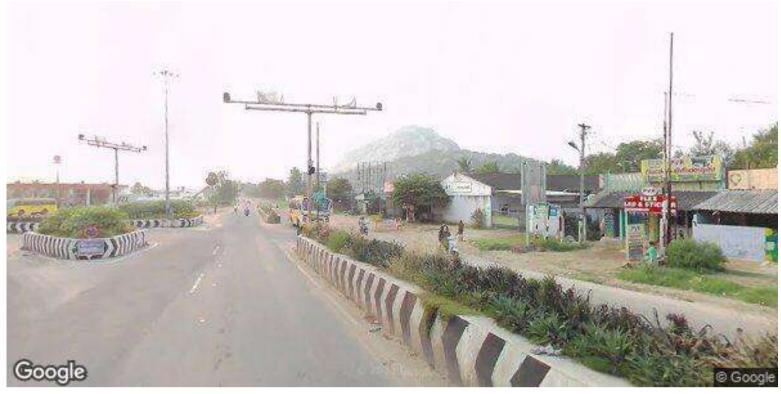
Coordinates: 11.46312, 77.84886

Risk Type: Turn
Risk Level: Medium
Speed Limit: 30 KM/Hr

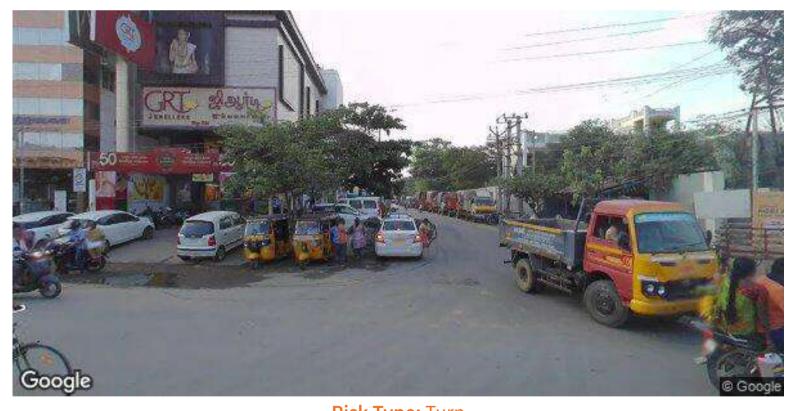
Coordinates: 11.34678, 77.73104

Risk Type: Turn
Risk Level: High
Speed Limit: 15 KM/Hr

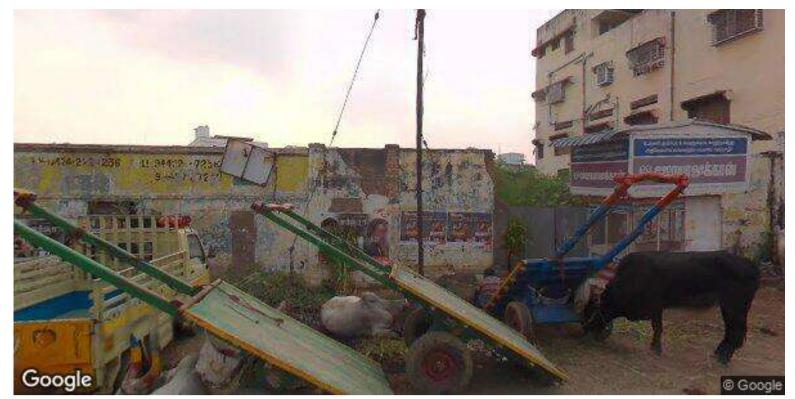
Risk Type: Turn
Risk Level: High
Speed Limit: 15 KM/Hr
Coordinates: 11.34678, 77.72581
