JOURNEY RISK MANAGEMENT (JRM) STUDY

Salem Terminal to SRI VEERAKUMAR AUTO SERVICE

Route Safety Analysis: Sangagiri to Chinnaputhur, Tamil Nadu

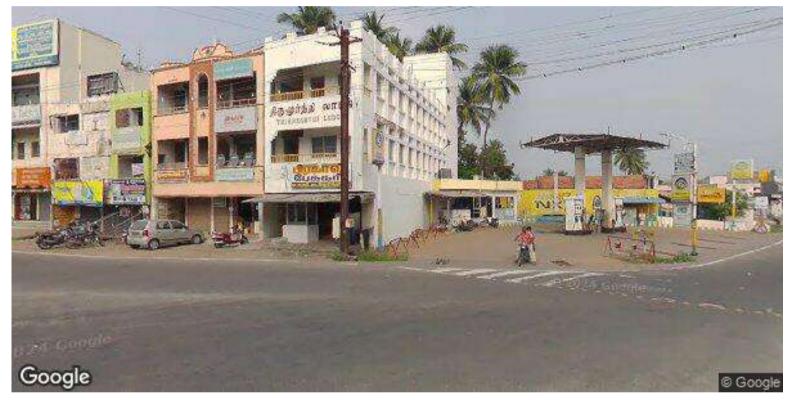
Risk Type: Roundabout
Risk Level: High
Speed Limit: 15 KM/Hr
Coordinates: 11.00172, 77.56268

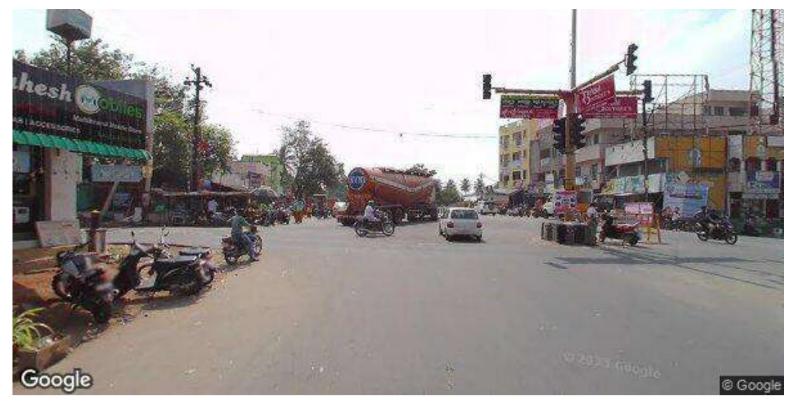
Risk Type: Turn
Risk Level: High
Speed Limit: 15 KM/Hr
Coordinates: 11.36616, 77.88885

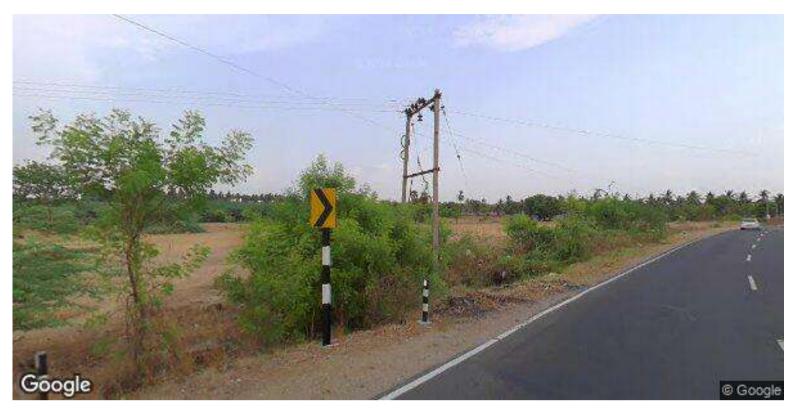
Risk Type: Turn
Risk Level: Medium
Speed Limit: 30 KM/Hr
Coordinates: 11.33778, 77.86236

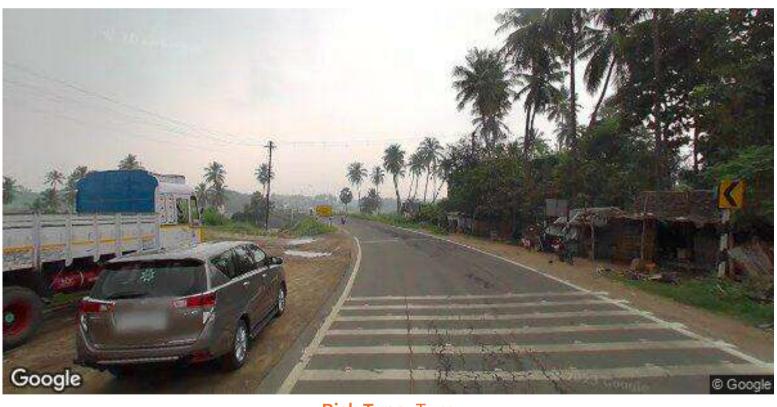
Risk Type: Turn
Risk Level: Medium
Speed Limit: 30 KM/Hr
Coordinates: 11.30952, 77.77587

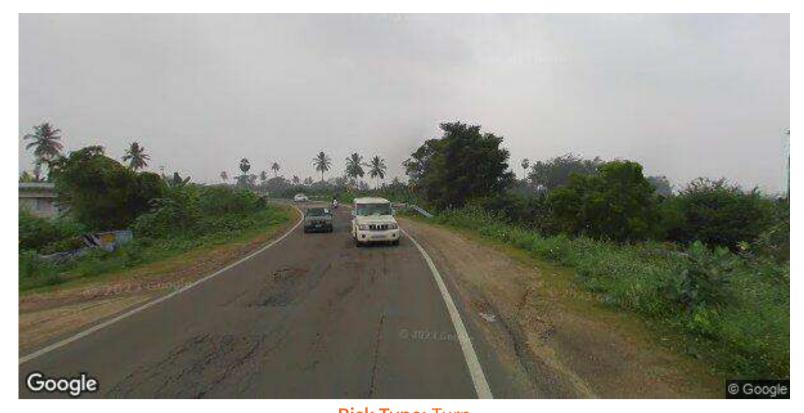
Risk Type: Turn
Risk Level: Medium
Speed Limit: 30 KM/Hr
Coordinates: 11.31111, 77.77178

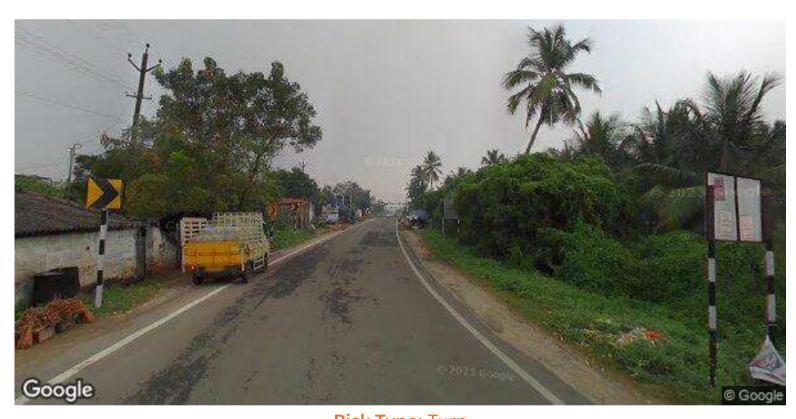
Risk Type: Turn
Risk Level: Medium
Speed Limit: 30 KM/Hr
Coordinates: 11.30973, 77.76712

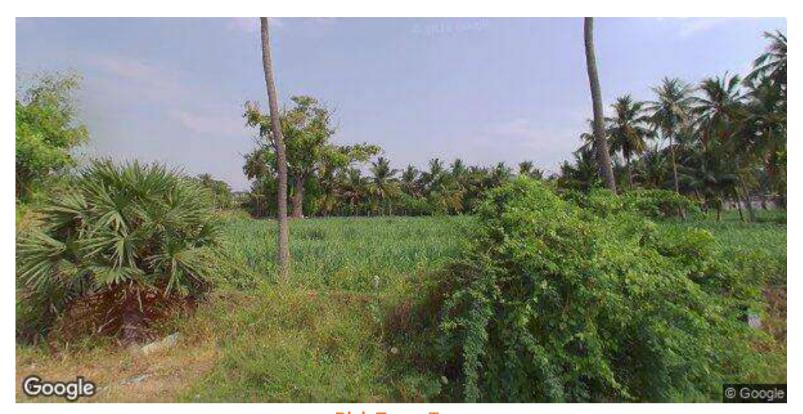
Coordinates: 11.29125, 77.74646

Risk Type: Turn
Risk Level: High
Speed Limit: 15 KM/Hr

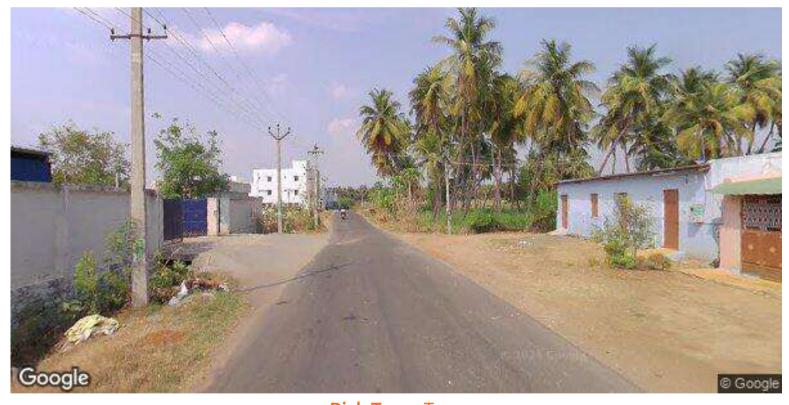
Risk Type: Turn
Risk Level: Medium
Speed Limit: 30 KM/Hr
Coordinates: 11.29076, 77.74528

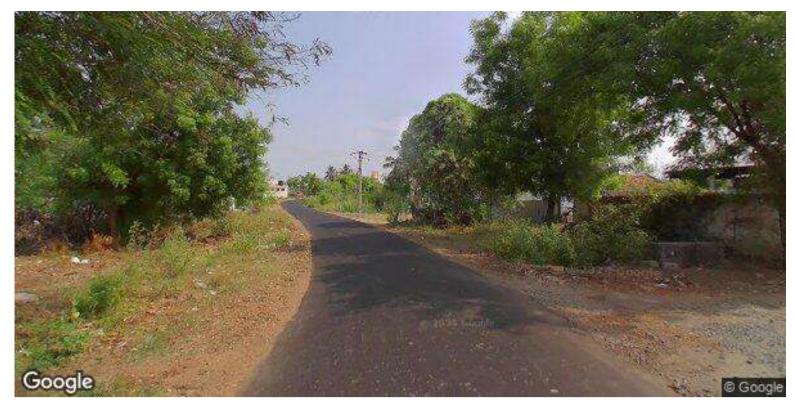
Risk Type: Turn
Risk Level: Medium
Speed Limit: 30 KM/Hr
Coordinates: 11.28844, 77.74319

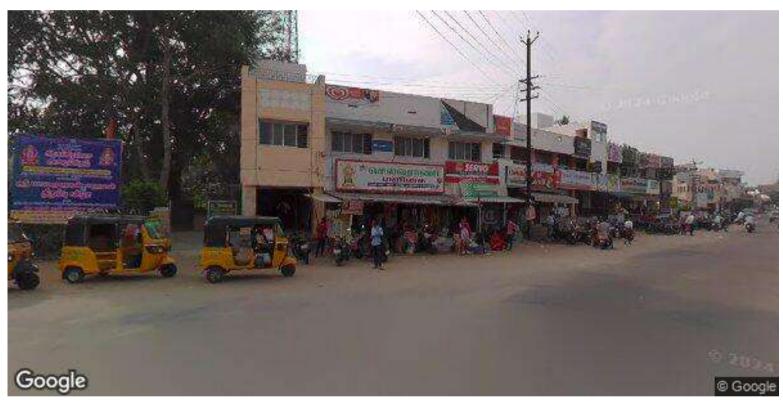
Risk Type: Turn
Risk Level: Medium
Speed Limit: 30 KM/Hr
Coordinates: 11.15942, 77.70068

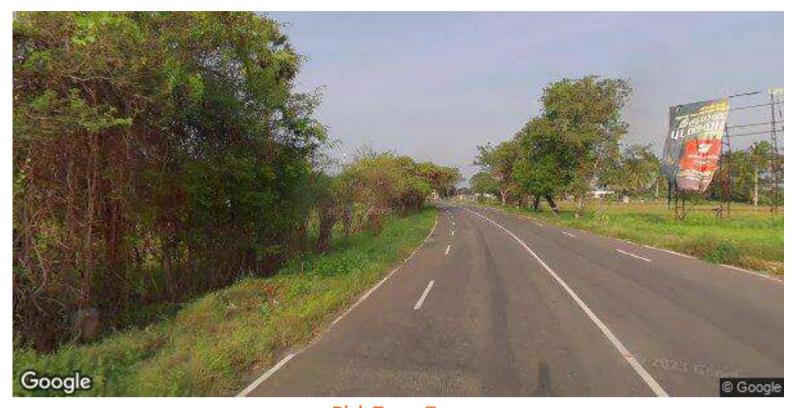
Risk Type: Turn
Risk Level: Medium
Speed Limit: 30 KM/Hr
Coordinates: 11.11932, 77.67786

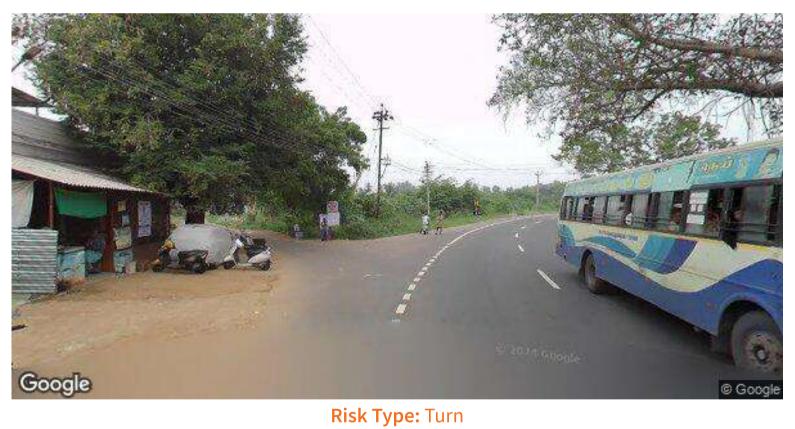
Risk Level: Medium
Speed Limit: 30 KM/Hr
Coordinates: 11.11710, 77.67175

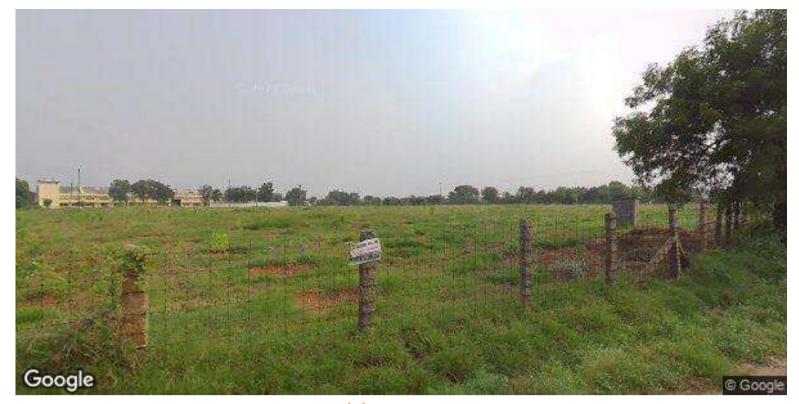
Risk Type: Turn
Risk Level: Medium
Speed Limit: 30 KM/Hr
Coordinates: 11.09491, 77.66603

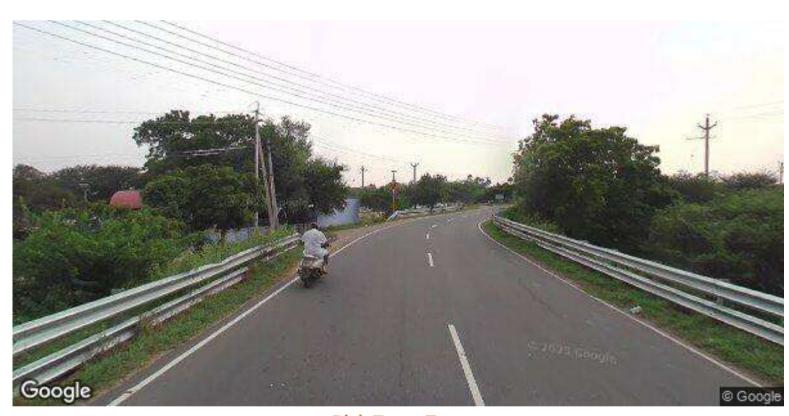
Coordinates: 10.94722, 77.54709

Risk Type: Turn
Risk Level: High
Speed Limit: 15 KM/Hr

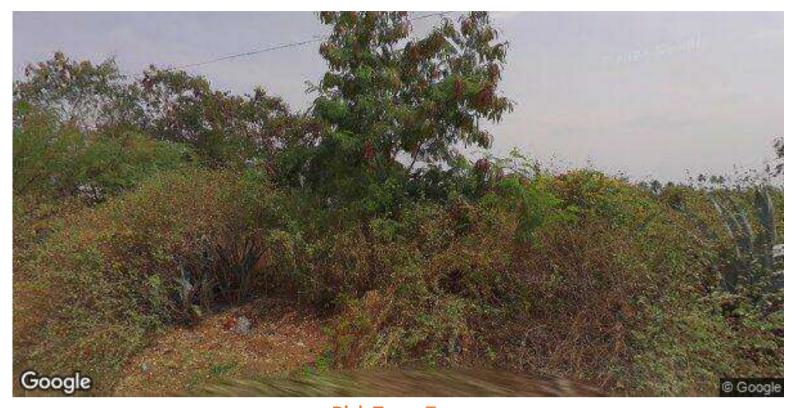
Risk Type: Turn
Risk Level: Medium
Speed Limit: 30 KM/Hr
Coordinates: 10.93054, 77.53265

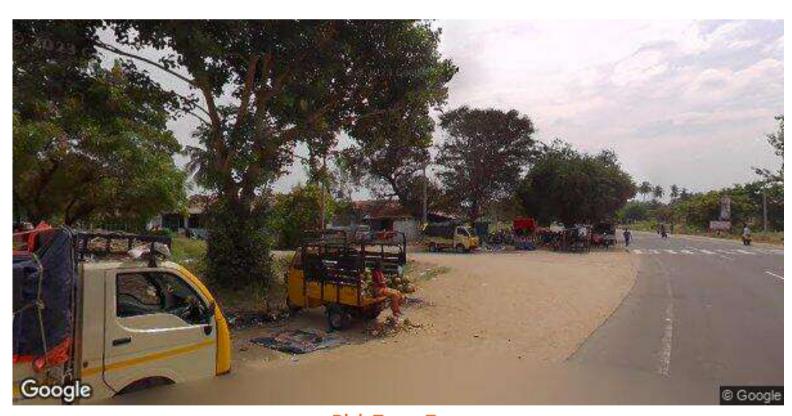
Risk Type: Turn
Risk Level: Medium
Speed Limit: 30 KM/Hr
Coordinates: 10.89213, 77.52646

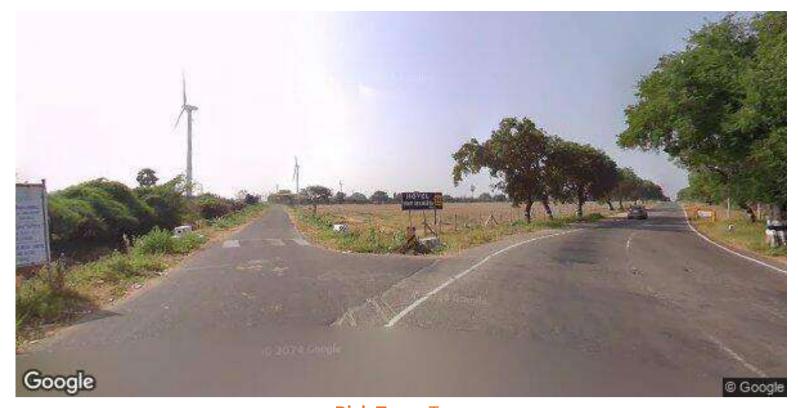
Risk Type: Turn Risk Level: Medium Speed Limit: 30 KM/Hr **Coordinates:** 10.83409, 77.52932

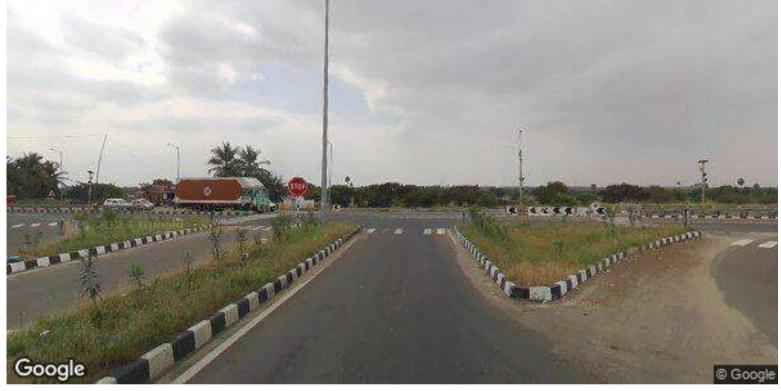
Risk Type: Turn Risk Level: Medium **Speed Limit:** 30 KM/Hr **Coordinates:** 10.77642, 77.50712

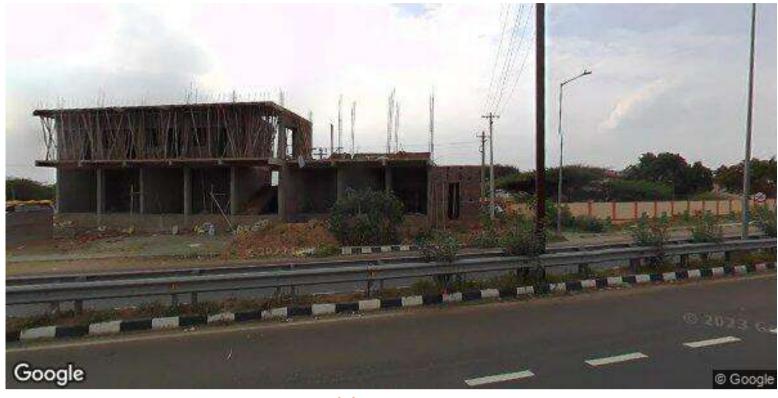
Coordinates: 10.75864, 77.51918

Risk Type: Turn
Risk Level: Medium
Speed Limit: 30 KM/Hr

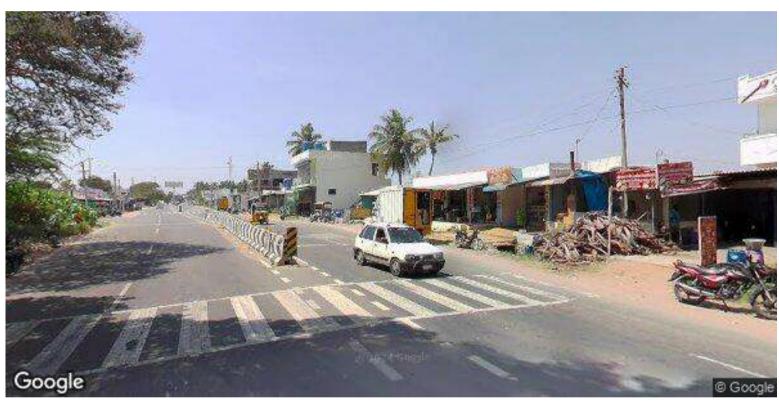
Coordinates: 10.70947, 77.43031

Risk Type: Blind Spot
Risk Level: Blind Spot
Speed Limit: 10 KM/Hr
