JOURNEY RISK MANAGEMENT (JRM) STUDY

Salem Terminal TO S S N AGENCIES

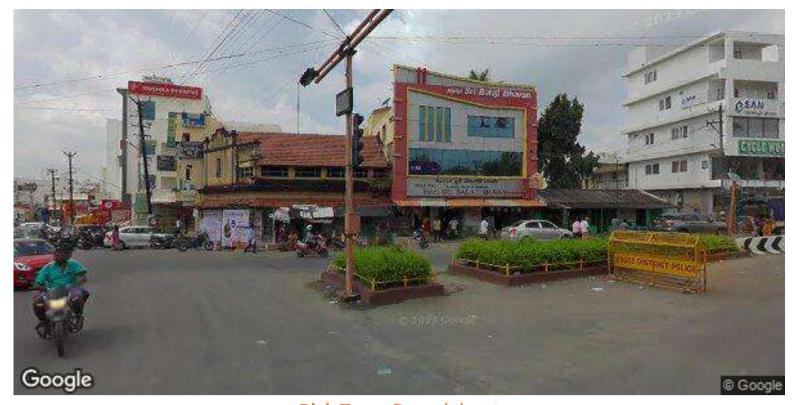
Risk Type: Roundabout
Risk Level: High
Speed Limit: 15 KM/Hr
Coordinates: 11.27925, 77.58494

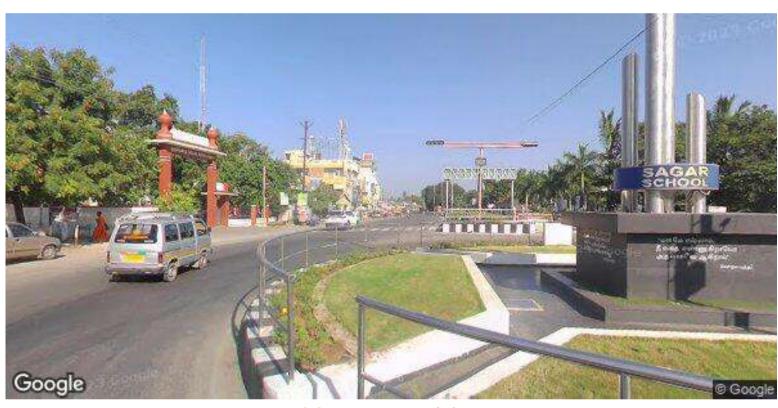
Risk Type: Roundabout
Risk Level: High
Speed Limit: 15 KM/Hr
Coordinates: 11.27732, 77.58658

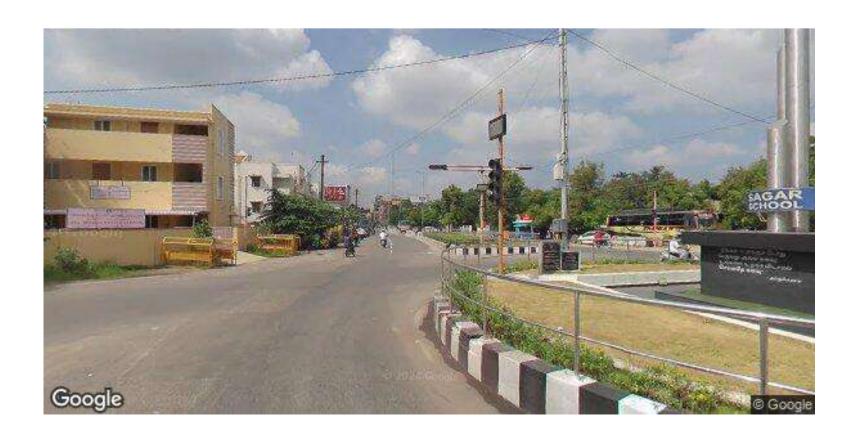
Coordinates: 11.27718, 77.58674

Risk Type: Roundabout
Risk Level: High
Speed Limit: 15 KM/Hr

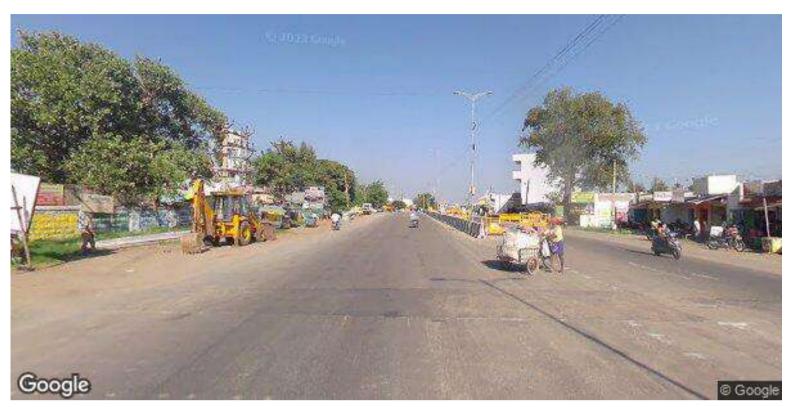
Coordinates: 11.278222, 77.5896496

Risk Type: U-Turn
Risk Level: High
Speed Limit: 10 KM/Hr

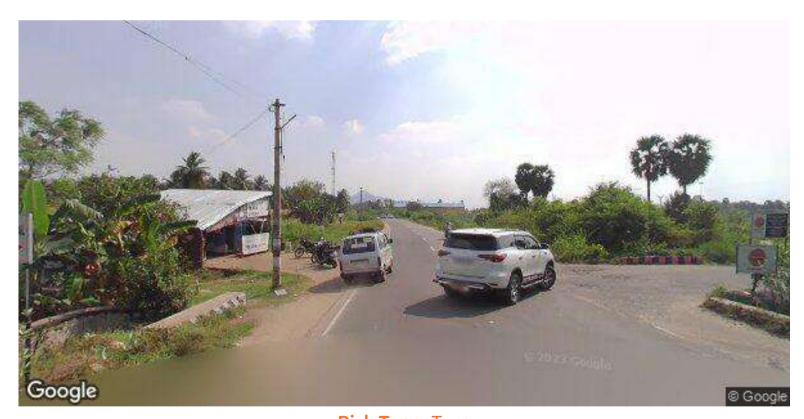
Risk Type: Turn
Risk Level: High
Speed Limit: 15 KM/Hr
Coordinates: 11.44029, 77.87544

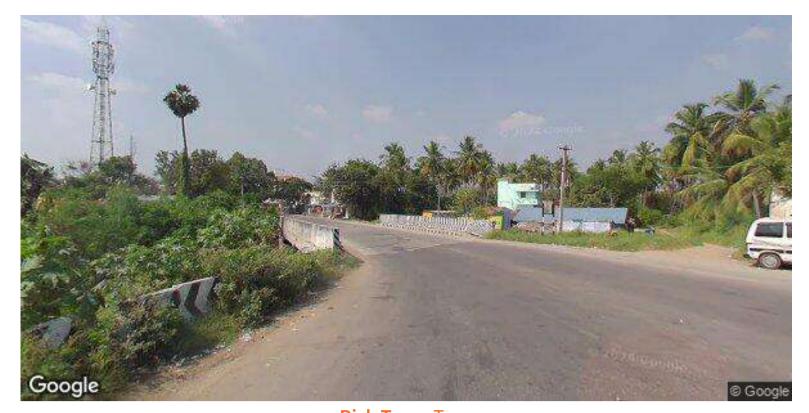
Risk Type: Turn
Risk Level: Medium
Speed Limit: 30 KM/Hr
Coordinates: 11.44893, 77.87413

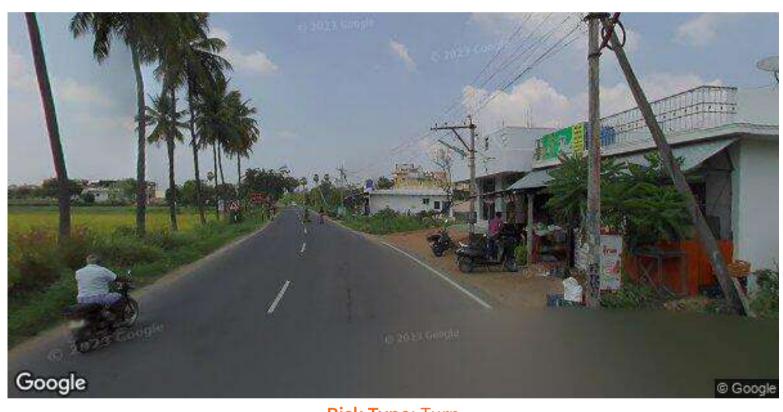
Risk Type: Turn
Risk Level: Medium
Speed Limit: 30 KM/Hr
Coordinates: 11.45127, 77.86734

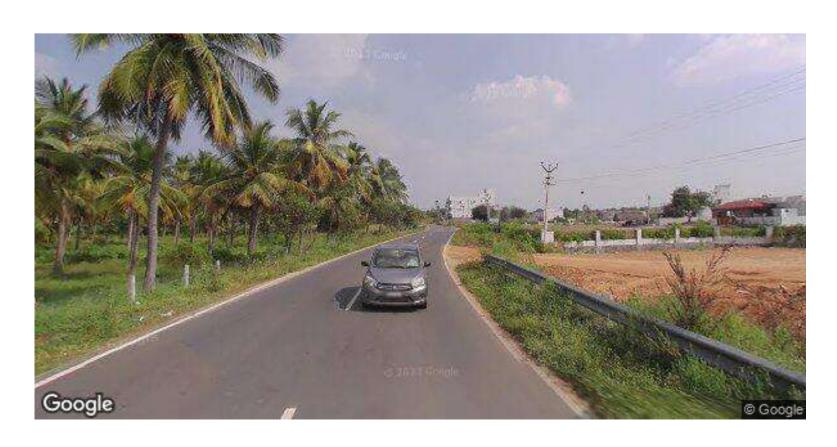
Coordinates: 11.45354, 77.85798

Risk Type: Turn
Risk Level: Medium
Speed Limit: 30 KM/Hr

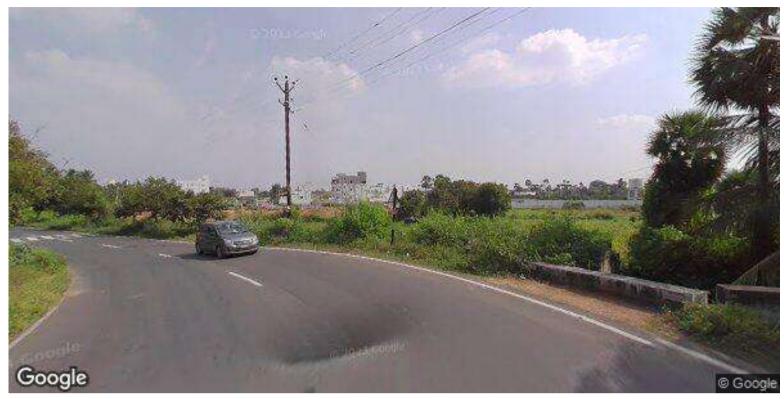
Coordinates: 11.45350, 77.85700

Risk Type: Turn
Risk Level: High
Speed Limit: 15 KM/Hr

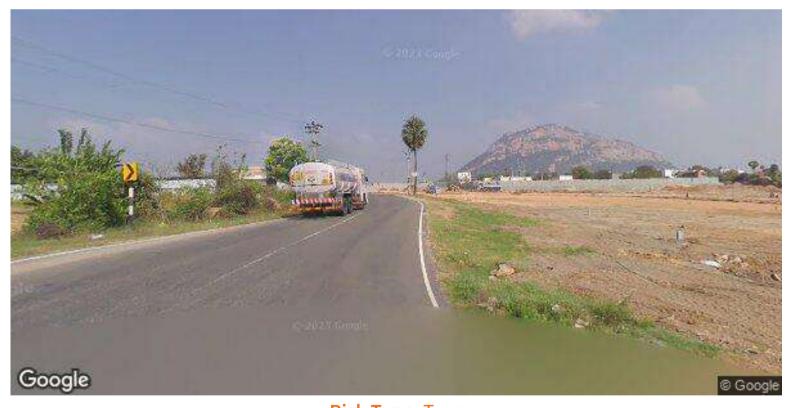
Coordinates: 11.45845, 77.85141

Risk Type: Turn
Risk Level: Medium
Speed Limit: 30 KM/Hr

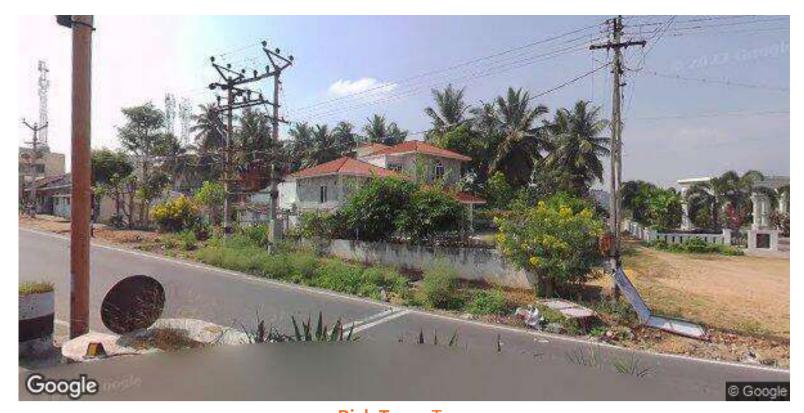
Risk Type: Turn
Risk Level: Medium
Speed Limit: 30 KM/Hr
Coordinates: 11.46303, 77.84945

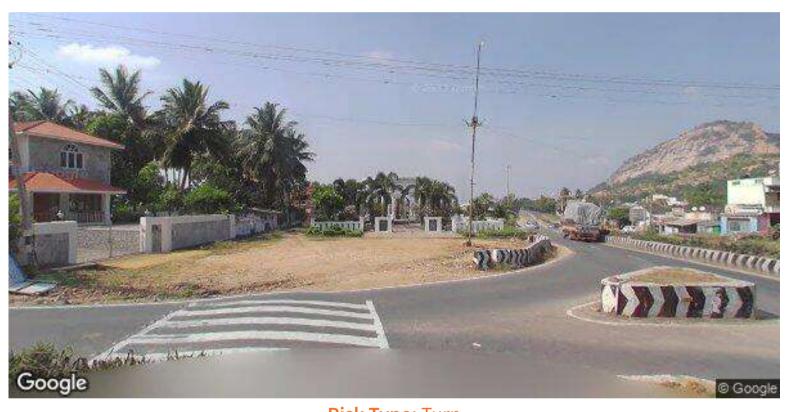
Risk Type: Turn
Risk Level: Medium
Speed Limit: 30 KM/Hr
Coordinates: 11.46311, 77.84934

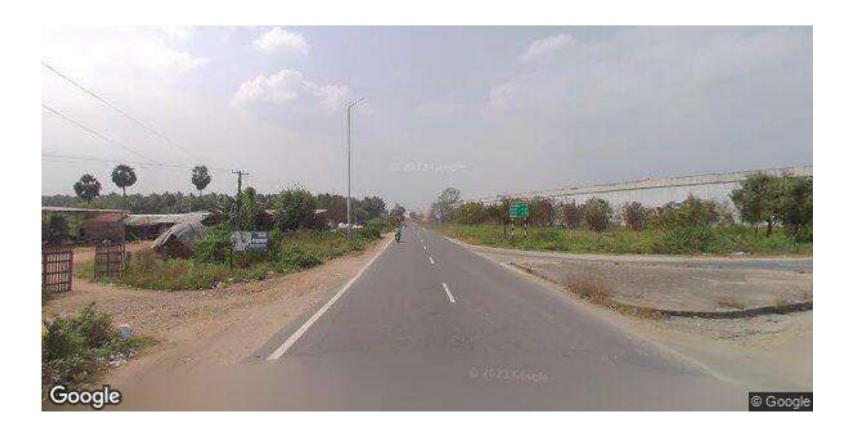
Coordinates: 11.45542, 77.81725

Risk Type: Turn
Risk Level: High
Speed Limit: 15 KM/Hr

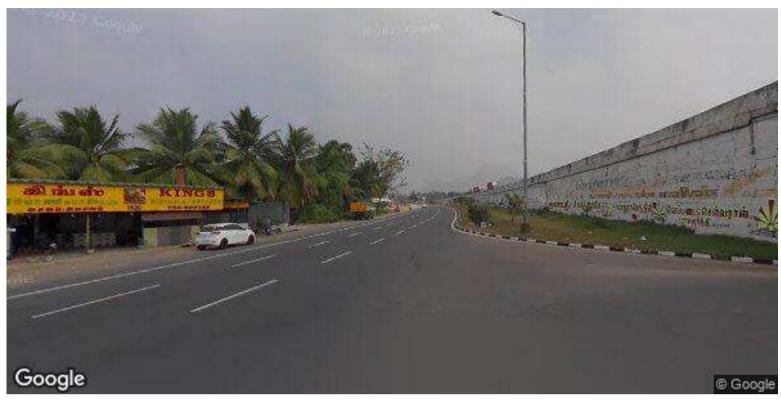
Coordinates: 11.45634, 77.81673

Risk Type: Blind Spot Risk Level: Blind Spot Speed Limit: 10 KM/Hr

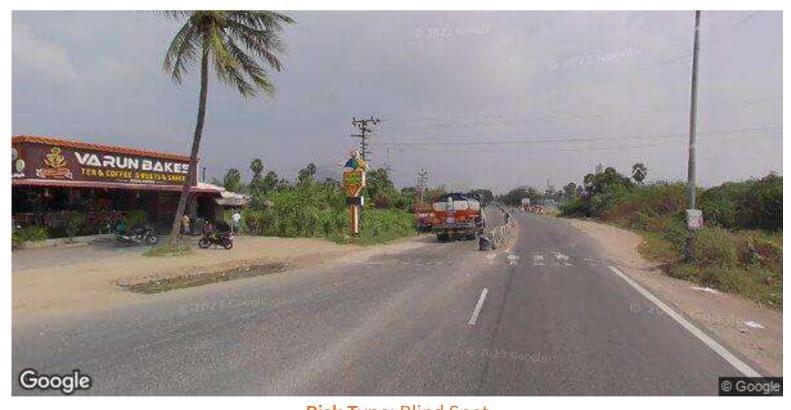
Coordinates: 11.45543, 77.81740

Risk Type: Blind Spot
Risk Level: Blind Spot
Speed Limit: 10 KM/Hr

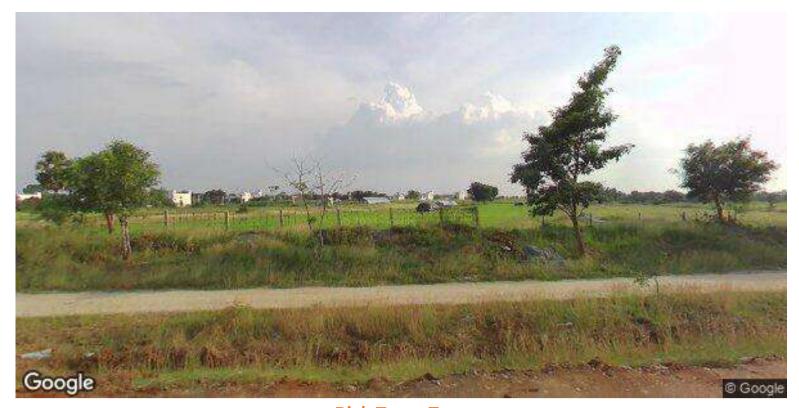
Risk Type: Turn
Risk Level: Medium
Speed Limit: 30 KM/Hr
Coordinates: 11.29288, 77.59030

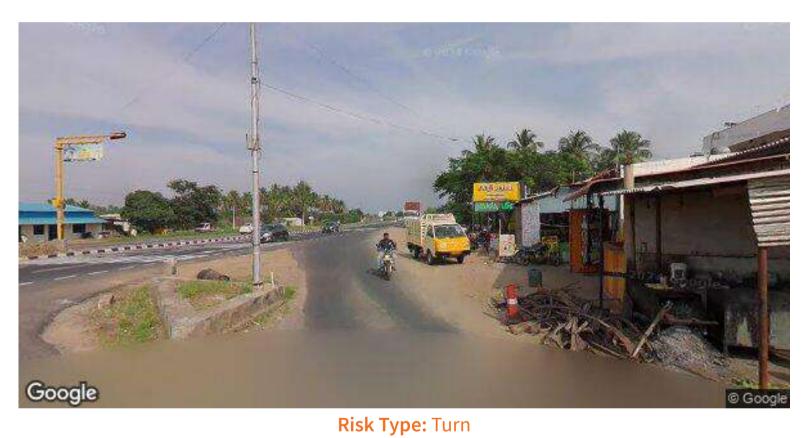
Risk Level: High
Speed Limit: 15 KM/Hr
Coordinates: 11.29164, 77.58609

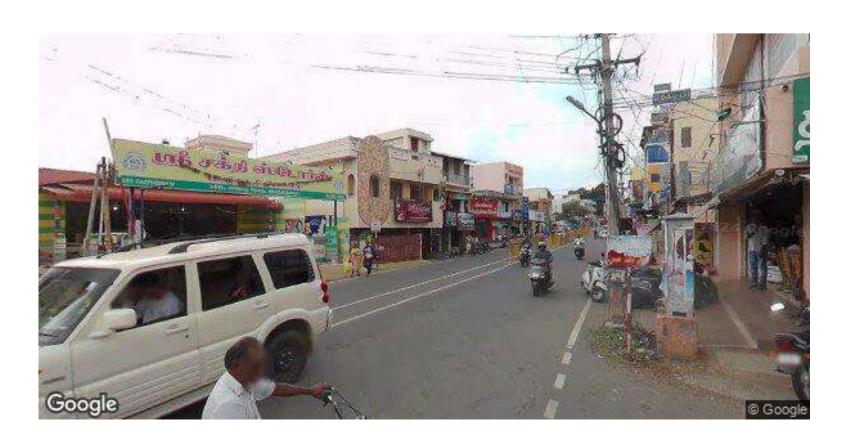
Coordinates: 11.27735, 77.58485

Risk Type: Blind Spot Risk Level: Blind Spot Speed Limit: 10 KM/Hr

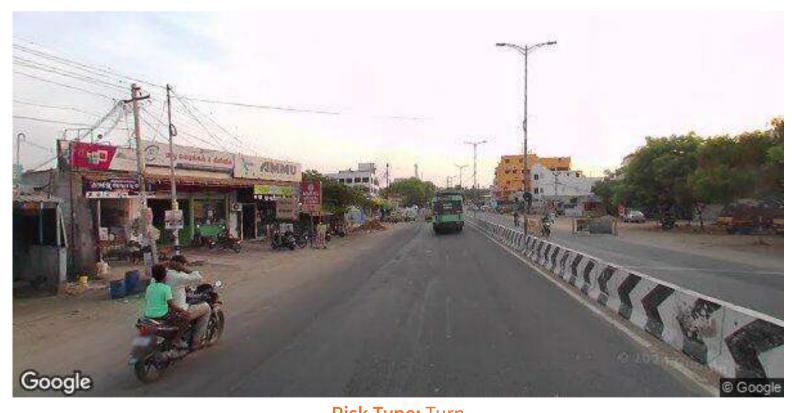
Coordinates: 11.27811, 77.58960

Risk Type: Turn
Risk Level: Medium
Speed Limit: 30 KM/Hr

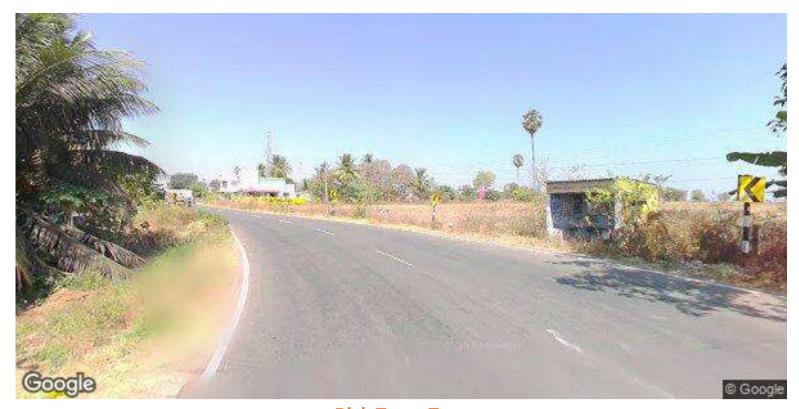
Risk Type: Turn
Risk Level: Medium
Speed Limit: 30 KM/Hr
Coordinates: 11.29283, 77.53812

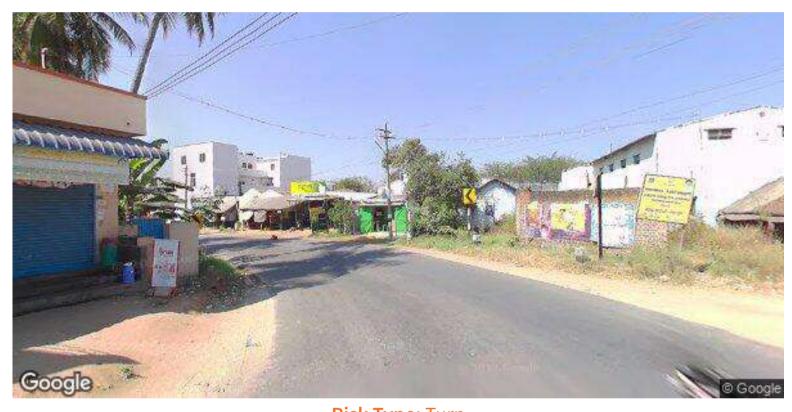
Risk Type: Turn
Risk Level: Medium
Speed Limit: 30 KM/Hr
Coordinates: 11.29250, 77.53034

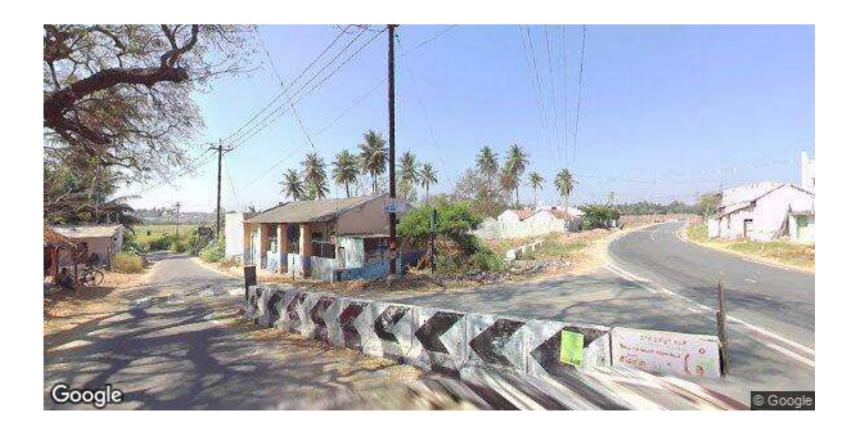
Coordinates: 11.29190, 77.52987

Risk Type: Turn
Risk Level: Medium
Speed Limit: 30 KM/Hr
