JOURNEY RISK MANAGEMENT (JRM) STUDY

Salem Terminal to SS AGENCY

Route Safety Analysis Report

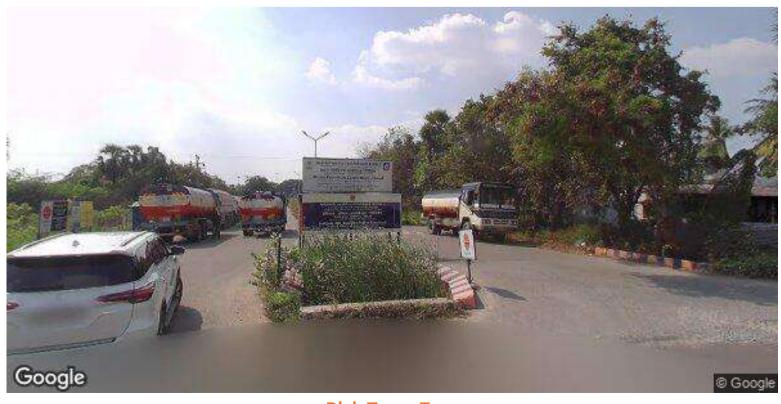
Risk Type: Turn Risk Level: High Speed Limit: 15 KM/Hr Coordinates: 11.44024, 77.87528

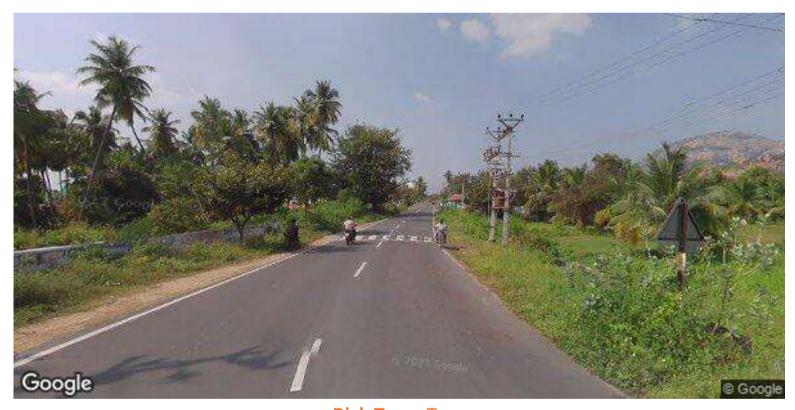
Risk Type: Turn
Risk Level: High
Speed Limit: 15 KM/Hr
Coordinates: 11.45352, 77.85698

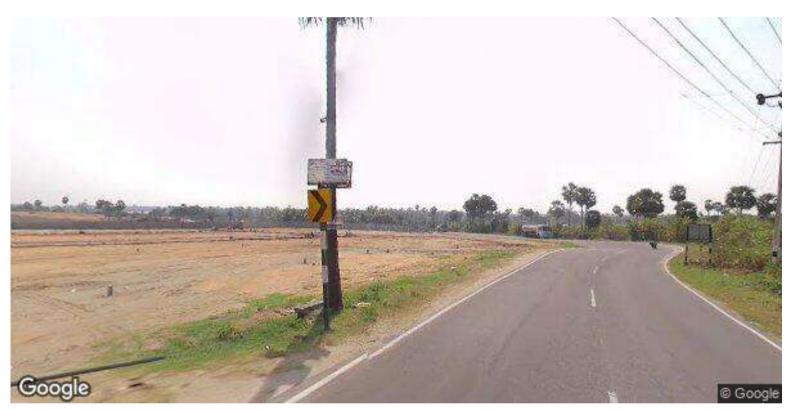
Risk Type: Turn
Risk Level: Medium
Speed Limit: 30 KM/Hr
Coordinates: 11.45898, 77.85135

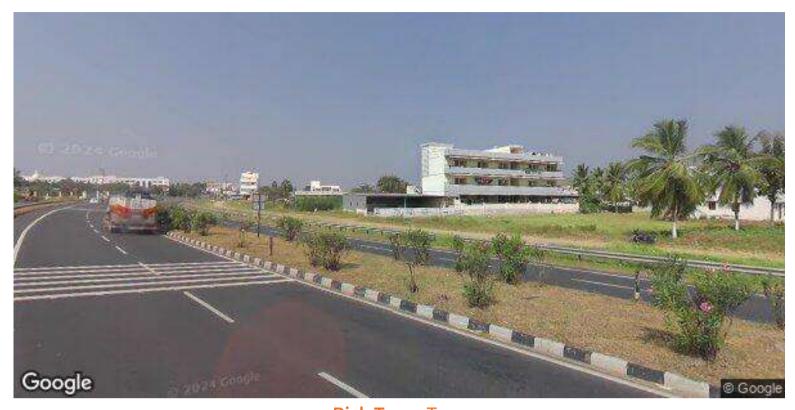
Risk Type: Turn
Risk Level: Medium
Speed Limit: 30 KM/Hr
Coordinates: 11.44965, 77.77565

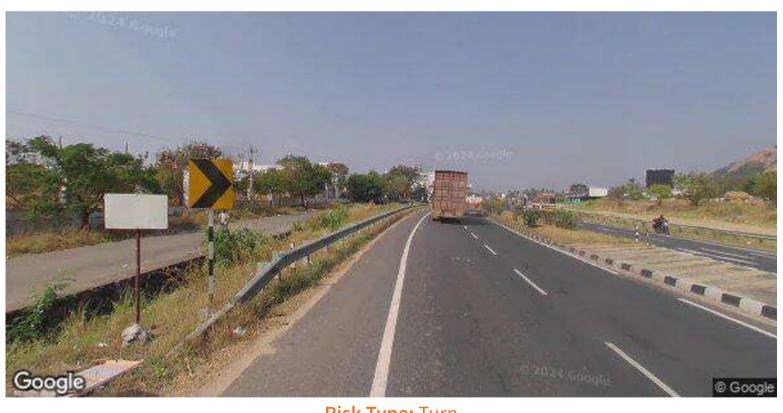
Risk Type: Turn
Risk Level: Medium
Speed Limit: 30 KM/Hr
Coordinates: 11.44953, 77.77344

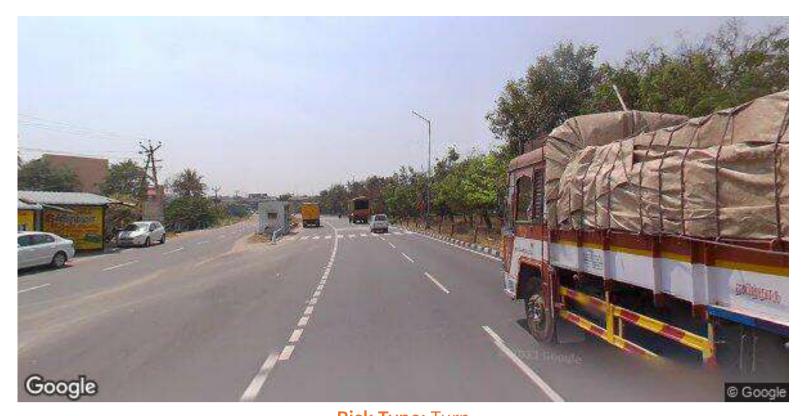
Risk Type: Turn
Risk Level: Medium
Speed Limit: 30 KM/Hr
Coordinates: 11.43165, 77.67734

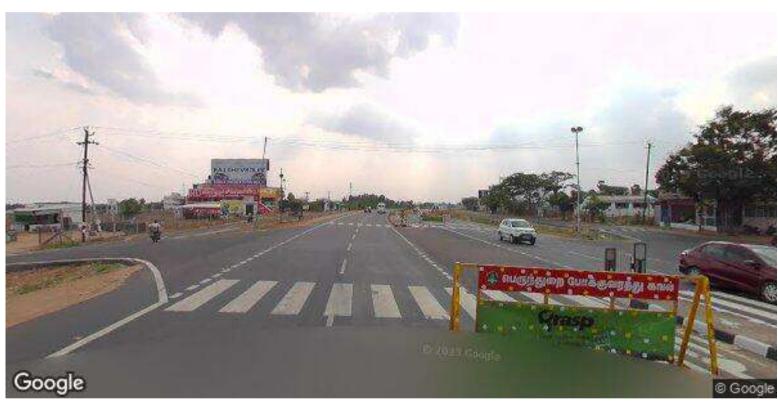
Risk Type: Turn
Risk Level: Medium
Speed Limit: 30 KM/Hr
Coordinates: 11.23724, 77.50686

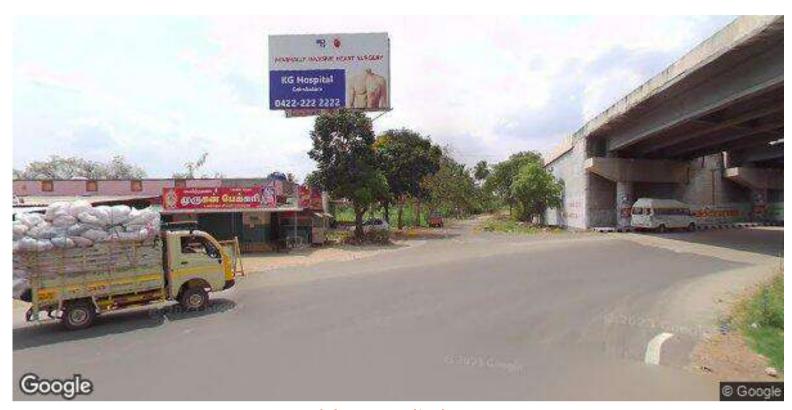
Coordinates: 11.23686, 77.50216

Risk Type: Blind Spot Risk Level: Blind Spot Speed Limit: 10 KM/Hr

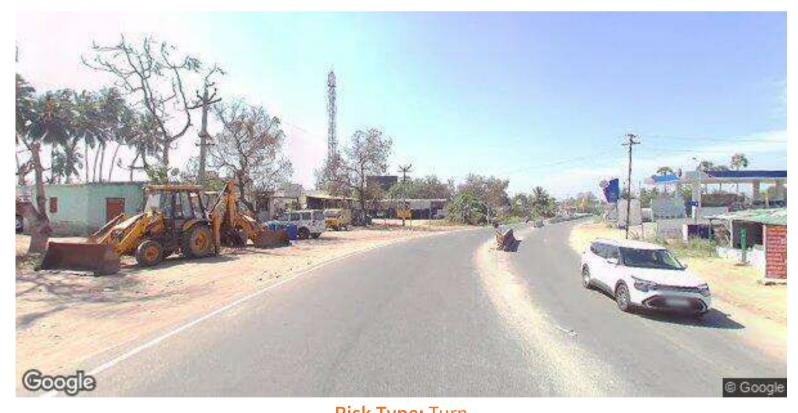
Coordinates: 11.23649, 77.50219

Risk Type: Turn
Risk Level: Medium
Speed Limit: 30 KM/Hr

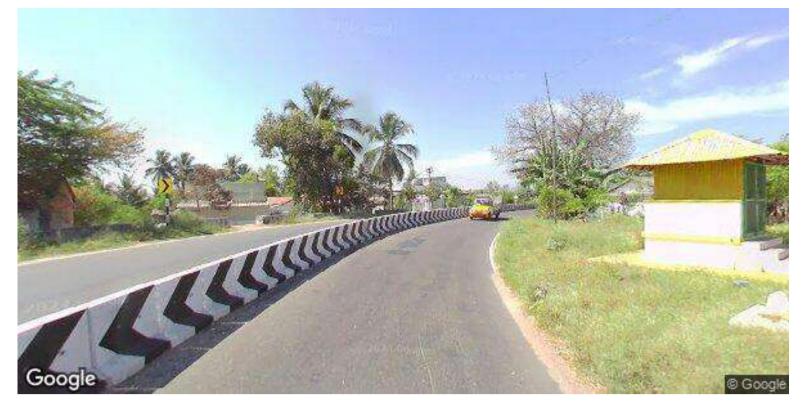
Risk Type: Turn
Risk Level: High
Speed Limit: 15 KM/Hr
Coordinates: 11.23396, 77.50105

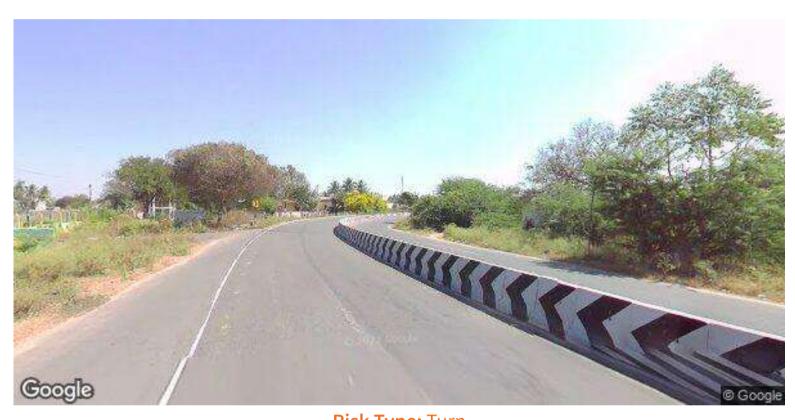
Risk Type: Turn
Risk Level: Medium
Speed Limit: 30 KM/Hr
Coordinates: 11.23287, 77.49934

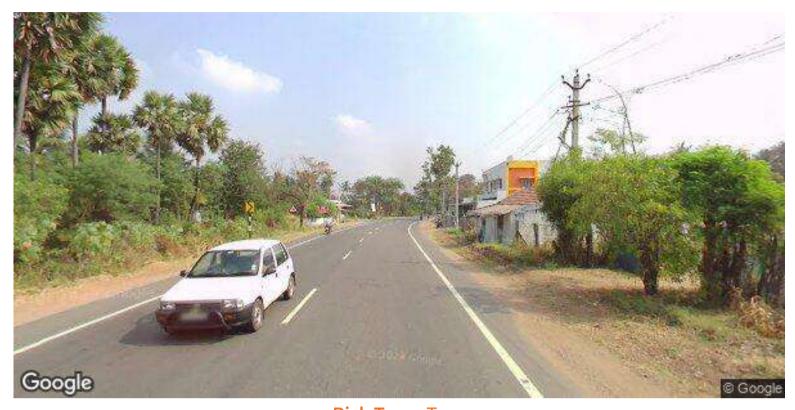
Risk Type: Turn
Risk Level: Medium
Speed Limit: 30 KM/Hr
Coordinates: 11.18273, 77.46224

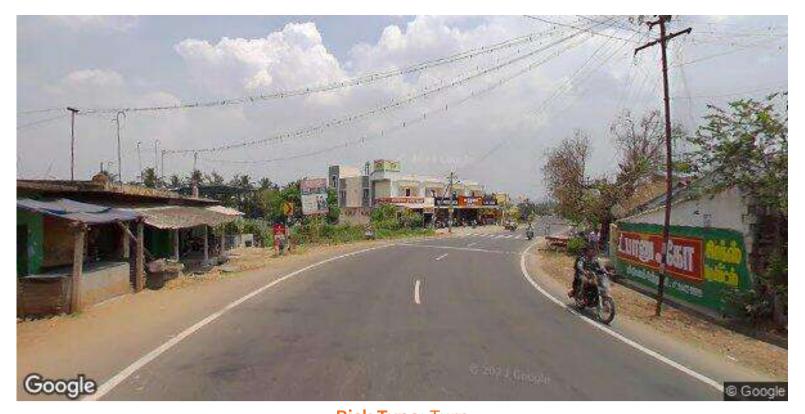
Risk Type: Turn
Risk Level: Medium
Speed Limit: 30 KM/Hr
Coordinates: 11.17368, 77.45730

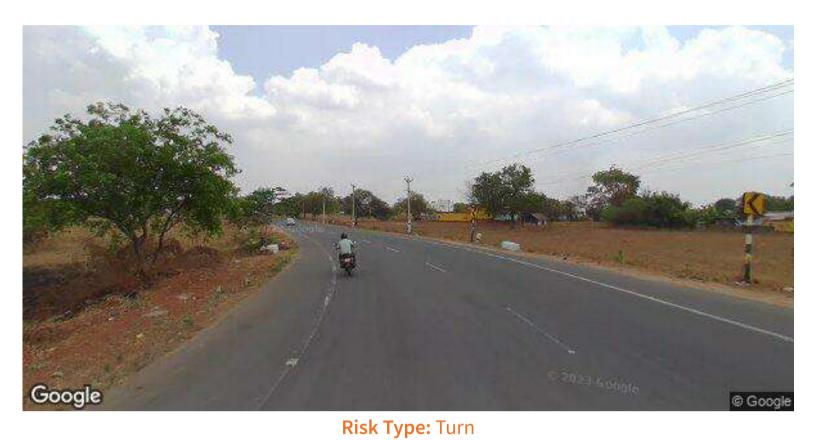
Risk Level: Medium
Speed Limit: 30 KM/Hr
Coordinates: 11.16381, 77.43700

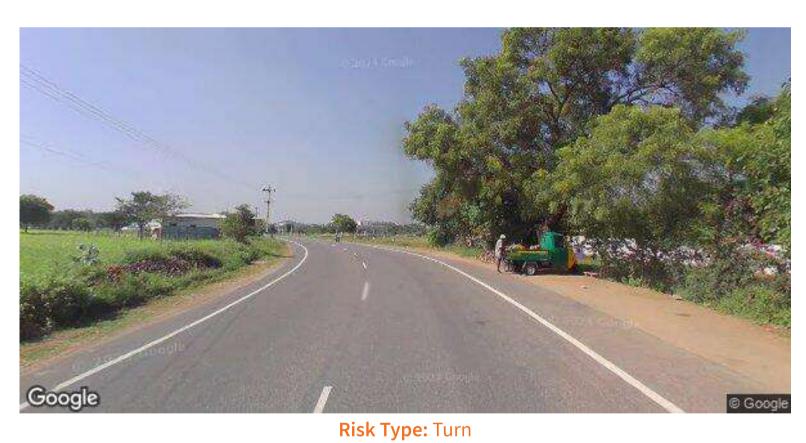
Risk Level: Medium
Speed Limit: 30 KM/Hr
Coordinates: 11.16280, 77.43139

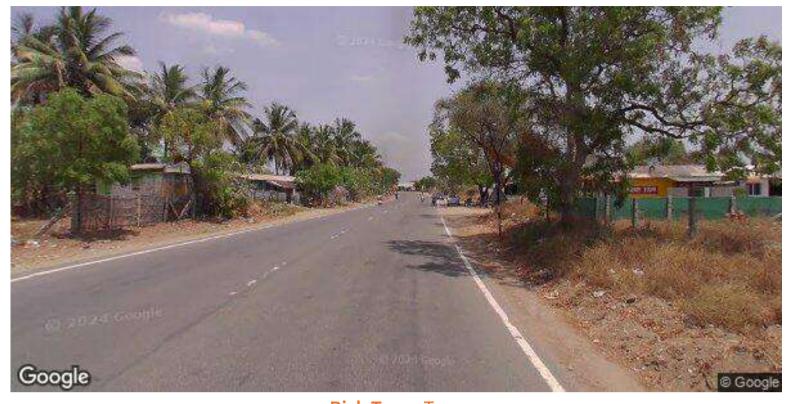
Risk Type: Turn
Risk Level: Medium
Speed Limit: 30 KM/Hr
Coordinates: 11.14925, 77.42065

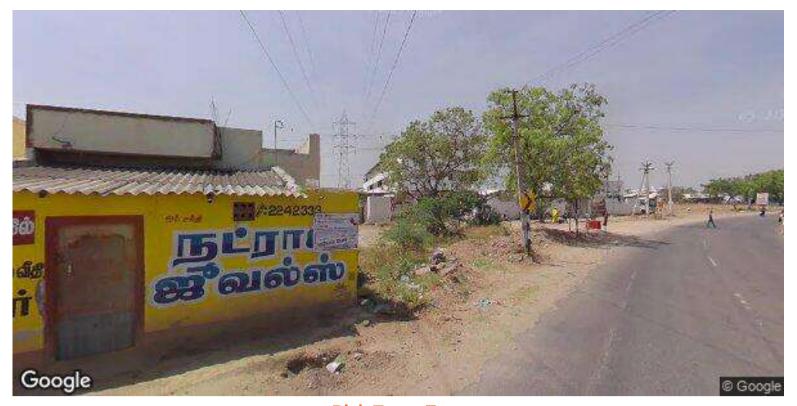
Risk Type: Turn
Risk Level: Medium
Speed Limit: 30 KM/Hr
Coordinates: 11.13578, 77.41299

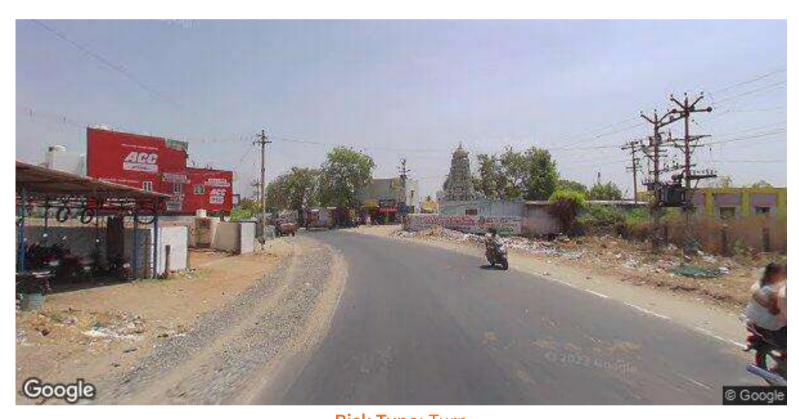
Risk Type: Turn
Risk Level: Medium
Speed Limit: 30 KM/Hr
Coordinates: 11.12989, 77.40302

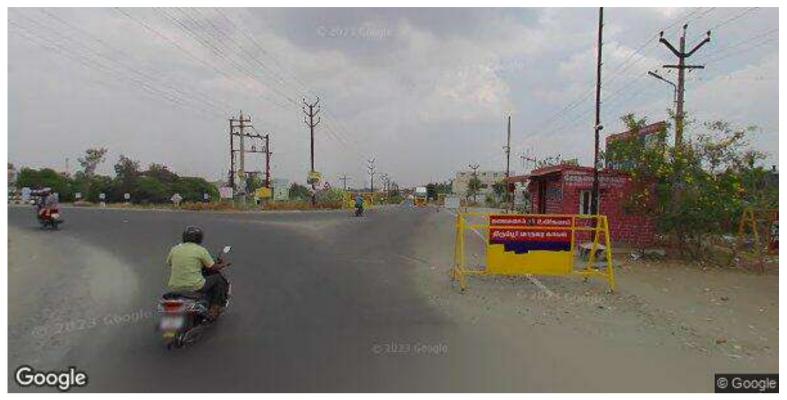
Coordinates: 11.11846, 77.39460

Risk Type: Turn
Risk Level: High
Speed Limit: 15 KM/Hr

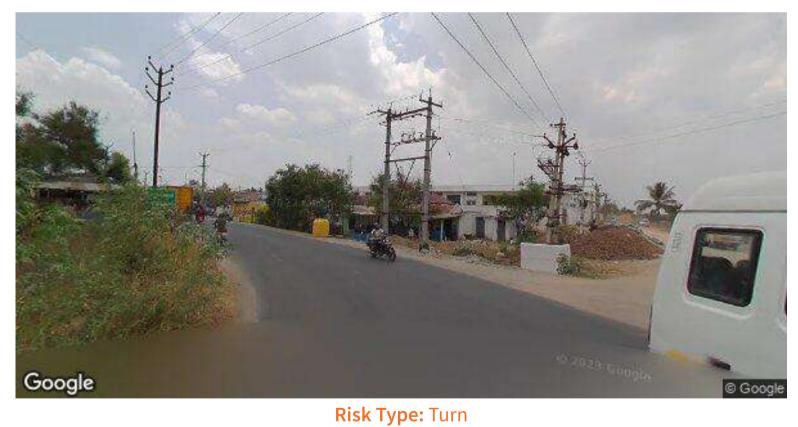
Coordinates: 11.11833, 77.39390

Risk Type: Turn

Risk Level: High

Speed Limit: 15 KM/Hr

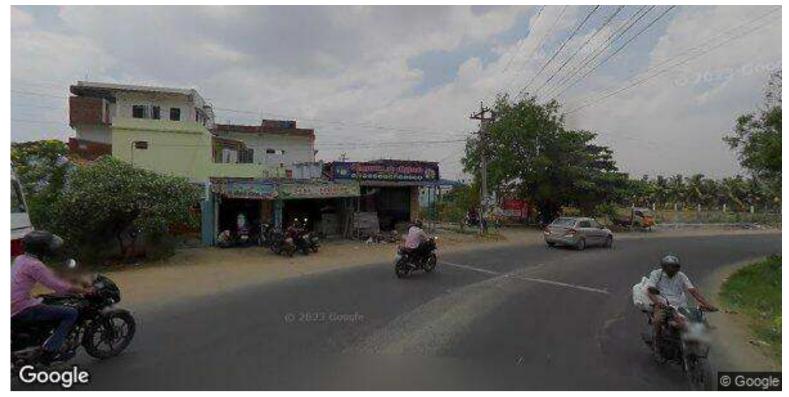
Risk Type: Turn
Risk Level: High
Speed Limit: 15 KM/Hr
Coordinates: 11.10276, 77.39199

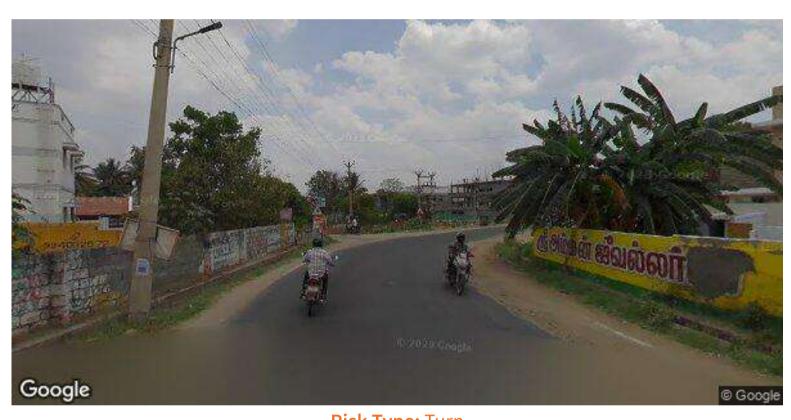
Risk Type: Turn
Risk Level: High
Speed Limit: 15 KM/Hr
Coordinates: 11.10256, 77.39273

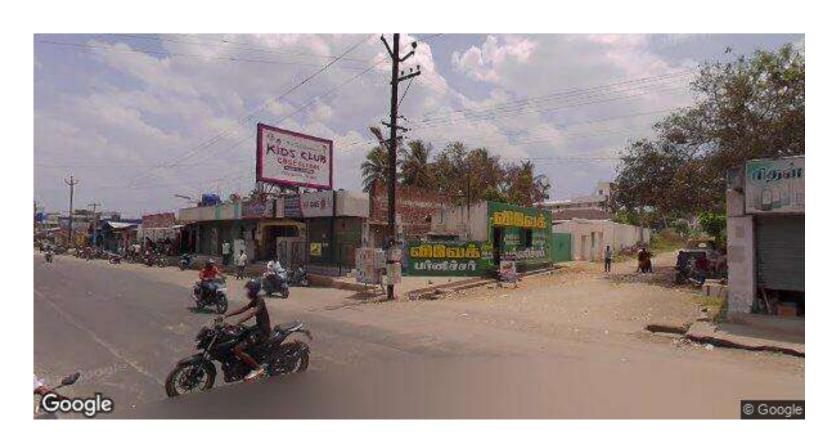
Coordinates: 11.09882, 77.39312

Risk Type: Blind Spot Risk Level: Blind Spot Speed Limit: 10 KM/Hr

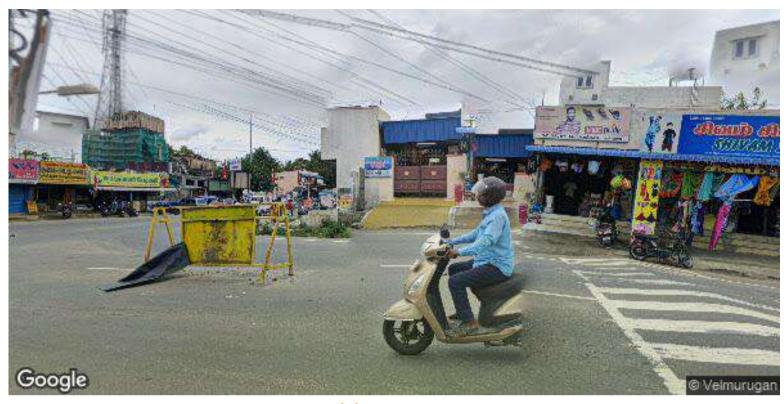
Coordinates: 11.09898, 77.39028

Risk Type: Turn
Risk Level: High
Speed Limit: 15 KM/Hr

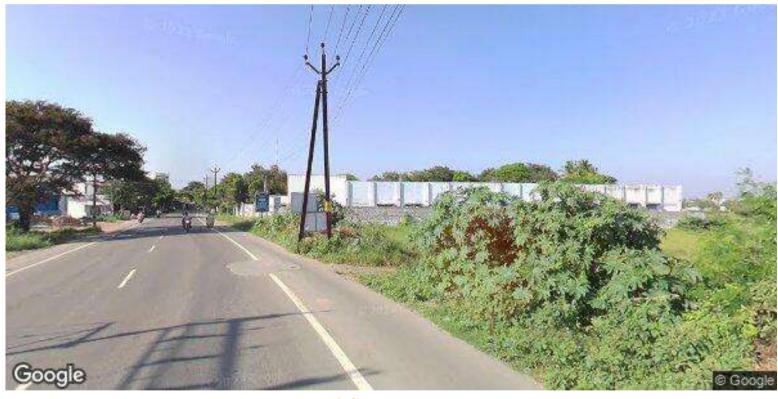
Coordinates: 11.09456, 77.39233

Risk Type: Turn
Risk Level: Medium
Speed Limit: 30 KM/Hr

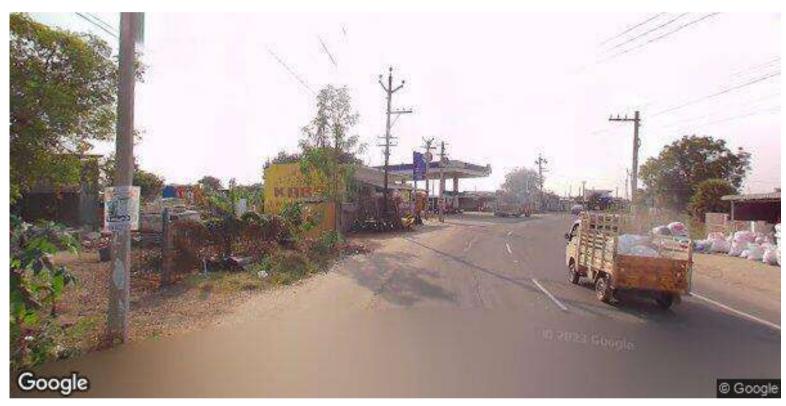
Risk Type: Turn
Risk Level: Medium
Speed Limit: 30 KM/Hr
Coordinates: 11.08531, 77.38413

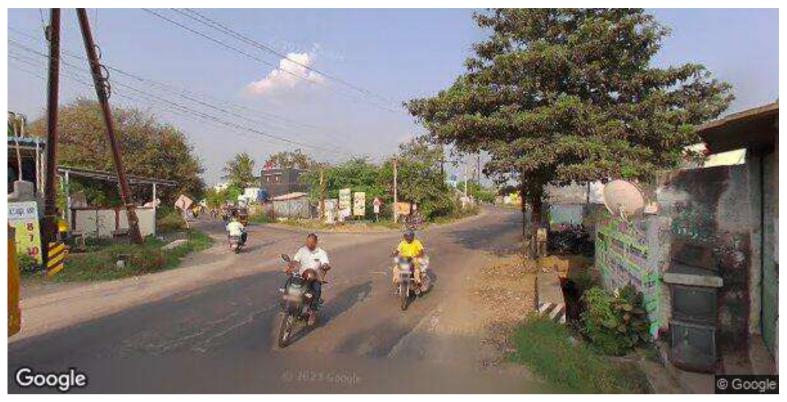
Risk Type: Turn
Risk Level: High
Speed Limit: 15 KM/Hr
Coordinates: 11.08536, 77.37919

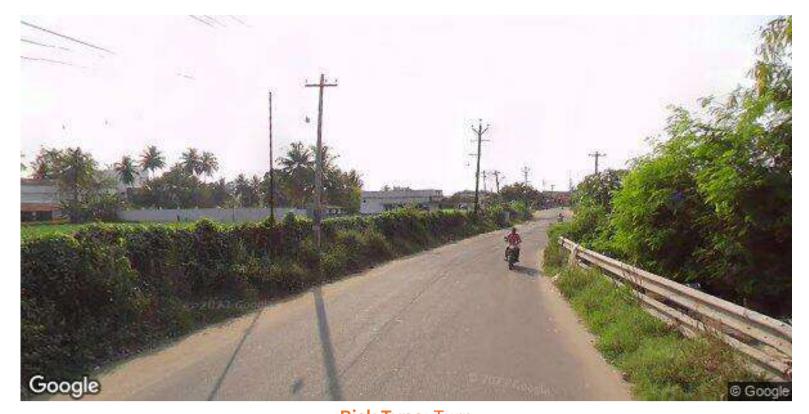
Risk Type: Turn
Risk Level: Medium
Speed Limit: 30 KM/Hr
Coordinates: 11.08448, 77.37842

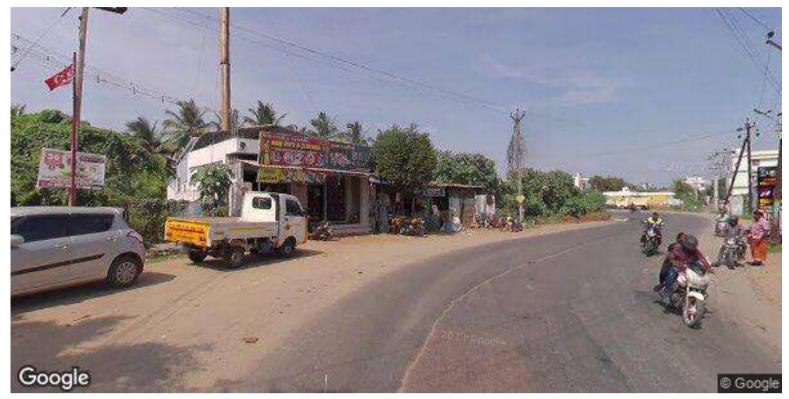
Coordinates: 11.08497, 77.37234

Risk Type: Turn
Risk Level: High
Speed Limit: 15 KM/Hr

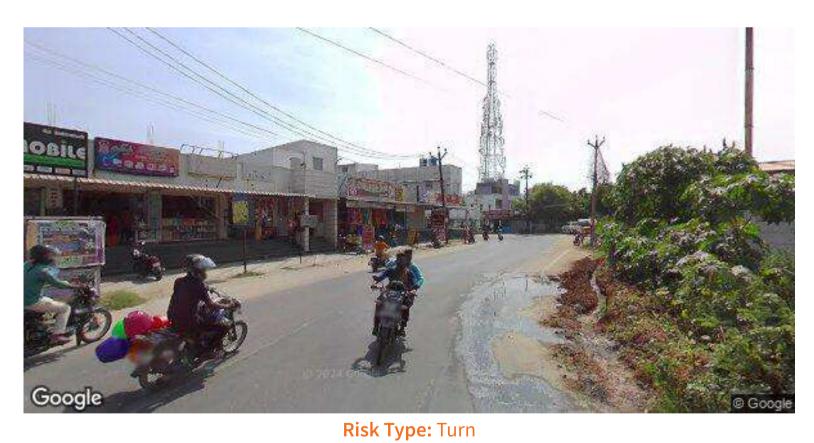
Risk Level: High
Speed Limit: 15 KM/Hr
Coordinates: 11.08544, 77.37228

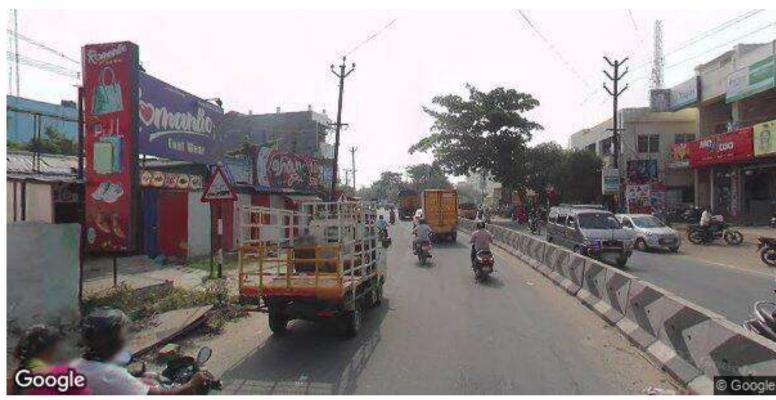
Coordinates: 11.08583, 77.36360

Risk Type: Turn
Risk Level: High
Speed Limit: 15 KM/Hr

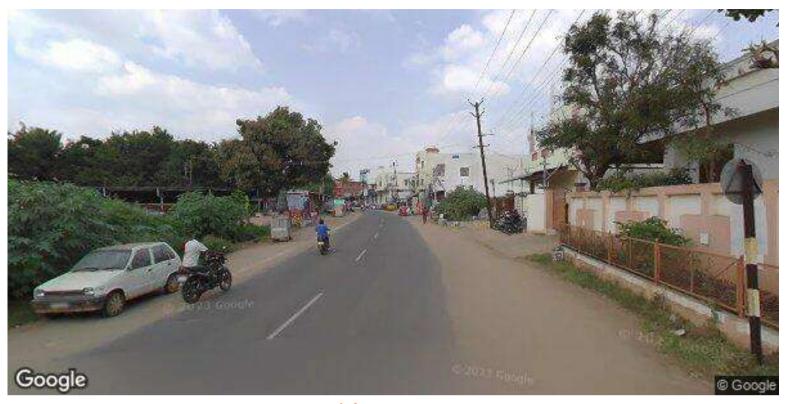
Risk Type: Turn
Risk Level: Medium
Speed Limit: 30 KM/Hr
Coordinates: 11.07037, 77.36701

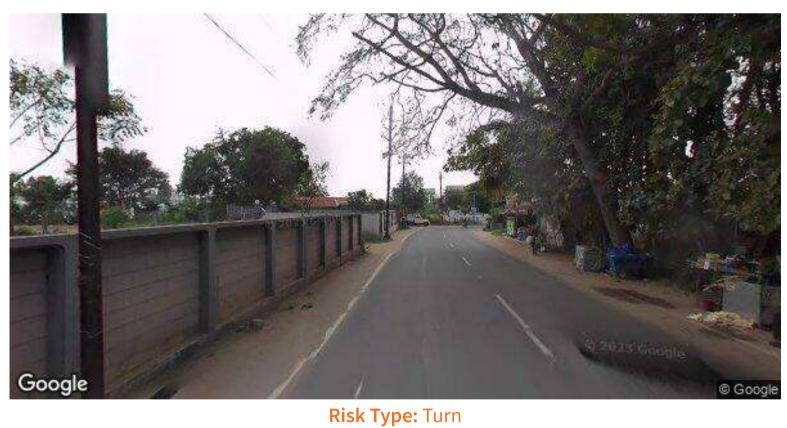
Risk Level: Medium
Speed Limit: 30 KM/Hr
Coordinates: 11.06962, 77.36676

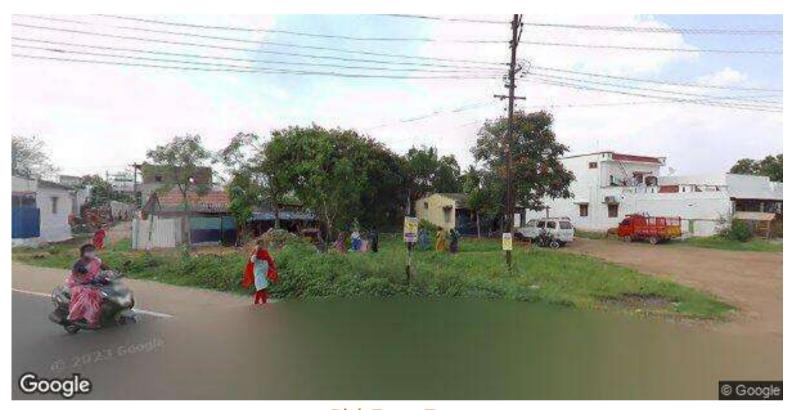
Risk Type: Turn
Risk Level: Medium
Speed Limit: 30 KM/Hr
Coordinates: 11.06888, 77.36568

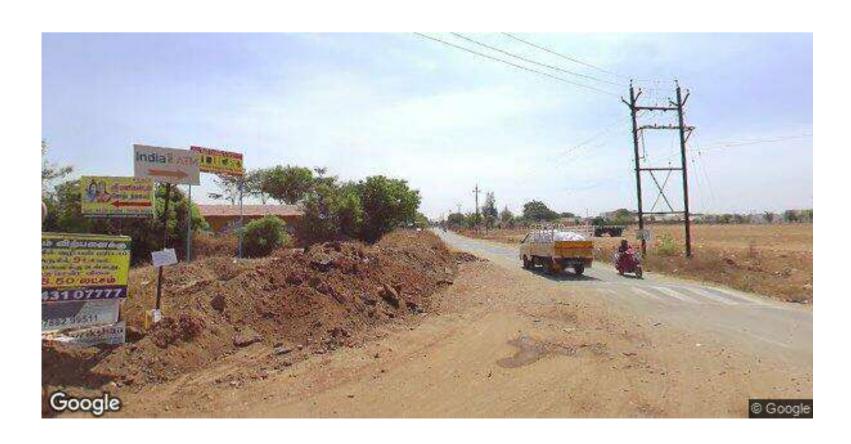
Coordinates: 11.06421, 77.36175

Risk Type: Blind Spot Risk Level: Blind Spot Speed Limit: 10 KM/Hr
