JOURNEY RISK MANAGEMENT (JRM) STUDY

IOCL Coimbatore Terminal to KCK & Co

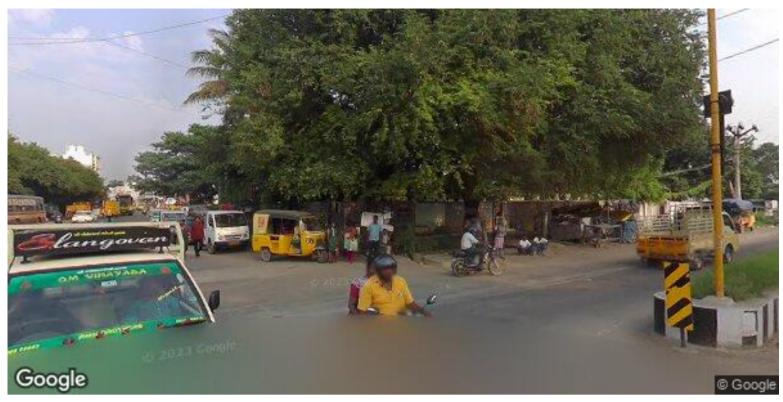
Coordinates: 11.07800, 77.03707

Risk Type: Roundabout
Risk Level: High
Speed Limit: 15 KM/Hr

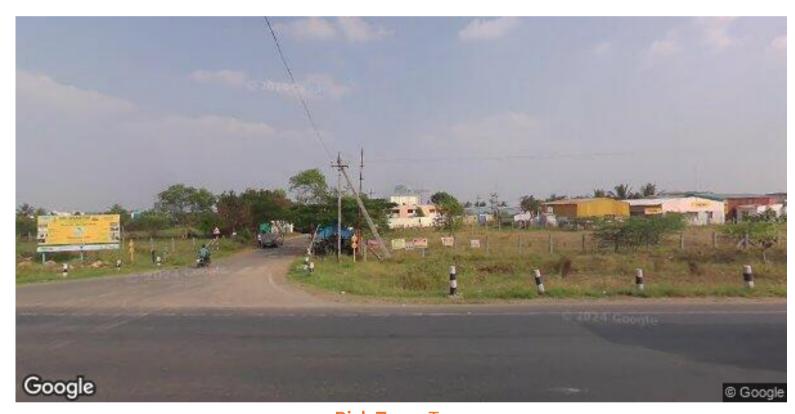
Risk Type: Turn
Risk Level: High
Speed Limit: 15 KM/Hr
Coordinates: 11.05129, 77.07919

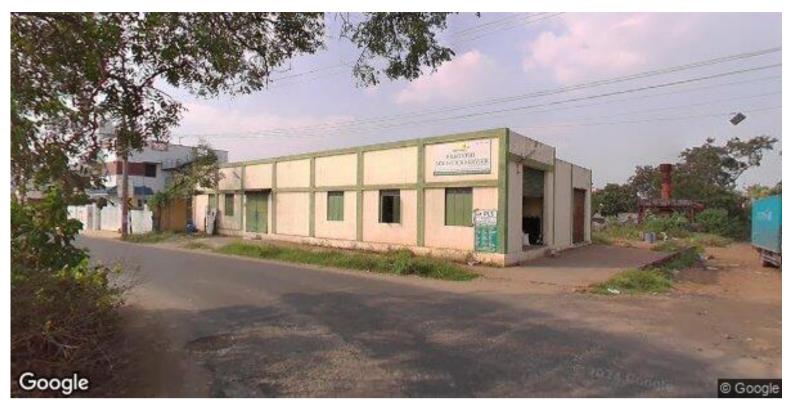
Risk Type: Turn
Risk Level: High
Speed Limit: 15 KM/Hr
Coordinates: 11.05222, 77.07690

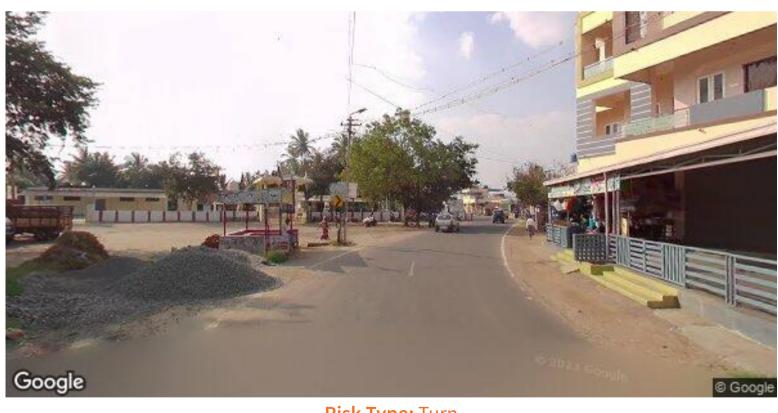
Risk Type: Turn
Risk Level: Medium
Speed Limit: 30 KM/Hr
Coordinates: 11.05281, 77.07261

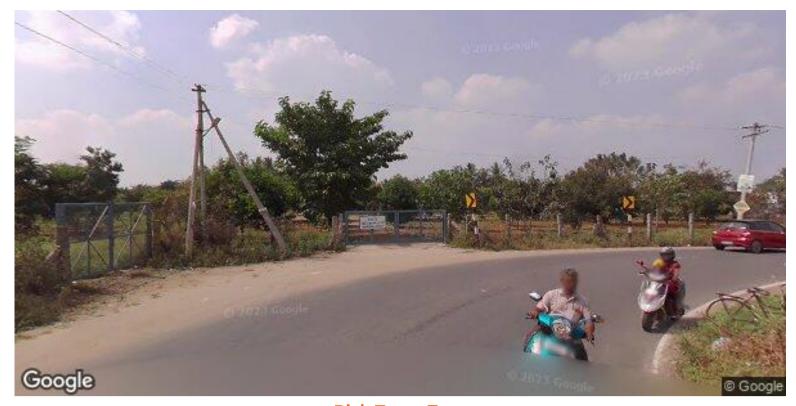
Risk Type: Turn
Risk Level: Medium
Speed Limit: 30 KM/Hr
Coordinates: 11.05343, 77.07106

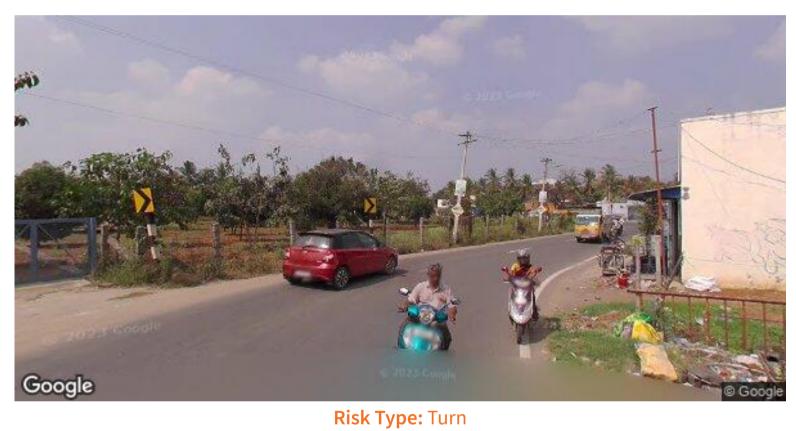
Risk Level: High
Speed Limit: 15 KM/Hr
Coordinates: 11.05351, 77.07099

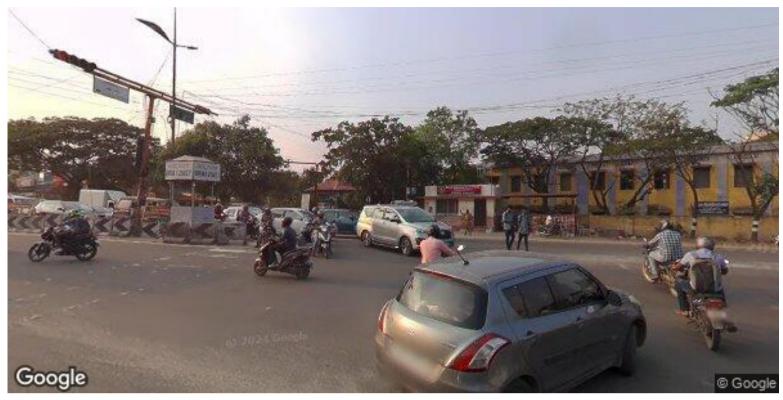
Coordinates: 11.05529, 77.06566

Risk Type: Turn
Risk Level: High
Speed Limit: 15 KM/Hr

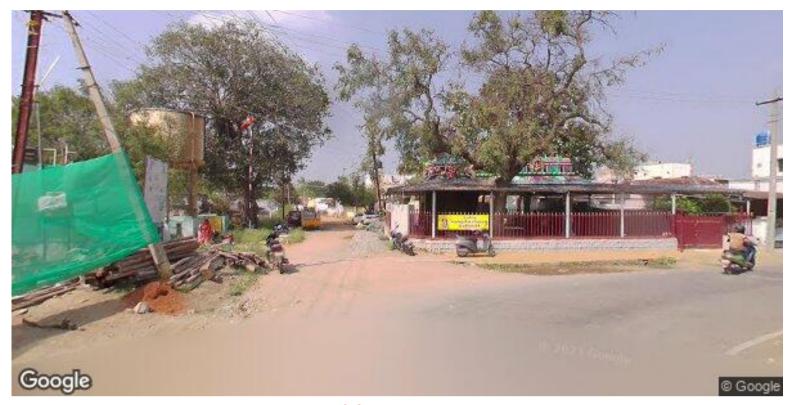
Coordinates: 11.06490, 77.06371

Risk Type: Turn
Risk Level: High
Speed Limit: 15 KM/Hr

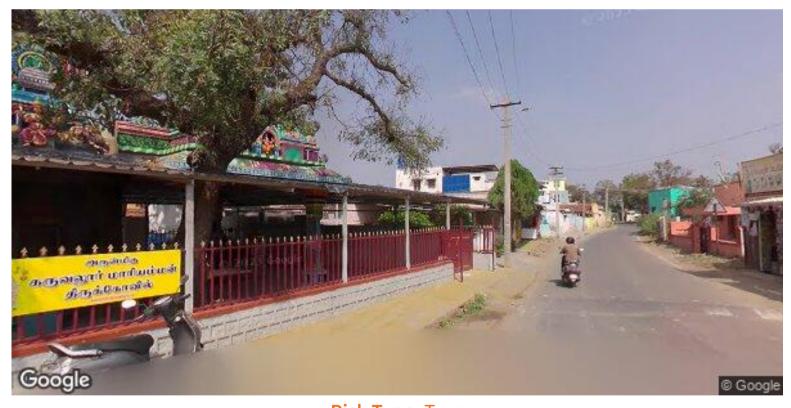
Coordinates: 11.06501, 77.06366

Risk Type: Turn
Risk Level: Medium
Speed Limit: 30 KM/Hr

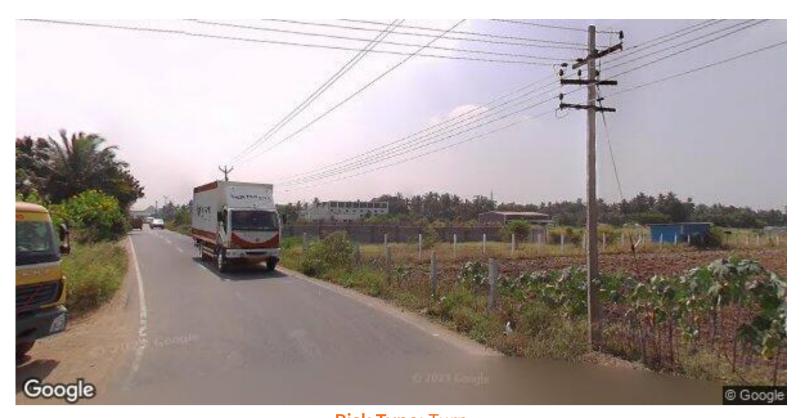
Risk Type: Turn
Risk Level: Medium
Speed Limit: 30 KM/Hr
Coordinates: 11.07201, 77.06366

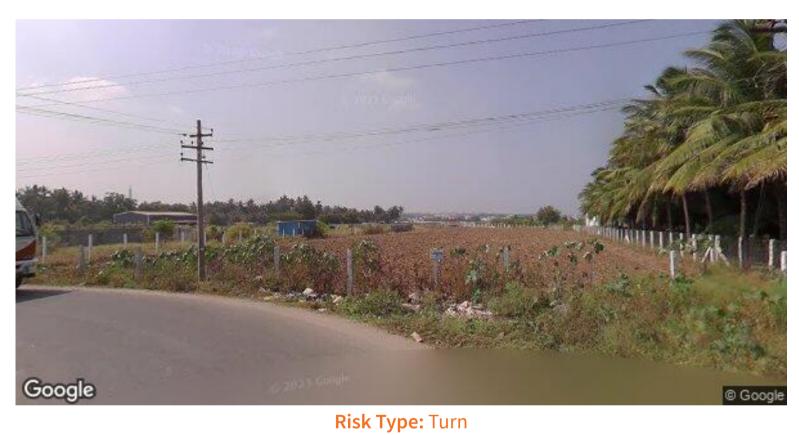
Risk Level: Medium
Speed Limit: 30 KM/Hr
Coordinates: 11.07209, 77.06370

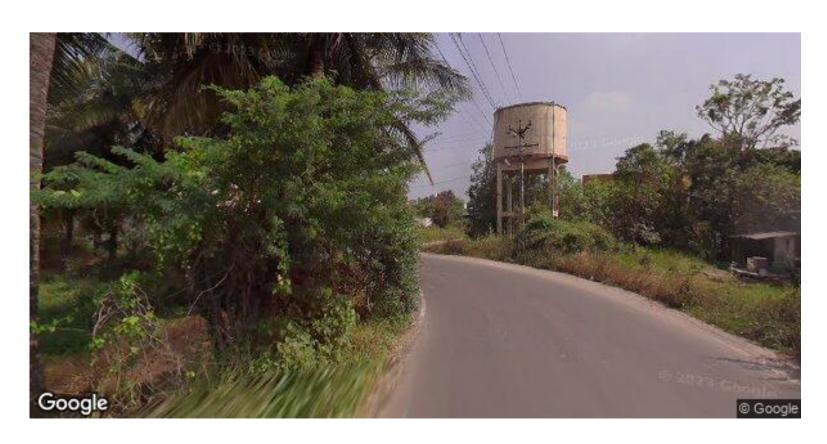
Coordinates: 11.07220, 77.06393

Risk Type: Turn
Risk Level: Medium
Speed Limit: 30 KM/Hr

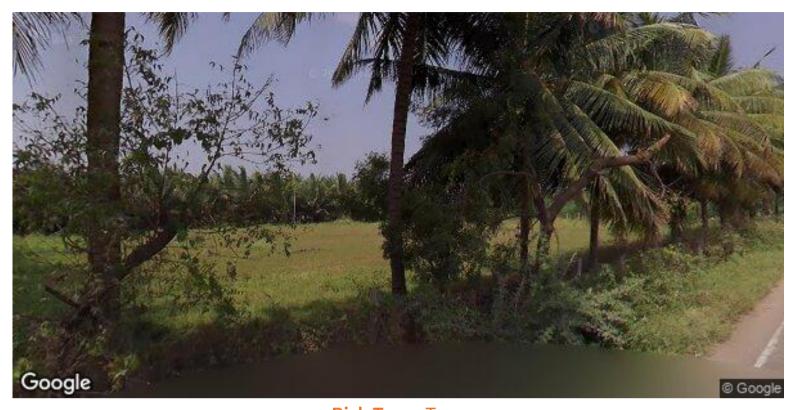
Risk Type: Turn
Risk Level: Medium
Speed Limit: 30 KM/Hr
Coordinates: 11.07232, 77.06400

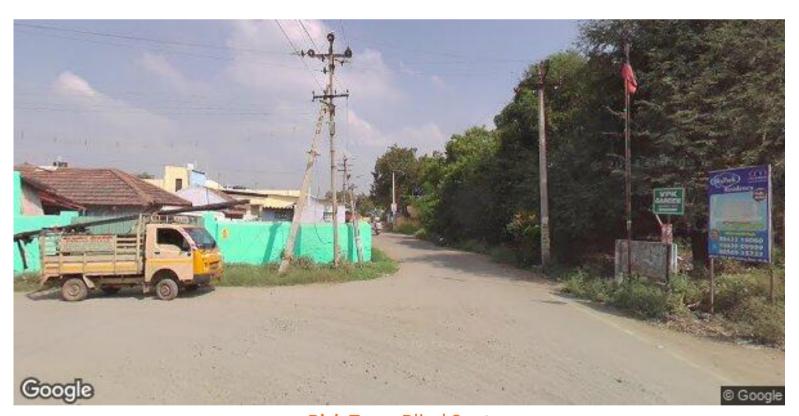
Coordinates: 11.07865, 77.06377

Risk Type: Blind Spot
Risk Level: Blind Spot
Speed Limit: 10 KM/Hr

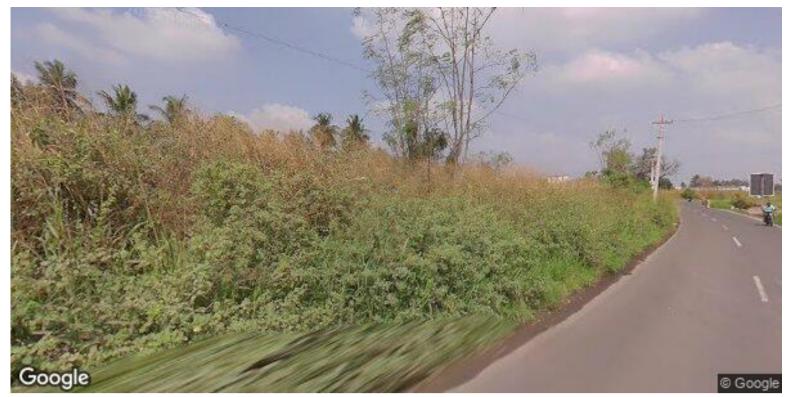
Risk Type: Turn
Risk Level: High
Speed Limit: 15 KM/Hr
Coordinates: 11.07773, 77.05884

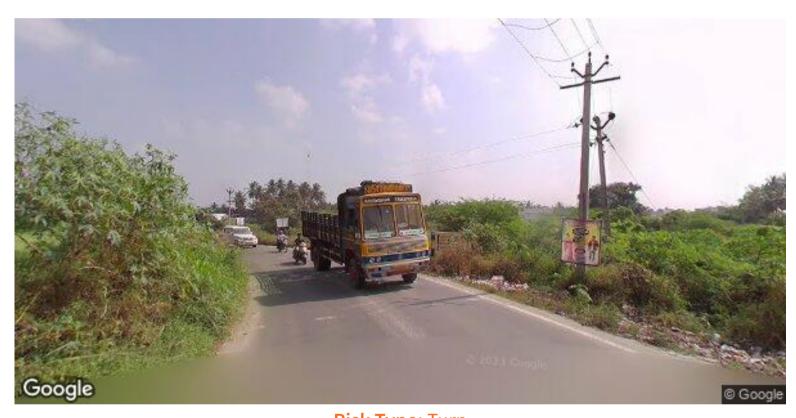
Risk Type: Turn
Risk Level: Medium
Speed Limit: 30 KM/Hr
Coordinates: 11.07655, 77.05823

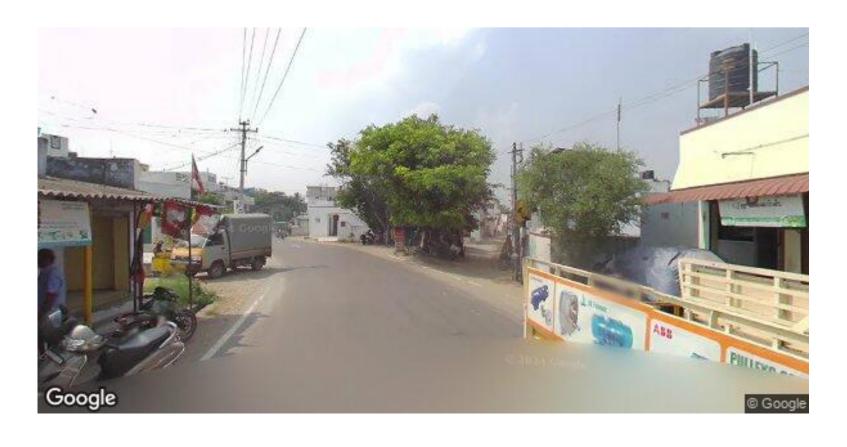
Coordinates: 11.07854, 77.03872

Risk Type: Turn
Risk Level: Medium
Speed Limit: 30 KM/Hr

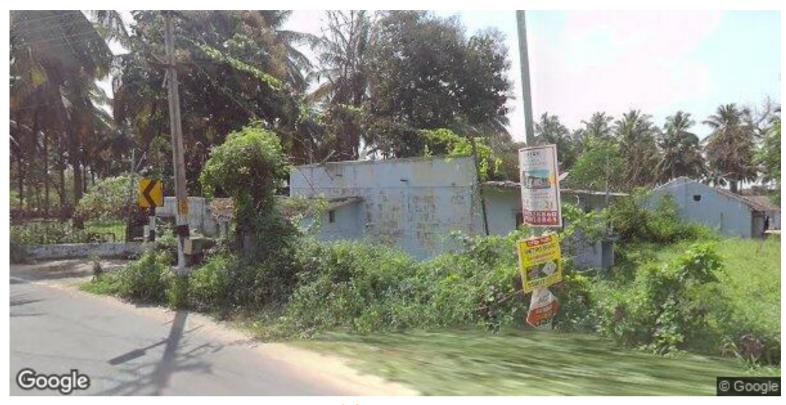
Coordinates: 11.09589, 77.03170

Risk Type: Turn
Risk Level: Medium
Speed Limit: 30 KM/Hr

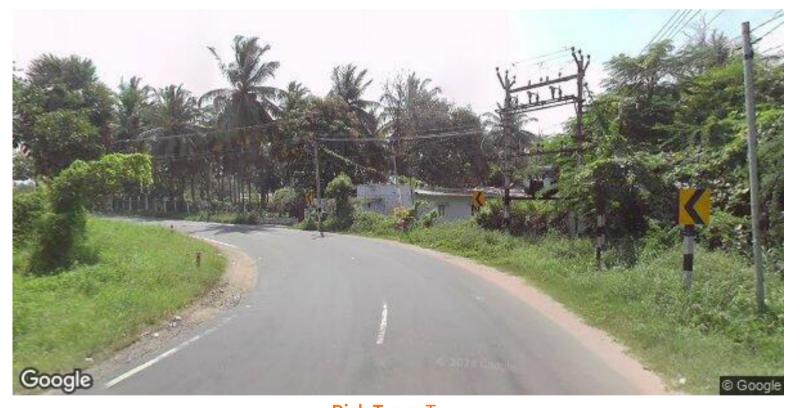
Coordinates: 11.09605, 77.03172

Risk Type: Turn
Risk Level: Medium
Speed Limit: 30 KM/Hr

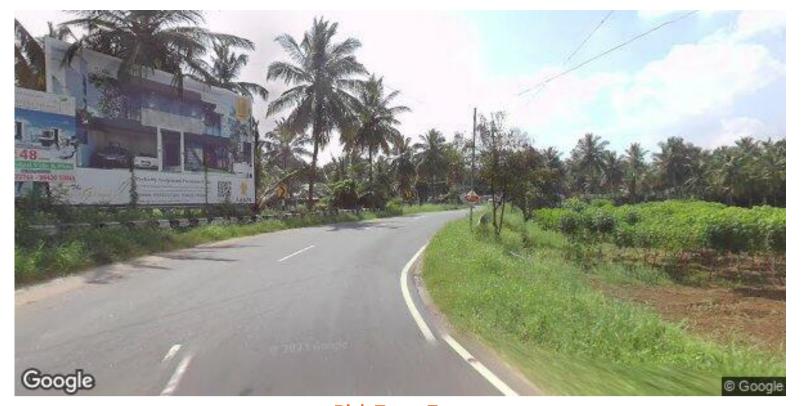
Risk Type: Turn
Risk Level: Medium
Speed Limit: 30 KM/Hr
Coordinates: 11.09655, 77.03237

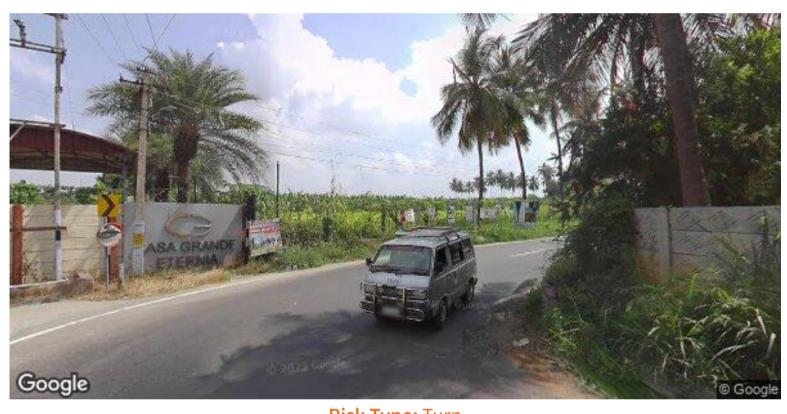
Risk Type: Turn
Risk Level: Medium
Speed Limit: 30 KM/Hr
Coordinates: 11.09846, 77.03245

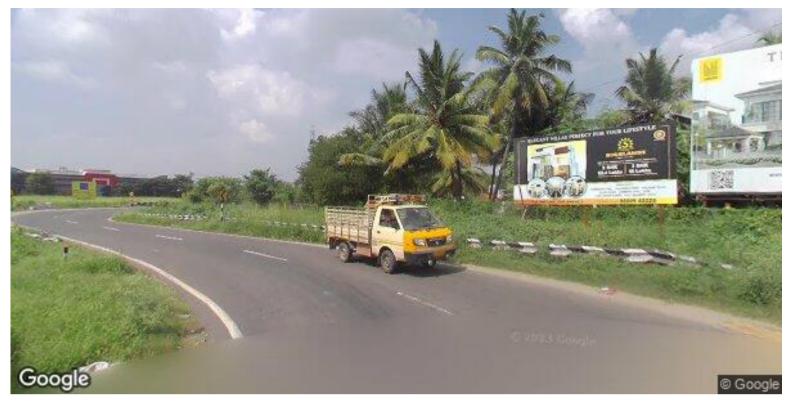
Coordinates: 11.10301, 77.03046

Risk Type: Turn
Risk Level: High
Speed Limit: 15 KM/Hr

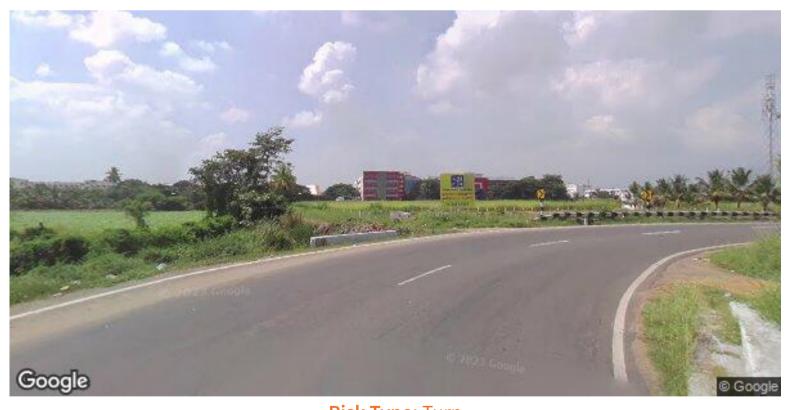
Coordinates: 11.10312, 77.03001

Risk Type: Turn
Risk Level: Medium
Speed Limit: 30 KM/Hr

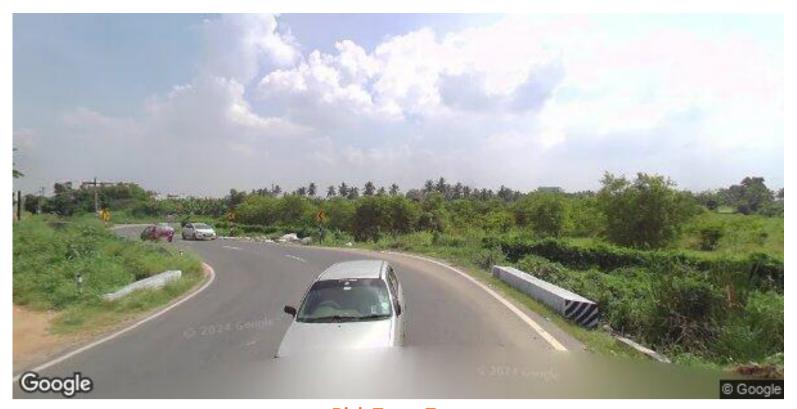
Coordinates: 11.10320, 77.02990

Risk Type: Turn
Risk Level: Medium
Speed Limit: 30 KM/Hr

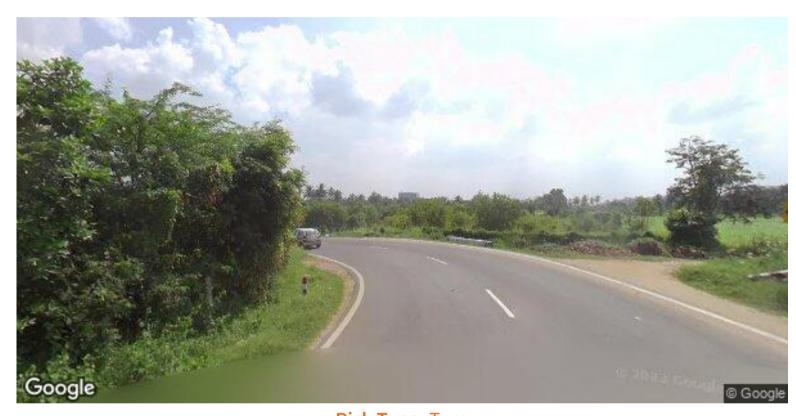
Risk Type: Turn
Risk Level: Medium
Speed Limit: 30 KM/Hr
Coordinates: 11.10331, 77.02984

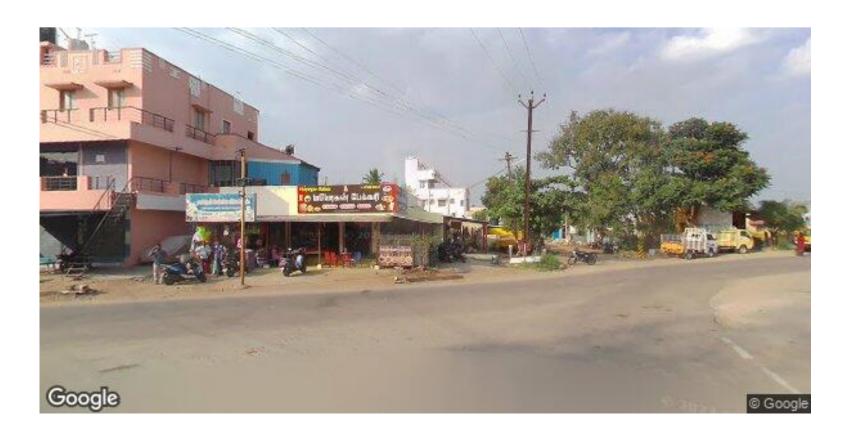
Coordinates: 11.11250, 77.03030

Risk Type: Blind Spot Risk Level: Blind Spot Speed Limit: 10 KM/Hr

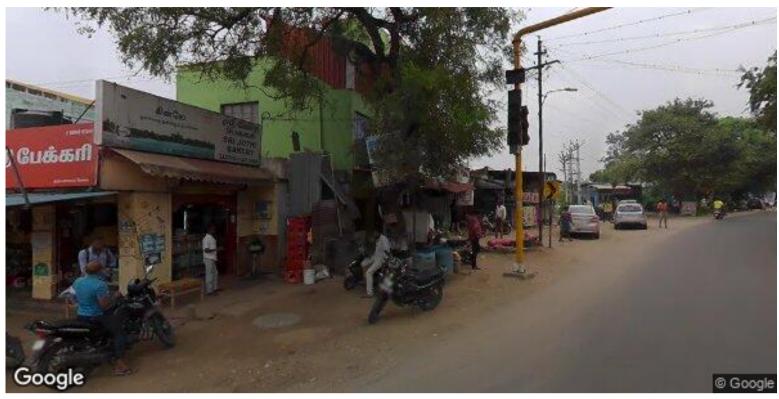
Risk Type: Blind Spot
Risk Level: Blind Spot
Speed Limit: 10 KM/Hr
Coordinates: 11.11256, 77.02901

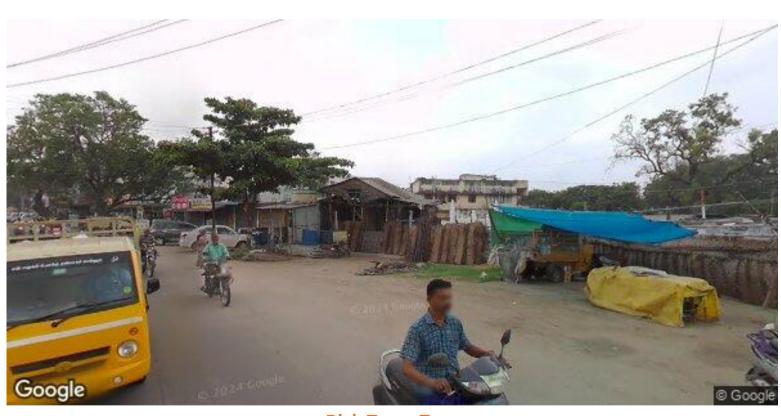
Risk Type: Turn
Risk Level: Medium
Speed Limit: 30 KM/Hr
Coordinates: 11.23309, 77.10252

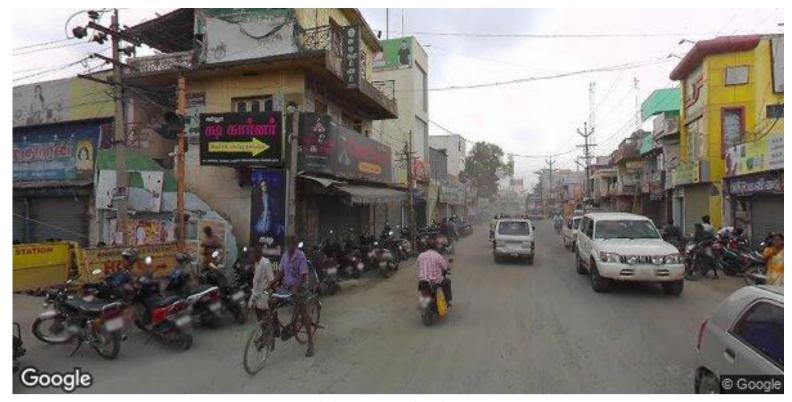
Risk Type: Blind Spot
Risk Level: Blind Spot
Speed Limit: 10 KM/Hr
Coordinates: 11.23330, 77.10347

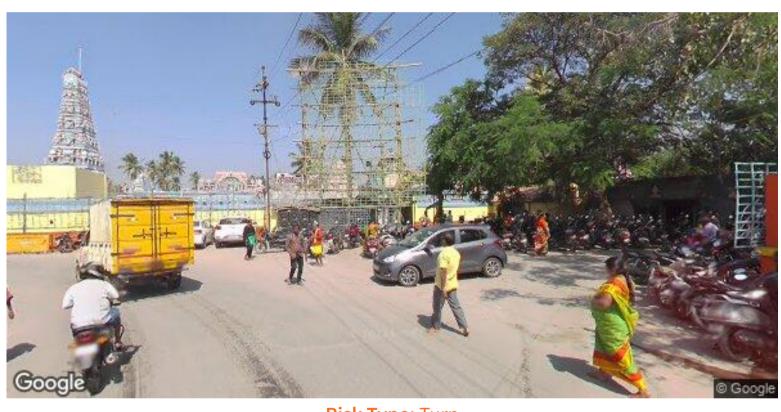
Risk Type: Turn
Risk Level: Medium
Speed Limit: 30 KM/Hr
Coordinates: 11.23489, 77.10353

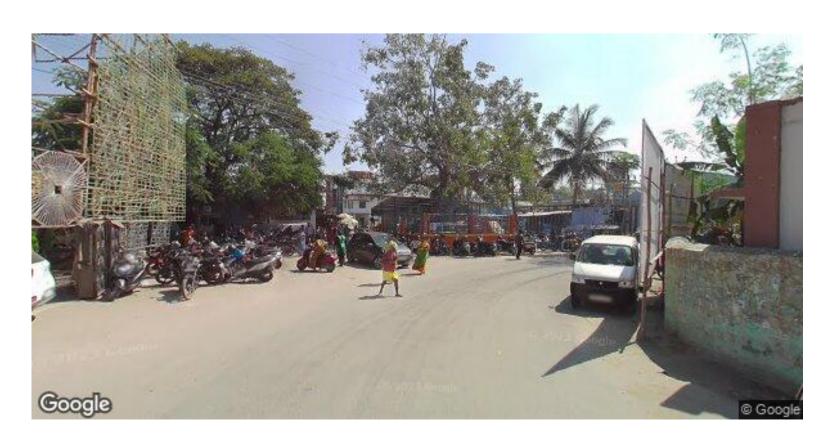
Coordinates: 11.23501, 77.10348

Risk Type: Turn
Risk Level: Medium
Speed Limit: 30 KM/Hr
