JOURNEY RISK MANAGEMENT (JRM) STUDY

Salem Terminal to SRS FUELS

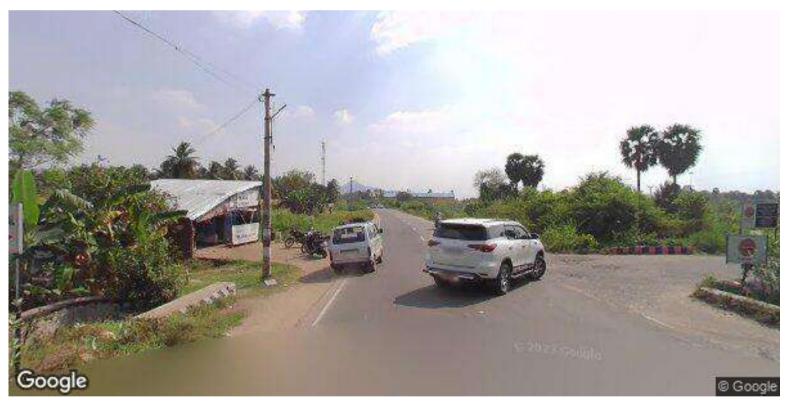
Coordinates: 11.44029, 77.87544

Risk Type: Turn
Risk Level: High
Speed Limit: 15 KM/Hr

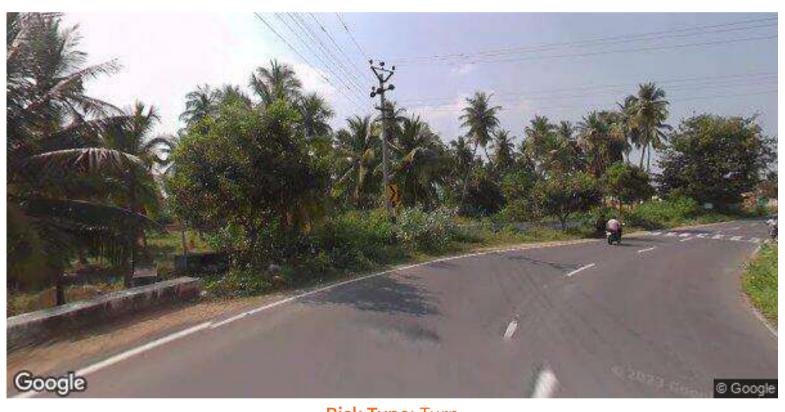
Risk Type: Turn
Risk Level: Medium
Speed Limit: 30 KM/Hr
Coordinates: 11.45348, 77.85706

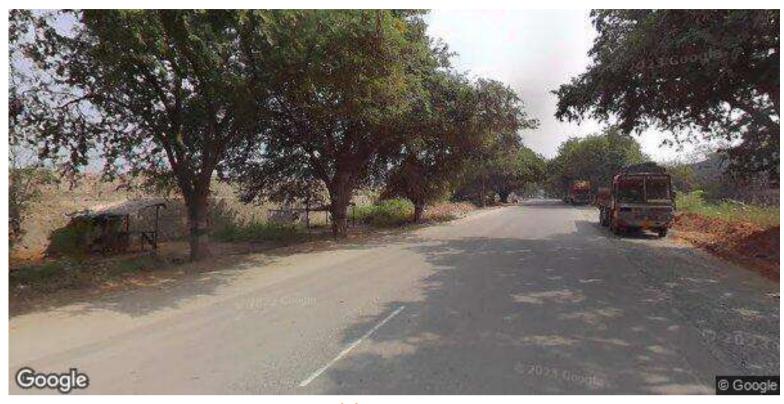
Risk Type: Turn
Risk Level: Medium
Speed Limit: 30 KM/Hr
Coordinates: 11.45697, 77.82719

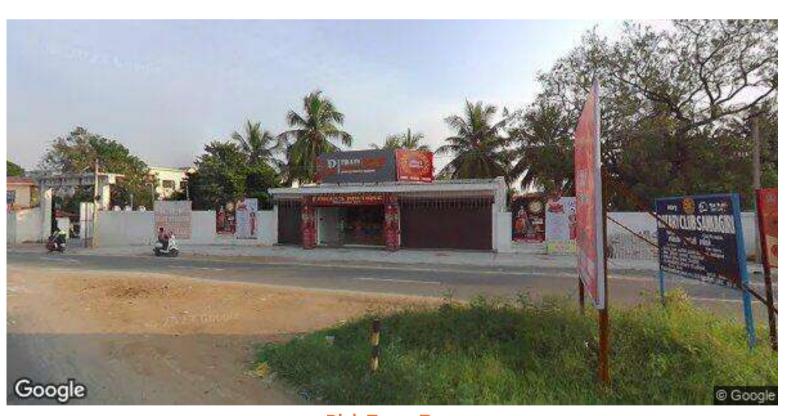
Risk Type: Turn
Risk Level: High
Speed Limit: 15 KM/Hr
Coordinates: 11.45516, 77.81346

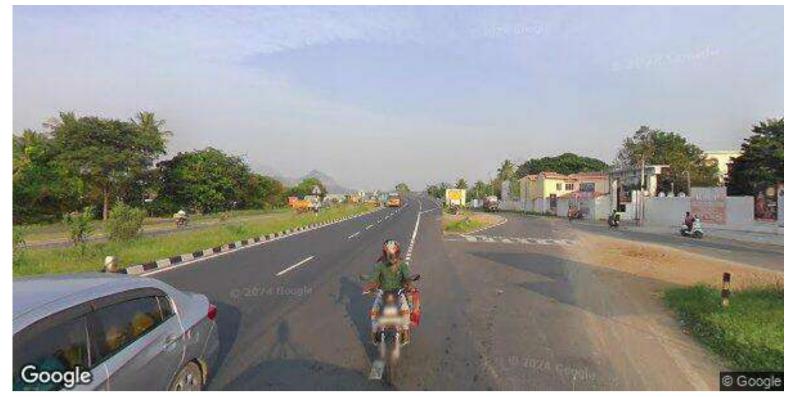
Risk Type: Turn
Risk Level: High
Speed Limit: 15 KM/Hr
Coordinates: 11.45521, 77.81343

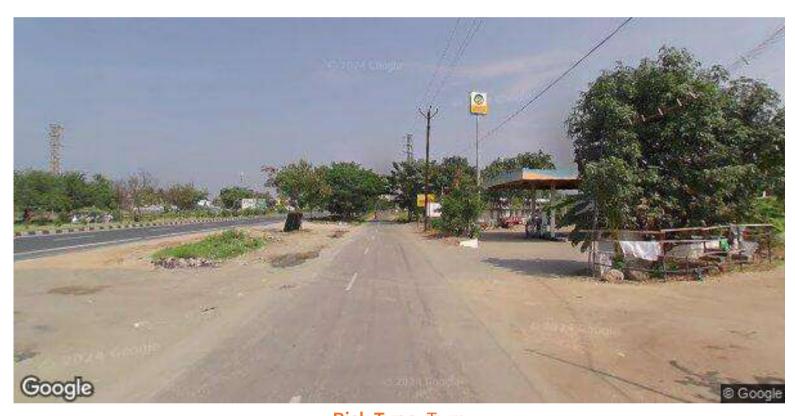
Risk Type: Turn
Risk Level: Medium
Speed Limit: 30 KM/Hr
Coordinates: 11.43994, 77.71111

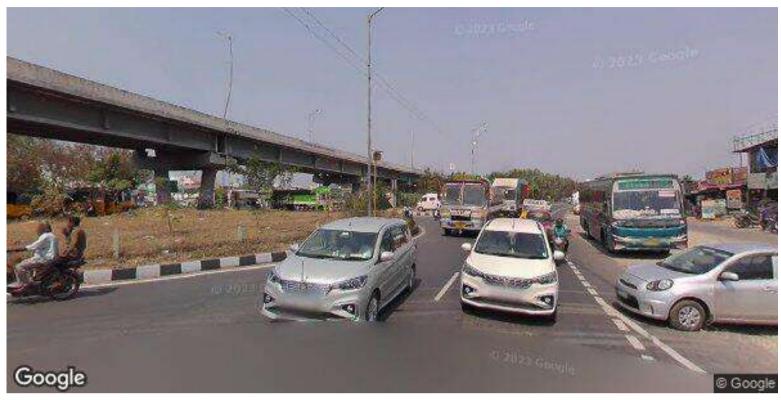
Coordinates: 11.43001, 77.67575

Risk Type: Turn
Risk Level: High
Speed Limit: 15 KM/Hr

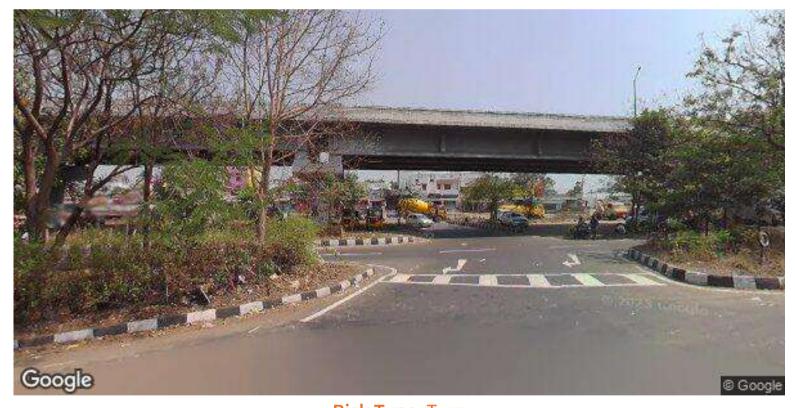
Risk Type: Turn
Risk Level: High
Speed Limit: 15 KM/Hr
Coordinates: 11.43026, 77.67525

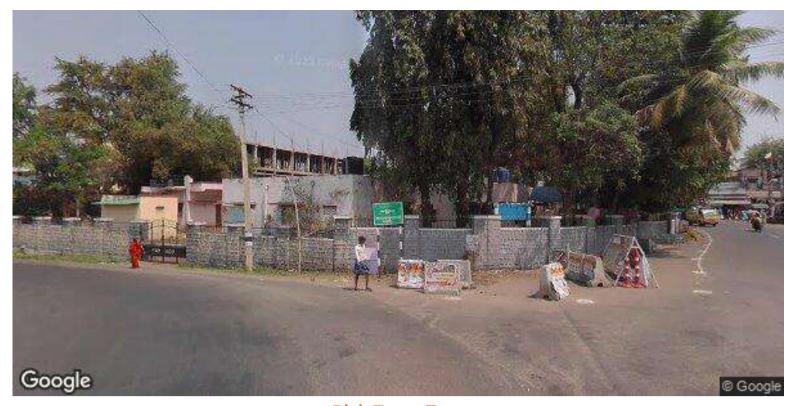
Risk Type: Turn
Risk Level: Medium
Speed Limit: 30 KM/Hr
Coordinates: 11.43865, 77.68226

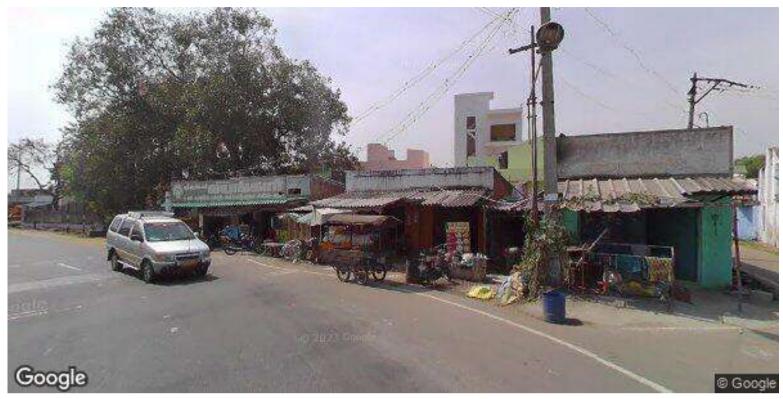
Risk Type: Turn
Risk Level: Medium
Speed Limit: 30 KM/Hr
Coordinates: 11.44107, 77.68189

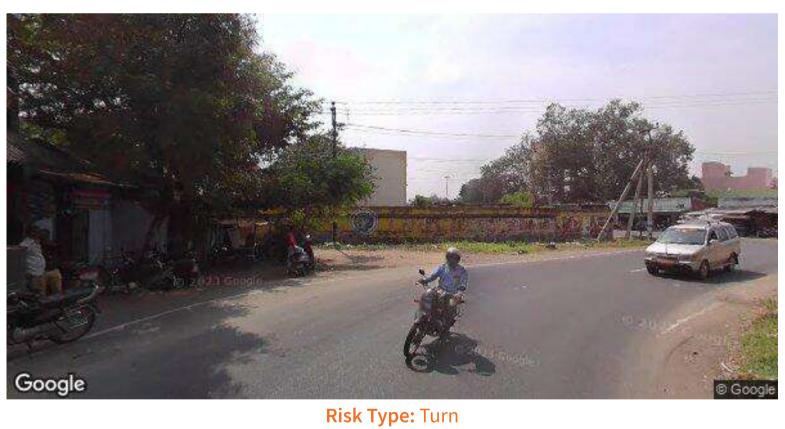
Risk Type. Turn
Risk Level: Medium
Speed Limit: 30 KM/Hr
Coordinates: 11.44122, 77.68219

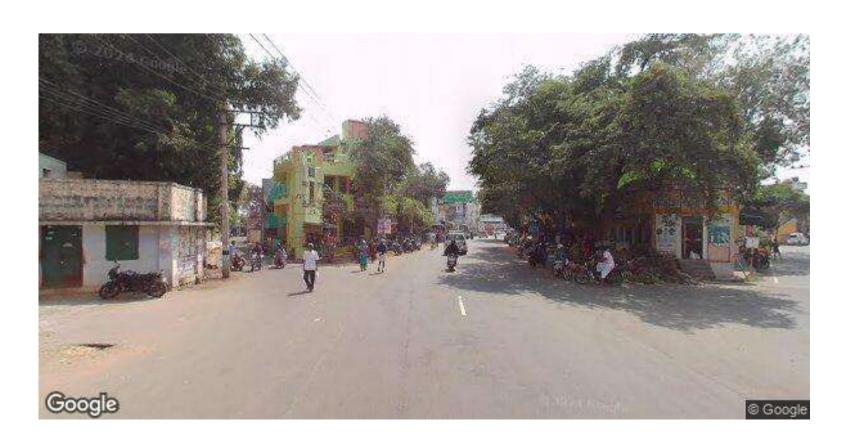
Coordinates: 11.44858, 77.68333

Risk Type: Turn
Risk Level: High
Speed Limit: 15 KM/Hr

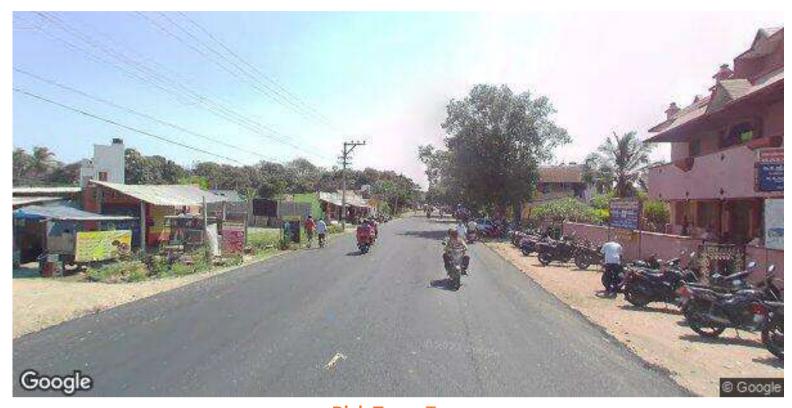
Coordinates: 11.45231, 77.68109

Risk Type: Turn
Risk Level: High
Speed Limit: 15 KM/Hr
