JOURNEY RISK MANAGEMENT (JRM) STUDY

IOCL Coimbatore Terminal to Coco Mettupalayam Adhoc Oxygen Fue

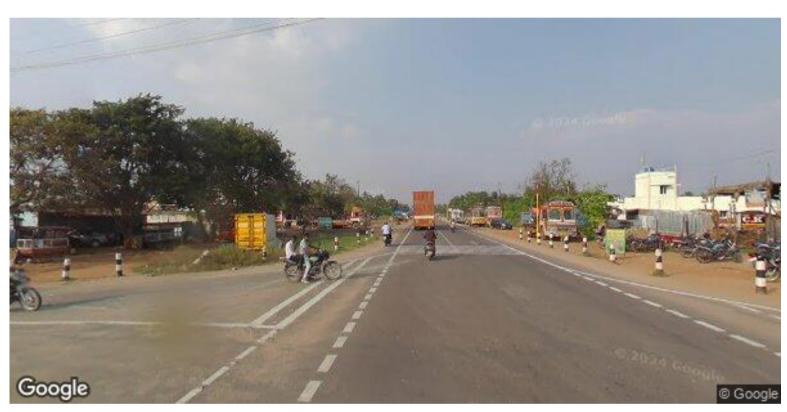
Risk Type: Turn
Risk Level: High
Speed Limit: 15 KM/Hr
Coordinates: 11.03211, 77.07640

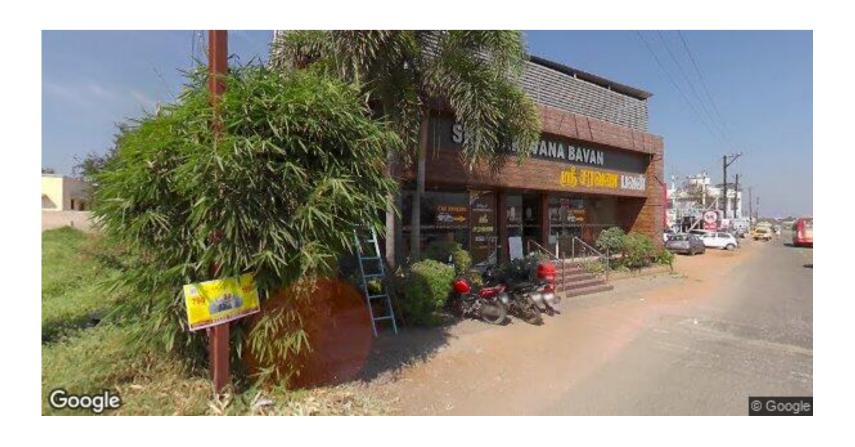
Coordinates: 11.10527, 77.17318

Risk Type: Turn
Risk Level: Medium
Speed Limit: 30 KM/Hr

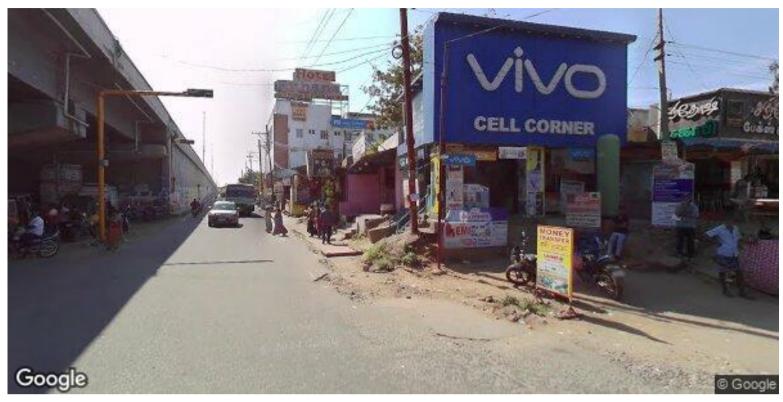
Coordinates: 11.10777, 77.17700

Risk Type: Turn
Risk Level: High
Speed Limit: 15 KM/Hr

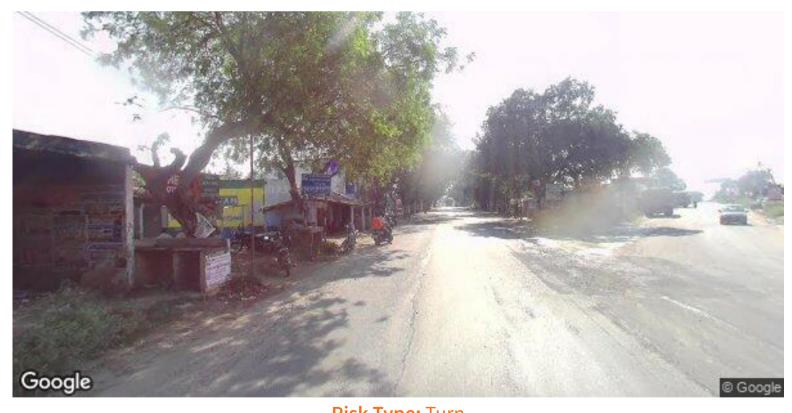
Coordinates: 11.22872, 77.12009

Risk Type: Turn
Risk Level: Medium
Speed Limit: 30 KM/Hr

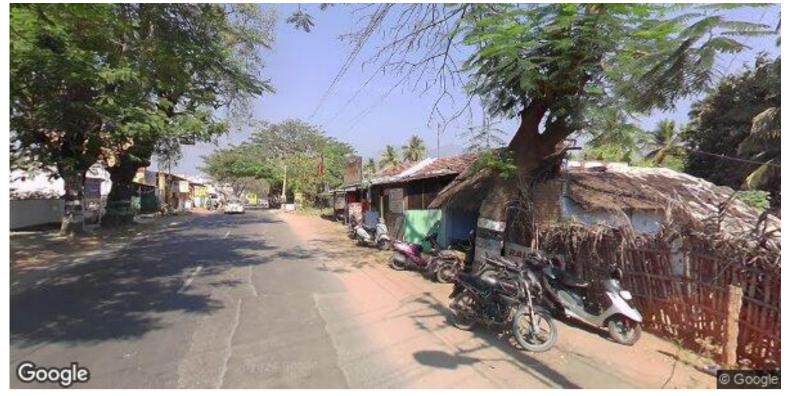
Risk Type: Blind Spot
Risk Level: Blind Spot
Speed Limit: 10 KM/Hr
Coordinates: 11.29801, 76.94539

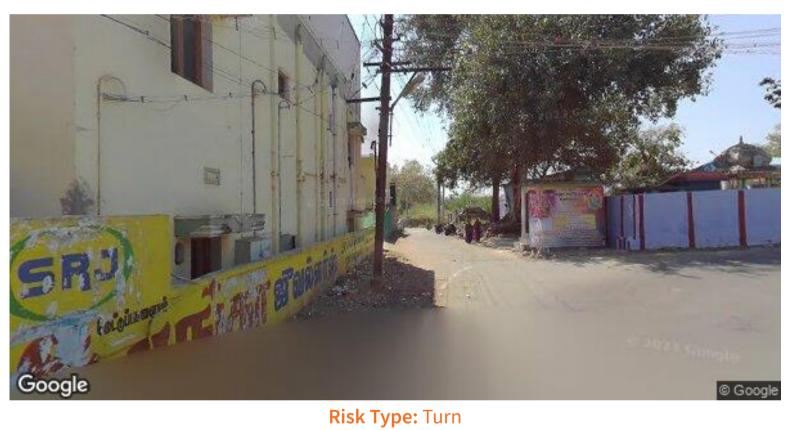
Risk Type: Turn
Risk Level: High
Speed Limit: 15 KM/Hr
Coordinates: 11.29723, 76.94534

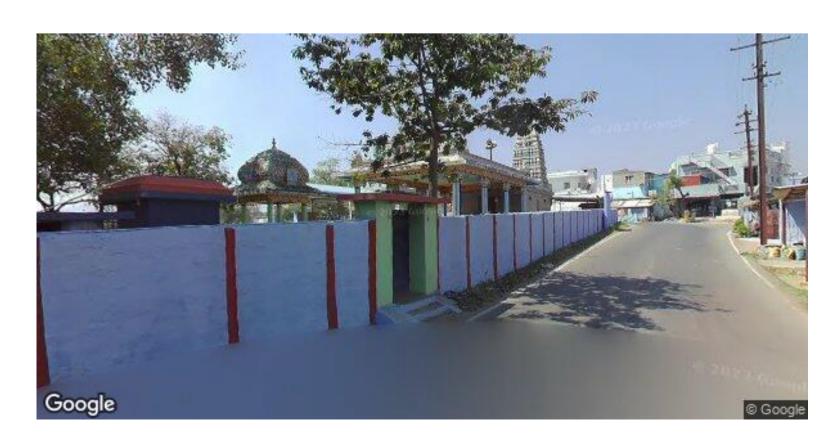
Coordinates: 11.29715, 76.94526

Risk Type: Turn
Risk Level: Medium
Speed Limit: 30 KM/Hr

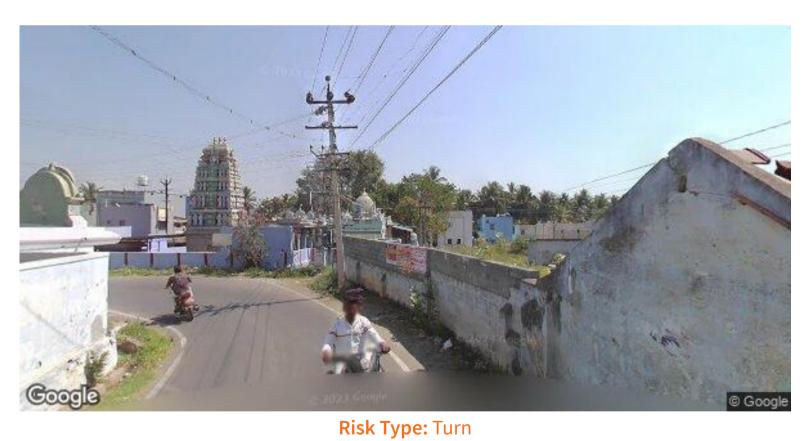
Risk Type. Turn
Risk Level: Medium
Speed Limit: 30 KM/Hr
Coordinates: 11.29680, 76.94474

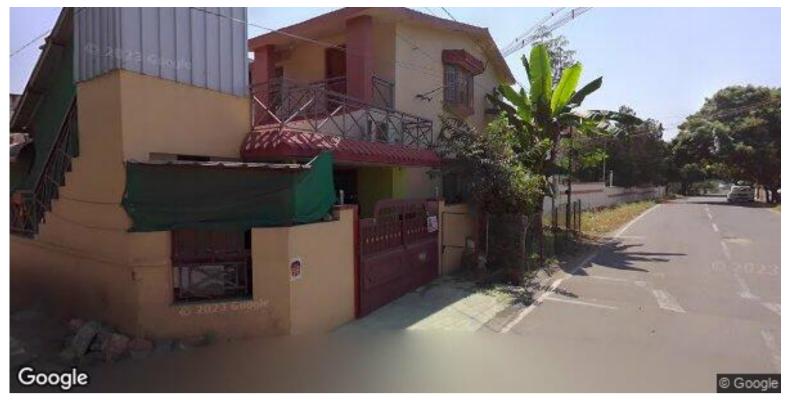
Risk Type: Turn
Risk Level: High
Speed Limit: 15 KM/Hr
Coordinates: 11.29635, 76.94327

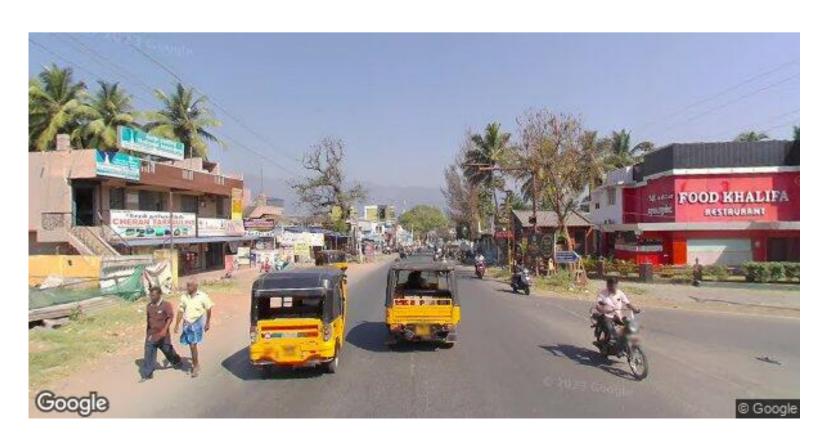
Coordinates: 11.29538, 76.93979

Risk Type: Blind Spot Risk Level: Blind Spot Speed Limit: 10 KM/Hr

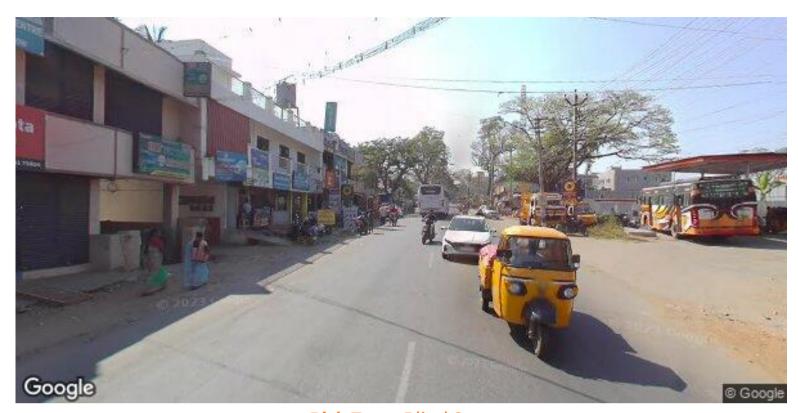
Coordinates: 11.29492, 76.93989

Risk Type: Blind Spot
Risk Level: Blind Spot
Speed Limit: 10 KM/Hr
