JOURNEY RISK MANAGEMENT (JRM) STUDY

IOCL Coimbatore Terminal to Abiga Petro Fills

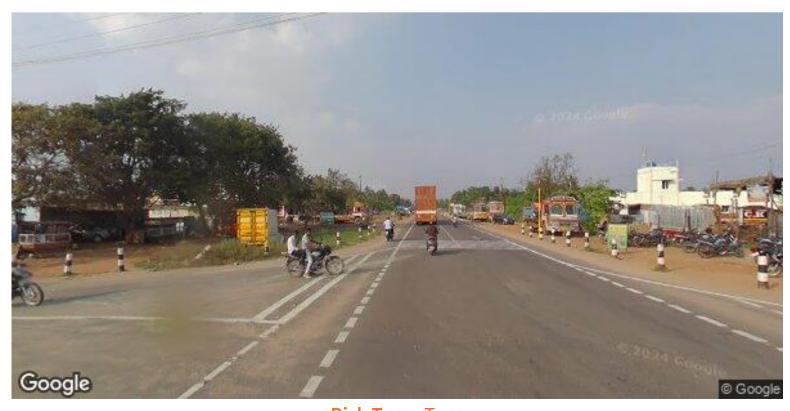
Risk Type: Turn
Risk Level: High

Speed Limit: 15 KM/Hr Coordinates: 11.03211, 77.07640

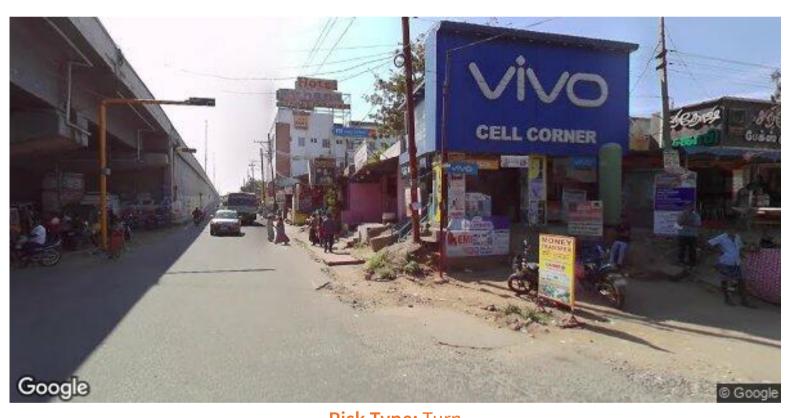
Risk Type: Turn
Risk Level: High
Speed Limit: 15 KM/Hr
Coordinates: 11.10777, 77.17700

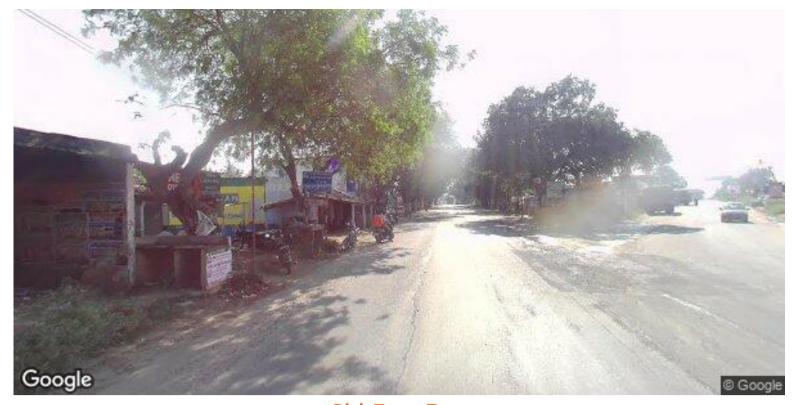
Risk Type: Turn
Risk Level: Medium
Speed Limit: 30 KM/Hr
Coordinates: 11.22872, 77.12009

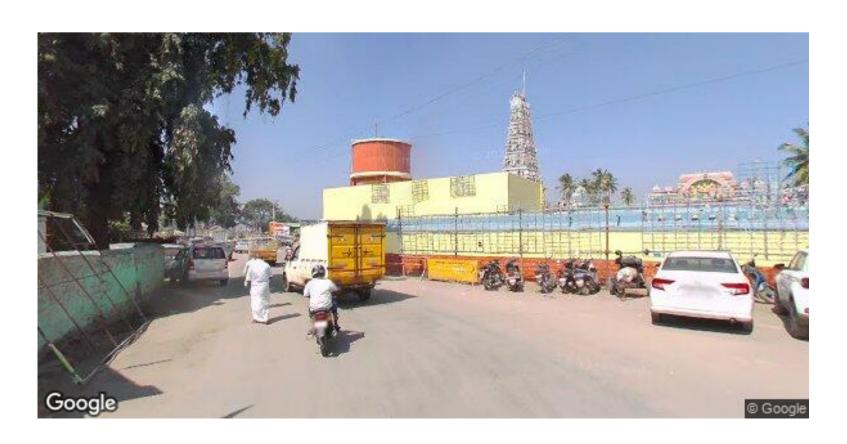
Risk Type: Turn
Risk Level: High
Speed Limit: 15 KM/Hr

Coordinates: 11.23499, 77.10349

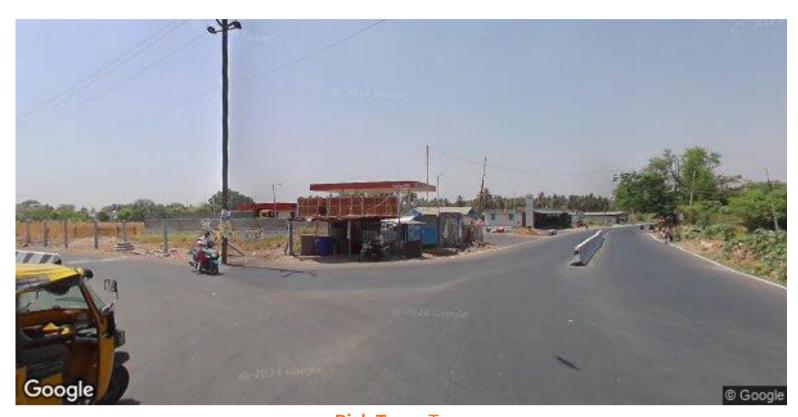
Risk Type: Turn
Risk Level: Medium
Speed Limit: 30 KM/Hr
Coordinates: 11.24077, 77.10268

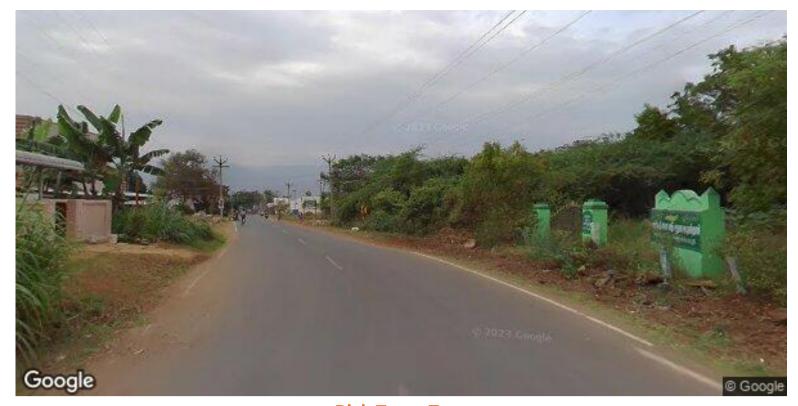
Risk Type: Turn
Risk Level: Medium
Speed Limit: 30 KM/Hr
Coordinates: 11.31097, 77.01227

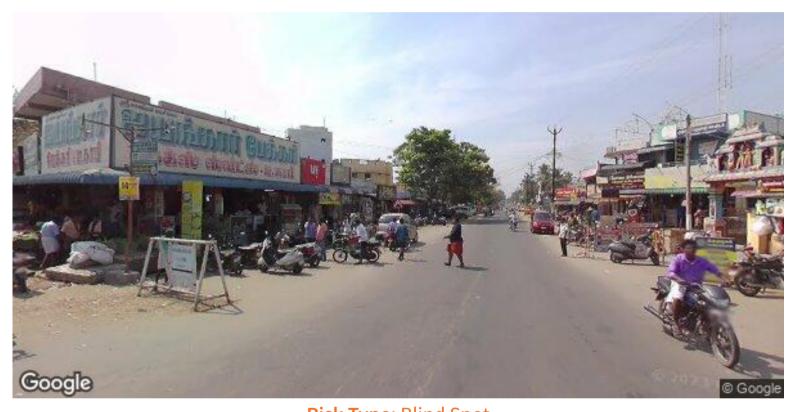
Risk Type: Blind Spot
Risk Level: Blind Spot
Speed Limit: 10 KM/Hr
Coordinates: 11.31822, 77.00654

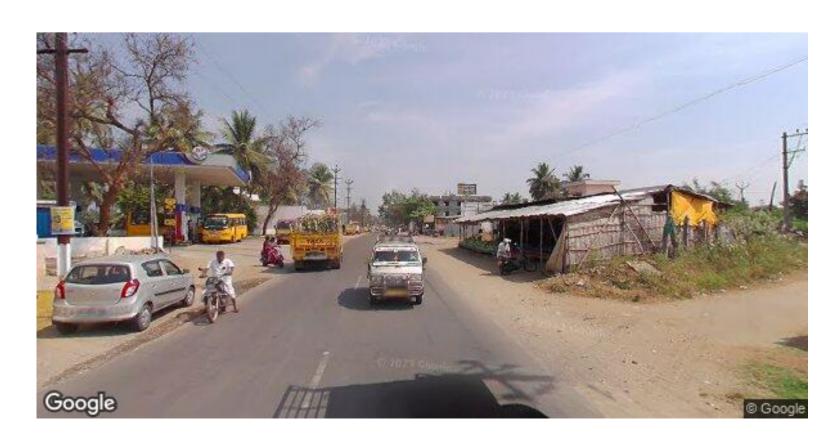
Risk Type: Blind Spot Risk Level: Blind Spot Speed Limit: 10 KM/Hr

Coordinates: 11.31492, 77.00429

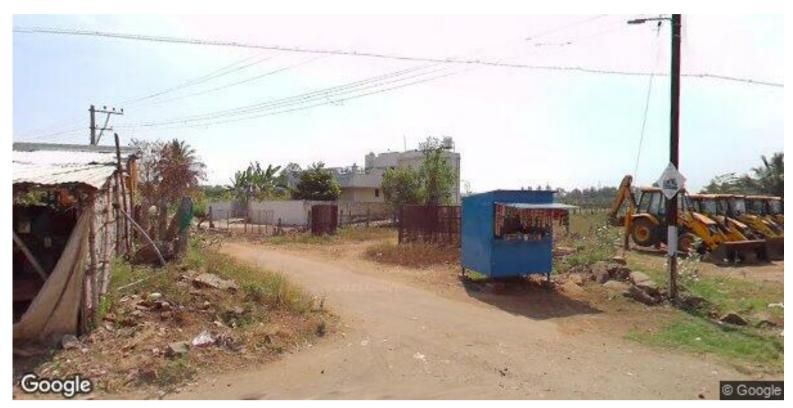
Risk Type: Turn
Risk Level: High
Speed Limit: 15 KM/Hr

Coordinates: 11.31488, 77.00444
