JOURNEY RISK MANAGEMENT (JRM) STUDY

Salem Terminal to ADVG AGENCIES

Route Safety Analysis Report

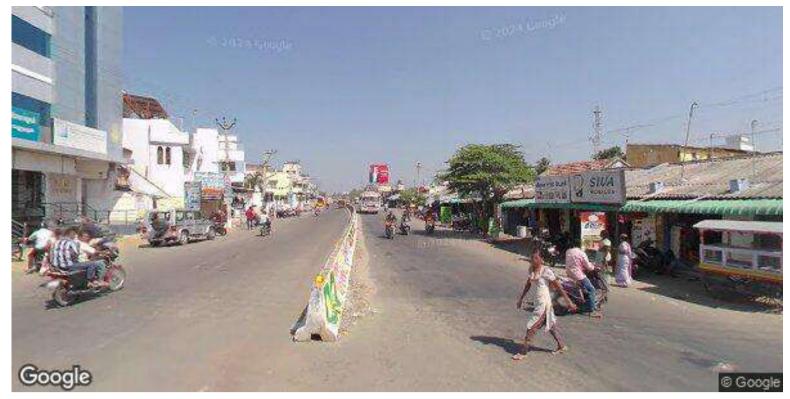
Risk Type: Roundabout
Risk Level: High
Speed Limit: 15 KM/Hr
Coordinates: 11.37086, 77.74828

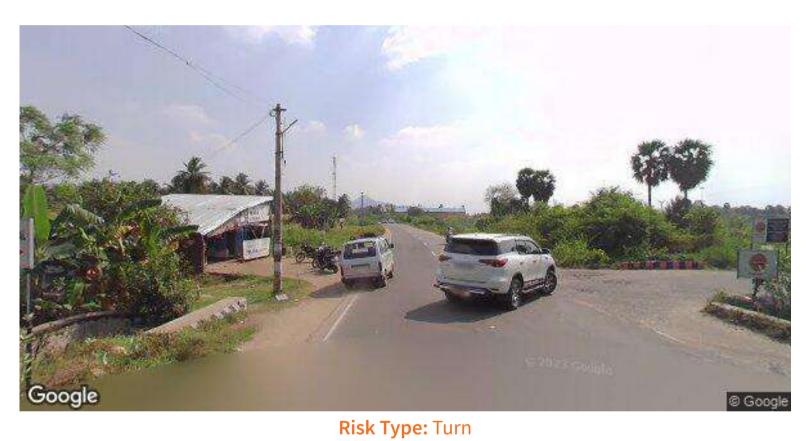
Risk Level: High
Speed Limit: 15 KM/Hr
Coordinates: 11.44029, 77.87544

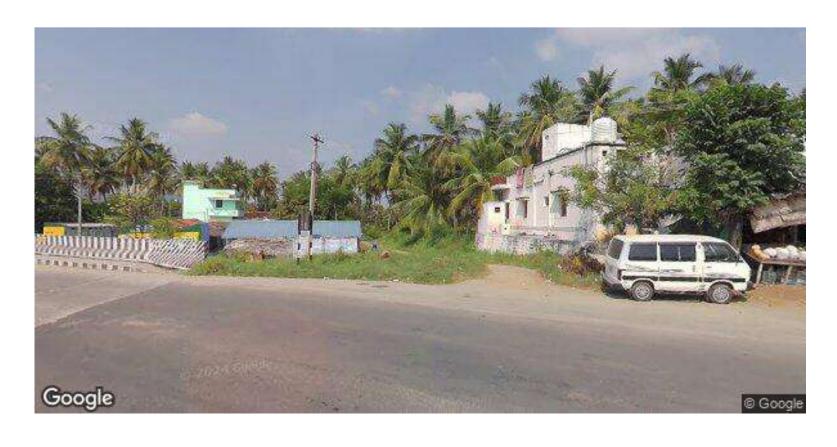
Coordinates: 11.44898, 77.87410

Risk Type: Turn
Risk Level: Medium
Speed Limit: 30 KM/Hr

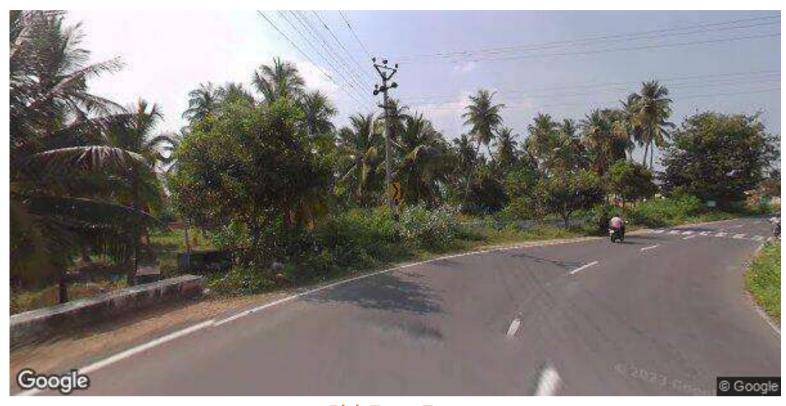
Coordinates: 11.45348, 77.85706

Risk Type: Turn
Risk Level: Medium
Speed Limit: 30 KM/Hr

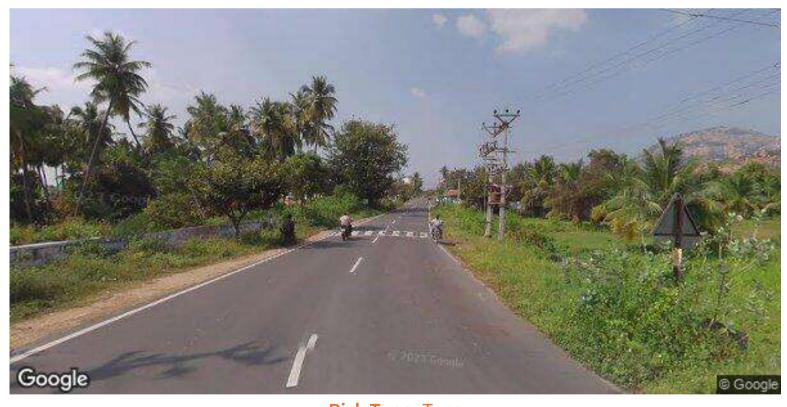
Risk Type: Turn
Risk Level: Medium
Speed Limit: 30 KM/Hr
Coordinates: 11.45352, 77.85698

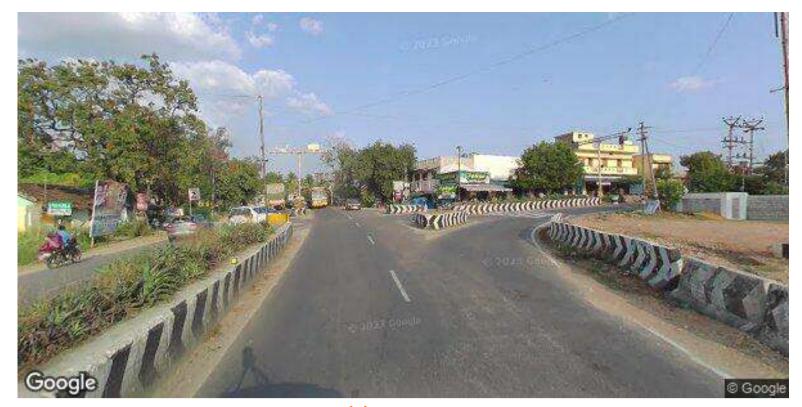
Risk Type: Turn
Risk Level: Medium
Speed Limit: 30 KM/Hr
Coordinates: 11.46318, 77.84913

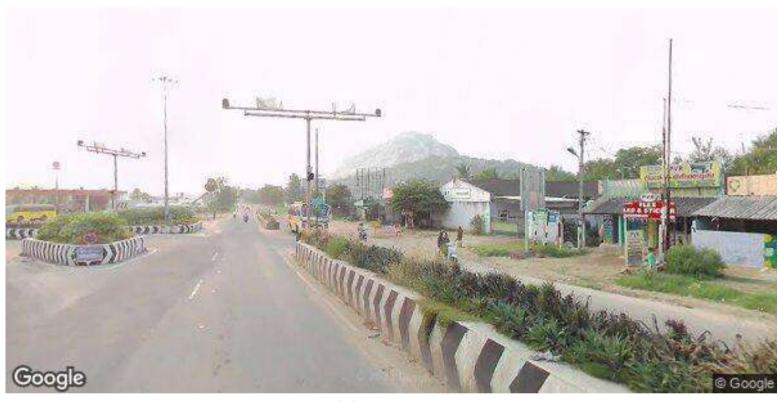
Risk Type: Turn
Risk Level: Medium
Speed Limit: 30 KM/Hr
Coordinates: 11.46312, 77.84886

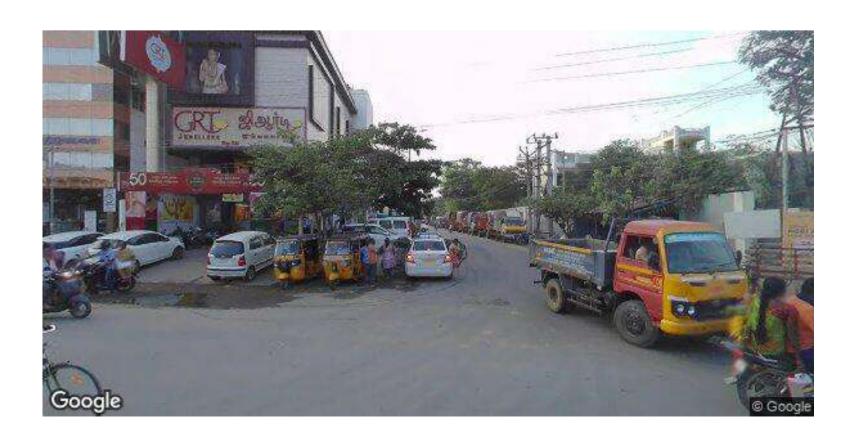
Coordinates: 11.34678, 77.73104

Risk Type: Turn
Risk Level: High
Speed Limit: 15 KM/Hr

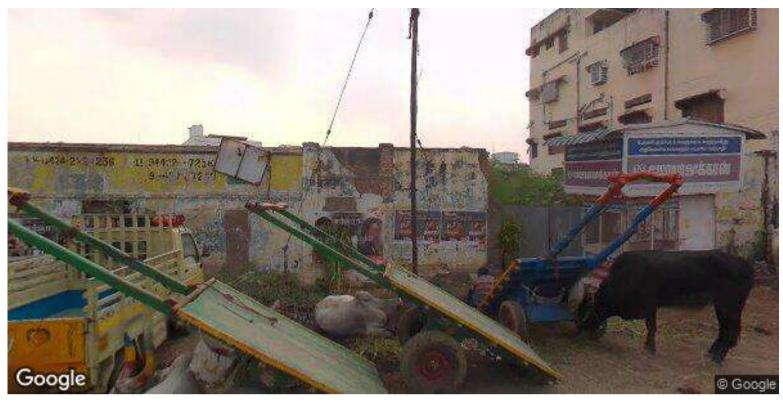
Coordinates: 11.34678, 77.72581

Risk Type: Turn
Risk Level: High
Speed Limit: 15 KM/Hr

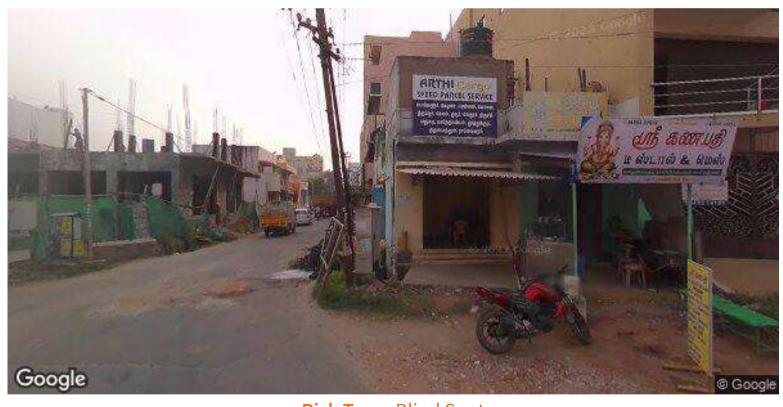
Coordinates: 11.34803, 77.72478

Risk Type: Blind Spot Risk Level: Blind Spot Speed Limit: 10 KM/Hr

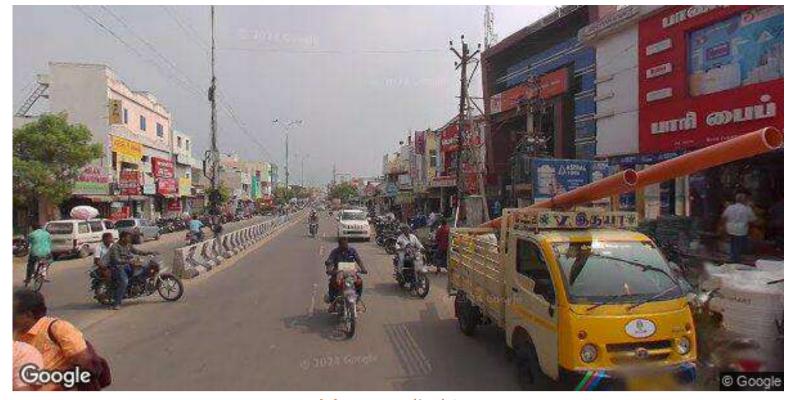
Risk Type: Blind Spot
Risk Level: Blind Spot
Speed Limit: 10 KM/Hr
Coordinates: 11.34625, 77.72392

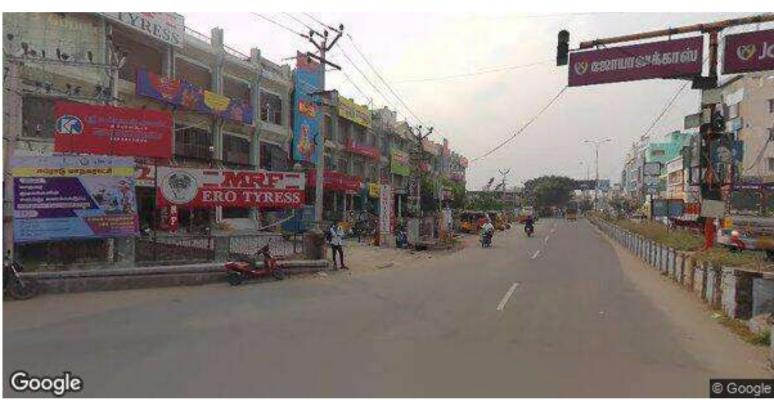
Coordinates: 11.34727, 77.72138

Risk Type: Turn
Risk Level: High
Speed Limit: 15 KM/Hr
