JOURNEY RISK MANAGEMENT (JRM) STUDY

Salem Terminal to SRI SARAVANA AGENCIES PUDUPAI

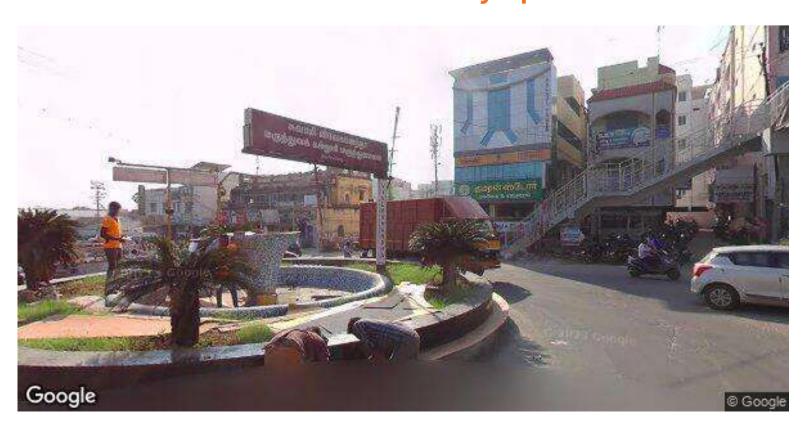
Coordinates: 11.38395, 77.89480

Risk Type: Roundabout
Risk Level: High
Speed Limit: 15 KM/Hr

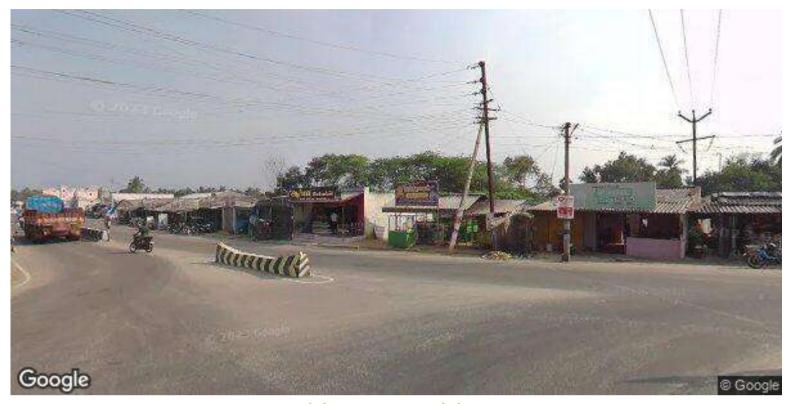
Coordinates: 11.04637, 77.73761

Risk Type: Roundabout
Risk Level: High
Speed Limit: 15 KM/Hr

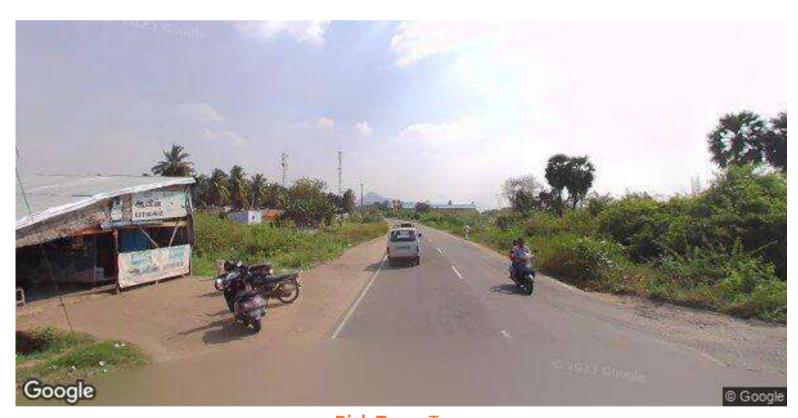
Risk Type: Turn
Risk Level: High
Speed Limit: 15 KM/Hr
Coordinates: 11.44022, 77.87546

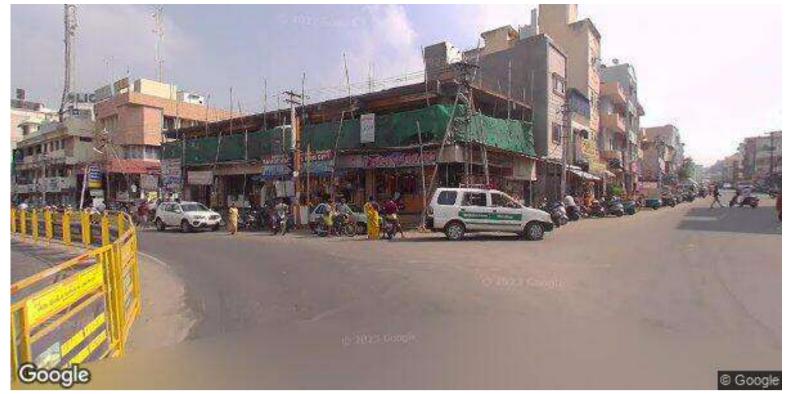
Coordinates: 11.37868, 77.89498

Risk Type: Turn
Risk Level: High
Speed Limit: 15 KM/Hr

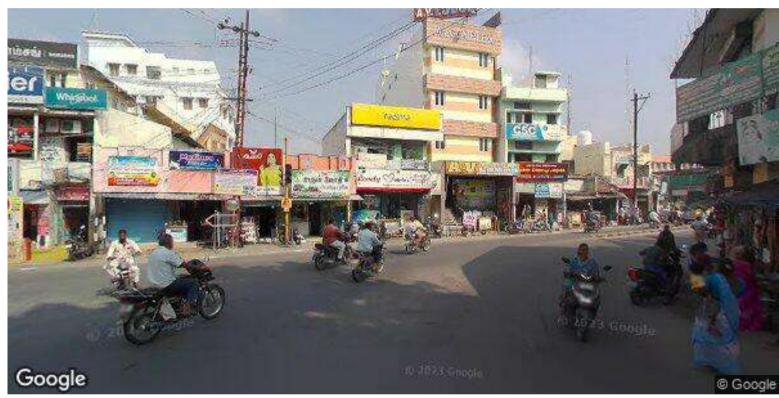
Risk Type: Turn
Risk Level: Medium
Speed Limit: 30 KM/Hr
Coordinates: 11.37842, 77.89452

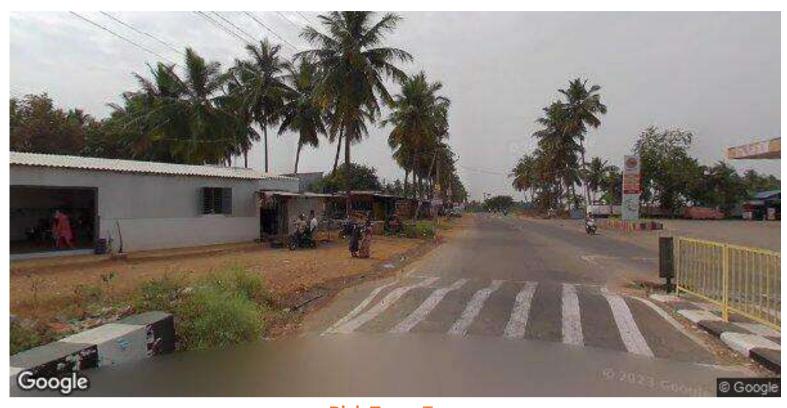
Coordinates: 11.30849, 77.92910

Risk Type: Turn
Risk Level: Medium
Speed Limit: 30 KM/Hr

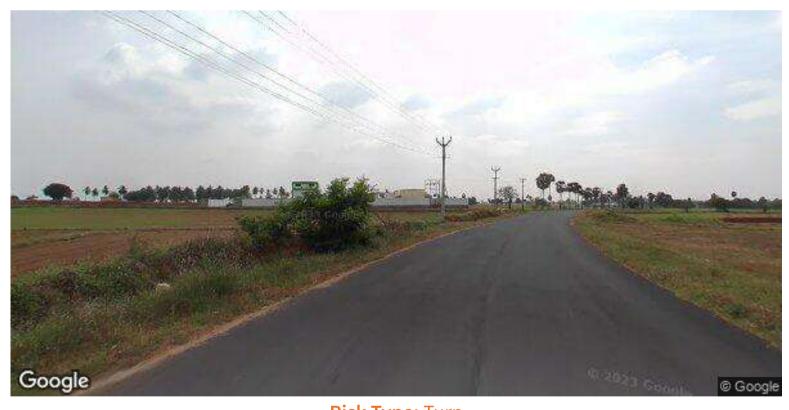
Risk Type: Turn
Risk Level: Medium
Speed Limit: 30 KM/Hr
Coordinates: 11.27840, 77.91284

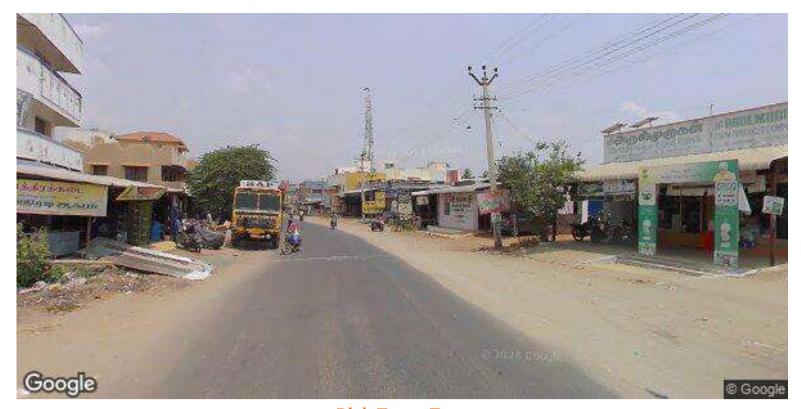
Risk Type: Turn
Risk Level: Medium
Speed Limit: 30 KM/Hr
Coordinates: 11.24172, 77.87357

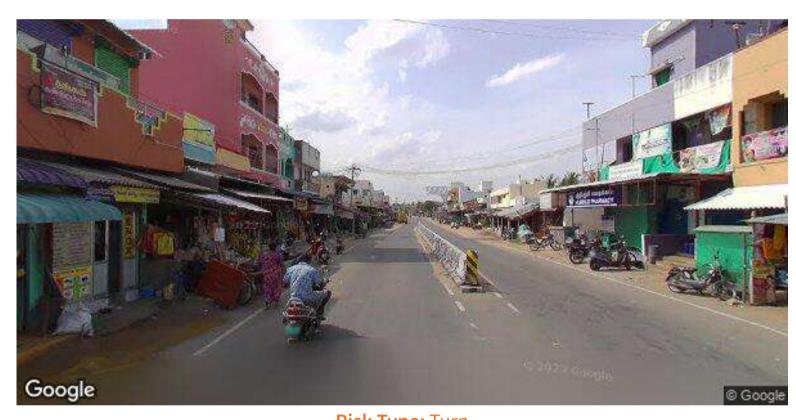
Risk Type: Turn
Risk Level: High
Speed Limit: 15 KM/Hr
Coordinates: 11.24000, 77.87363

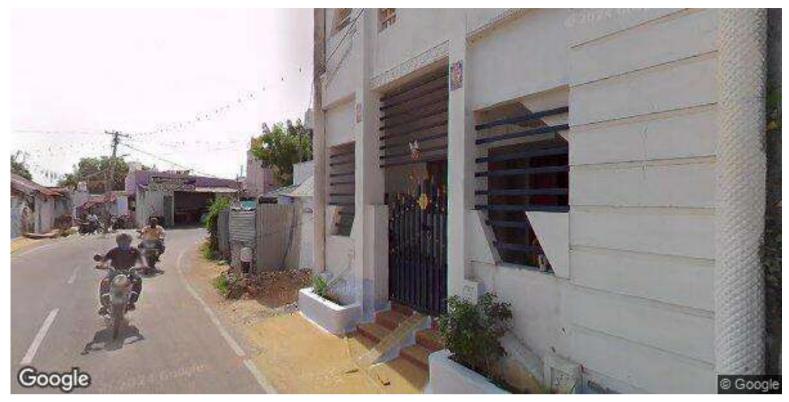
Coordinates: 11.24159, 77.86874

Risk Type: Turn
Risk Level: High
Speed Limit: 15 KM/Hr

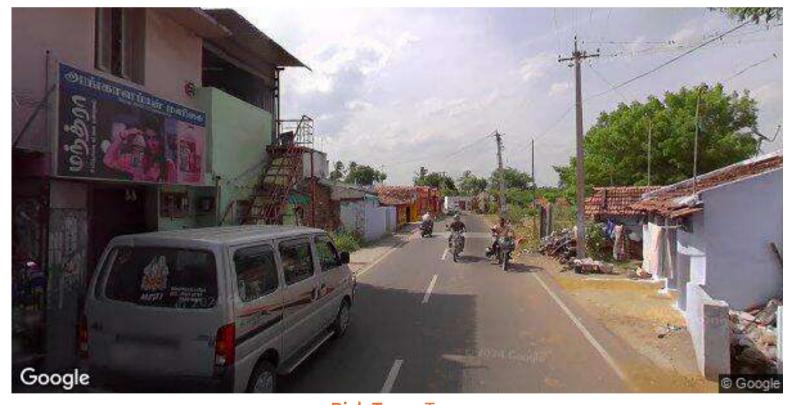
Risk Type: Turn
Risk Level: High
Speed Limit: 15 KM/Hr
Coordinates: 11.24170, 77.86842

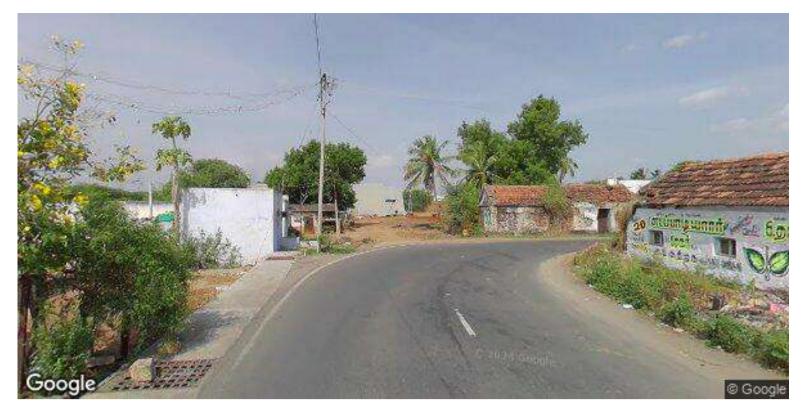
Risk Type: Turn
Risk Level: High
Speed Limit: 15 KM/Hr
Coordinates: 11.24248, 77.86829

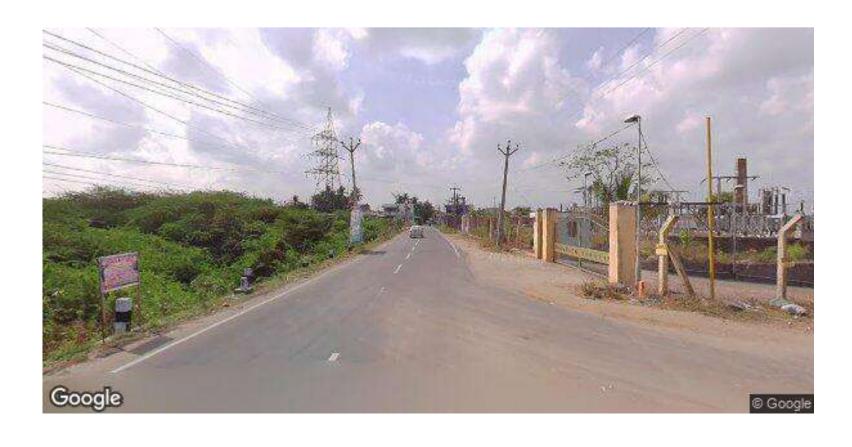
Coordinates: 11.24384, 77.86689

Risk Type: Blind Spot
Risk Level: Blind Spot
Speed Limit: 10 KM/Hr

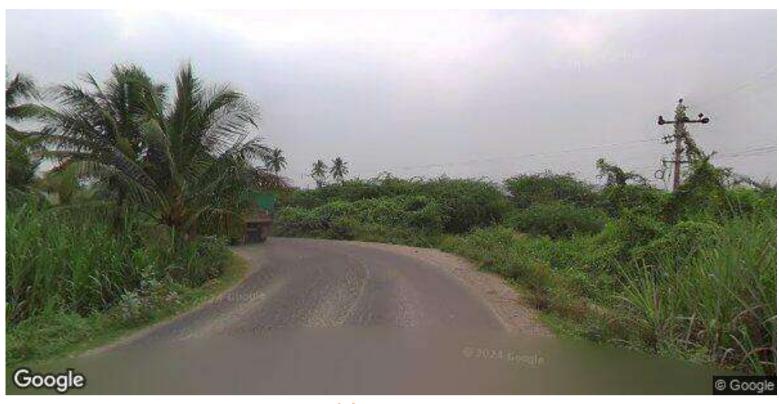
Risk Type: Turn
Risk Level: High
Speed Limit: 15 KM/Hr
Coordinates: 11.24103, 77.86020

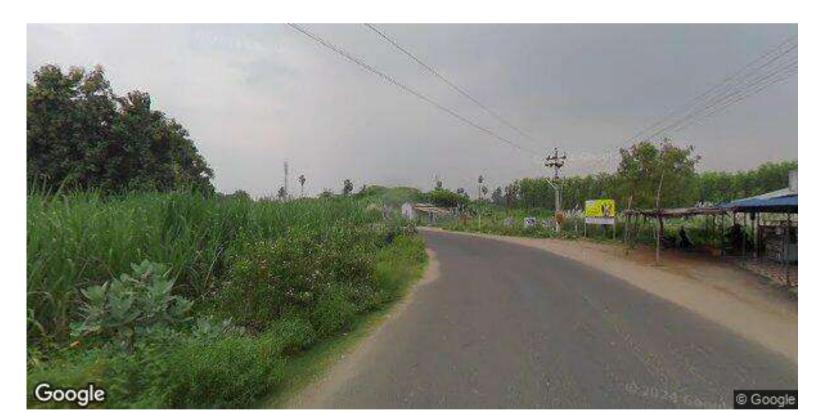
Risk Type: Turn
Risk Level: High
Speed Limit: 15 KM/Hr
Coordinates: 11.24200, 77.85882

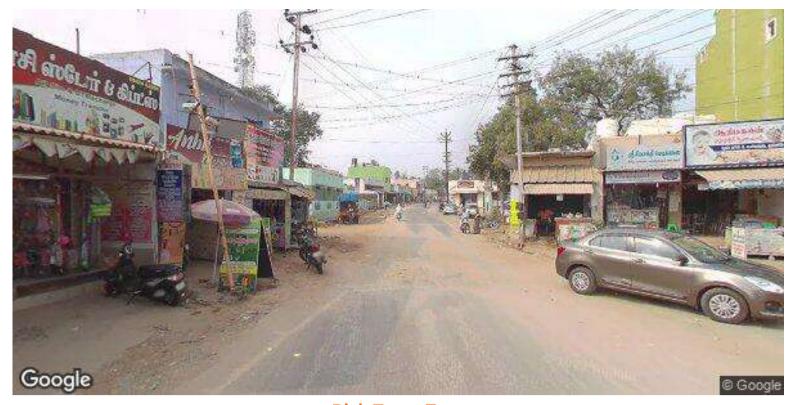
Risk Type: Turn
Risk Level: High
Speed Limit: 15 KM/Hr
Coordinates: 11.18856, 77.77110

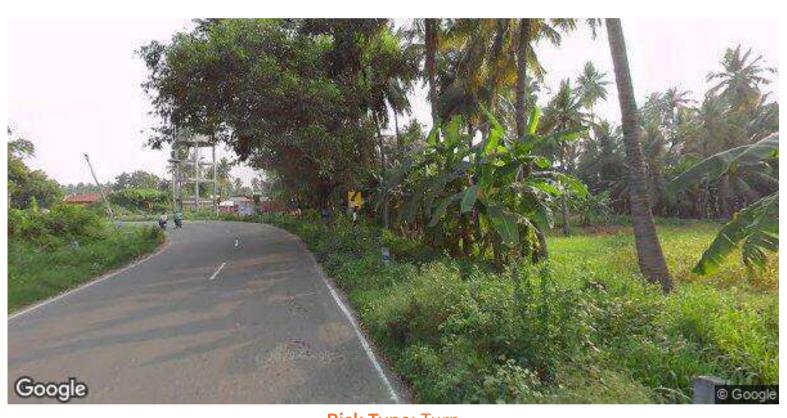
Risk Type: Turn
Risk Level: Medium
Speed Limit: 30 KM/Hr
Coordinates: 11.16441, 77.77358

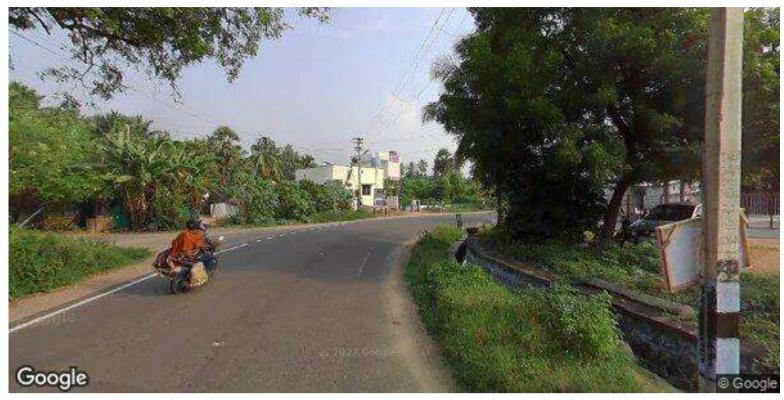
Coordinates: 11.16377, 77.77421

Risk Type: Turn
Risk Level: High
Speed Limit: 15 KM/Hr

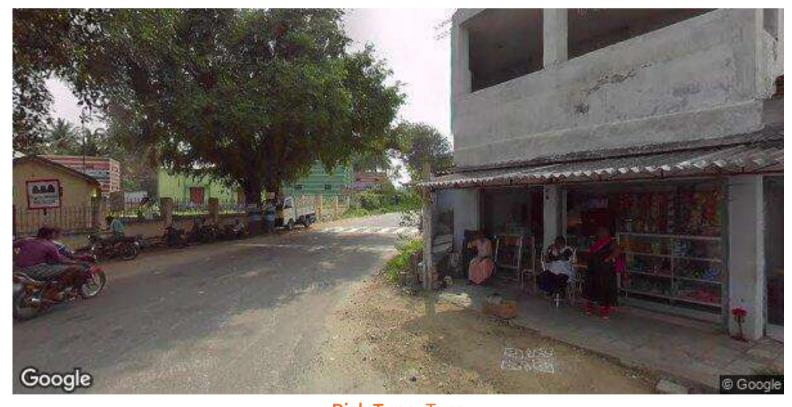
Risk Type: Turn
Risk Level: Medium
Speed Limit: 30 KM/Hr
Coordinates: 11.13664, 77.76524

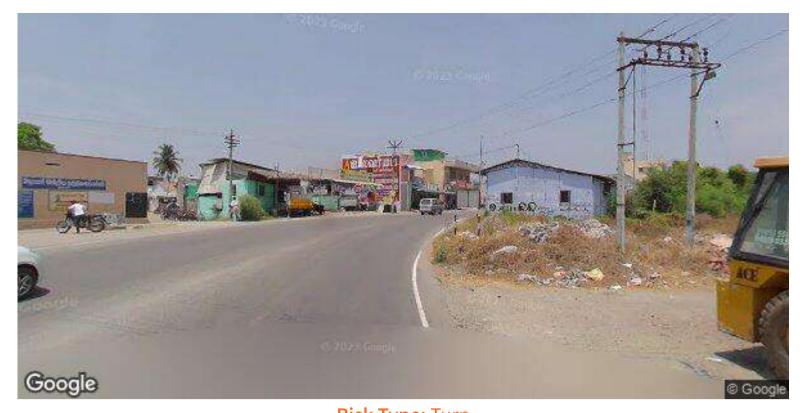
Risk Type: Turn
Risk Level: Medium
Speed Limit: 30 KM/Hr
Coordinates: 11.04699, 77.73747

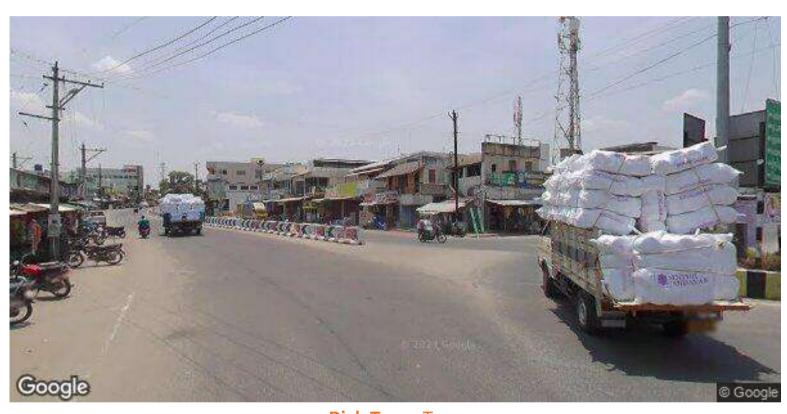
Risk Type: Turn
Risk Level: High
Speed Limit: 15 KM/Hr
Coordinates: 11.04515, 77.73621

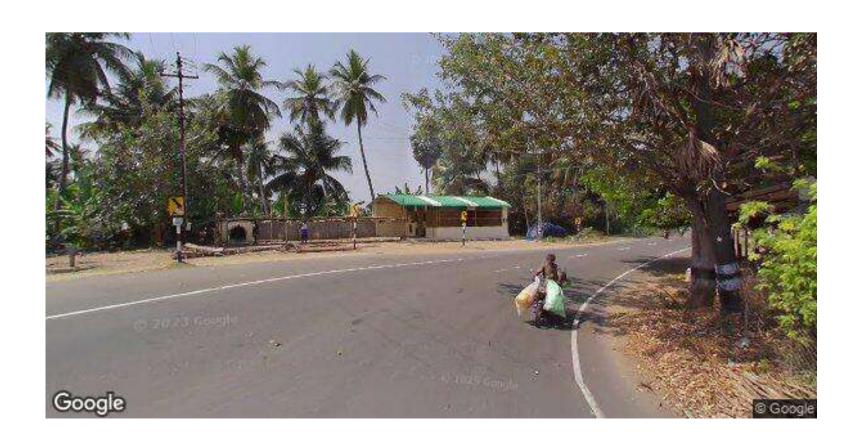
Coordinates: 10.99026, 77.72511

Risk Type: Turn
Risk Level: High
Speed Limit: 15 KM/Hr

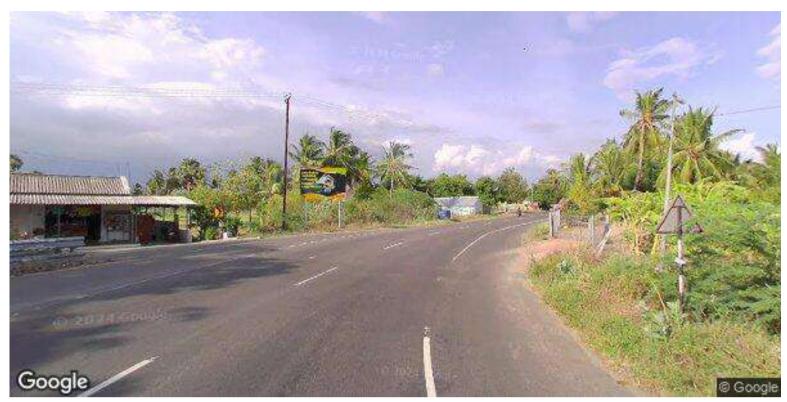
Coordinates: 10.98974, 77.72388

Risk Type: Turn
Risk Level: High
Speed Limit: 15 KM/Hr

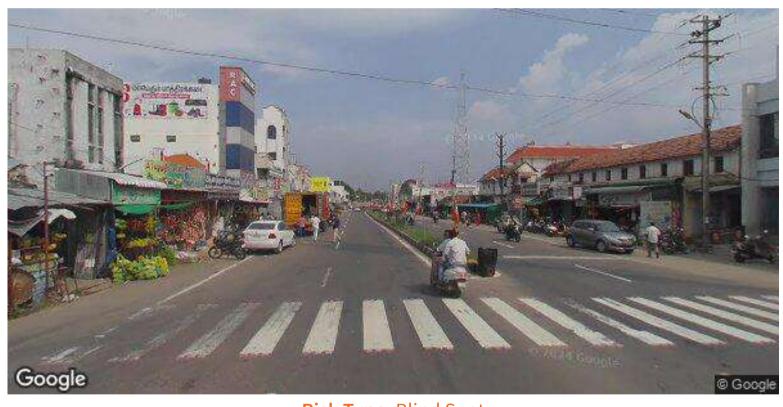
Coordinates: 10.94597, 77.71319

Risk Type: Blind Spot
Risk Level: Blind Spot
Speed Limit: 10 KM/Hr

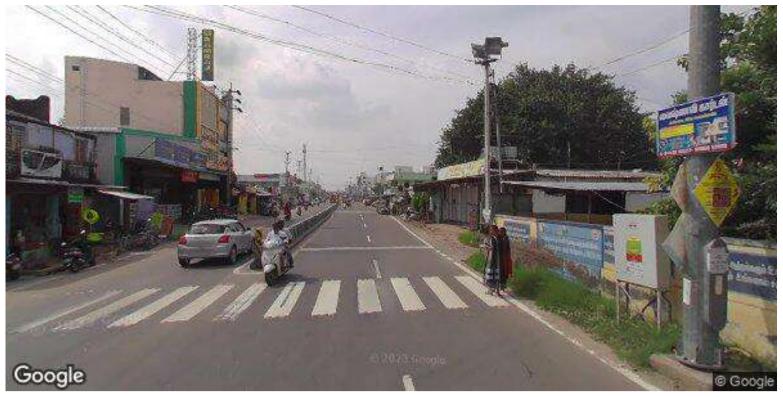
Risk Type: Turn
Risk Level: High
Speed Limit: 15 KM/Hr
Coordinates: 10.94571, 77.71574

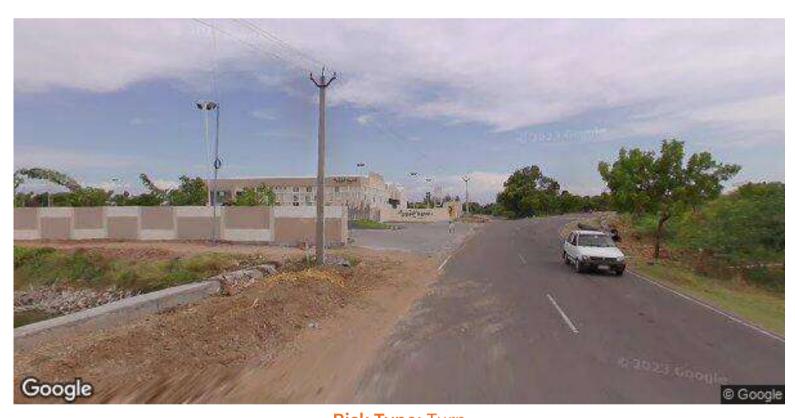
Risk Type: Turn
Risk Level: Medium
Speed Limit: 30 KM/Hr
Coordinates: 10.92251, 77.72391
