JOURNEY RISK MANAGEMENT (JRM) STUDY

IOCL Coimbatore Terminal to Sri Moorthy Agencies

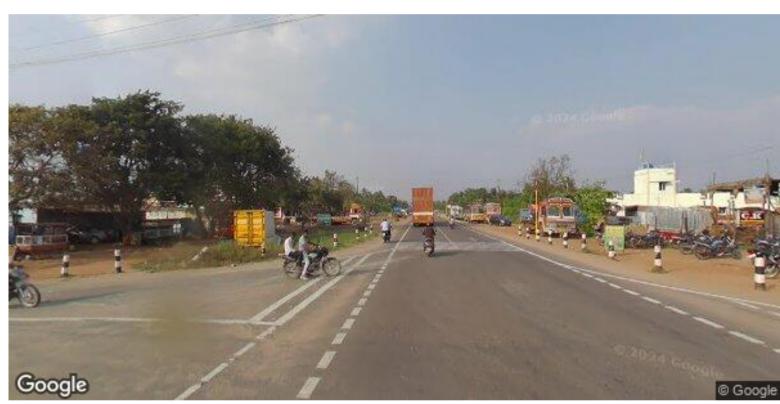
Coordinates: 11.03211, 77.07640

Risk Type: Turn
Risk Level: High
Speed Limit: 15 KM/Hr

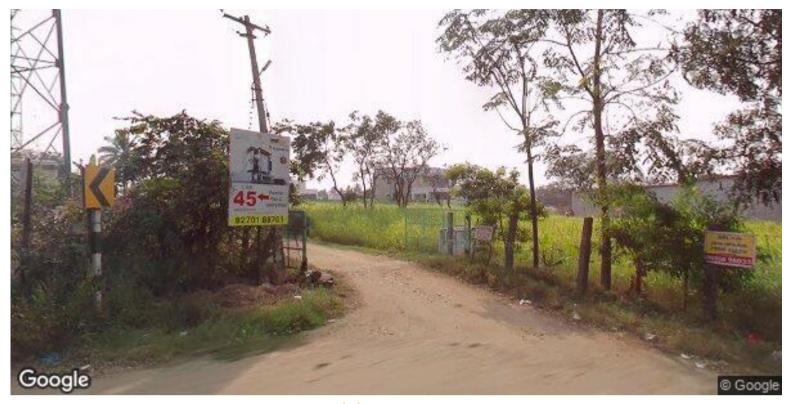
Coordinates: 11.05181, 77.07696

Risk Type: Turn
Risk Level: High
Speed Limit: 15 KM/Hr

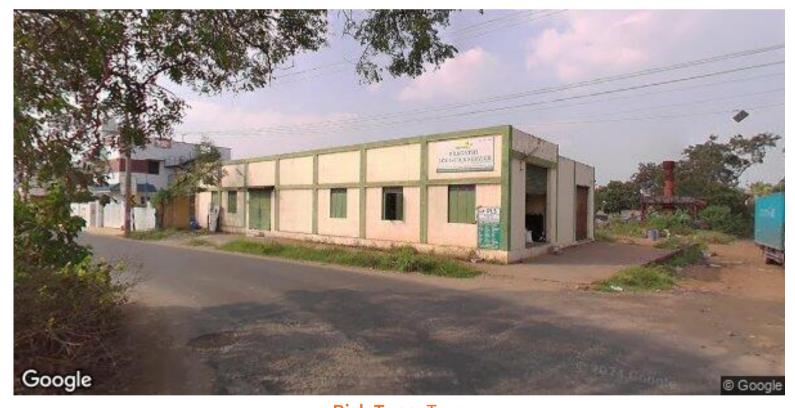
Coordinates: 11.05222, 77.07690

Risk Type: Turn
Risk Level: High
Speed Limit: 15 KM/Hr

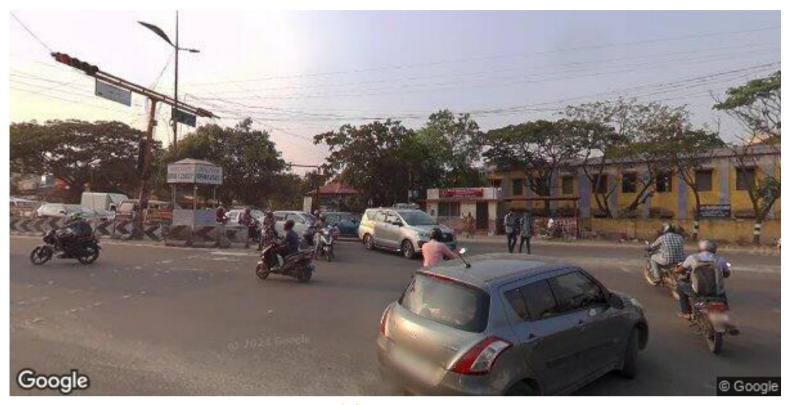
Coordinates: 11.05529, 77.06566

Risk Type: Turn
Risk Level: High
Speed Limit: 15 KM/Hr

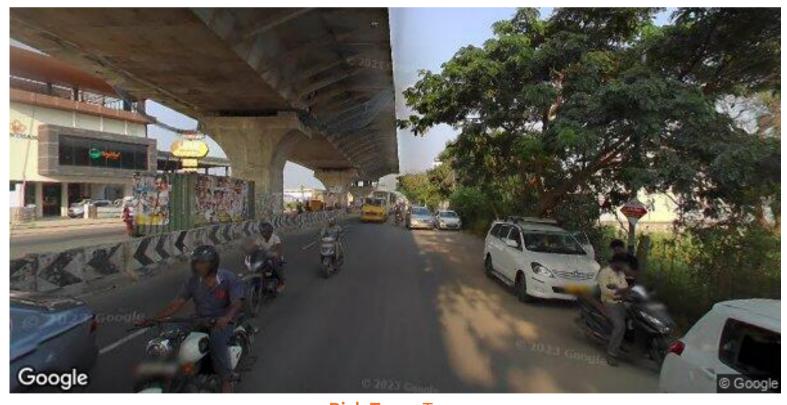
Risk Type: Turn
Risk Level: High
Speed Limit: 15 KM/Hr
Coordinates: 11.04195, 77.04309

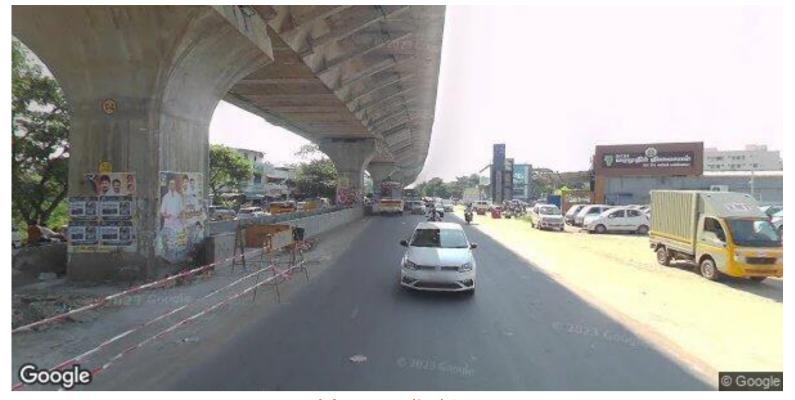
Coordinates: 11.04203, 77.04303

Risk Type: Blind Spot Risk Level: Blind Spot Speed Limit: 10 KM/Hr

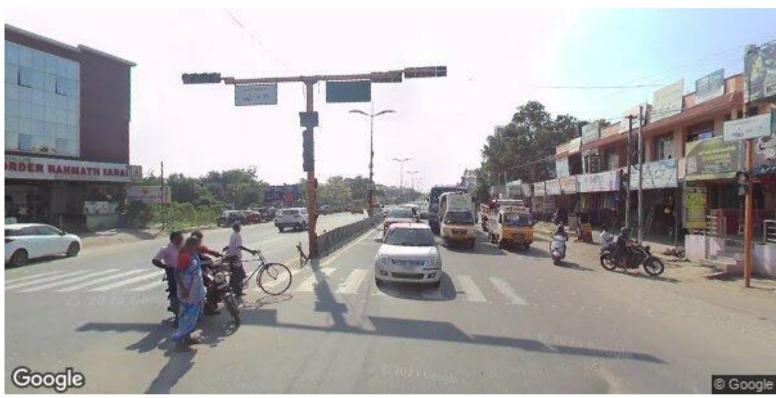
Risk Type: Blind Spot
Risk Level: Blind Spot
Speed Limit: 10 KM/Hr
Coordinates: 11.04636, 77.05199

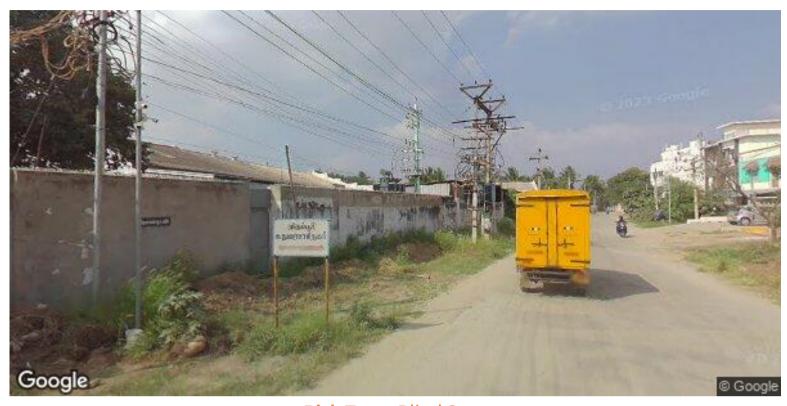
Coordinates: 11.05130, 77.04643

Risk Type: Blind Spot Risk Level: Blind Spot Speed Limit: 10 KM/Hr

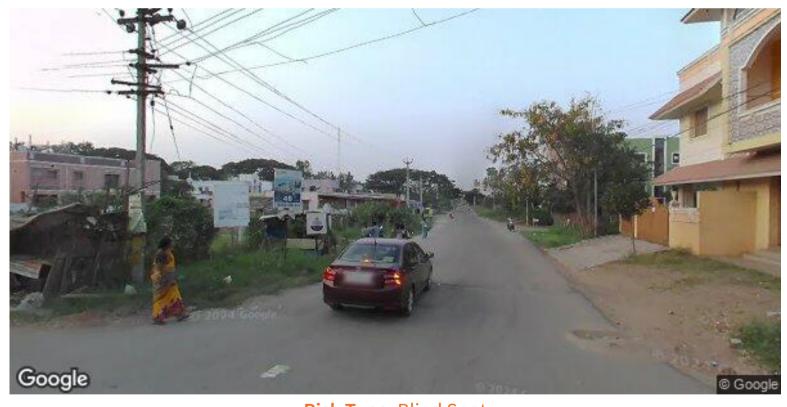
Coordinates: 11.05528, 77.04708

Risk Type: Blind Spot Risk Level: Blind Spot Speed Limit: 10 KM/Hr

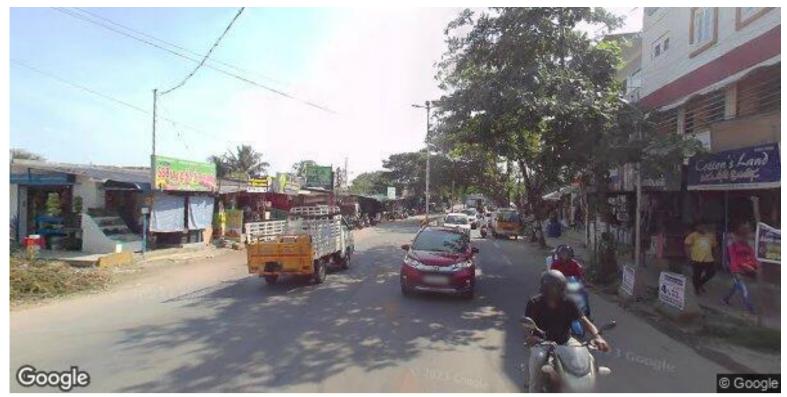
Risk Type: Turn
Risk Level: High
Speed Limit: 15 KM/Hr
Coordinates: 11.05356, 77.03890

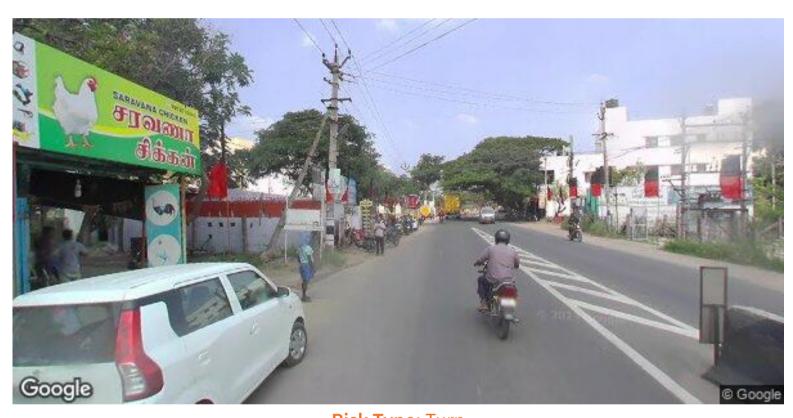
Risk Type: Turn
Risk Level: Medium
Speed Limit: 30 KM/Hr
Coordinates: 11.05427, 77.03879

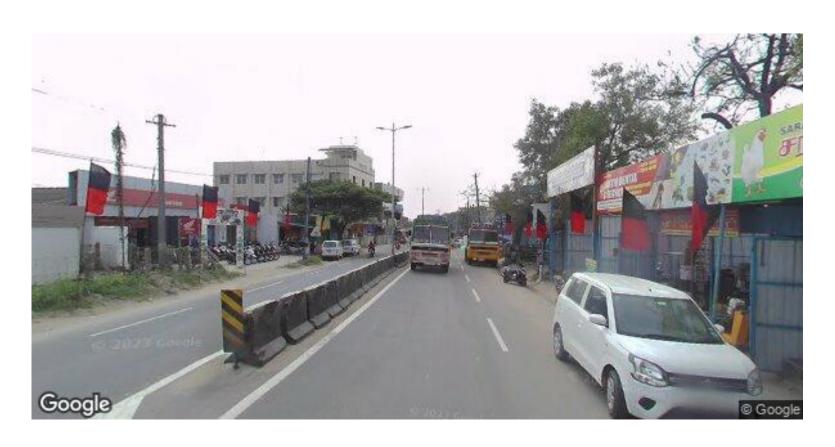
Coordinates: 11.05431, 77.03881

Risk Type: Turn
Risk Level: Medium
Speed Limit: 30 KM/Hr

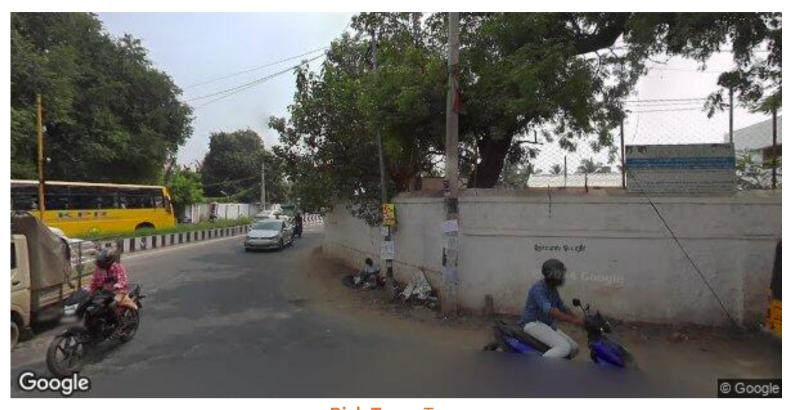
Risk Type: Turn
Risk Level: Medium
Speed Limit: 30 KM/Hr
Coordinates: 11.07800, 77.03694

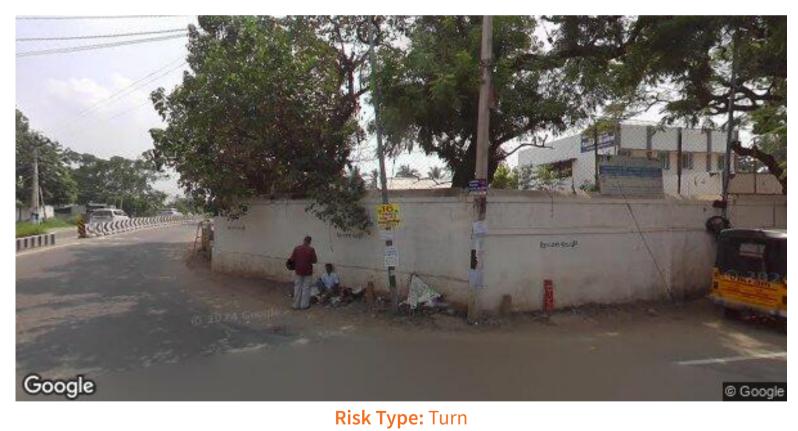
Risk Level: Medium
Speed Limit: 30 KM/Hr
Coordinates: 11.07803, 77.03694

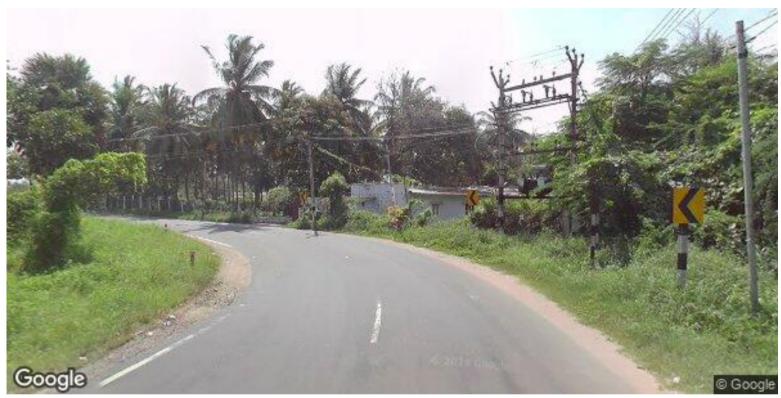
Risk Type: Turn
Risk Level: Medium
Speed Limit: 30 KM/Hr
Coordinates: 11.09605, 77.03172

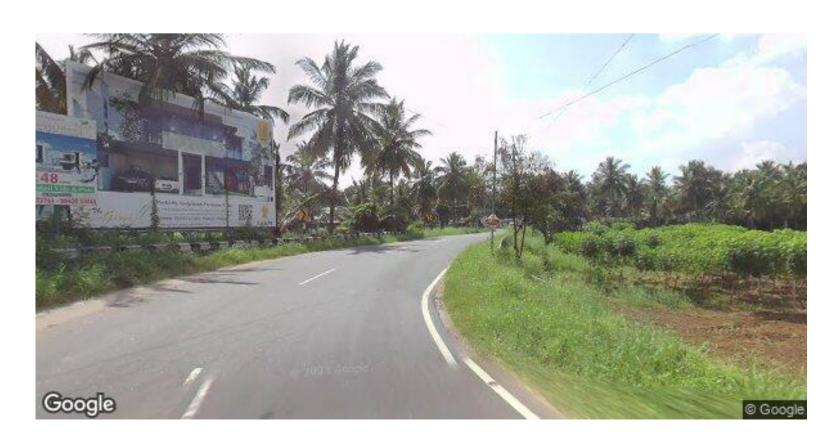
Coordinates: 11.09655, 77.03237

Risk Type: Turn
Risk Level: Medium
Speed Limit: 30 KM/Hr

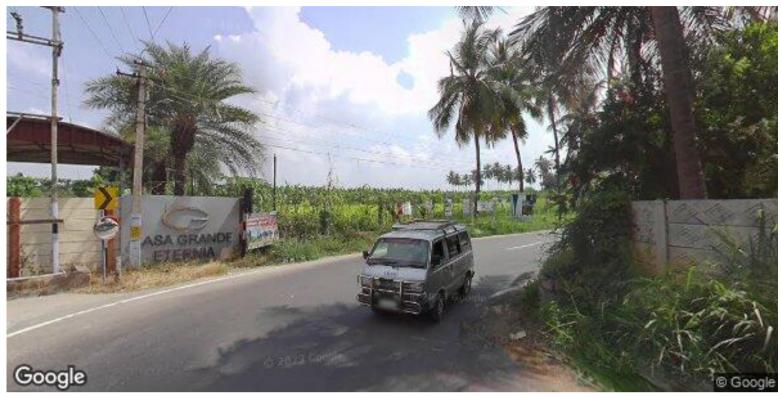
Risk Type: Turn
Risk Level: Medium
Speed Limit: 30 KM/Hr
Coordinates: 11.09846, 77.03245

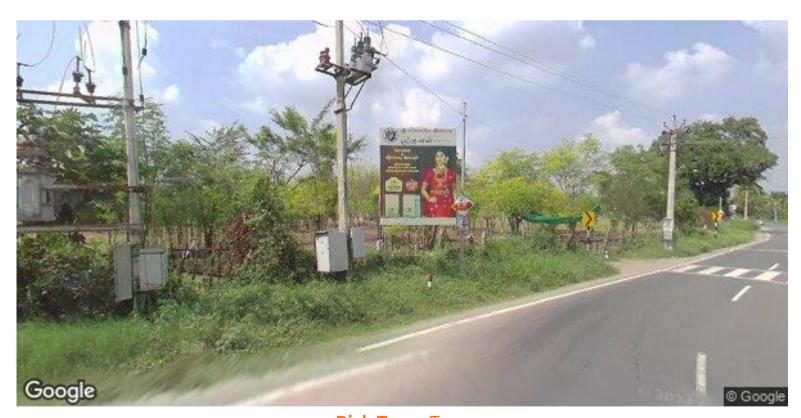
Risk Type: Turn
Risk Level: High
Speed Limit: 15 KM/Hr
Coordinates: 11.09883, 77.03091

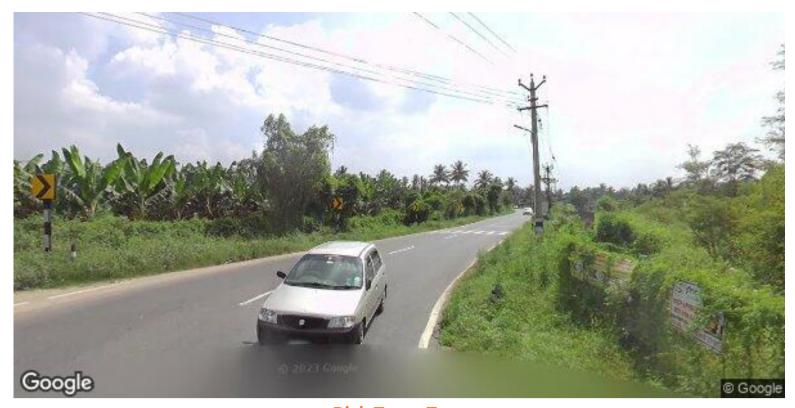
Risk Type: Turn
Risk Level: Medium
Speed Limit: 30 KM/Hr
Coordinates: 11.10295, 77.03049

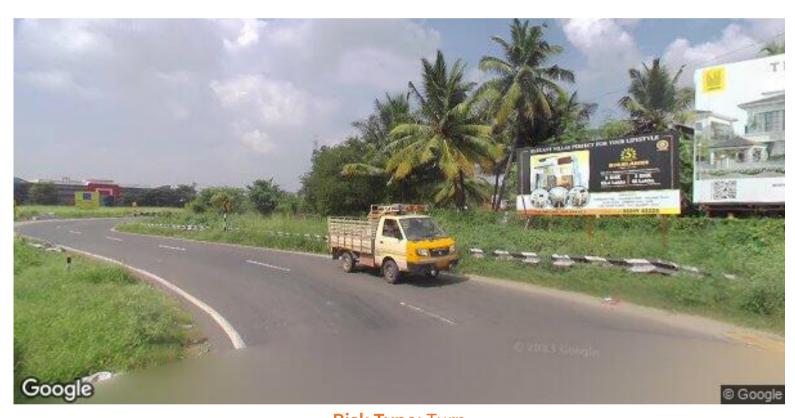
Risk Type: Turn
Risk Level: Medium
Speed Limit: 30 KM/Hr
Coordinates: 11.10301, 77.03046

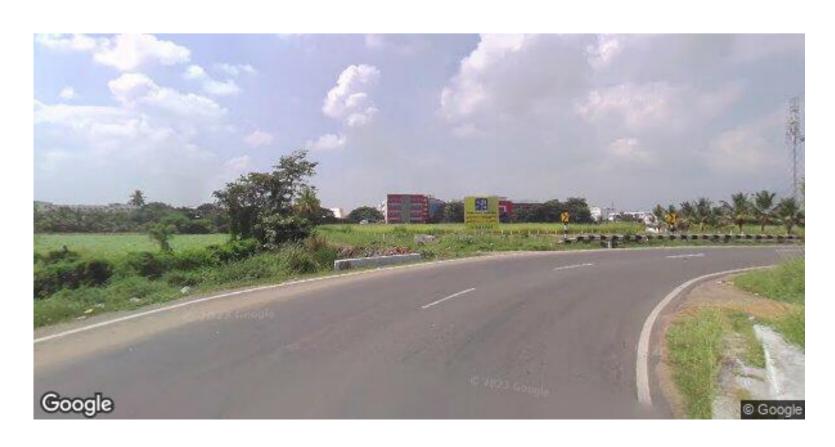
Coordinates: 11.10312, 77.03001

Risk Type: Turn
Risk Level: Medium
Speed Limit: 30 KM/Hr

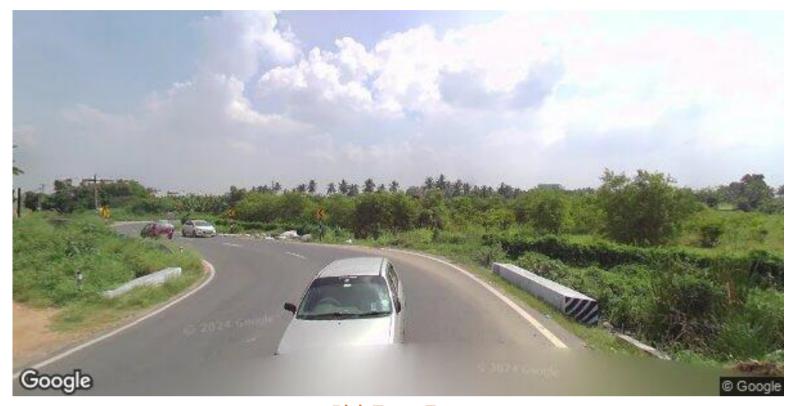
Risk Type: Turn
Risk Level: Medium
Speed Limit: 30 KM/Hr
Coordinates: 11.10320, 77.02990

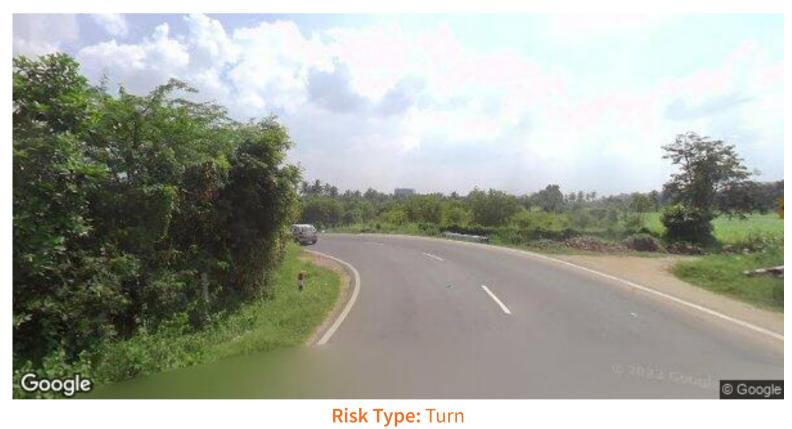
Risk Level: Medium
Speed Limit: 30 KM/Hr
Coordinates: 11.10331, 77.02984

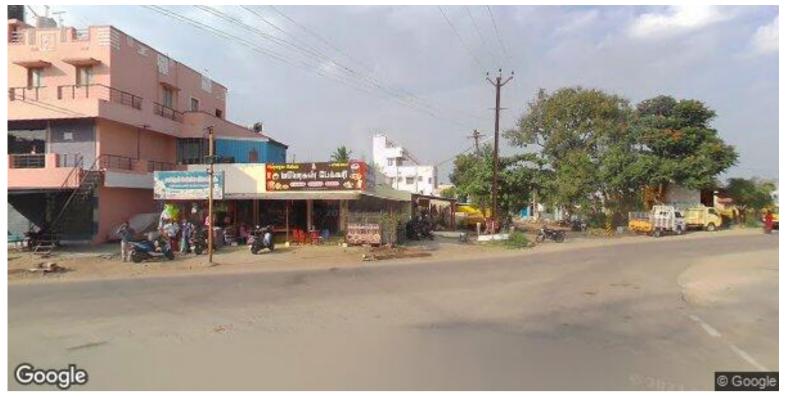
Coordinates: 11.11250, 77.03030

Risk Type: Blind Spot Risk Level: Blind Spot Speed Limit: 10 KM/Hr

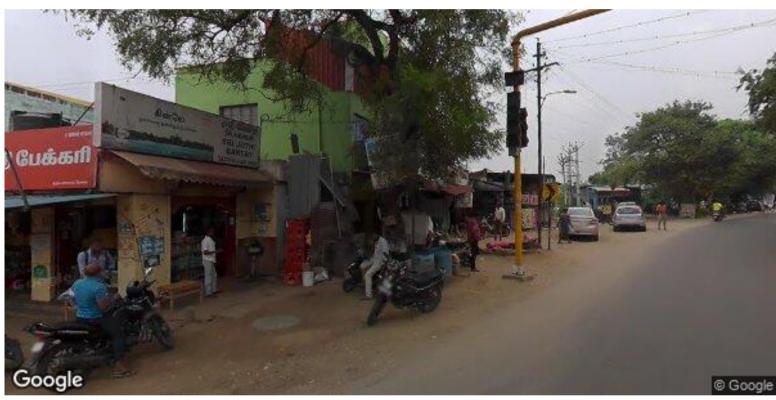
Risk Type: Blind Spot
Risk Level: Blind Spot
Speed Limit: 10 KM/Hr
Coordinates: 11.11256, 77.02901

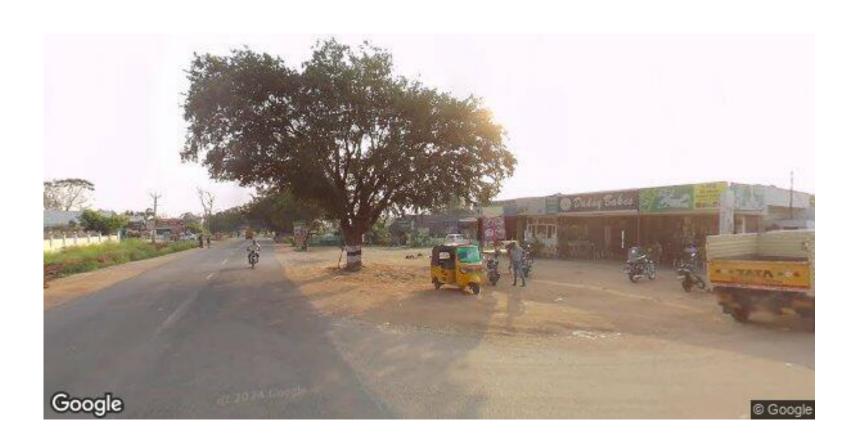
Coordinates: 11.16156, 77.05154

Risk Type: Blind Spot
Risk Level: Blind Spot
Speed Limit: 10 KM/Hr

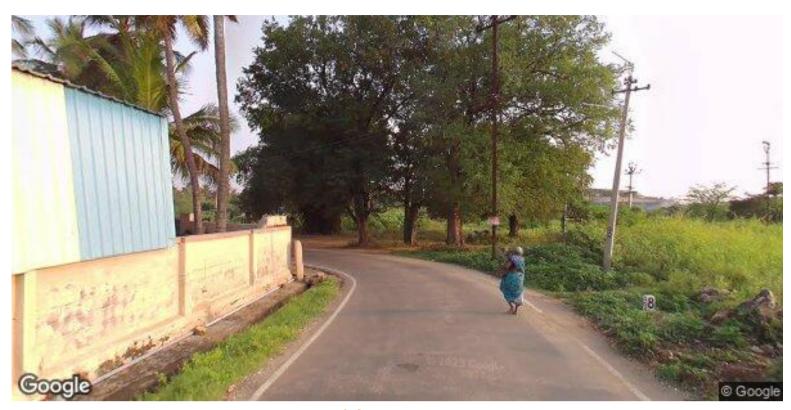
Risk Type: Turn
Risk Level: Medium
Speed Limit: 30 KM/Hr
Coordinates: 11.16486, 77.04558

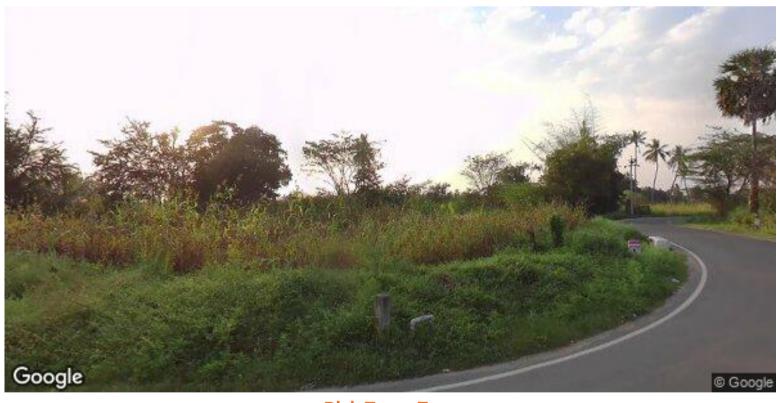
Risk Type: Turn
Risk Level: High
Speed Limit: 15 KM/Hr
Coordinates: 11.16646, 77.04545

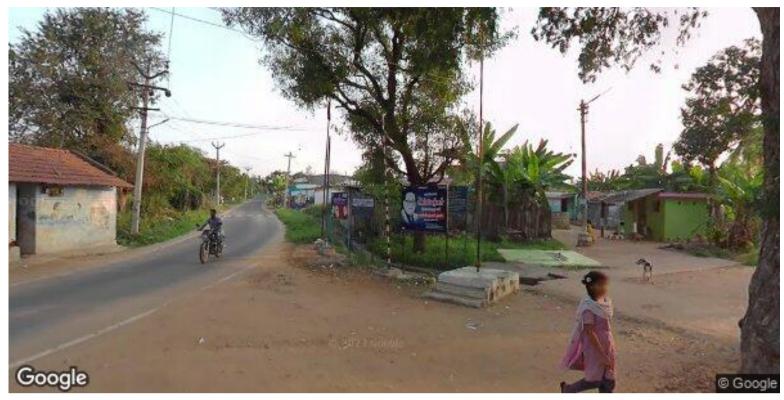
Coordinates: 11.17195, 77.04420

Risk Type: Turn
Risk Level: High
Speed Limit: 15 KM/Hr

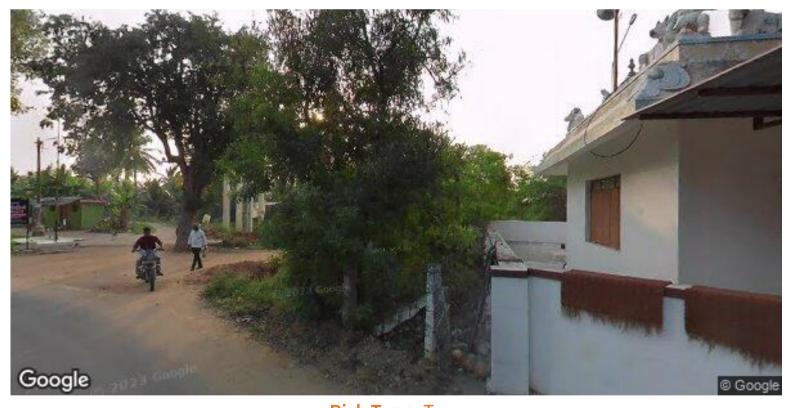
Coordinates: 11.17210, 77.04428

Risk Type: Turn
Risk Level: Medium
Speed Limit: 30 KM/Hr

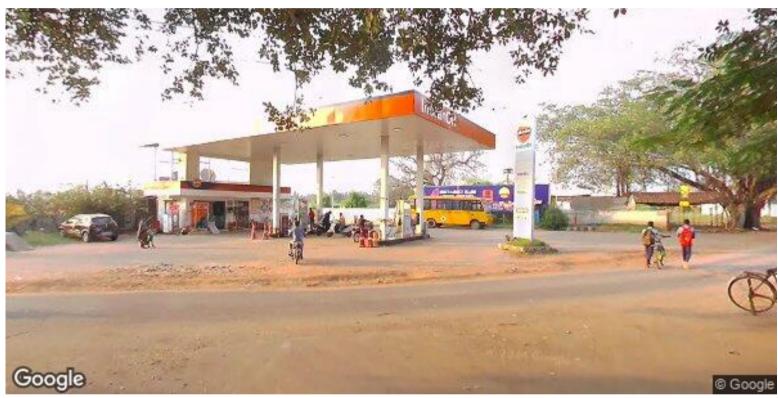
Coordinates: 11.17466, 77.04502

Risk Type: Turn
Risk Level: High
Speed Limit: 15 KM/Hr
