JOURNEY RISK MANAGEMENT (JRM) STUDY

Salem Terminal TO KUMAR AGENCIES

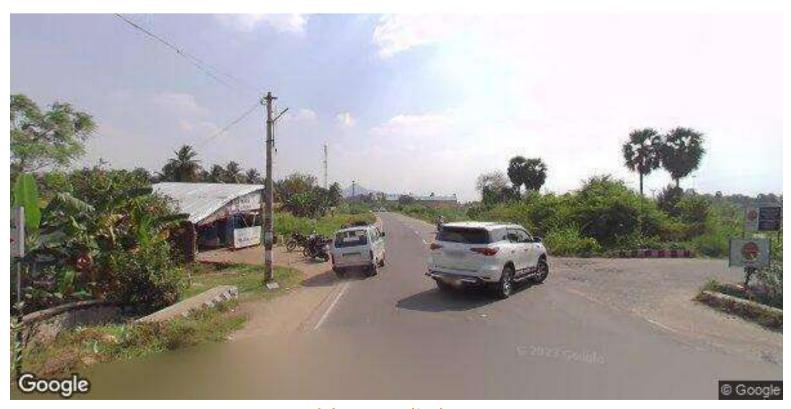
Risk Type: Blind Spot Risk Level: Blind Spot Speed Limit: 10 KM/Hr Coordinates: 11.44029, 77.87544

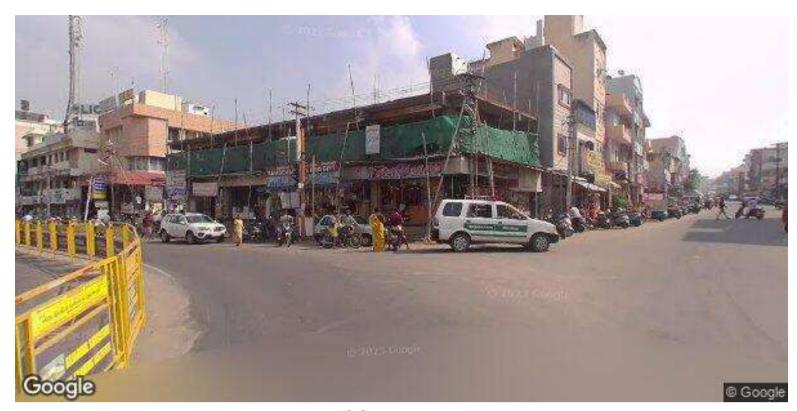
Coordinates: 11.37868, 77.89498

Risk Type: Turn
Risk Level: High
Speed Limit: 15 KM/Hr

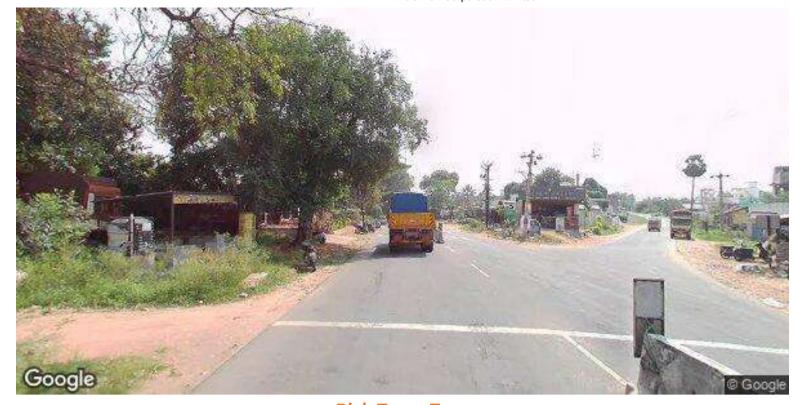
Risk Type: Turn
Risk Level: Medium
Speed Limit: 30 KM/Hr
Coordinates: 11.35759, 77.89191

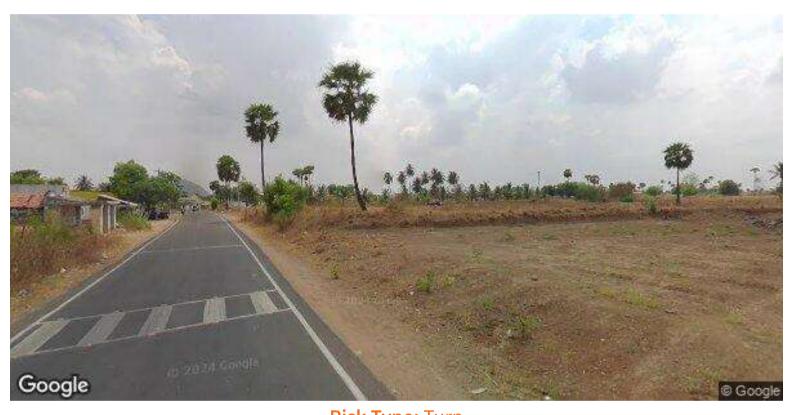
Risk Type: Turn
Risk Level: Medium
Speed Limit: 30 KM/Hr
Coordinates: 11.33071, 77.88660

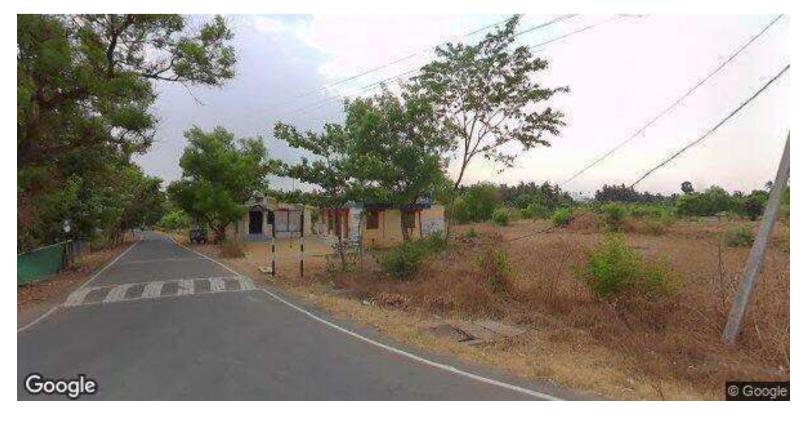
Coordinates: 11.33065, 77.88650

Risk Type: Turn
Risk Level: High
Speed Limit: 15 KM/Hr

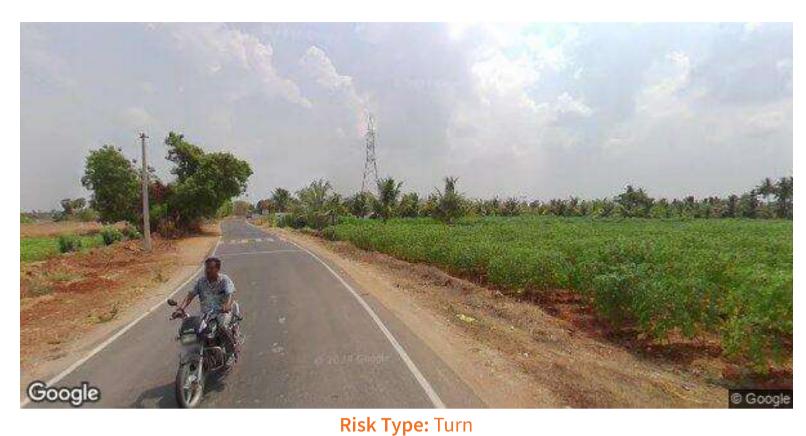
Coordinates: 11.32155, 77.88499

Risk Type: Turn
Risk Level: Medium
Speed Limit: 30 KM/Hr

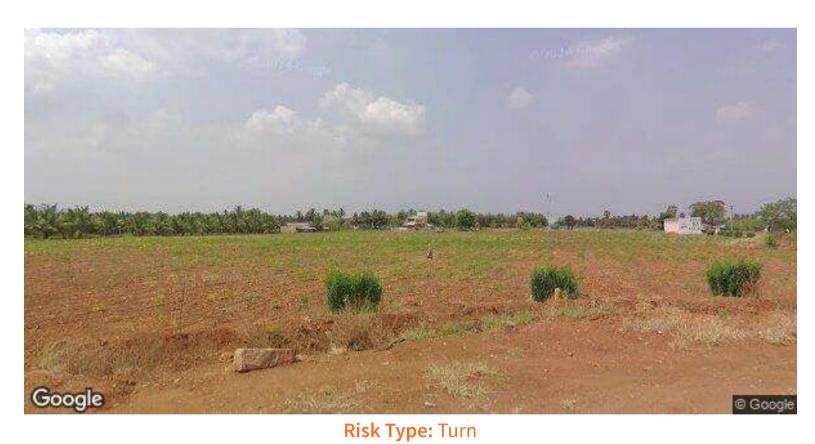
Coordinates: 11.32130, 77.88484

Risk Level: Medium
Speed Limit: 30 KM/Hr

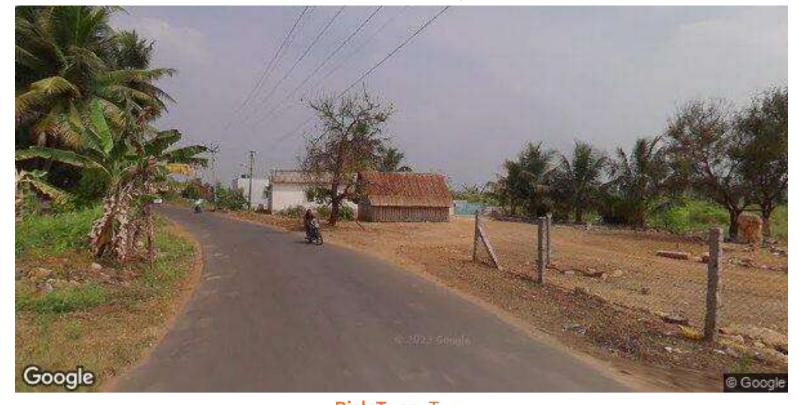
Risk Type: Turn
Risk Level: Medium
Speed Limit: 30 KM/Hr
Coordinates: 11.31205, 77.88131

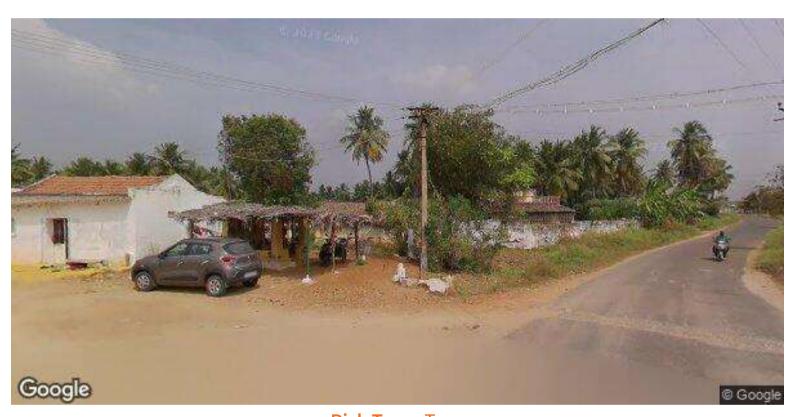
Risk Type: Turn
Risk Level: Medium
Speed Limit: 30 KM/Hr
Coordinates: 11.31151, 77.88008

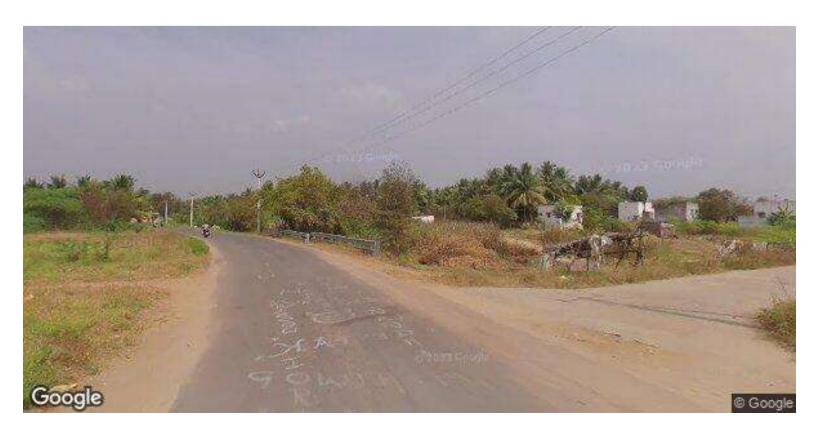
Coordinates: 11.30805, 77.87934

Risk Type: Turn
Risk Level: Medium
Speed Limit: 30 KM/Hr

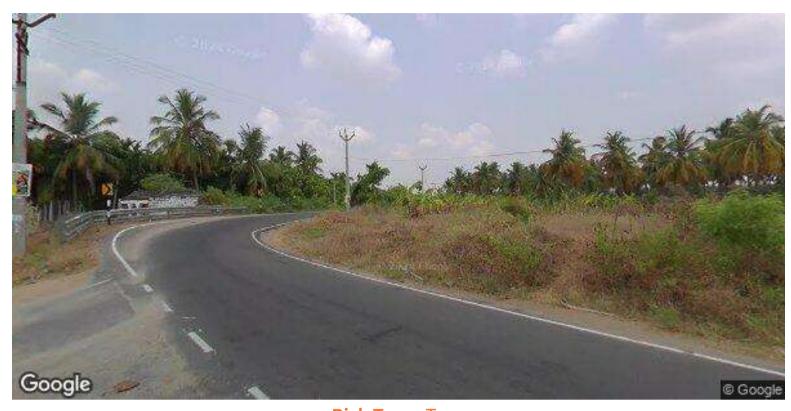
Coordinates: 11.29763, 77.87710

Risk Type: Turn
Risk Level: High
Speed Limit: 15 KM/Hr

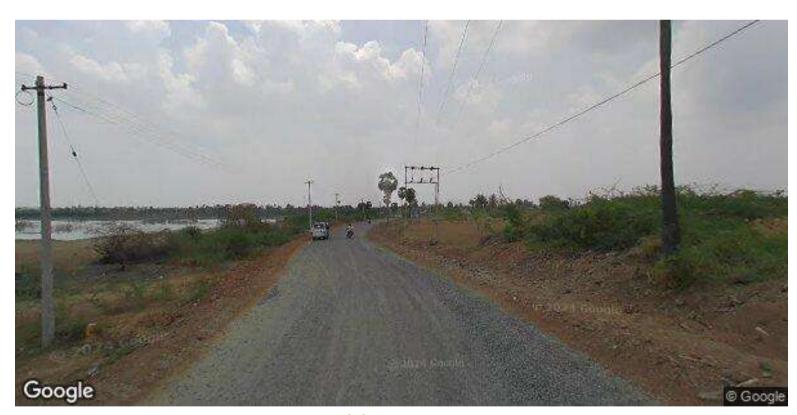
Coordinates: 11.27590, 77.87354

Risk Type: Turn
Risk Level: Medium
Speed Limit: 30 KM/Hr

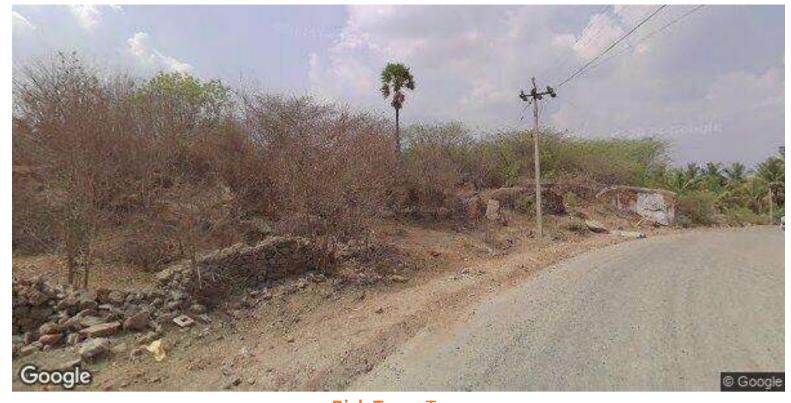
Risk Type: Turn
Risk Level: Medium
Speed Limit: 30 KM/Hr
Coordinates: 11.27057, 77.86827

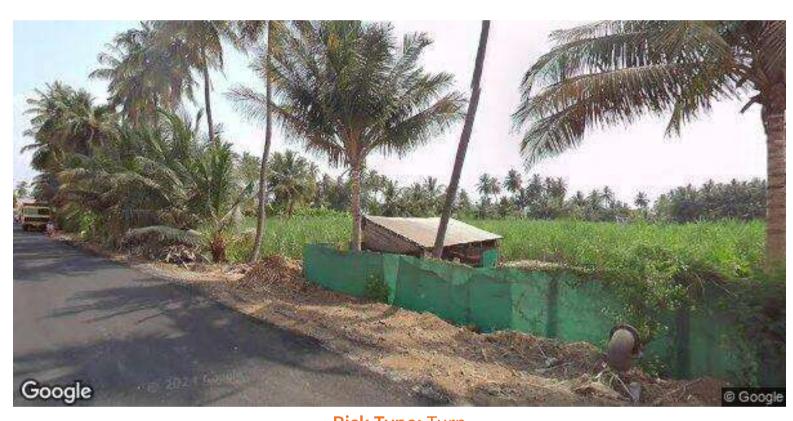
Risk Type: Turn
Risk Level: High
Speed Limit: 15 KM/Hr
Coordinates: 11.26017, 77.85606

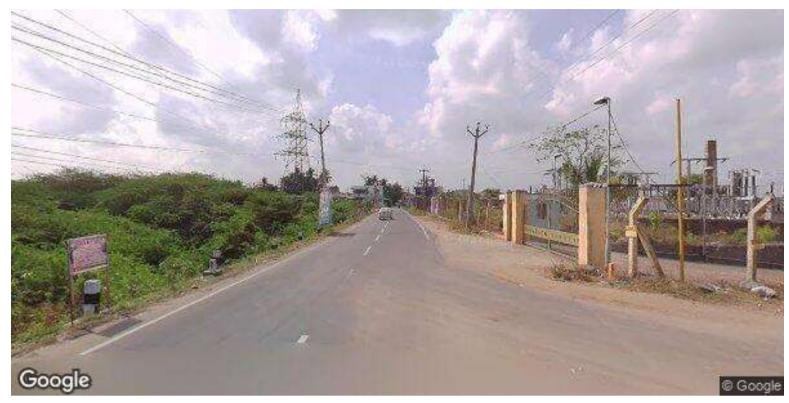
Coordinates: 11.24384, 77.86689

Risk Type: Turn
Risk Level: High
Speed Limit: 15 KM/Hr

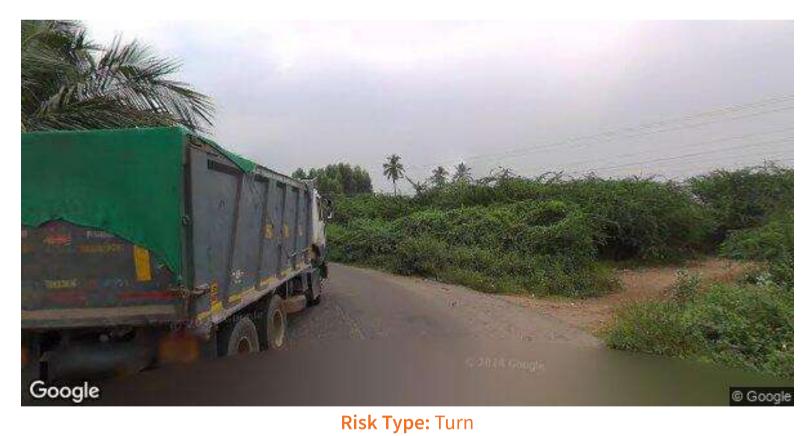
Coordinates: 11.24100, 77.86030

Risk Level: High
Speed Limit: 15 KM/Hr

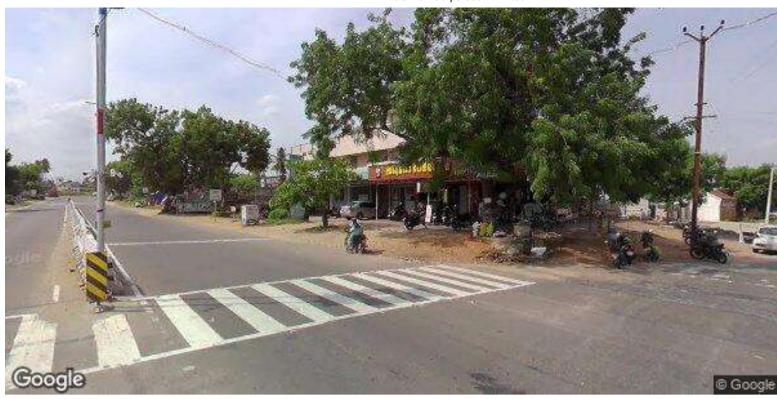
Coordinates: 11.22377, 77.83980

Risk Type: Turn
Risk Level: High
Speed Limit: 15 KM/Hr
