JOURNEY RISK MANAGEMENT (JRM) STUDY

Salem Terminal TO NO 1 PETROLEUM

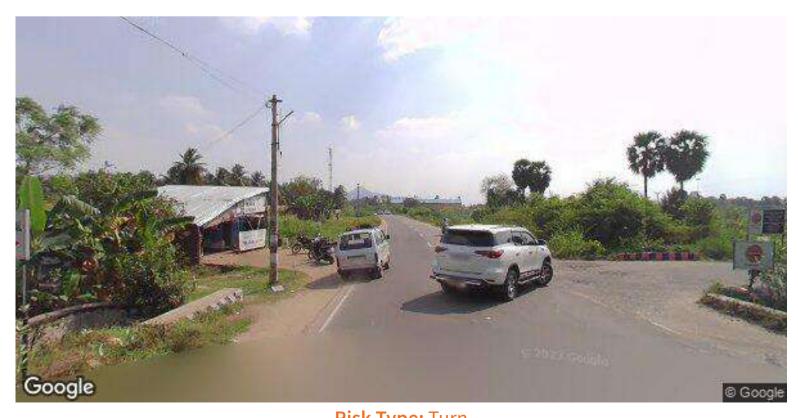
Risk Type: Turn
Speed Limit: 15 KM/Hr

Distance from Start: 0.28 km **Coordinates:** 11.44029, 77.87544

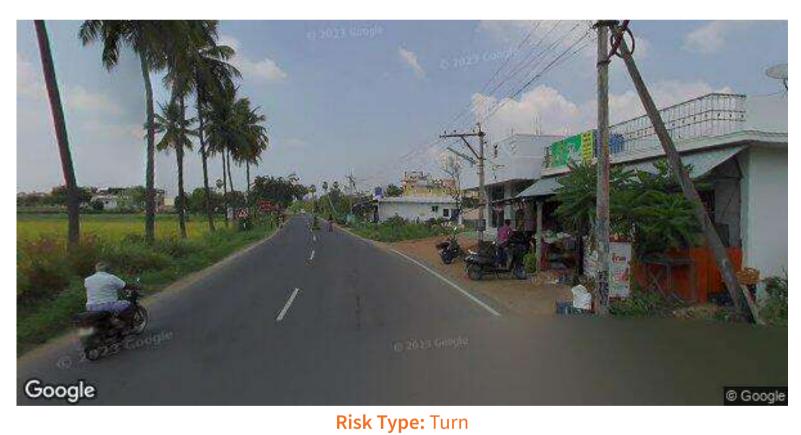
Speed Limit: 15 KM/Hr
Distance from Start: 2.15 km
Coordinates: 11.45127, 77.86734

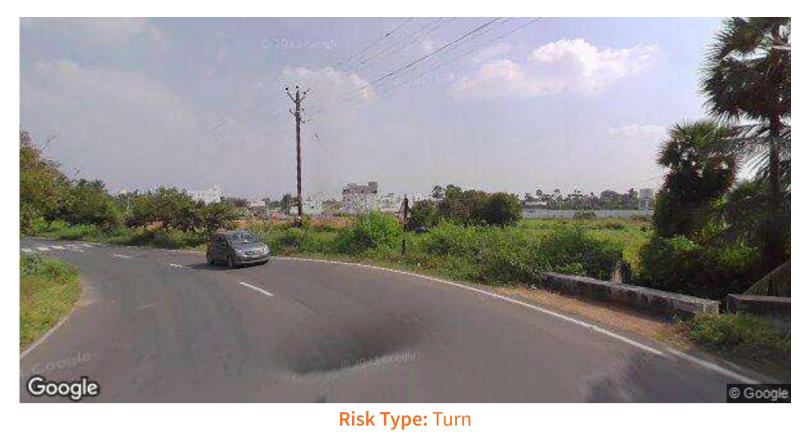
Speed Limit: 15 KM/Hr
Distance from Start: 3.29 km
Coordinates: 11.45350, 77.85700

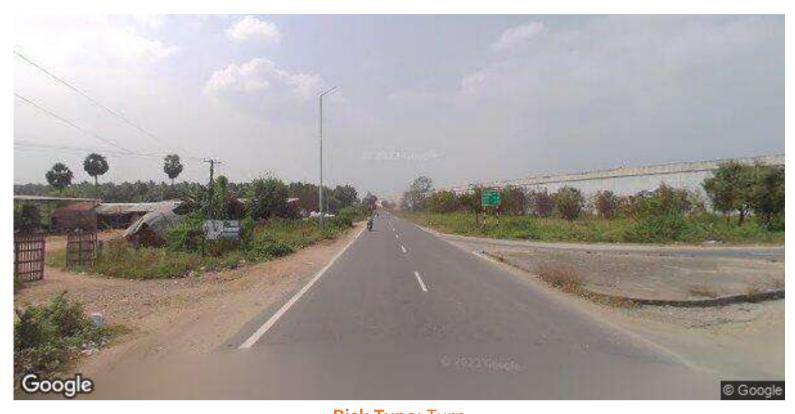
Risk Type: Turn
Speed Limit: 15 KM/Hr
Distance from Start: 8.36 km
Coordinates: 11.45542, 77.81725

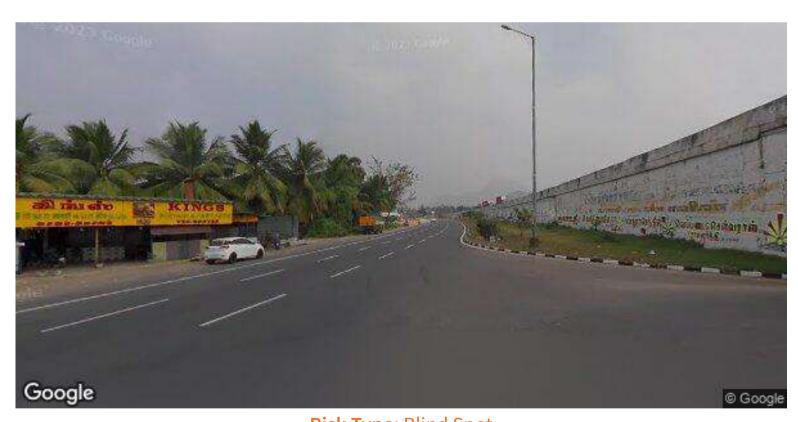
Risk Type: Blind Spot
Speed Limit: 10 KM/Hr
Distance from Start: 8.50 km
Coordinates: 11.45634, 77.81673

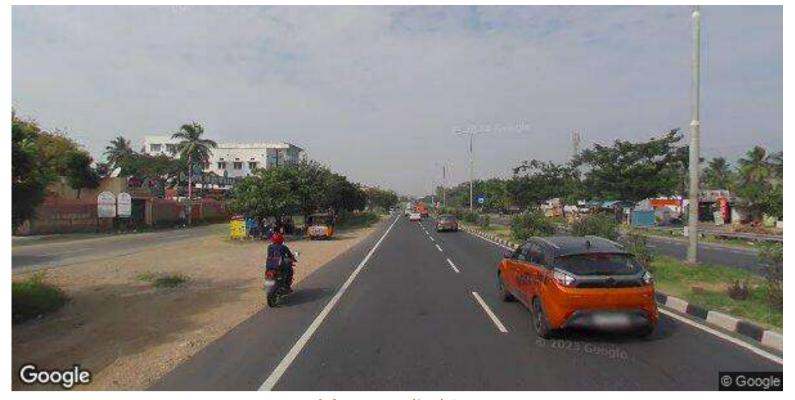
Risk Type: Blind Spot
Speed Limit: 10 KM/Hr
Distance from Start: 18.62 km
Coordinates: 11.44530, 77.72783

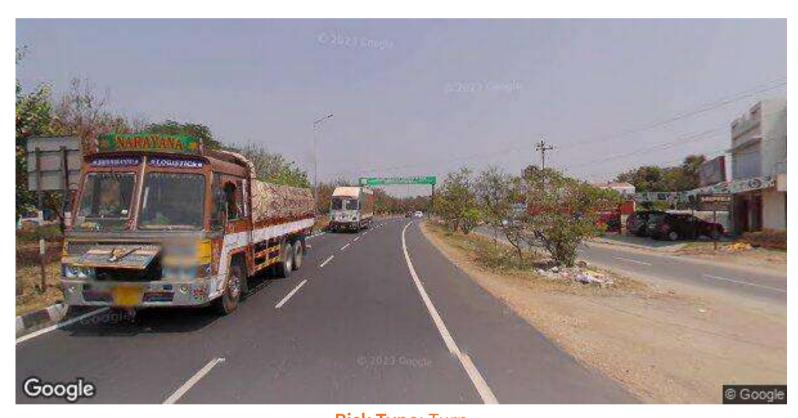
Risk Type: Turn
Speed Limit: 15 KM/Hr
Distance from Start: 24.43 km
Coordinates: 11.43192, 77.67803

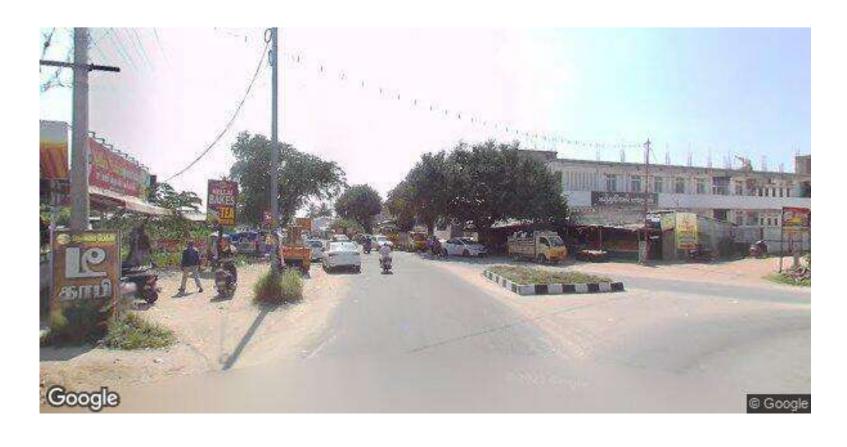
Risk Type: Roundabout
Speed Limit: 15 KM/Hr
Distance from Start: 86.65 km

Coordinates: 11.17250, 77.26863

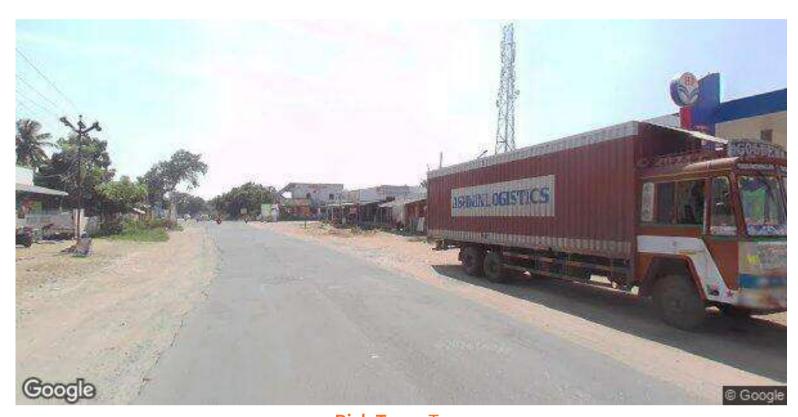
Risk Type: Turn
Speed Limit: 15 KM/Hr
Distance from Start: 87.15 km
Coordinates: 11.16848, 77.26757

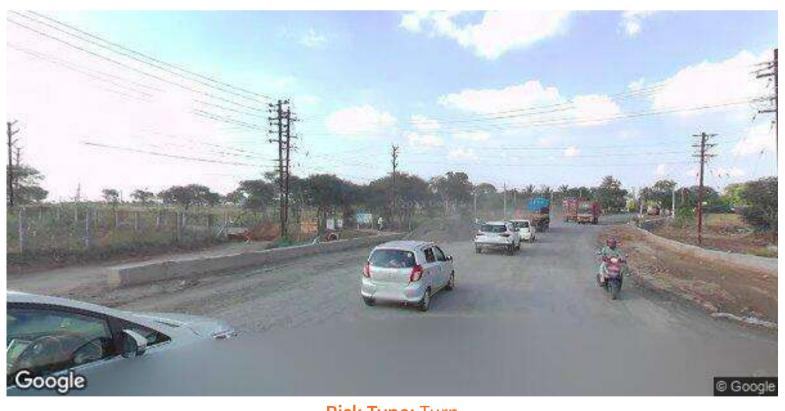
Risk Type: Turn
Speed Limit: 15 KM/Hr
Distance from Start: 89.71 km
Coordinates: 11.14580, 77.26363

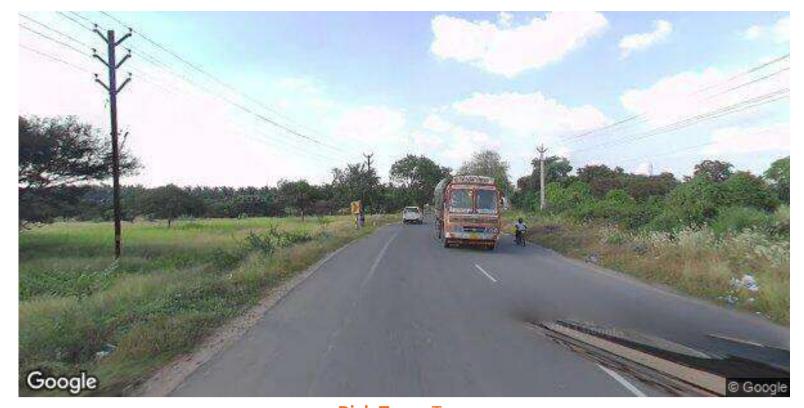
Risk Type: Turn
Speed Limit: 15 KM/Hr
Distance from Start: 90.29 km
Coordinates: 11.14029, 77.26520

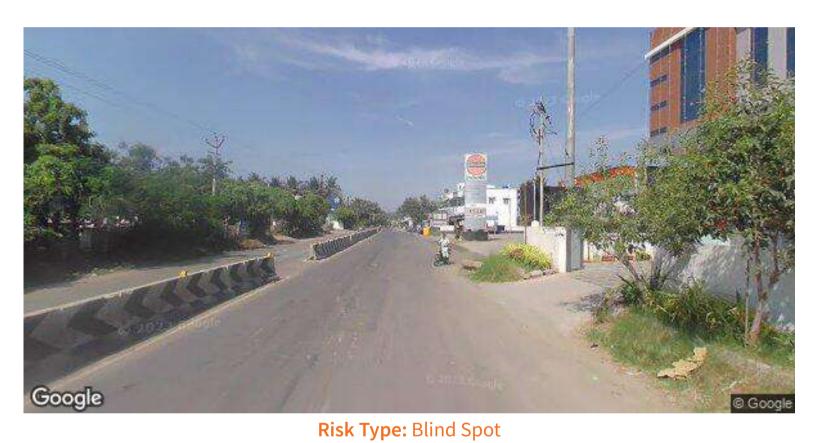
Speed Limit: 10 KM/Hr
Distance from Start: 92.12 km
Coordinates: 11.12510, 77.26688
