JOURNEY RISK MANAGEMENT (JRM) STUDY

Salem Terminal TO MANITHAM PETROLEUM

Route Safety Analysis for CVQF+23W, Sangagiri to XC9F+34, Kavundanpudur, Tamil Nadu

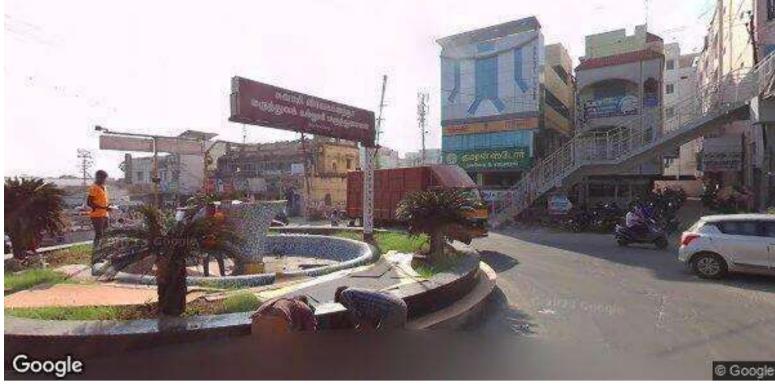
Risk Type: Roundabout
Risk Level: High
Speed Limit: 15 KM/Hr
Coordinates: 11.38395, 77.89480

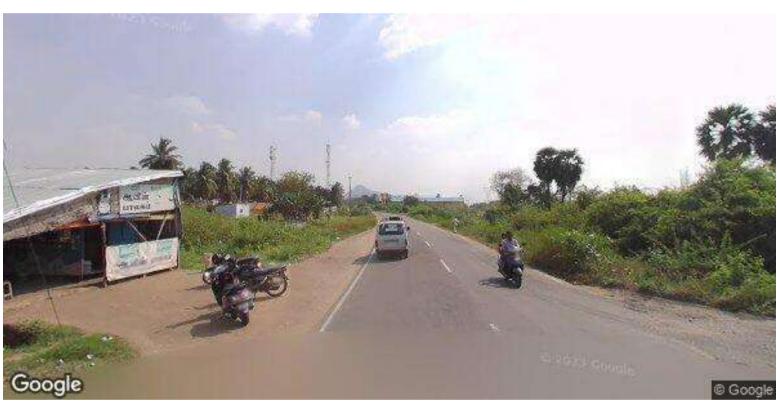
Risk Type: Turn
Risk Level: High
Speed Limit: 15 KM/Hr
Coordinates: 11.44022, 77.87546

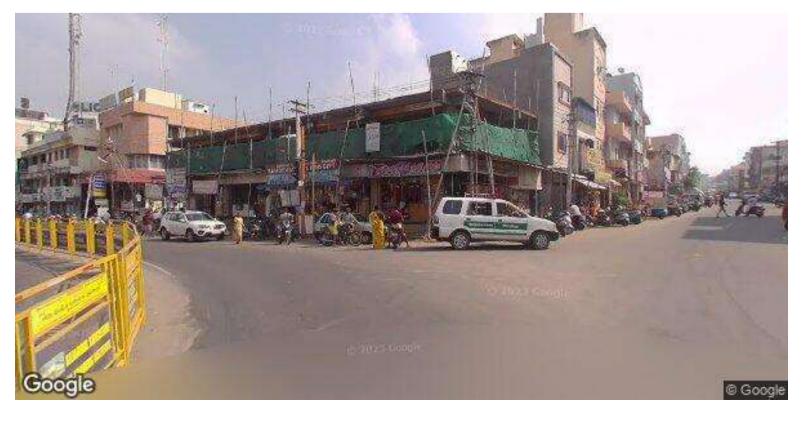
Coordinates: 11.37868, 77.89498

Risk Type: Turn
Risk Level: High
Speed Limit: 15 KM/Hr

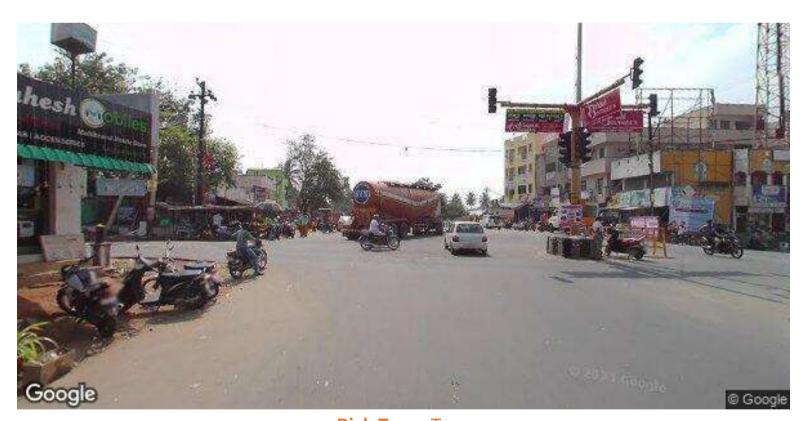
Coordinates: 11.36616, 77.88885

Risk Type: Turn
Risk Level: High
Speed Limit: 15 KM/Hr

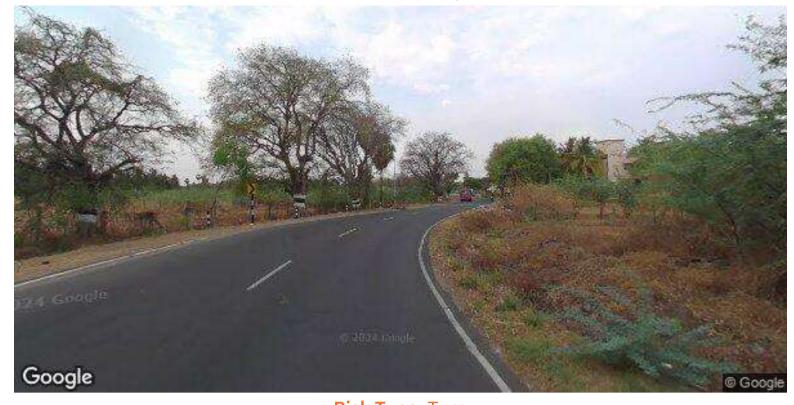
Risk Type: Turn
Risk Level: Medium
Speed Limit: 30 KM/Hr
Coordinates: 11.34067, 77.86347

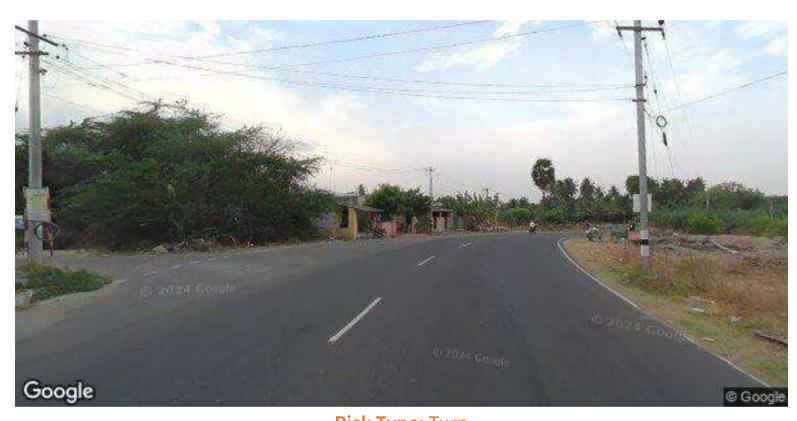
Risk Type: Turn
Risk Level: Medium
Speed Limit: 30 KM/Hr
Coordinates: 11.33854, 77.86216

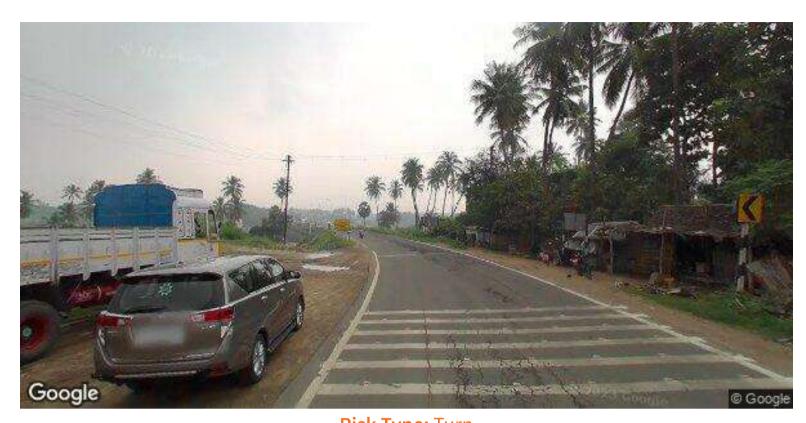
Risk Type: Turn
Risk Level: Medium
Speed Limit: 30 KM/Hr
Coordinates: 11.30952, 77.77587

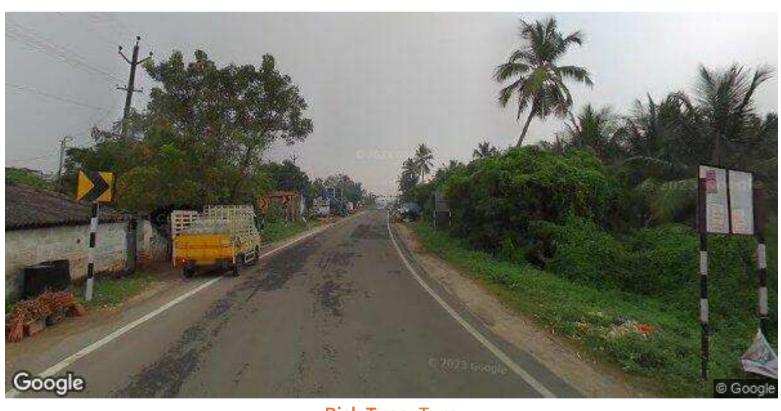
Coordinates: 11.30973, 77.76712

Risk Type: Turn
Risk Level: Medium
Speed Limit: 30 KM/Hr

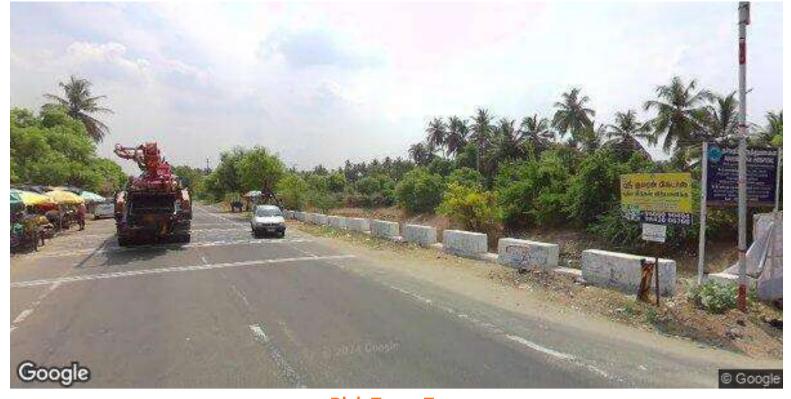
Risk Type: Turn
Risk Level: High
Speed Limit: 15 KM/Hr
Coordinates: 11.29490, 77.74685

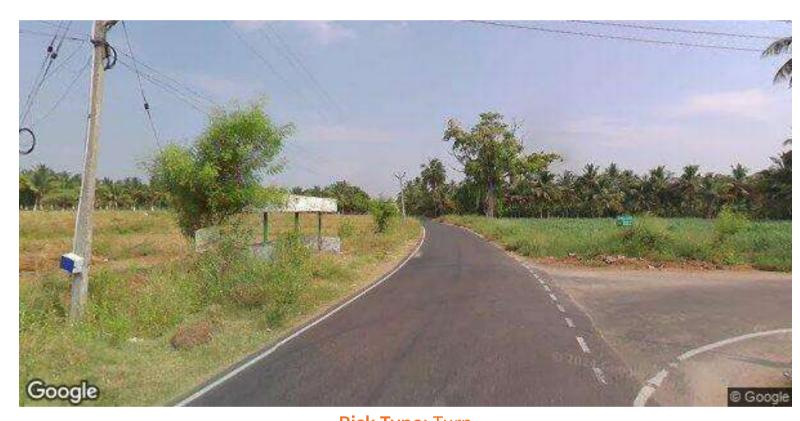
Risk Type: Turn
Risk Level: High
Speed Limit: 15 KM/Hr
Coordinates: 11.29141, 77.74662

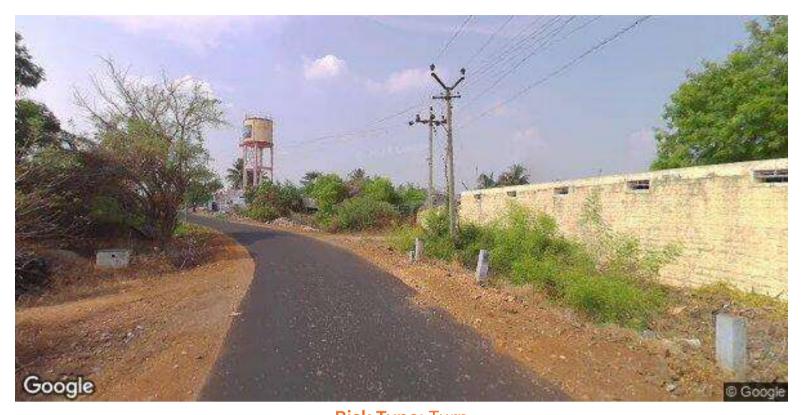
Risk Type: Turn
Risk Level: Medium
Speed Limit: 30 KM/Hr
Coordinates: 11.28573, 77.74281

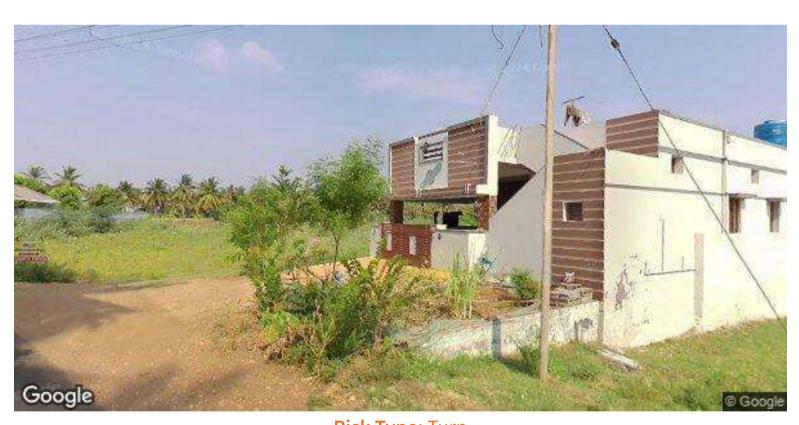
Coordinates: 11.27319, 77.72981

Risk Type: Turn
Risk Level: High
Speed Limit: 15 KM/Hr

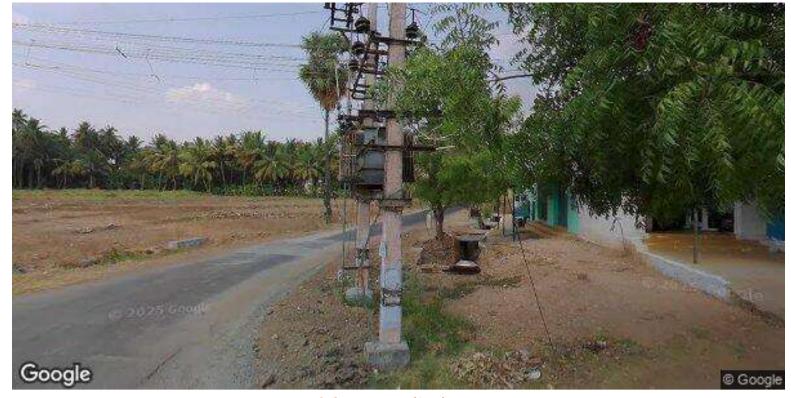
Risk Type: Blind Spot
Risk Level: Blind Spot
Speed Limit: 10 KM/Hr
Coordinates: 11.27330, 77.72715

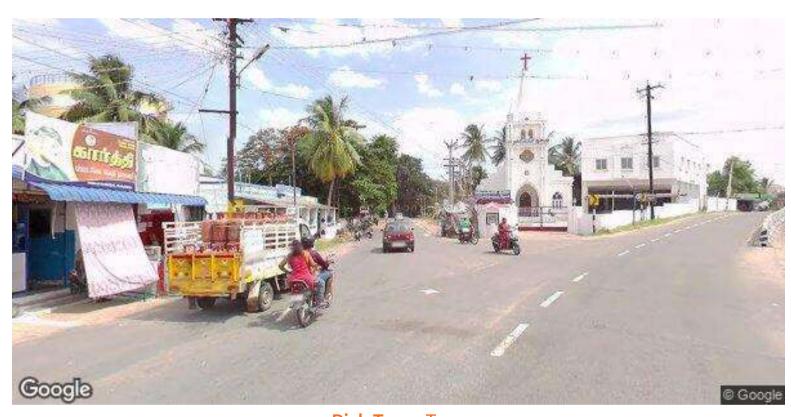
Risk Type: Turn
Risk Level: Medium
Speed Limit: 30 KM/Hr
Coordinates: 11.23054, 77.71796

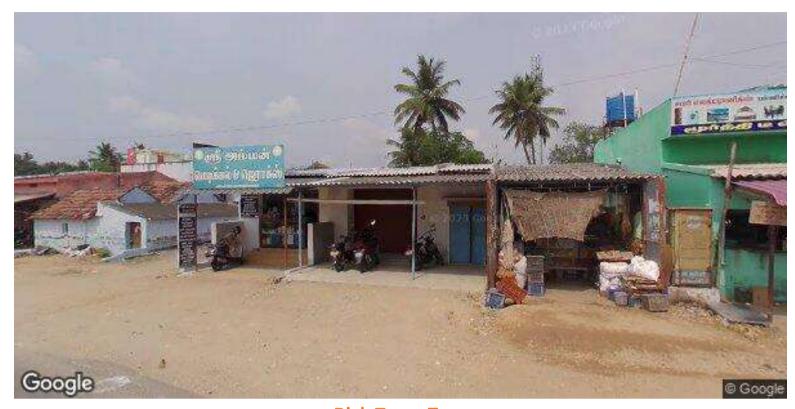
Risk Type: Turn
Risk Level: Medium
Speed Limit: 30 KM/Hr
Coordinates: 11.20776, 77.70916

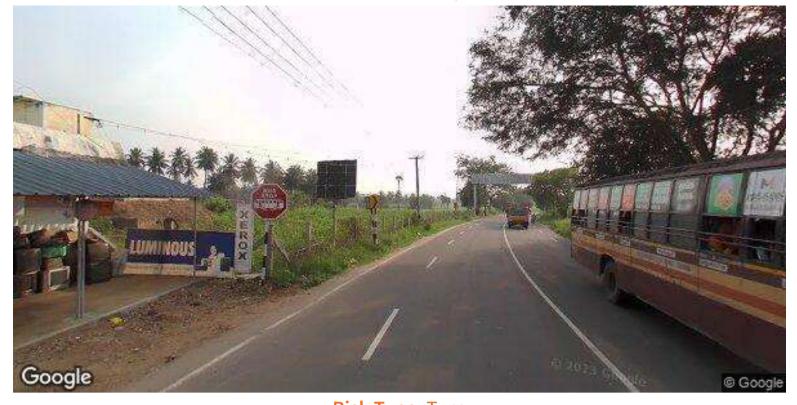
Risk Type: Turn
Risk Level: Medium
Speed Limit: 30 KM/Hr
Coordinates: 11.12102, 77.67919

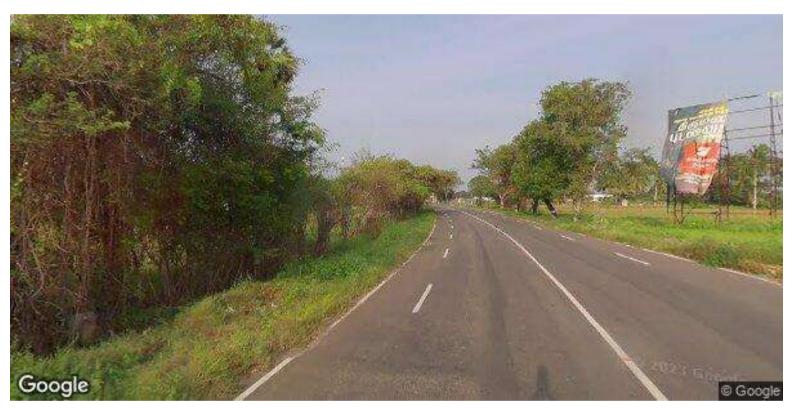
Risk Type: Turn
Risk Level: Medium
Speed Limit: 30 KM/Hr
Coordinates: 11.11932, 77.67786

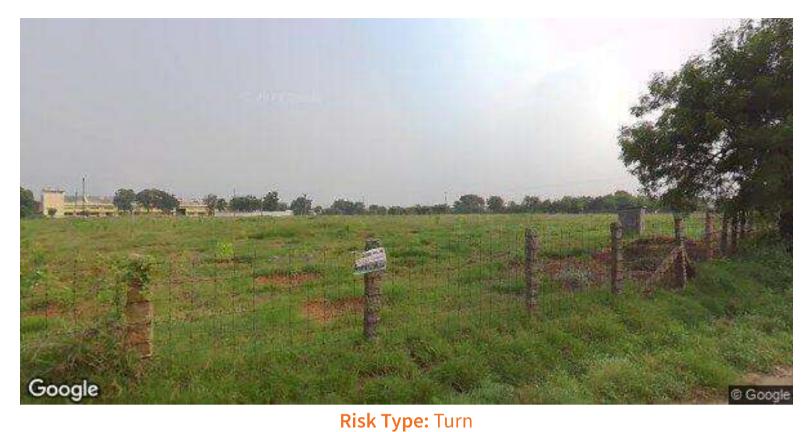
Risk Type: Turn
Risk Level: Medium
Speed Limit: 30 KM/Hr
Coordinates: 11.09491, 77.66603

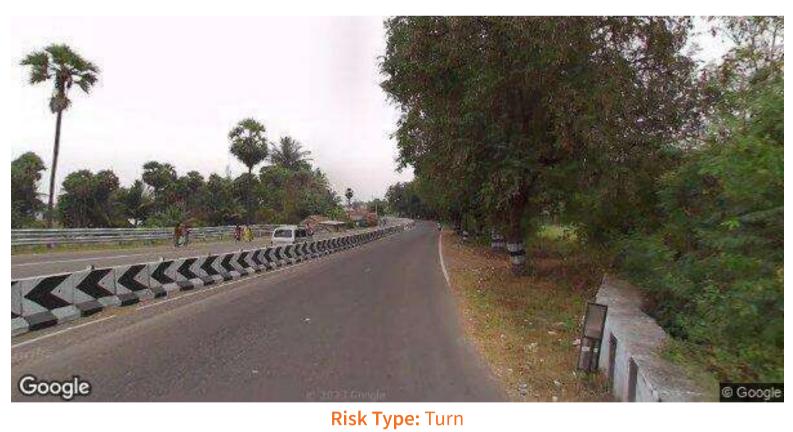
Coordinates: 11.08296, 77.65857

Risk Type: Turn
Risk Level: Medium
Speed Limit: 30 KM/Hr

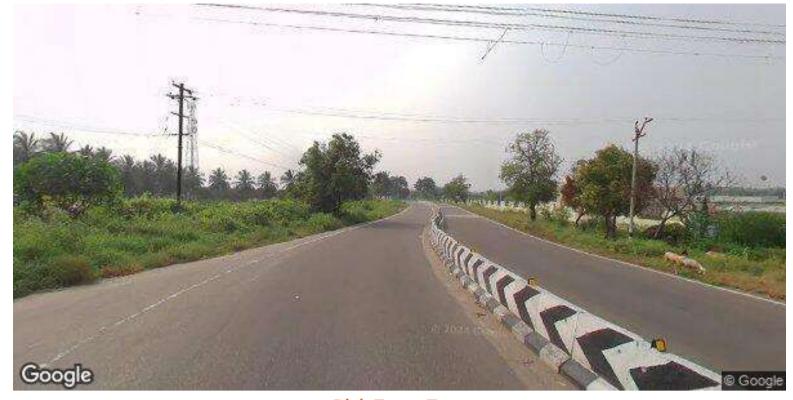
Risk Type: Turn
Risk Level: Medium
Speed Limit: 30 KM/Hr
Coordinates: 11.06183, 77.63924

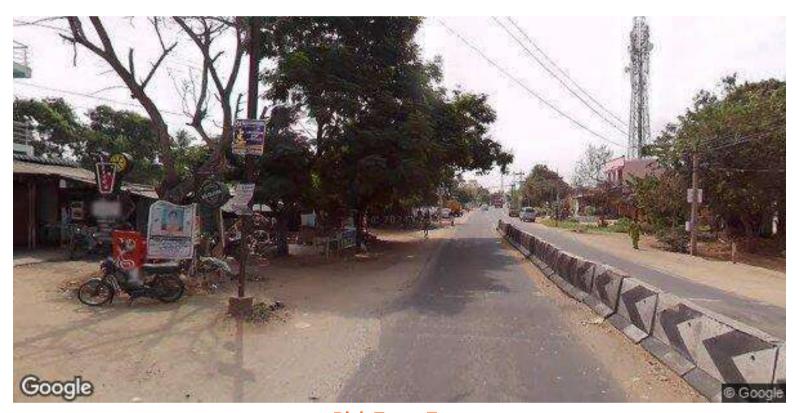
Risk Type: Turn
Risk Level: High
Speed Limit: 15 KM/Hr
Coordinates: 11.00826, 77.56962

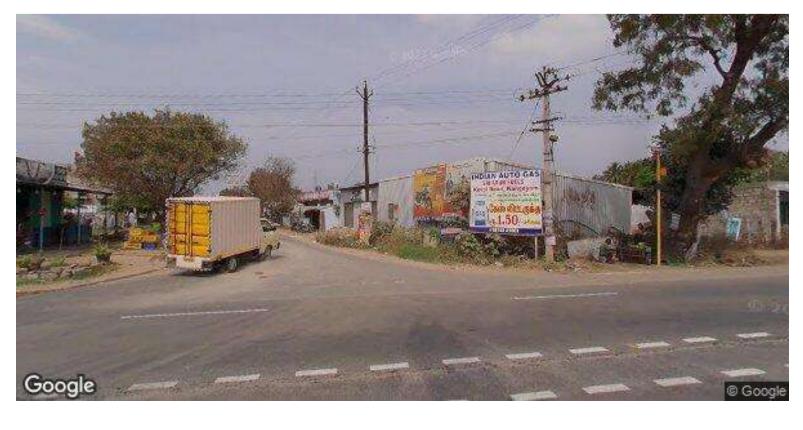
Coordinates: 11.00058, 77.56882

Risk Type: Blind Spot Risk Level: Blind Spot Speed Limit: 10 KM/Hr

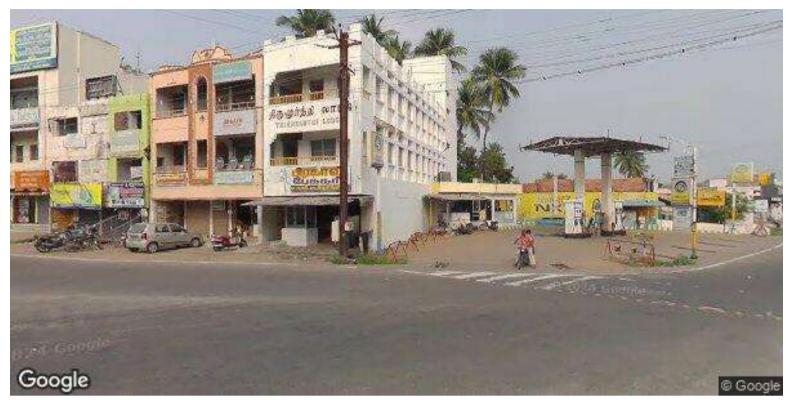
Coordinates: 11.00172, 77.56268

Risk Type: Turn
Risk Level: High
Speed Limit: 15 KM/Hr

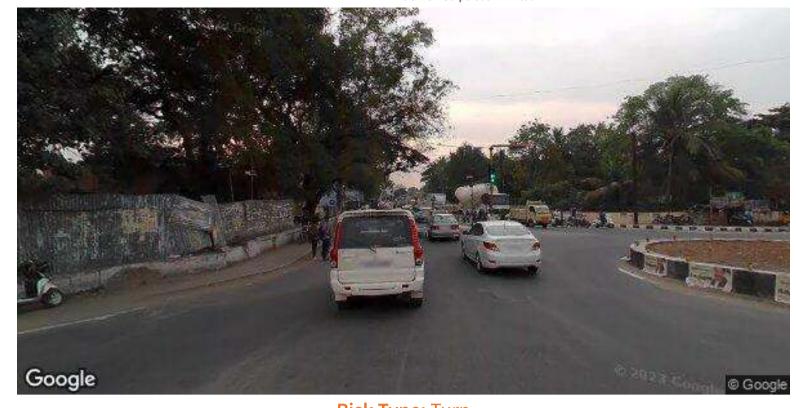
Risk Type: Turn
Risk Level: Medium
Speed Limit: 30 KM/Hr
Coordinates: 11.00168, 77.56264

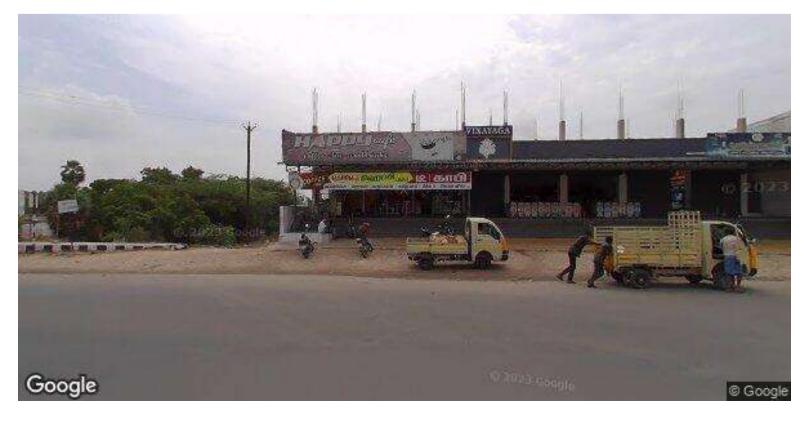
Coordinates: 10.96805, 77.42718

Risk Type: Turn Risk Level: High

Speed Limit: 15 KM/Hr
