JOURNEY RISK MANAGEMENT (JRM) STUDY

Salem Terminal to V K AGENCIES

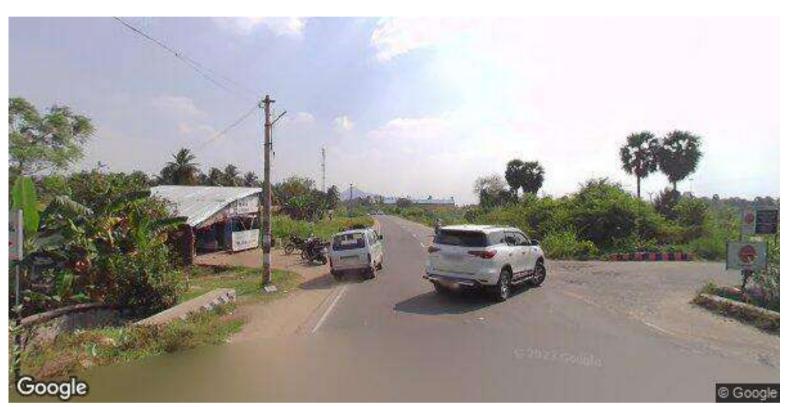
Coordinates: 11.44029, 77.87544

Risk Type: Turn
Risk Level: High
Speed Limit: 15 KM/Hr

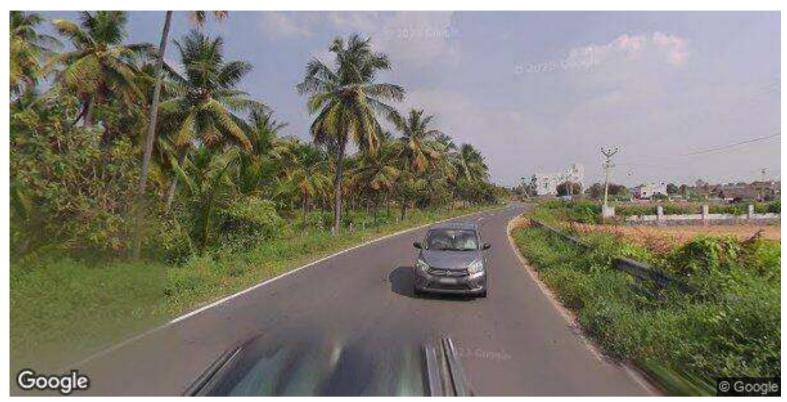
Risk Type: Turn
Risk Level: Medium
Speed Limit: 30 KM/Hr
Coordinates: 11.45357, 77.85789

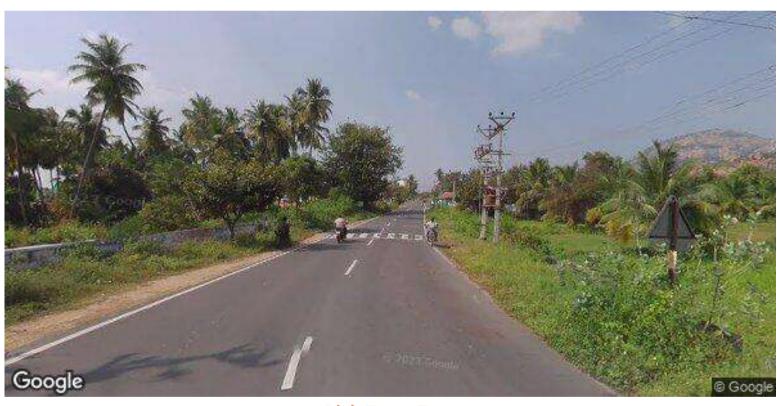
Risk Type: Turn
Risk Level: High
Speed Limit: 15 KM/Hr
Coordinates: 11.45352, 77.85698

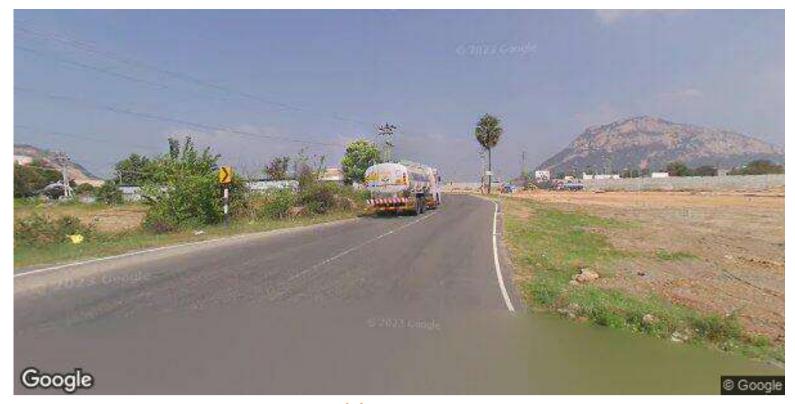
Risk Type: Turn
Risk Level: Medium
Speed Limit: 30 KM/Hr
Coordinates: 11.45847, 77.85140

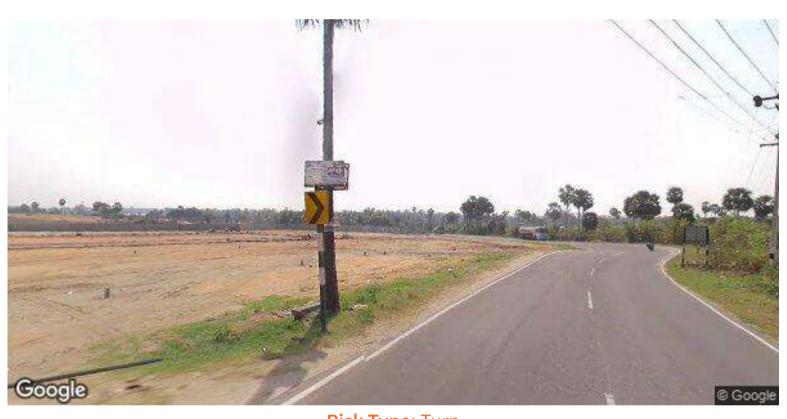
Risk Type: Turn
Risk Level: Medium
Speed Limit: 30 KM/Hr
Coordinates: 11.45898, 77.85135

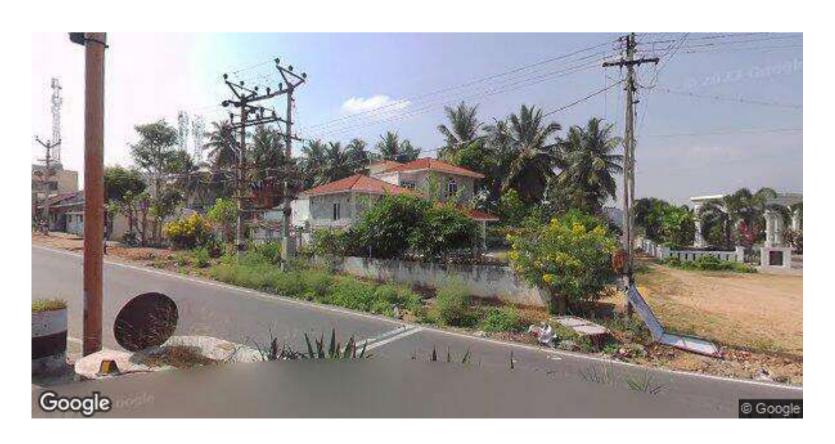
Coordinates: 11.46303, 77.84945

Risk Type: Turn
Risk Level: Medium
Speed Limit: 30 KM/Hr

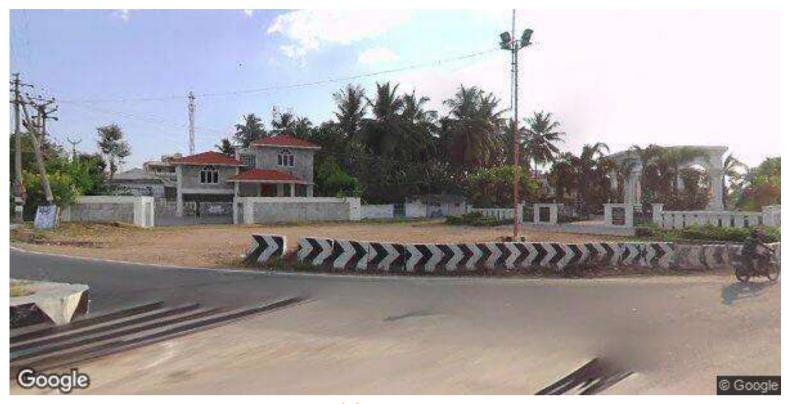
Coordinates: 11.46314, 77.84928

Risk Type: Turn
Risk Level: Medium
Speed Limit: 30 KM/Hr

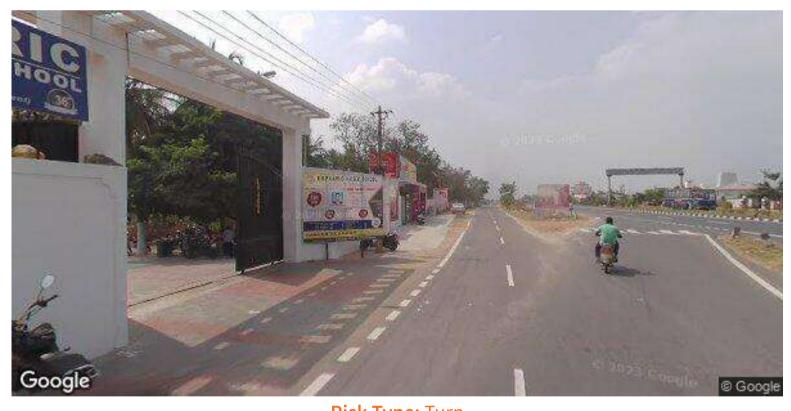
Coordinates: 11.45509, 77.81383

Risk Type: Turn
Risk Level: Medium
Speed Limit: 30 KM/Hr

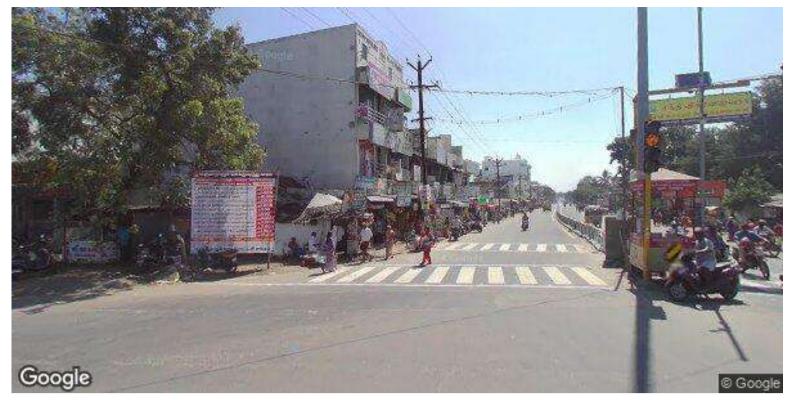
Risk Type: Turn
Risk Level: High
Speed Limit: 15 KM/Hr
Coordinates: 11.20728, 77.35914

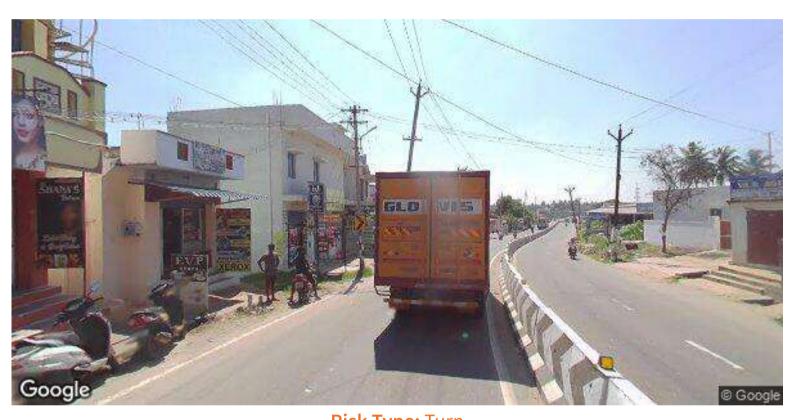
Risk Type: Turn
Risk Level: Medium
Speed Limit: 30 KM/Hr
Coordinates: 11.20246, 77.35895

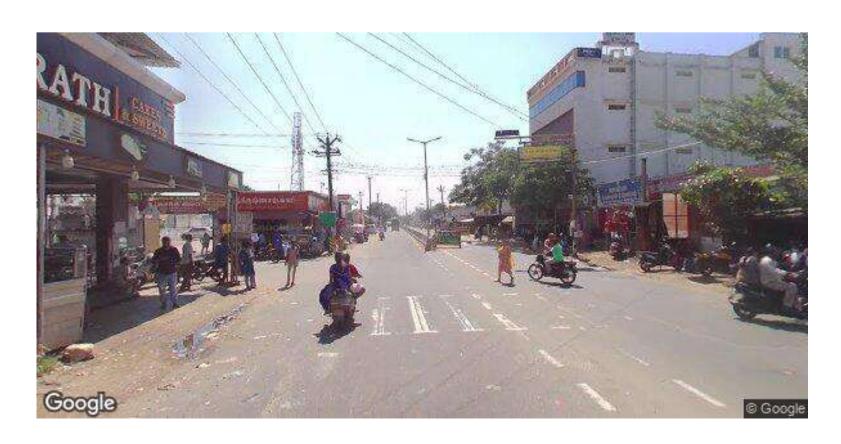
Coordinates: 11.18416, 77.35188

Risk Type: Turn
Risk Level: High
Speed Limit: 15 KM/Hr

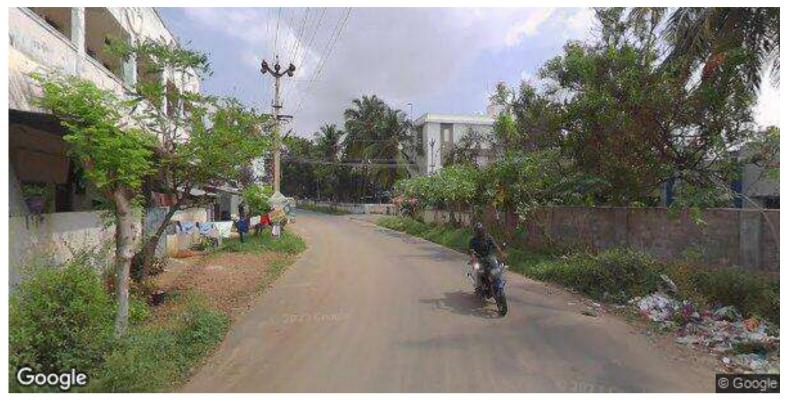
Coordinates: 11.18451, 77.34879

Risk Type: Turn
Risk Level: High
Speed Limit: 15 KM/Hr

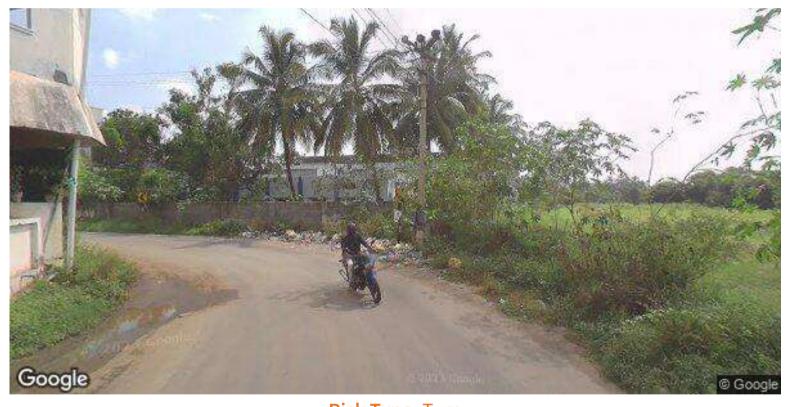
Risk Type: Turn
Risk Level: Medium
Speed Limit: 30 KM/Hr
Coordinates: 11.18464, 77.34868

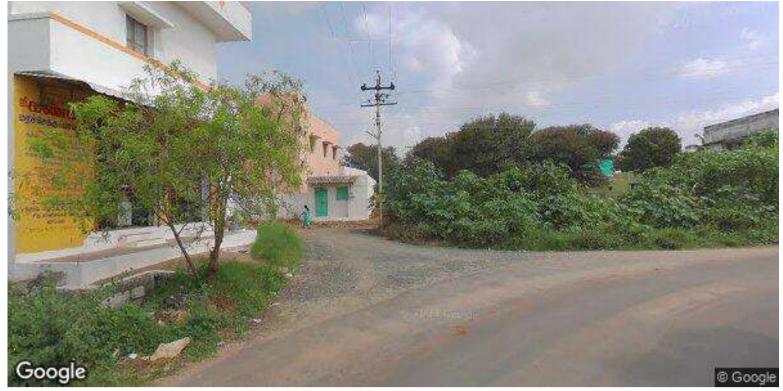
Risk Type: Turn
Risk Level: High
Speed Limit: 15 KM/Hr
Coordinates: 11.18501, 77.34861

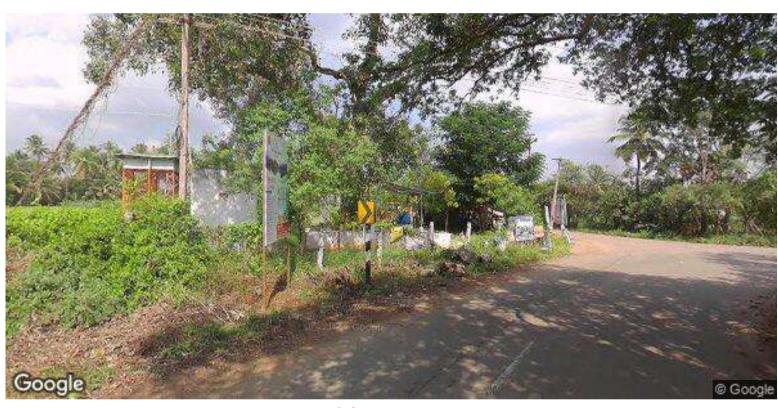
Coordinates: 11.18497, 77.33917

Risk Type: Turn
Risk Level: High
Speed Limit: 15 KM/Hr
