# JOURNEY RISK MANAGEMENT (JRM) STUDY

#### Salem Terminal To SRE KRISHNA ENTERPRISES

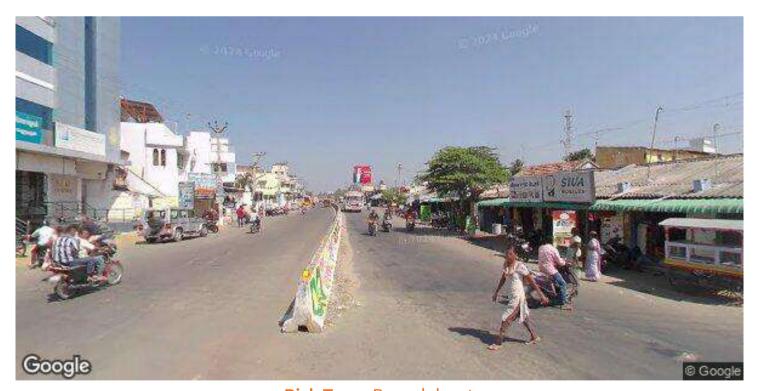
Risk Type: Roundabout
Risk Level: High
Speed Limit: 15 KM/Hr
Coordinates: 11.37086, 77.74828

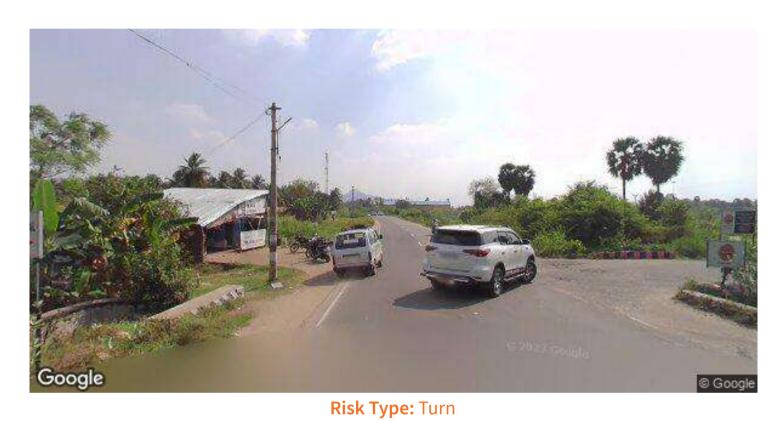
Risk Level: High
Speed Limit: 15 KM/Hr
Coordinates: 11.44029, 77.87544

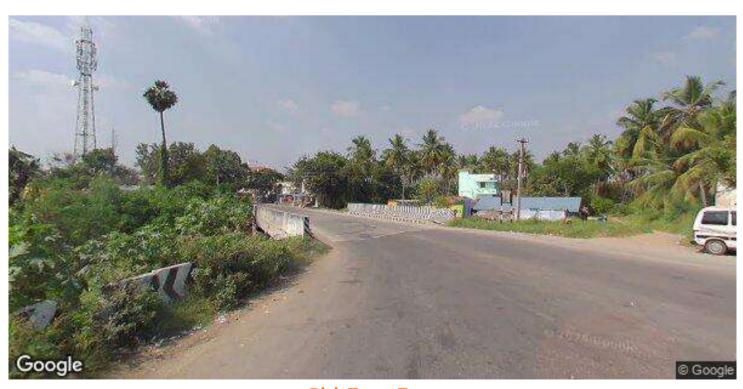
Risk Type: Turn
Risk Level: Medium

Speed Limit: 30 KM/Hr Coordinates: 11.44893, 77.87413

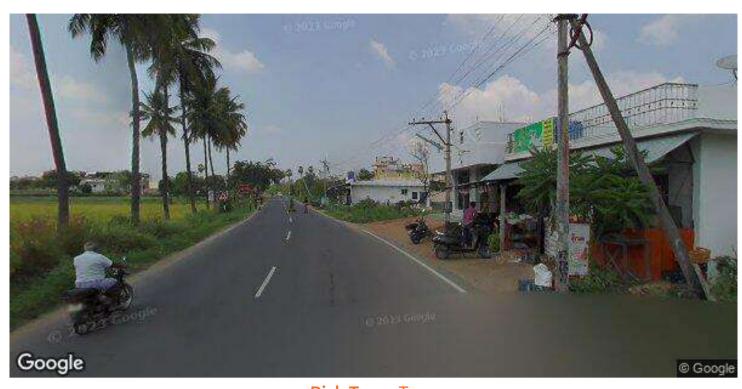
Risk Type: Turn
Risk Level: Medium
Speed Limit: 30 KM/Hr
Coordinates: 11.45127, 77.86734

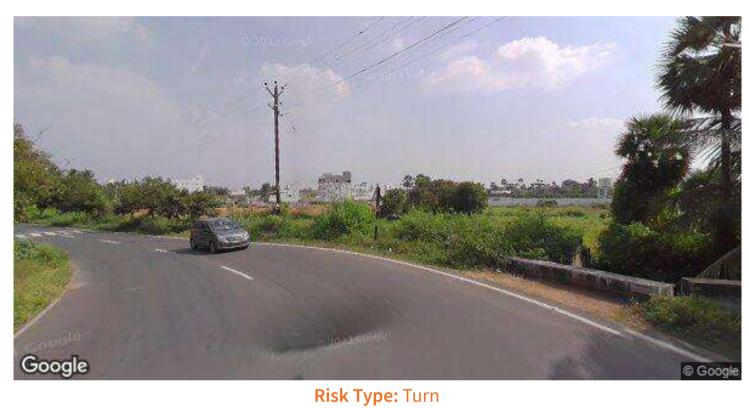
Risk Type: Turn
Risk Level: High
Speed Limit: 15 KM/Hr

**Coordinates:** 11.45350, 77.85700

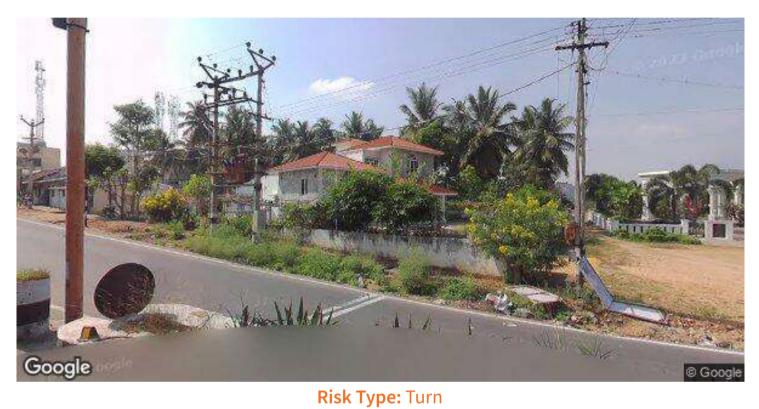
Risk Level: Medium
Speed Limit: 30 KM/Hr
Coordinates: 11.46303, 77.84945

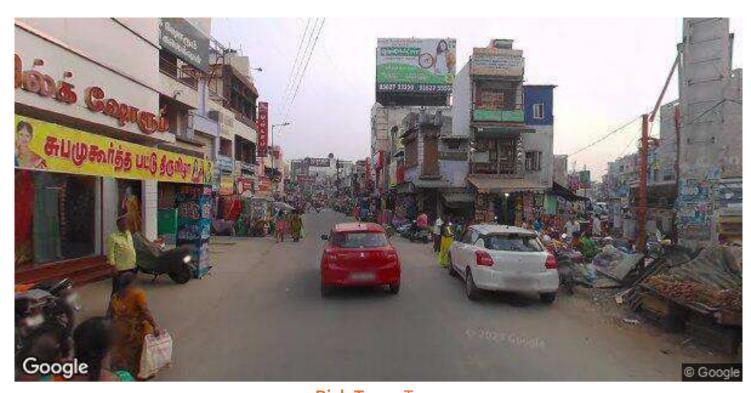
Risk Type: Turn
Risk Level: Medium
Speed Limit: 30 KM/Hr
Coordinates: 11.34172, 77.72823

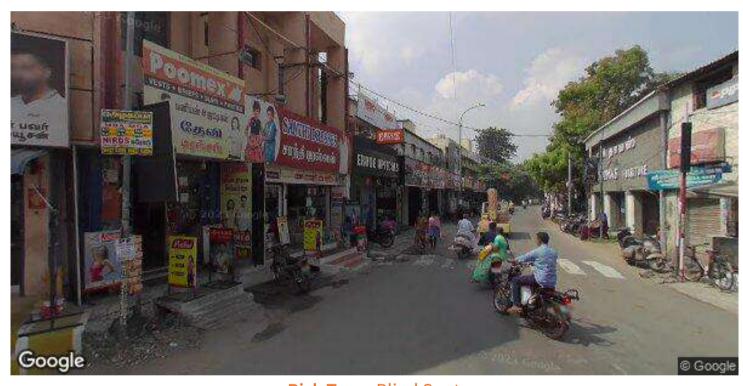
Risk Type: Blind Spot
Risk Level: Blind Spot
Speed Limit: 10 KM/Hr
Coordinates: 11.33920, 77.72902

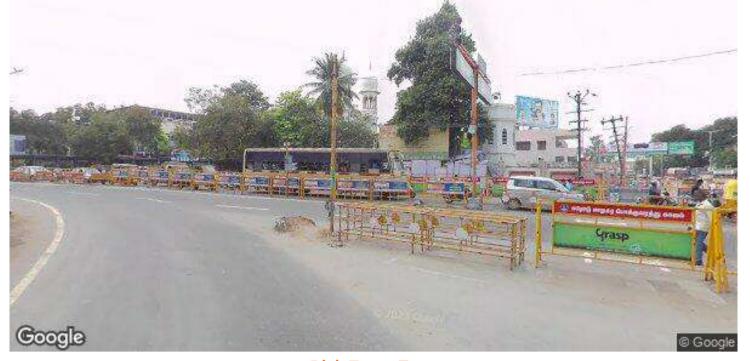
Risk Type: Turn
Risk Level: Medium
Speed Limit: 30 KM/Hr
Coordinates: 11.33909, 77.72653

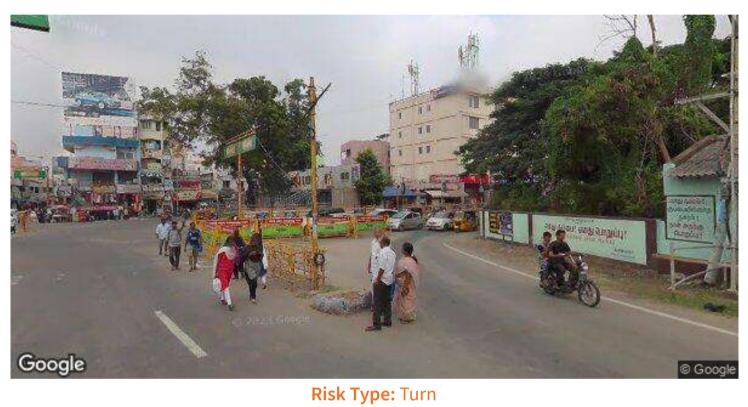
Risk Level: Medium
Speed Limit: 30 KM/Hr
Coordinates: 11.33896, 77.72642

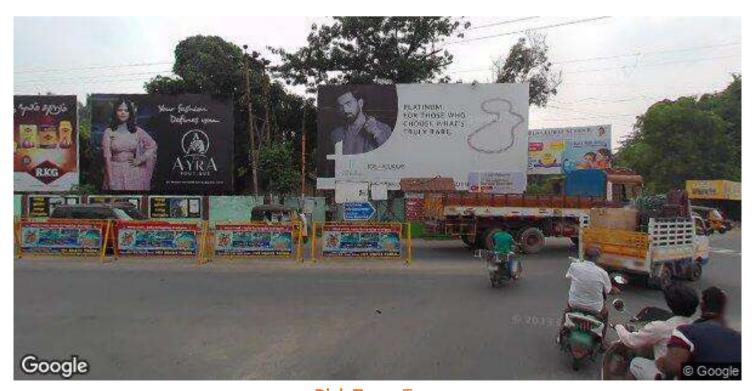
Risk Type: Turn
Risk Level: Medium

Speed Limit: 30 KM/Hr Coordinates: 11.33092, 77.72748

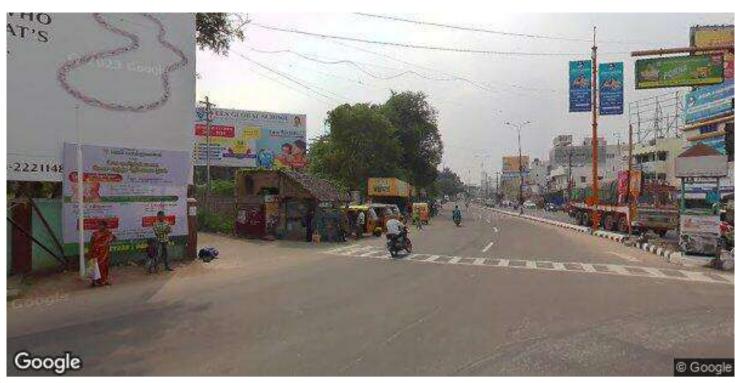
Risk Type: Turn
Risk Level: Medium
Speed Limit: 30 KM/Hr
Coordinates: 11.33085, 77.72744

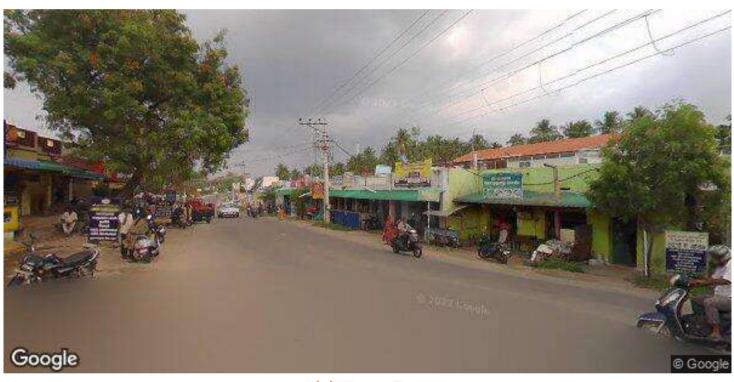
Risk Type: Turn
Risk Level: High
Speed Limit: 15 KM/Hr

**Coordinates:** 11.31172, 77.70715

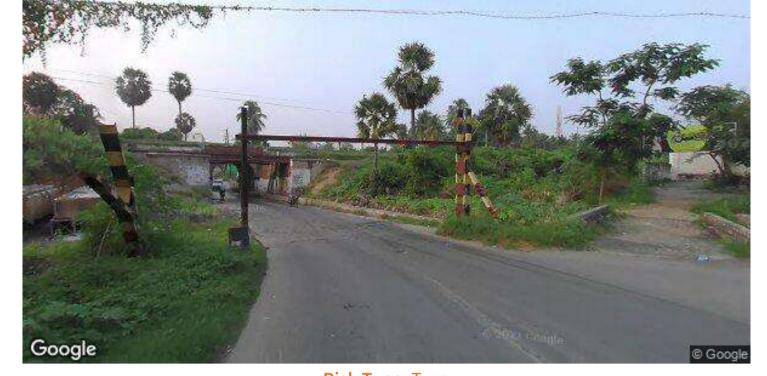
Risk Type: Turn
Risk Level: Medium
Speed Limit: 30 KM/Hr
Coordinates: 11.31043, 77.70784

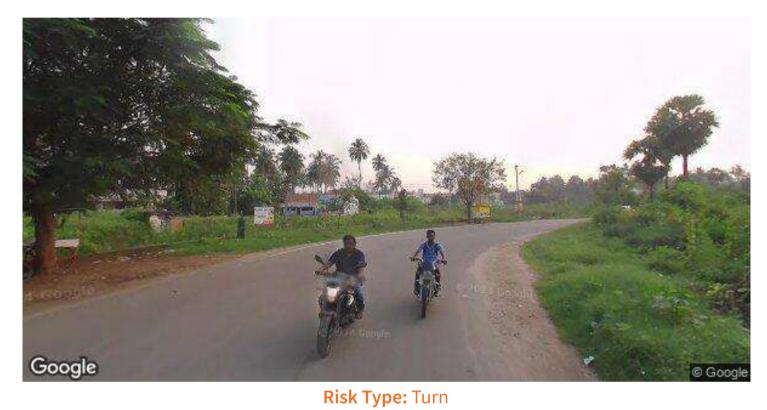
Risk Level: Medium
Speed Limit: 30 KM/Hr
Coordinates: 11.31028, 77.70782

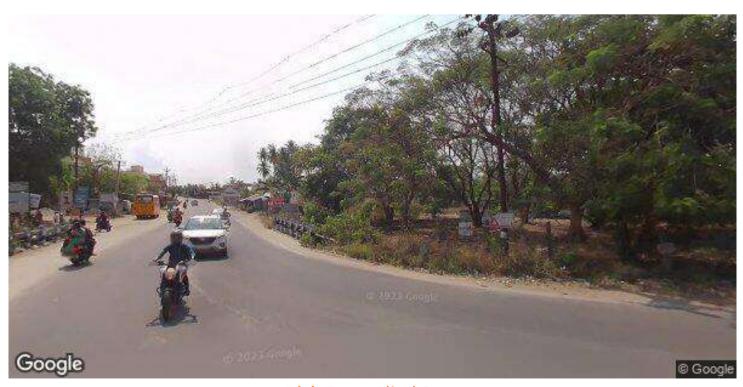
Risk Type: Blind Spot Risk Level: Blind Spot

Speed Limit: 10 KM/Hr Coordinates: 11.23904, 77.66459

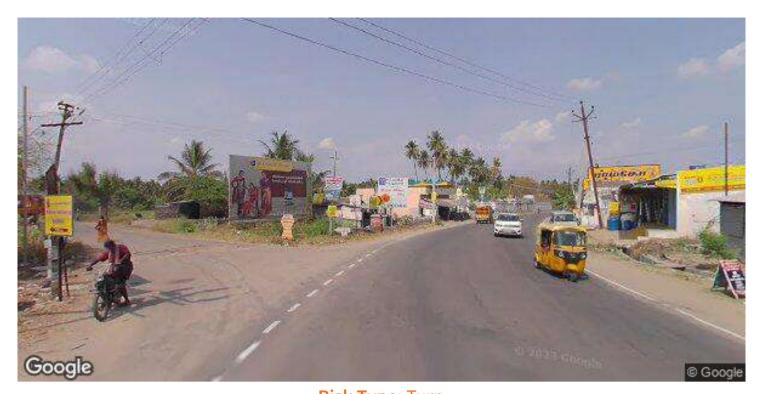
Risk Type: Turn
Risk Level: Medium
Speed Limit: 30 KM/Hr
Coordinates: 11.23843, 77.66240

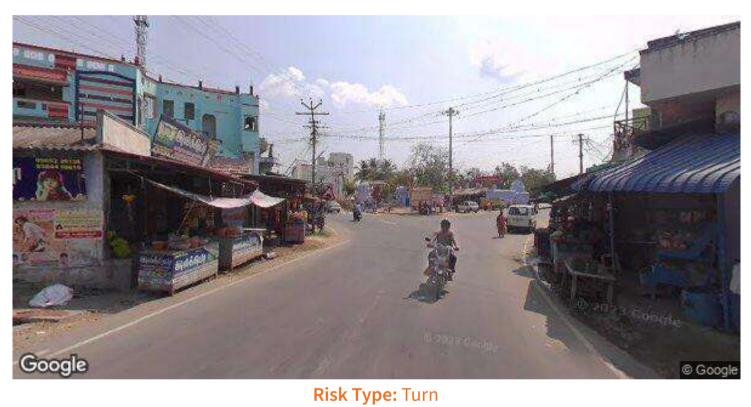
Risk Type: Turn
Risk Level: Medium
Speed Limit: 30 KM/Hr
Coordinates: 11.23750, 77.66185

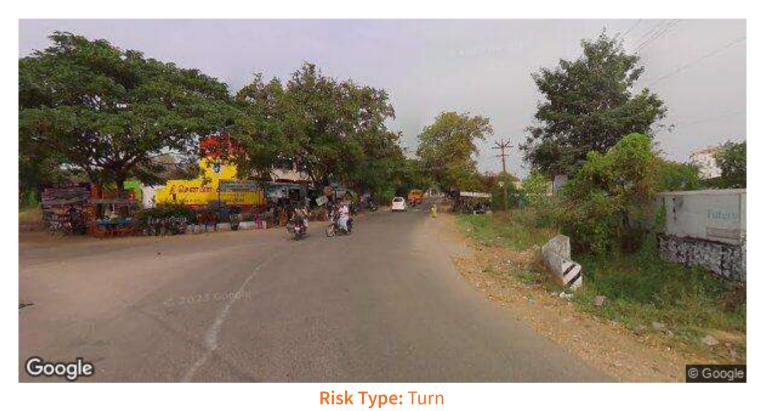
Risk Level: High
Speed Limit: 15 KM/Hr
Coordinates: 11.18700, 77.60980
