JOURNEY RISK MANAGEMENT (JRM) STUDY

Salem Terminal To SRI LAXMI OIL AGENCY

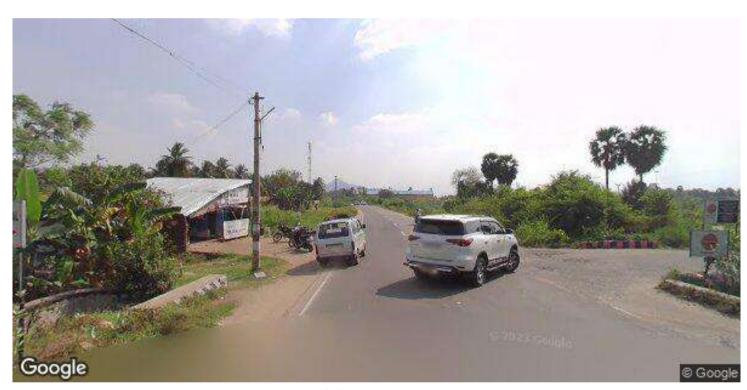
Coordinates: 11.44029, 77.87544

Risk Type: Turn
Risk Level: High
Speed Limit: 15 KM/Hr

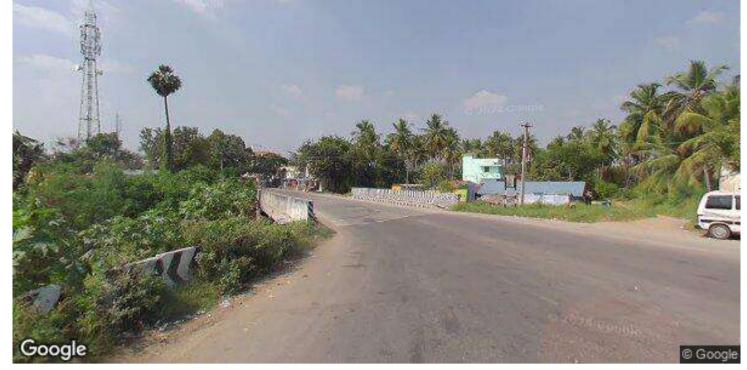
Risk Type: Turn
Risk Level: High
Speed Limit: 15 KM/Hr
Coordinates: 11.44893, 77.87413

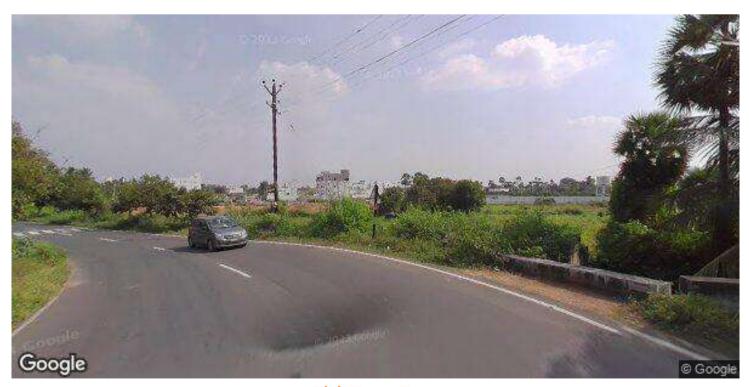
Risk Type: Turn Risk Level: High

Speed Limit: 15 KM/Hr Coordinates: 11.45350, 77.85700

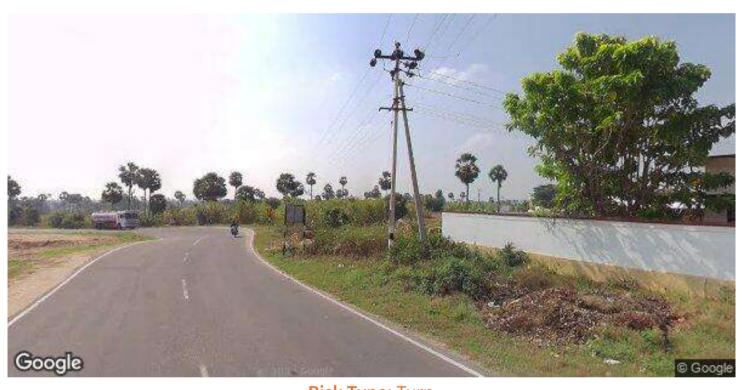
Risk Type: Turn
Risk Level: Medium
Speed Limit: 30 KM/Hr
Coordinates: 11.45889, 77.85136

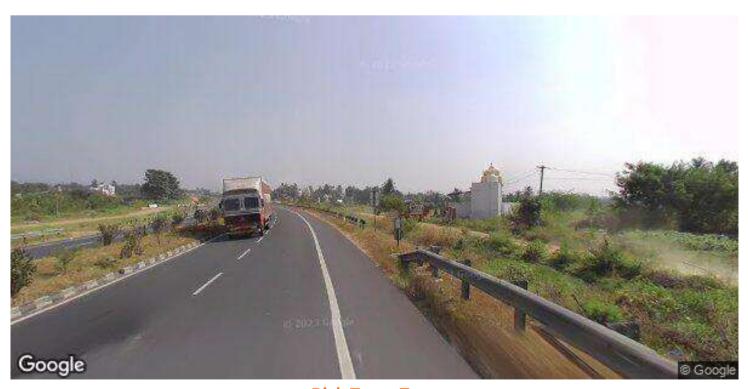
Risk Type: Turn
Risk Level: Medium

Speed Limit: 30 KM/Hr Coordinates: 11.44971, 77.77586

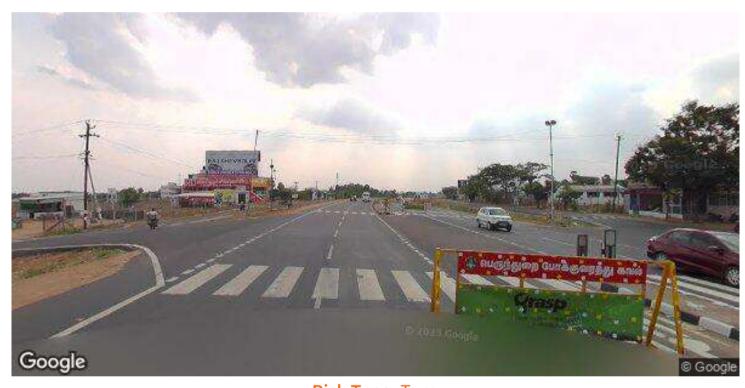
Coordinates: 11.23724, 77.50686

Risk Type: Turn
Risk Level: Medium
Speed Limit: 30 KM/Hr

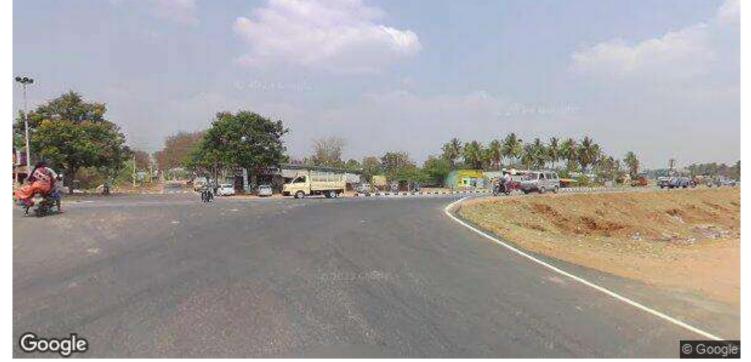
Coordinates: 11.23704, 77.50676

Risk Type: Turn
Risk Level: High
Speed Limit: 15 KM/Hr

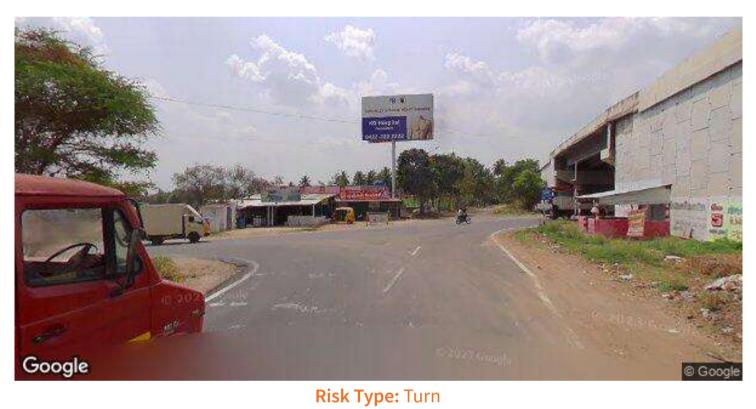
Risk Level: Medium
Speed Limit: 30 KM/Hr
Coordinates: 11.23685, 77.50236

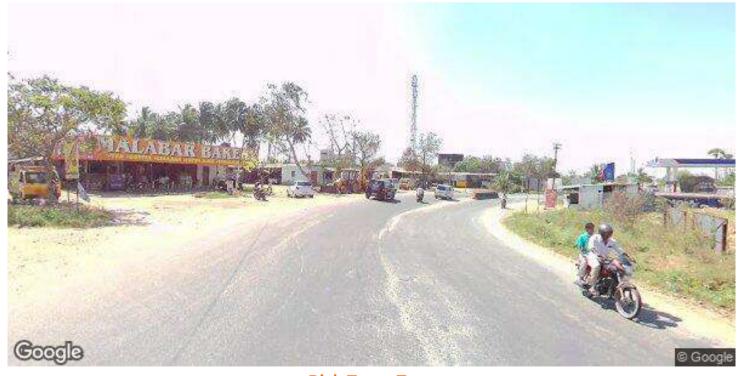
Risk Type: Turn Risk Level: High

Speed Limit: 15 KM/Hr Coordinates: 11.23675, 77.50215

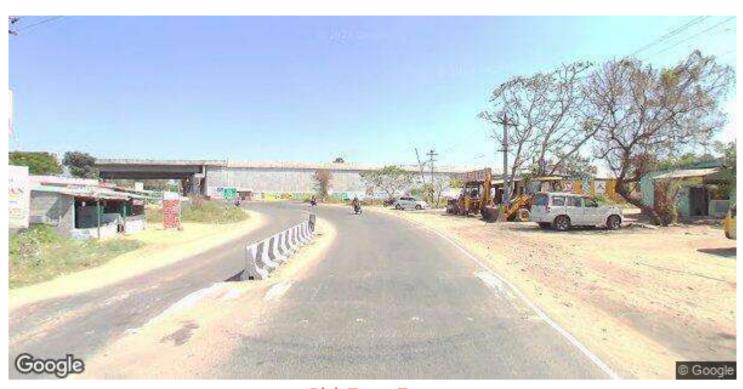
Risk Type: Turn
Risk Level: Medium
Speed Limit: 30 KM/Hr
Coordinates: 11.23622, 77.50210

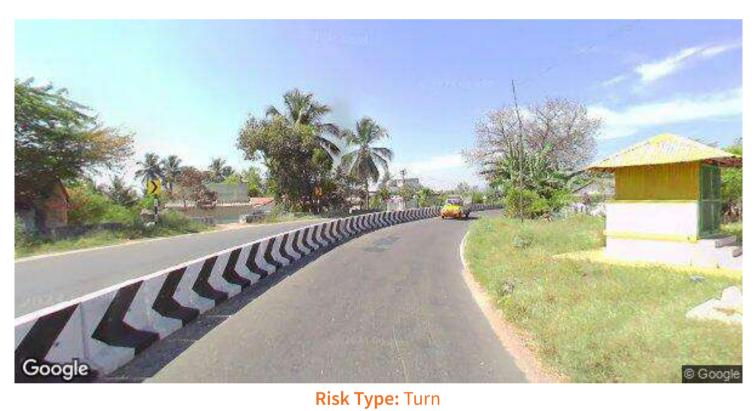
Risk Level: Medium
Speed Limit: 30 KM/Hr
Coordinates: 11.23396, 77.50105

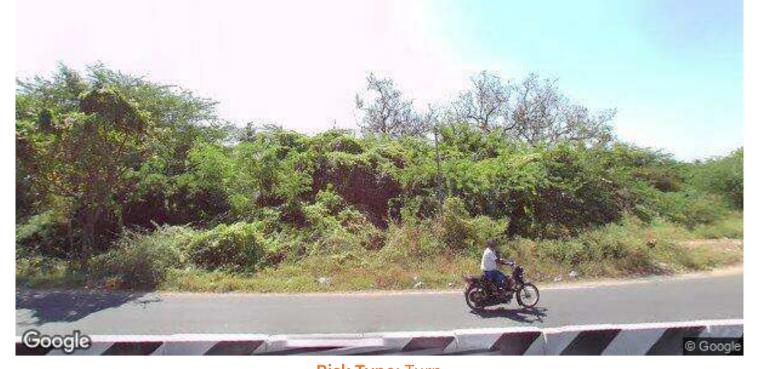
Risk Type: Turn
Risk Level: Medium
Speed Limit: 30 KM/Hr
Coordinates: 11.23329, 77.49966

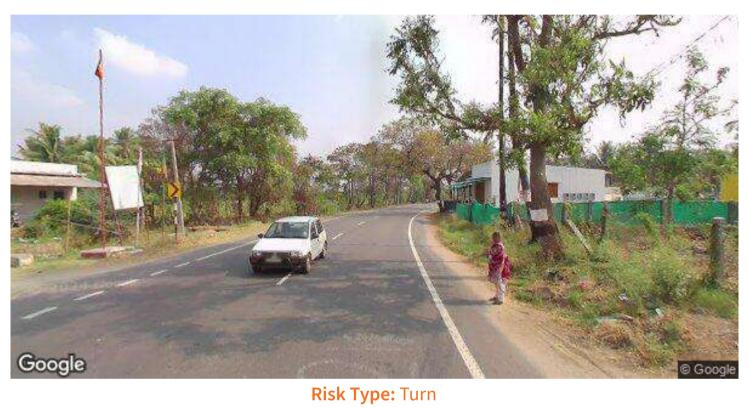
Risk Level: Medium
Speed Limit: 30 KM/Hr
Coordinates: 11.18329, 77.46249

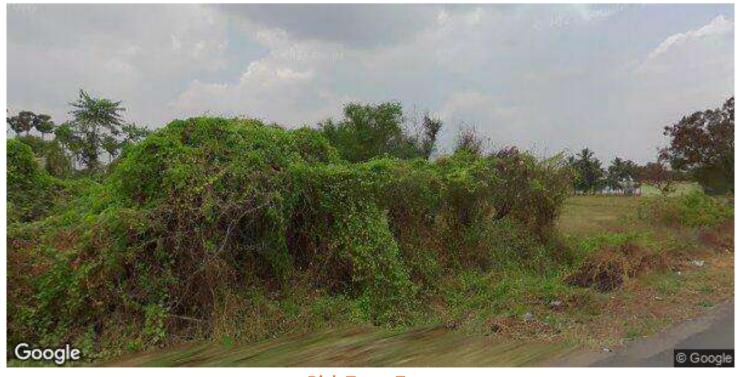
Risk Type: Turn
Risk Level: Medium

Speed Limit: 30 KM/Hr Coordinates: 11.17851, 77.46169

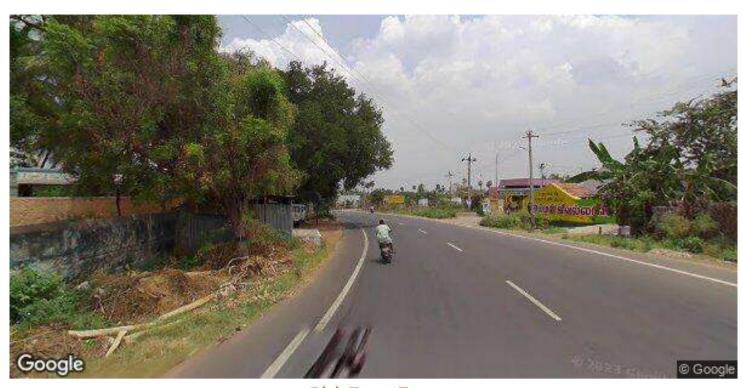
Risk Type: Turn
Risk Level: Medium
Speed Limit: 30 KM/Hr
Coordinates: 11.17497, 77.45961

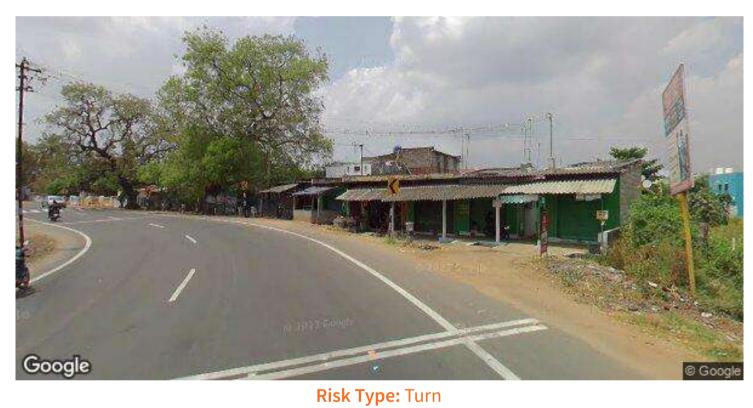
Risk Type. Turn
Risk Level: Medium
Speed Limit: 30 KM/Hr
Coordinates: 11.17383, 77.45750

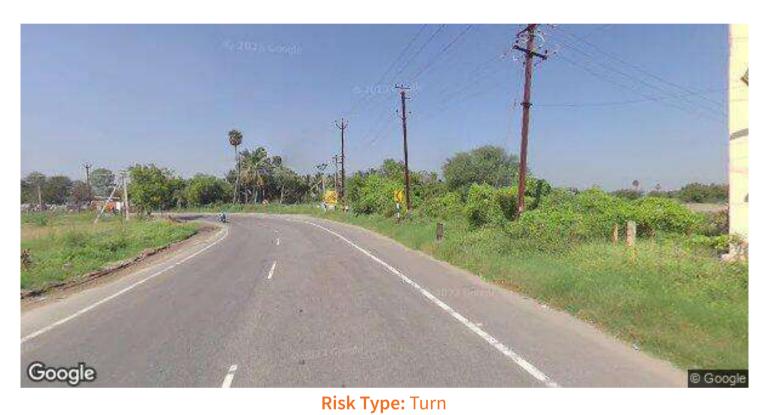
Risk Level: Medium
Speed Limit: 30 KM/Hr
Coordinates: 11.16959, 77.44438

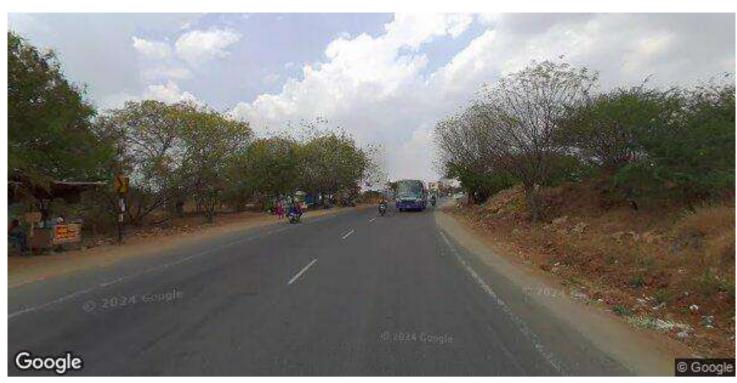
Risk Type: Turn
Risk Level: Medium
Speed Limit: 30 KM/Hr
Coordinates: 11.16364, 77.43649

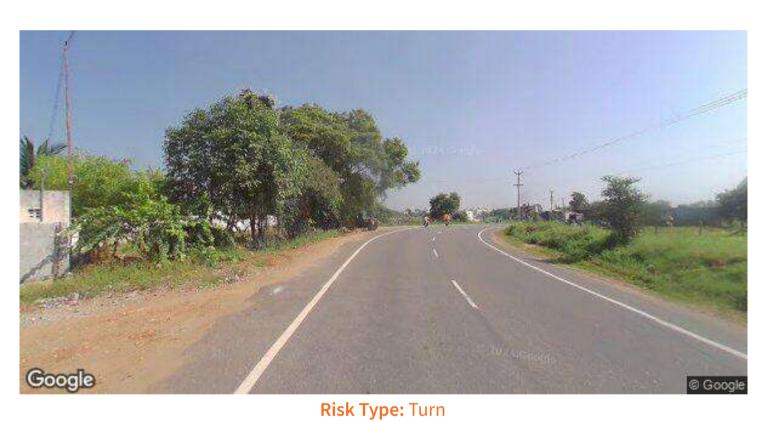
Risk Level: Medium
Speed Limit: 30 KM/Hr
Coordinates: 11.16259, 77.43103

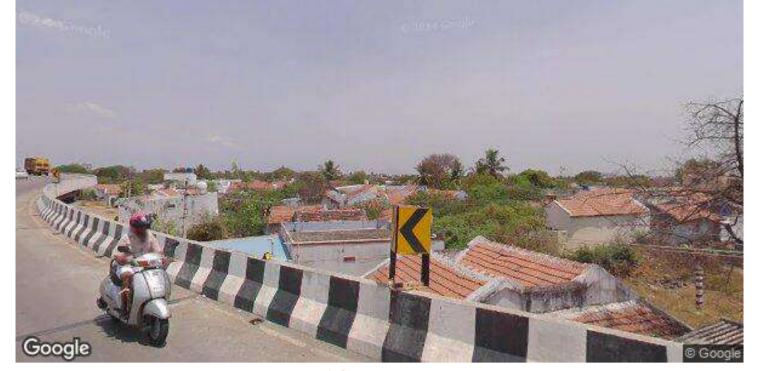
Risk Type: Turn
Risk Level: Medium
Speed Limit: 30 KM/Hr
Coordinates: 11.15161, 77.42320

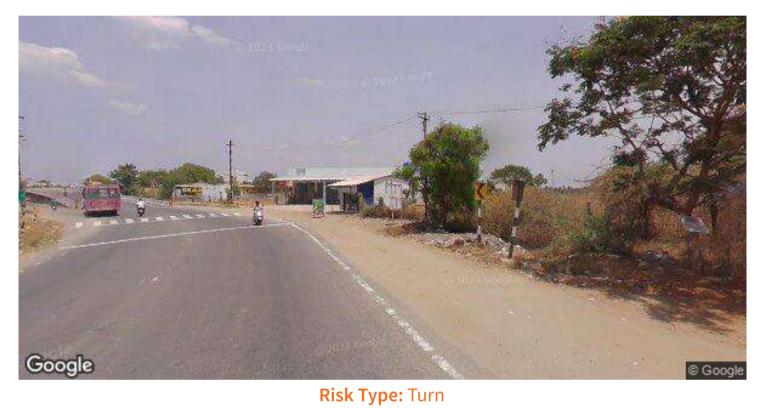
Risk Level: Medium
Speed Limit: 30 KM/Hr
Coordinates: 11.14985, 77.42215

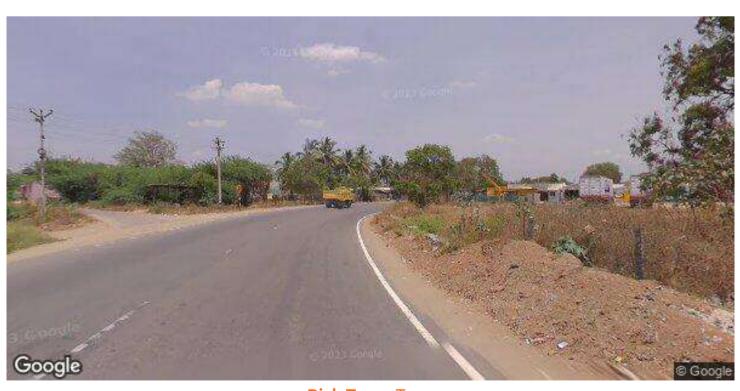
Risk Type: Turn
Risk Level: Medium

Speed Limit: 30 KM/Hr Coordinates: 11.14892, 77.42022

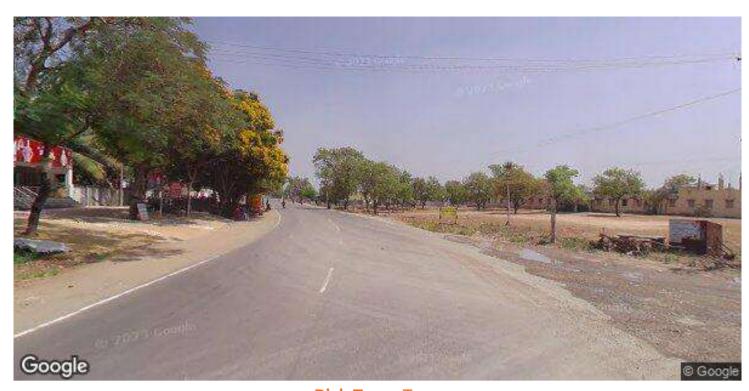
Risk Type: Turn
Risk Level: Medium
Speed Limit: 30 KM/Hr
Coordinates: 11.13893, 77.41649

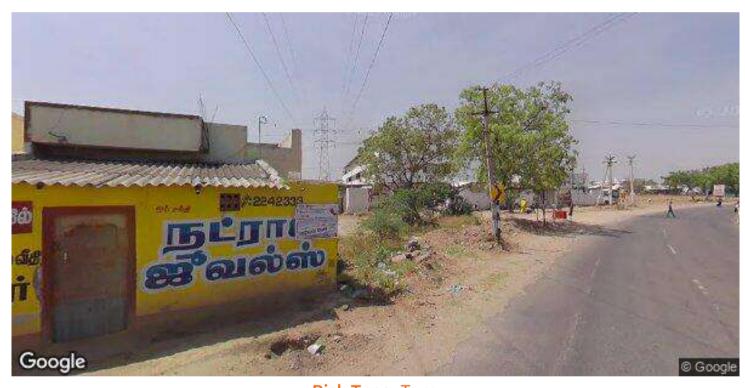
Risk Type: Turn
Risk Level: Medium
Speed Limit: 30 KM/Hr
Coordinates: 11.13578, 77.41299

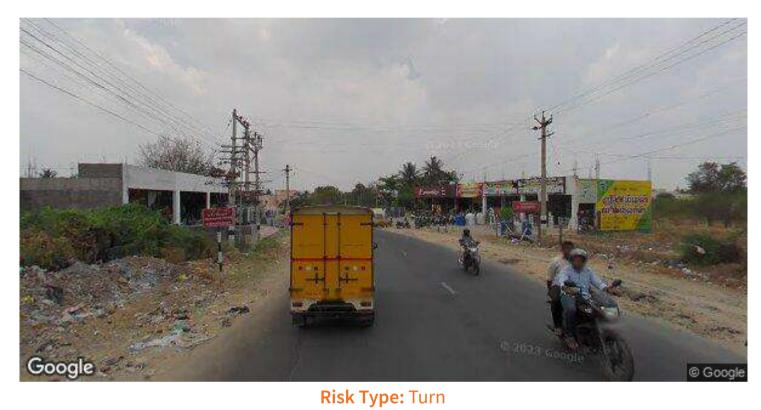
Risk Level: Medium
Speed Limit: 30 KM/Hr
Coordinates: 11.12475, 77.38681

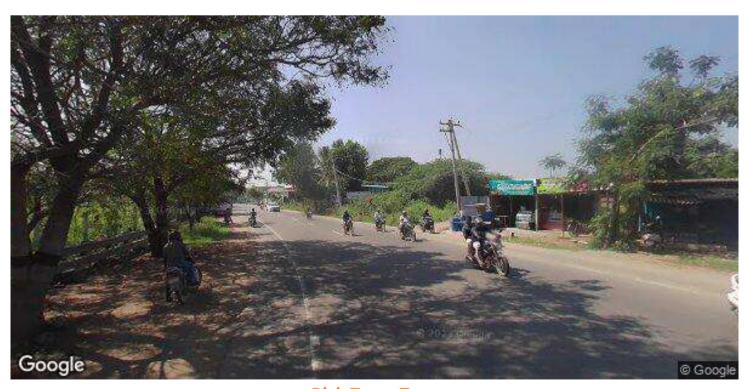
Risk Type: Turn
Risk Level: Medium

Speed Limit: 30 KM/Hr Coordinates: 11.12251, 77.38307

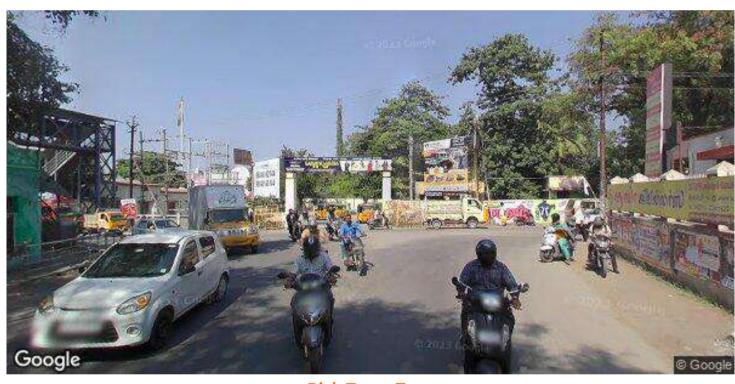
Risk Type: Turn
Risk Level: High
Speed Limit: 15 KM/Hr
Coordinates: 11.10780, 77.34080

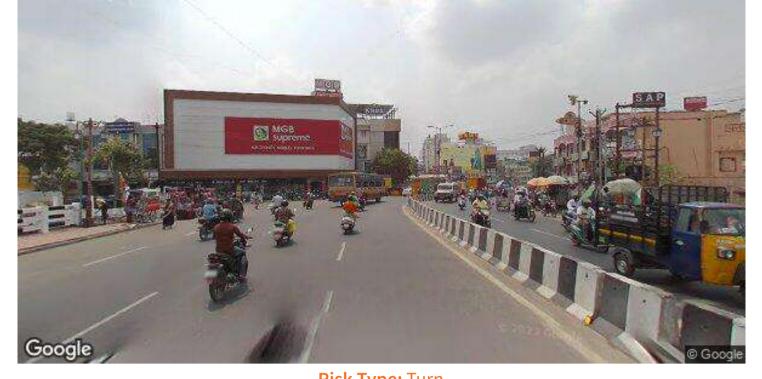
Risk Type: Turn
Risk Level: Medium
Speed Limit: 30 KM/Hr
Coordinates: 11.10310, 77.34634

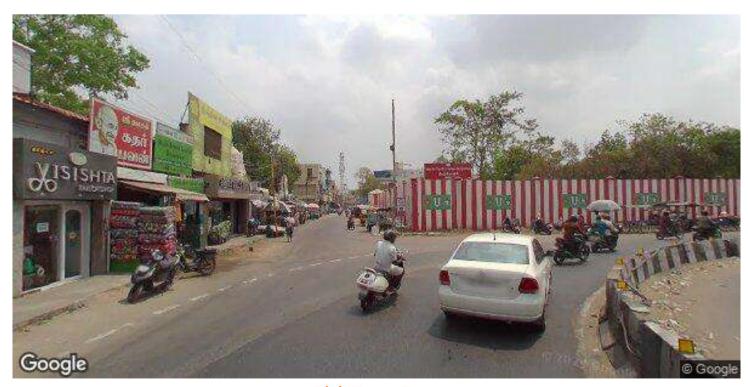
Risk Type: Turn Risk Level: High Speed Limit: 15 KM/Hr Coordinates: 11.10159, 77.34796

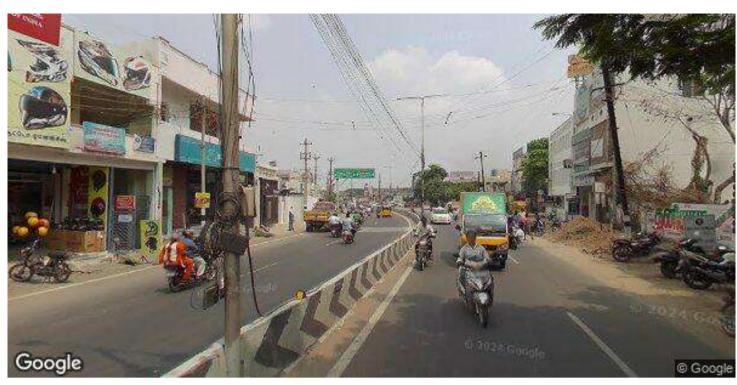
Risk Type: Turn
Risk Level: Medium
Speed Limit: 30 KM/Hr
Coordinates: 11.08626, 77.34604

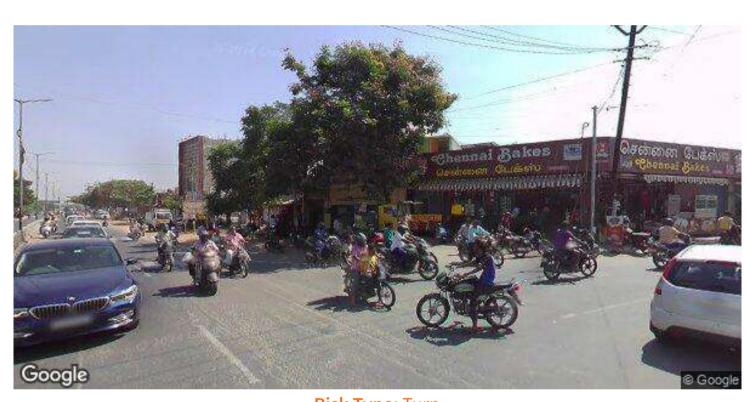
Coordinates: 11.06204, 77.33852

Risk Type: Turn
Risk Level: High
Speed Limit: 15 KM/Hr

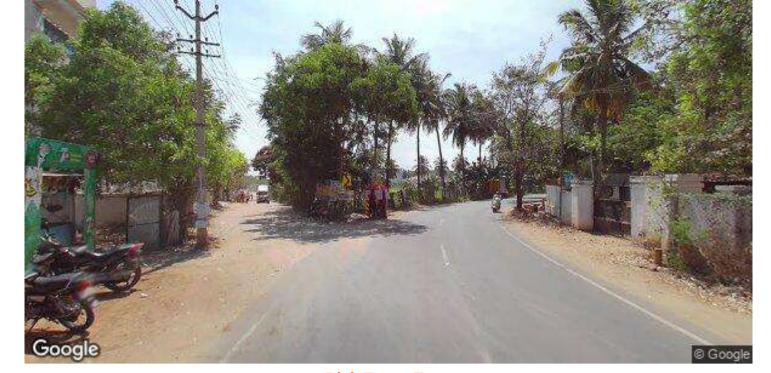
Risk Type: Turn
Risk Level: Medium
Speed Limit: 30 KM/Hr
Coordinates: 11.06050, 77.34154
