JOURNEY RISK MANAGEMENT (JRM) STUDY

Salem Terminal TO DR NGP MOTOR AGENCY

Route Photos of Risky Spots

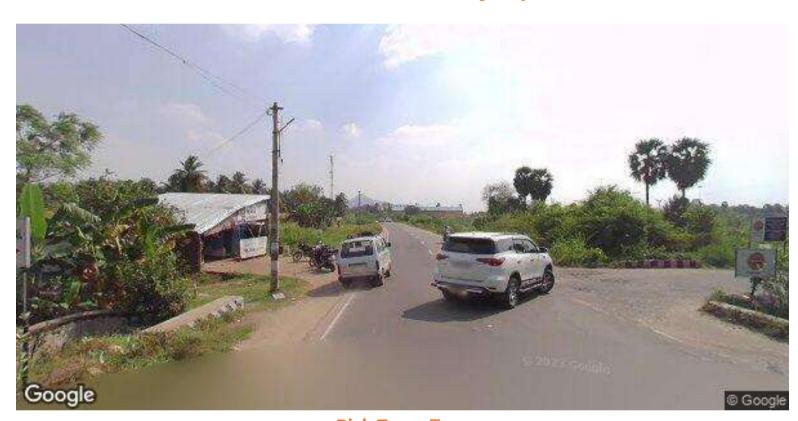
Risk Type: Turn
Risk Level: High
Speed Limit: 15 KM/Hr
Coordinates: 11.44029, 77.87544

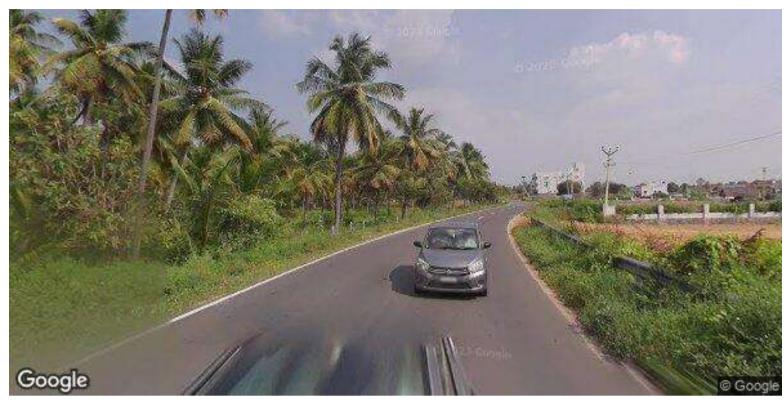
Coordinates: 11.45357, 77.85789

Risk Type: Turn
Risk Level: Medium
Speed Limit: 30 KM/Hr

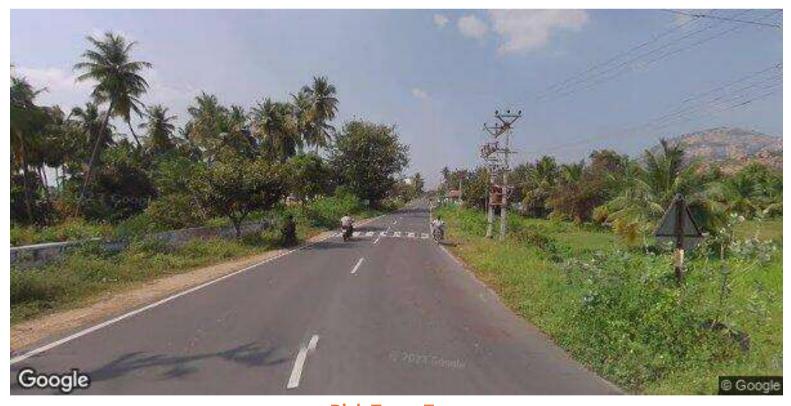
Coordinates: 11.45352, 77.85698

Risk Type: Turn
Risk Level: Medium
Speed Limit: 30 KM/Hr

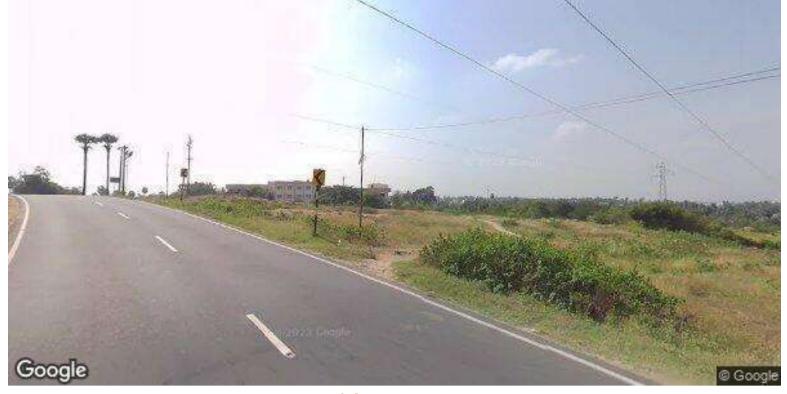
Risk Type: Turn
Risk Level: Medium
Speed Limit: 30 KM/Hr
Coordinates: 11.46048, 77.85036

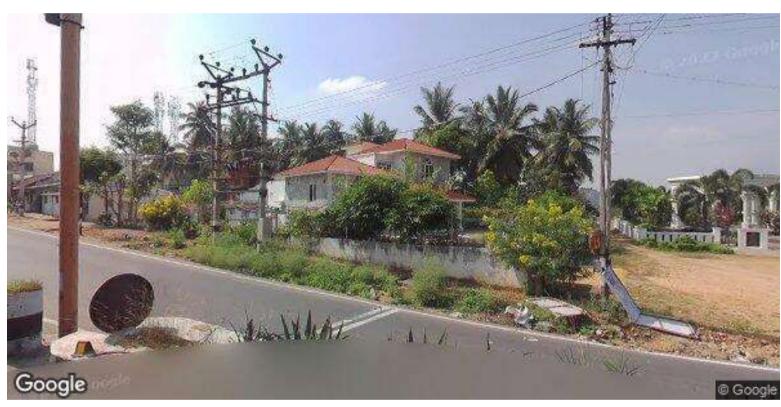
Risk Type: Turn
Risk Level: Medium
Speed Limit: 30 KM/Hr
Coordinates: 11.46303, 77.84945

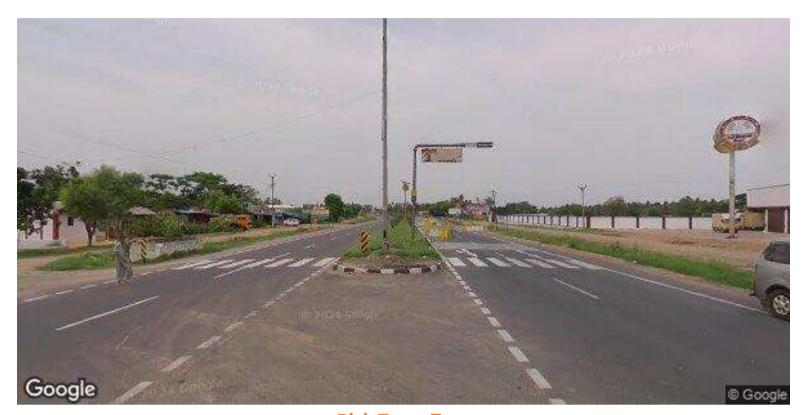
Coordinates: 11.34315, 77.63670

Risk Type: Turn
Risk Level: High
Speed Limit: 15 KM/Hr

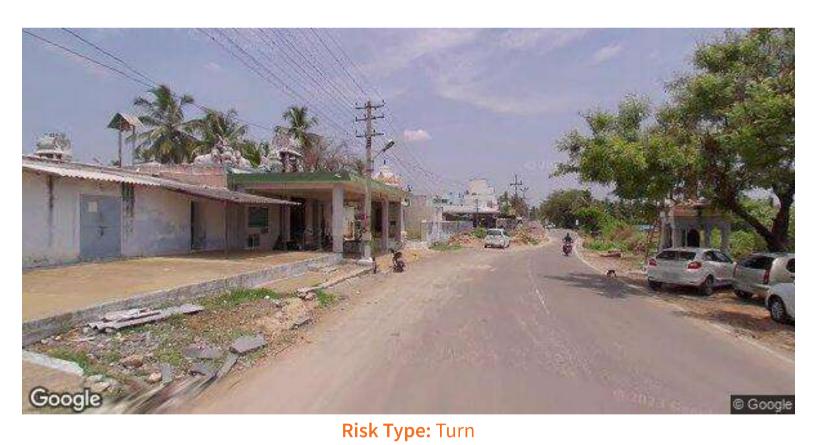
Coordinates: 11.33890, 77.63610

Risk Level: High
Speed Limit: 15 KM/Hr

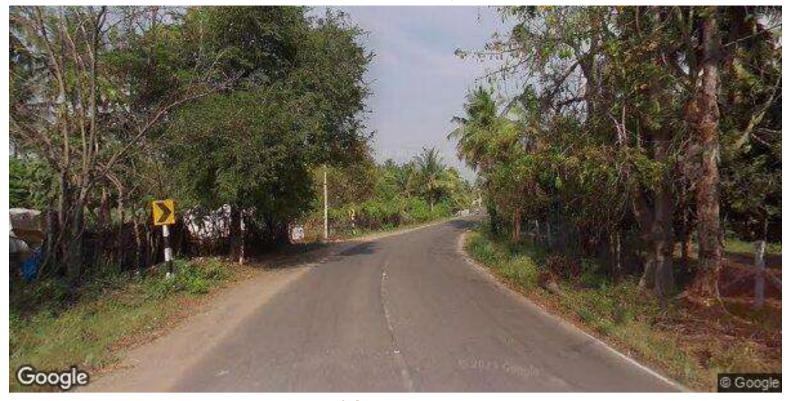
Risk Type: Turn
Risk Level: Medium
Speed Limit: 30 KM/Hr
Coordinates: 11.34241, 77.61957

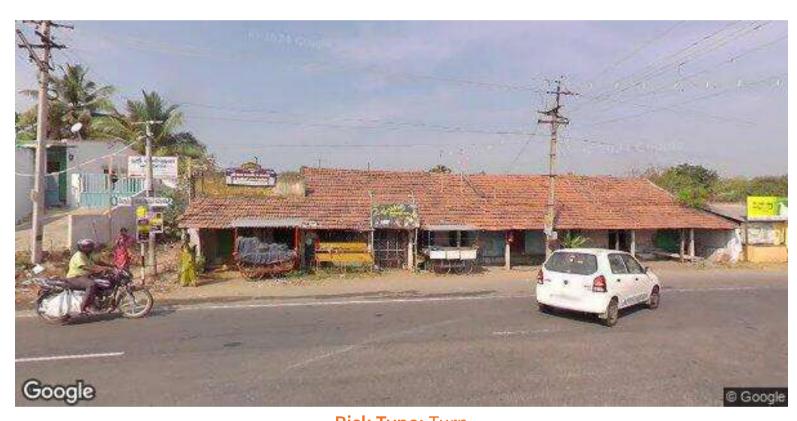
Risk Type: Turn
Risk Level: High
Speed Limit: 15 KM/Hr
Coordinates: 11.34865, 77.59559

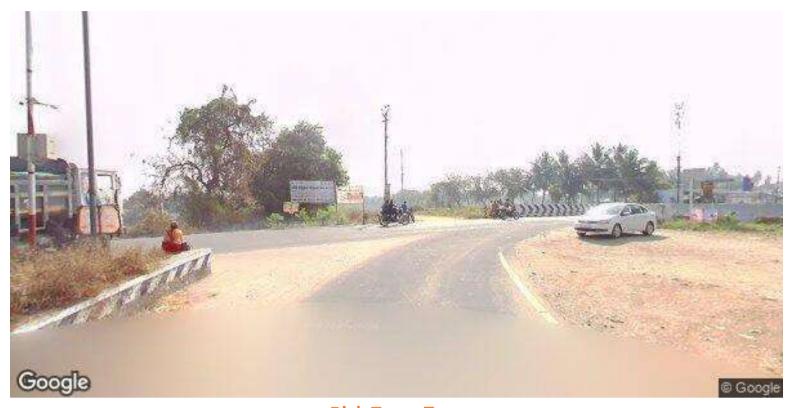
Risk Type: Turn
Risk Level: Medium
Speed Limit: 30 KM/Hr
Coordinates: 11.35165, 77.59474

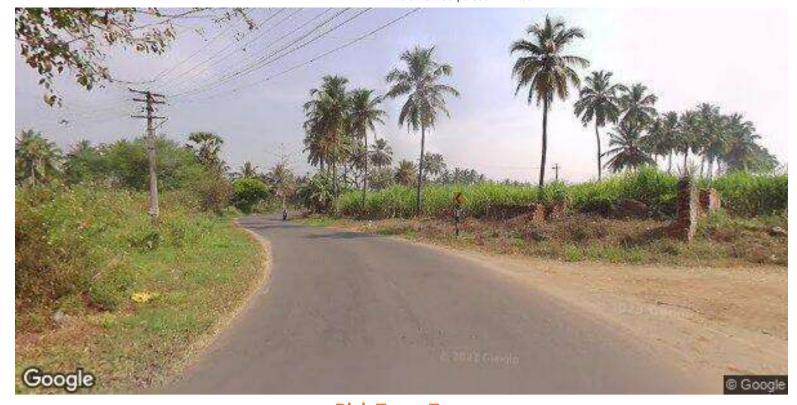
Risk Type: Turn
Risk Level: Medium
Speed Limit: 30 KM/Hr
Coordinates: 11.35106, 77.57318
