# JOURNEY RISK MANAGEMENT (JRM) STUDY

# IOCL Coimbatore Terminal to Vedhanayagam Oil Company

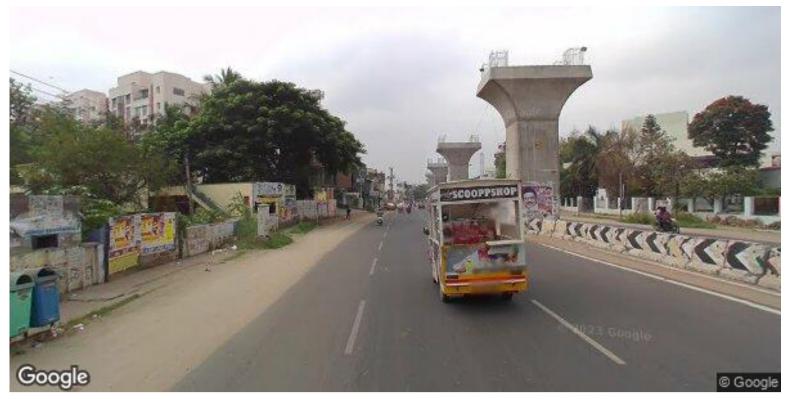
**Coordinates:** 11.0161282, 76.9896128

Risk Type: U-Turn
Risk Level: High
Speed Limit: 10 KM/Hr

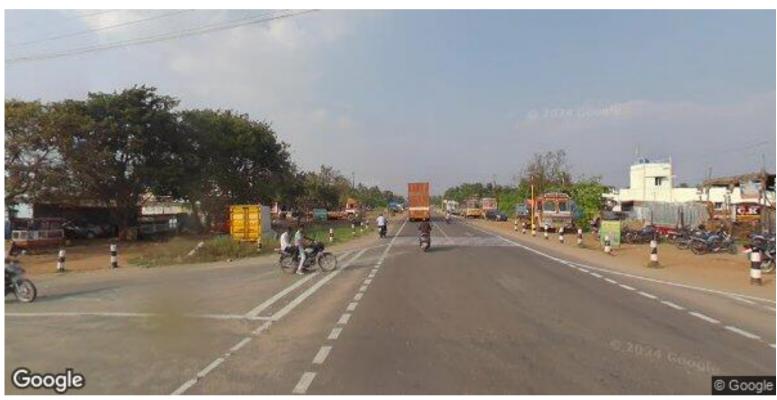
**Coordinates:** 11.03211, 77.07640

Risk Type: Turn
Risk Level: High
Speed Limit: 15 KM/Hr

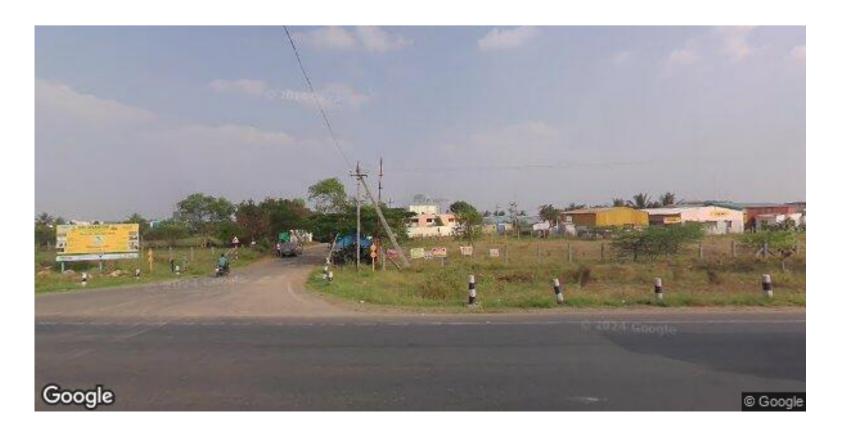
**Coordinates:** 11.05129, 77.07919

Risk Type: Turn
Risk Level: High
Speed Limit: 15 KM/Hr

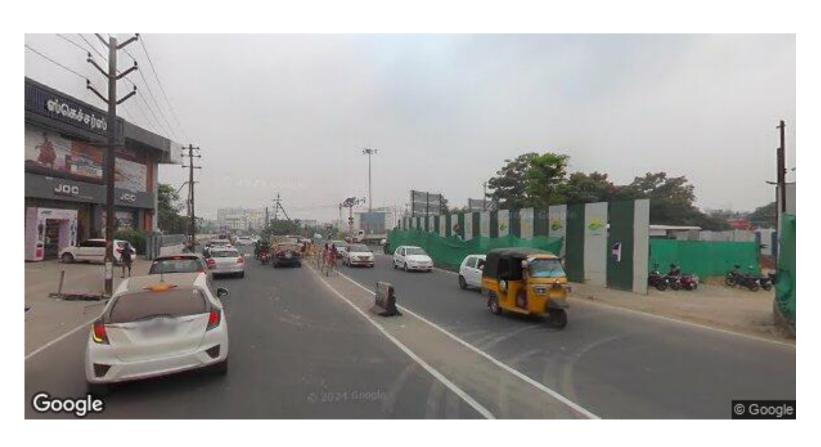
**Coordinates:** 11.02051, 76.99177

Risk Type: Turn
Risk Level: Medium
Speed Limit: 30 KM/Hr

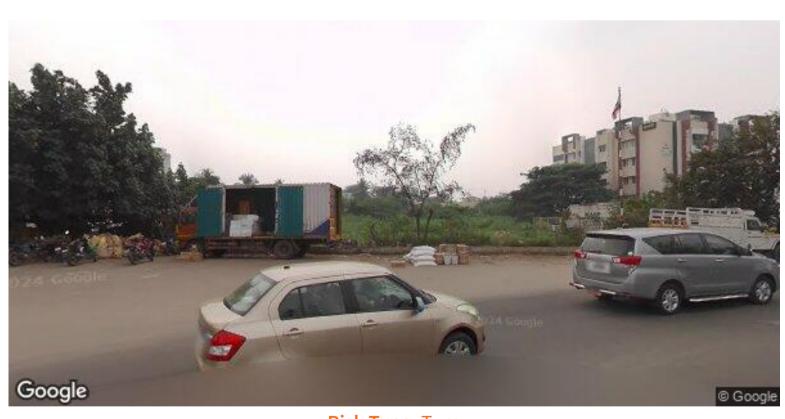
Risk Type: Turn
Risk Level: High
Speed Limit: 15 KM/Hr
Coordinates: 11.02097, 76.98650

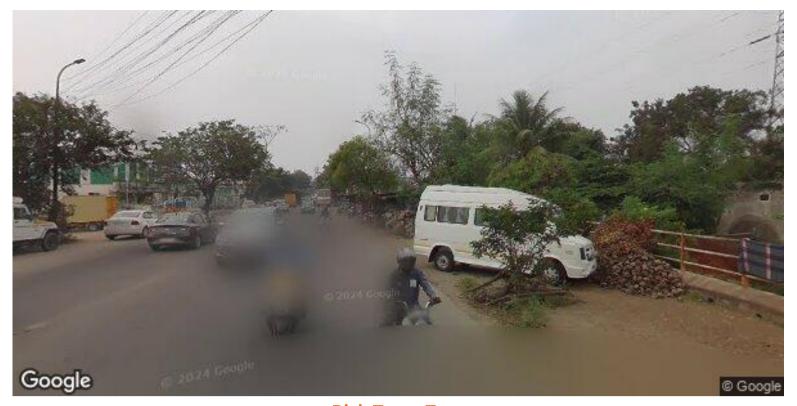
Risk Type: Turn
Risk Level: Medium
Speed Limit: 30 KM/Hr
Coordinates: 11.02095, 76.98644

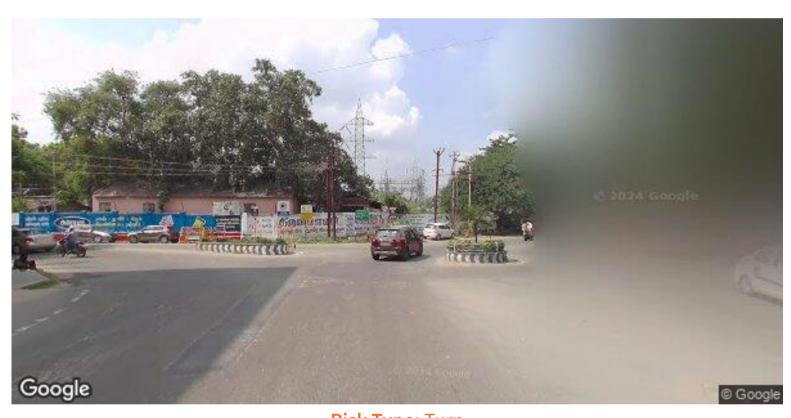
Risk Type: Turn
Risk Level: Medium
Speed Limit: 30 KM/Hr
Coordinates: 11.01886, 76.96047

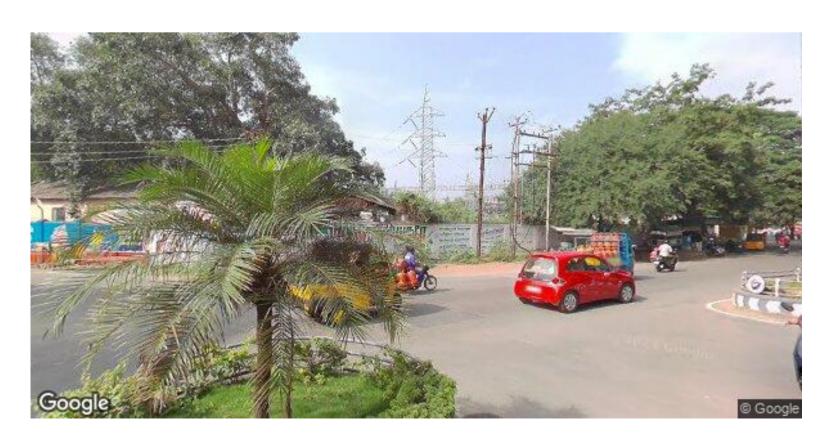
**Coordinates:** 11.01891, 76.96036

Risk Type: Turn
Risk Level: High
Speed Limit: 15 KM/Hr

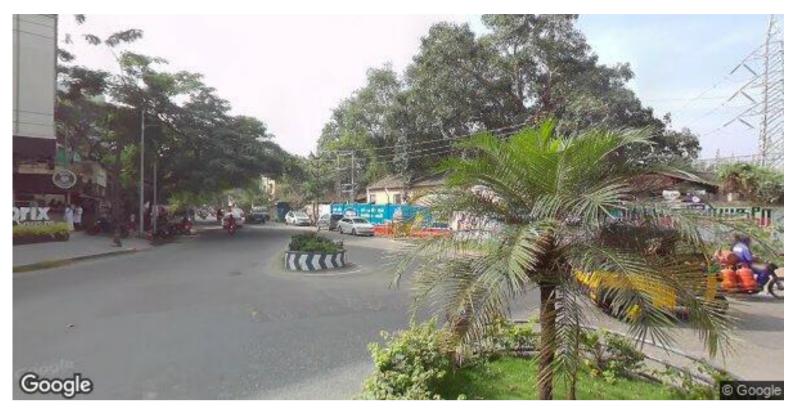
**Coordinates:** 11.01889, 76.96035

Risk Type: Turn
Risk Level: High
Speed Limit: 15 KM/Hr

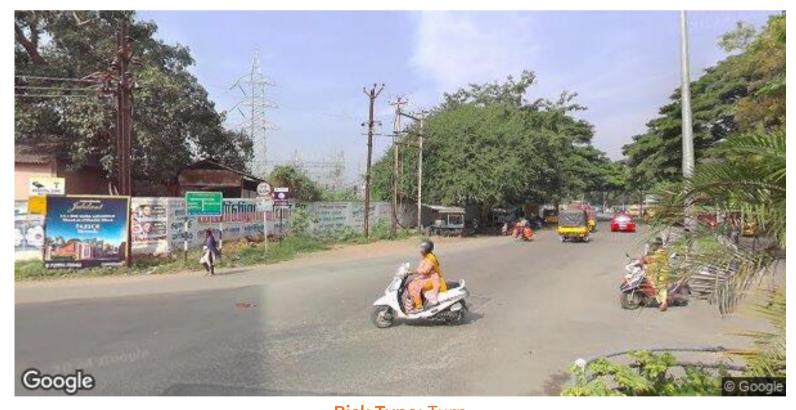
**Coordinates:** 11.01889, 76.96029

Risk Type: Turn
Risk Level: Medium
Speed Limit: 30 KM/Hr

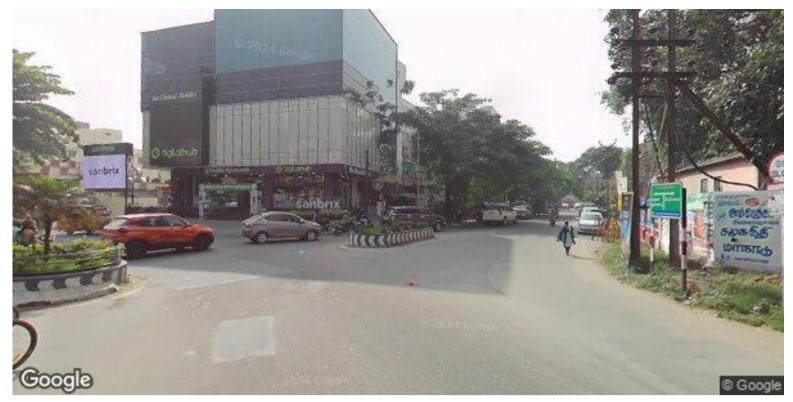
Risk Type: Turn
Risk Level: High
Speed Limit: 15 KM/Hr
Coordinates: 11.01893, 76.96023

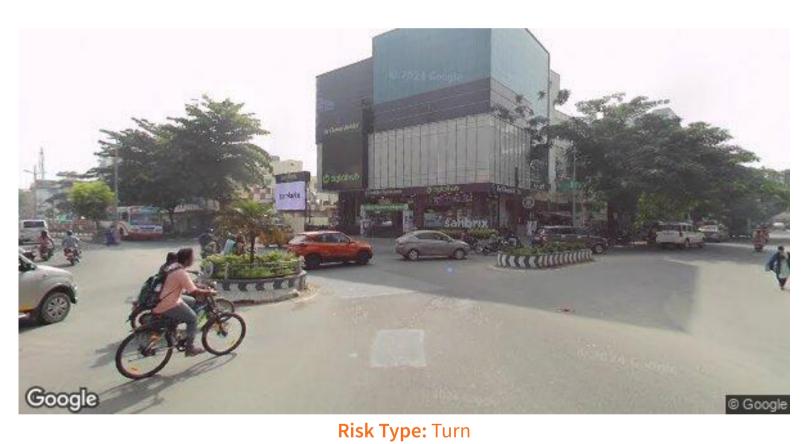
Risk Level: High
Speed Limit: 15 KM/Hr
Coordinates: 11.01895, 76.96023

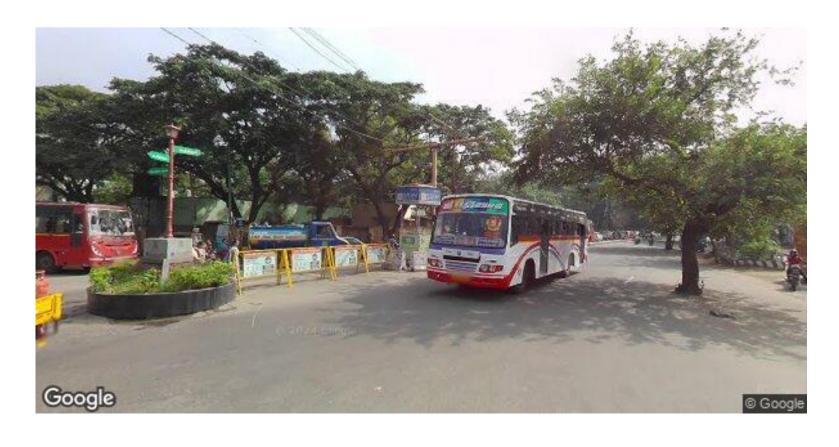
**Coordinates:** 11.01944, 76.95923

Risk Type: Turn
Risk Level: High
Speed Limit: 15 KM/Hr

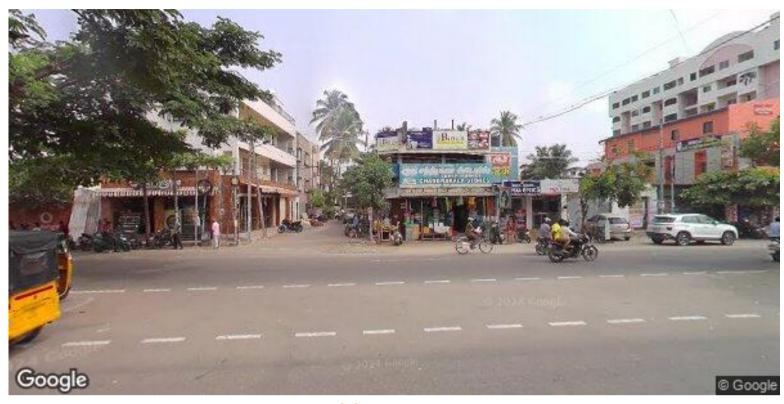
**Coordinates:** 11.02444, 76.95905

Risk Type: Turn
Risk Level: High
Speed Limit: 15 KM/Hr

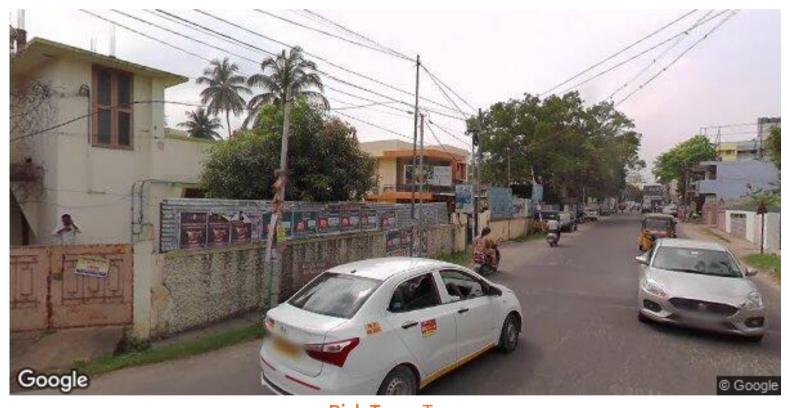
**Coordinates:** 11.02504, 76.95710

Risk Type: Turn
Risk Level: High
Speed Limit: 15 KM/Hr

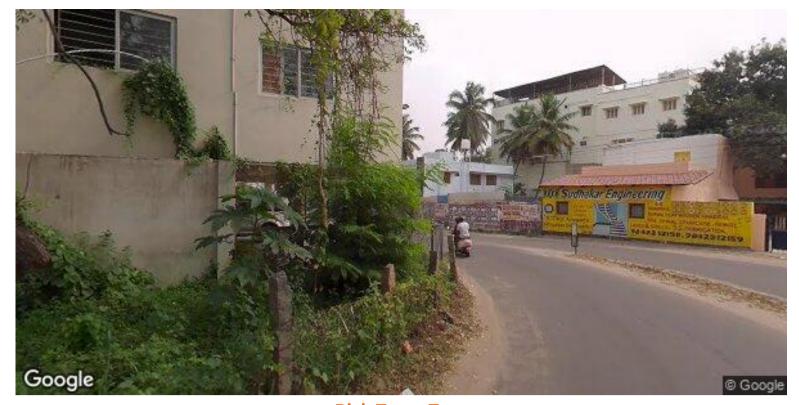
Risk Type: Turn
Risk Level: Medium
Speed Limit: 30 KM/Hr
Coordinates: 11.02503, 76.95553

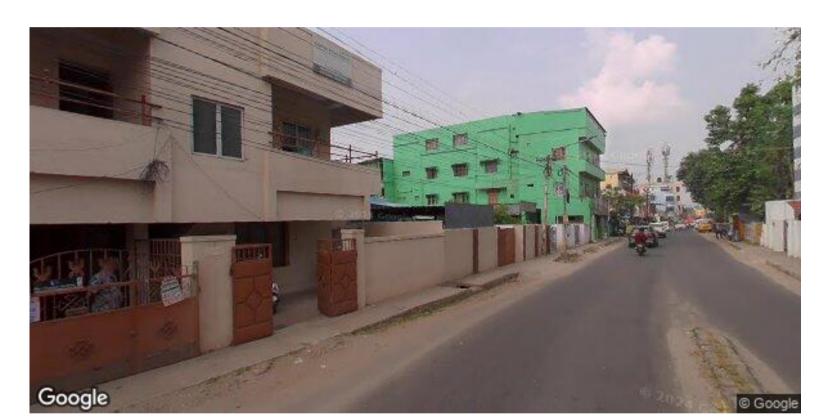
Risk Type: Turn
Risk Level: Medium
Speed Limit: 30 KM/Hr
Coordinates: 11.02514, 76.95541

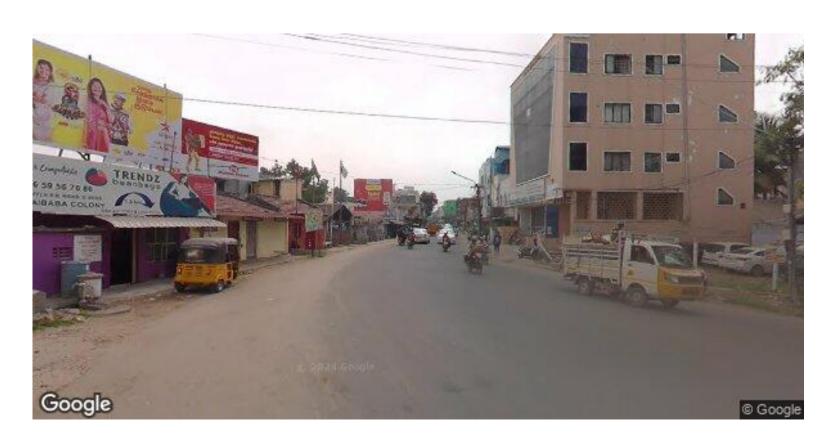
**Coordinates:** 11.02696, 76.95577

Risk Type: Turn
Risk Level: High
Speed Limit: 15 KM/Hr

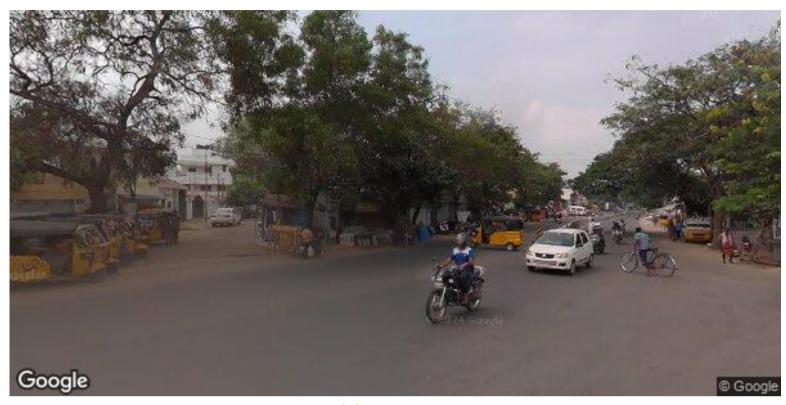
**Coordinates:** 11.02700, 76.95569

Risk Type: Turn
Risk Level: Medium
Speed Limit: 30 KM/Hr

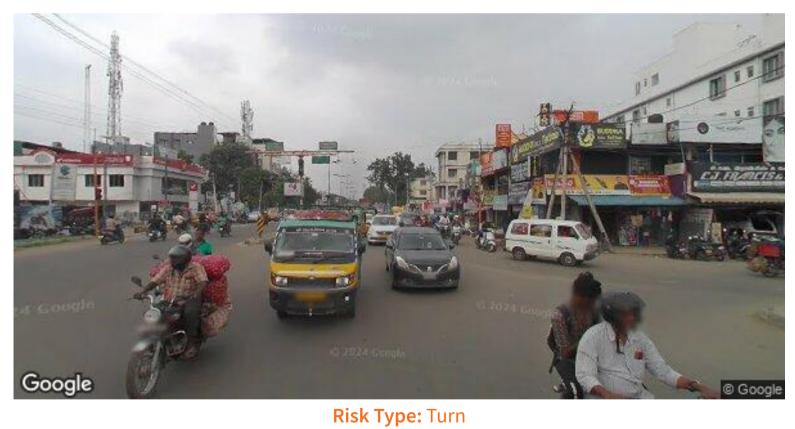
**Coordinates:** 11.02838, 76.95130

Risk Type: Turn
Risk Level: High
Speed Limit: 15 KM/Hr

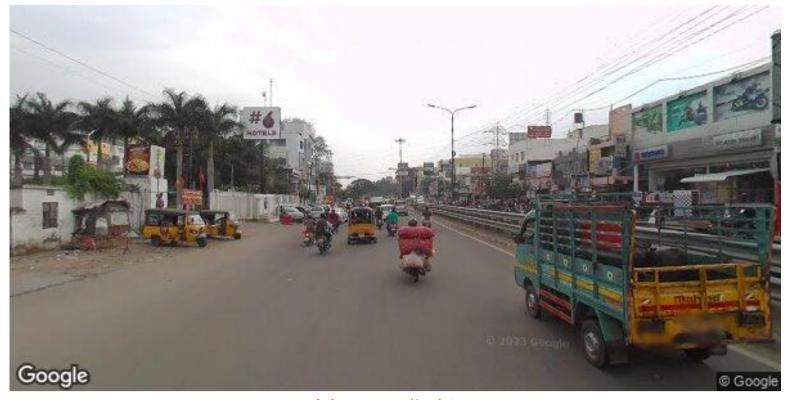
**Coordinates:** 11.02760, 76.95134

Risk Type: Blind Spot
Risk Level: Blind Spot
Speed Limit: 10 KM/Hr
