JOURNEY RISK MANAGEMENT (JRM) STUDY

Salem Terminal TO ERODE PRECISION FARM PRODUCER

Route Analysis Report from CVQF+23W, Sangagiri to 4RG3+9C6, SH 84C, Tamil Nadu

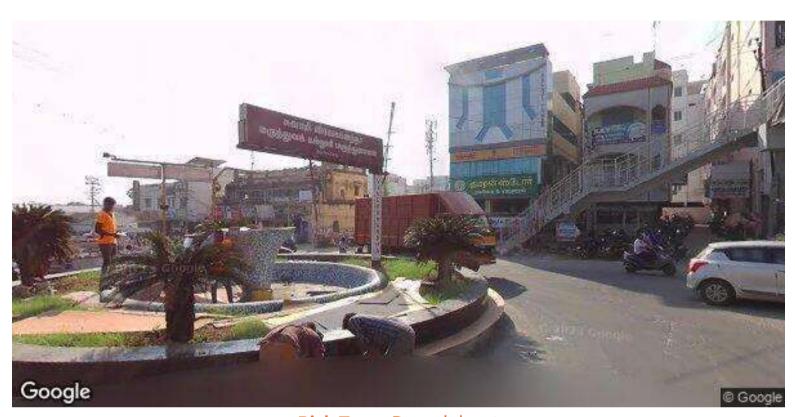
Coordinates: 11.38395, 77.89480

Risk Type: Roundabout
Risk Level: High
Speed Limit: 15 KM/Hr

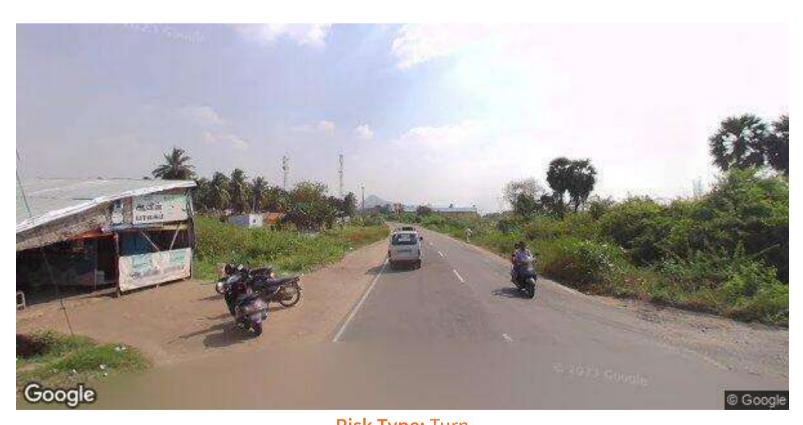
Coordinates: 11.44022, 77.87546

Risk Type: Turn
Risk Level: High
Speed Limit: 15 KM/Hr

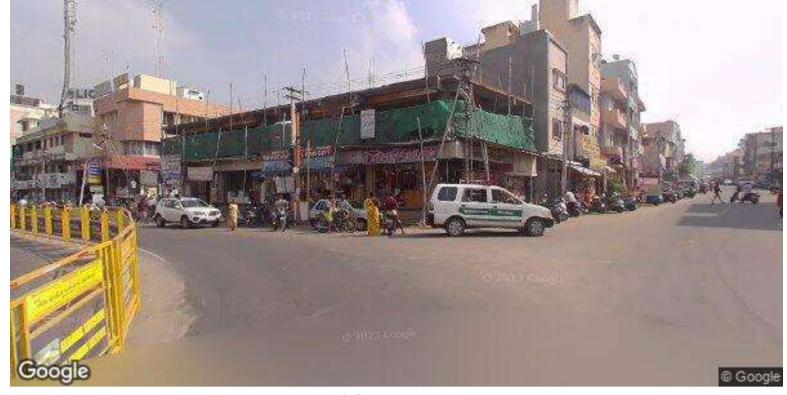
Risk Type: Turn
Risk Level: High
Speed Limit: 15 KM/Hr
Coordinates: 11.37868, 77.89498

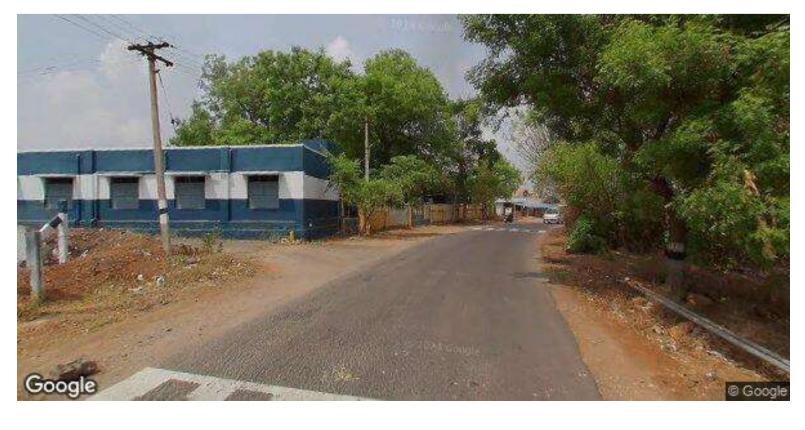
Coordinates: 11.33268, 77.88827

Risk Type: Turn
Risk Level: High
Speed Limit: 15 KM/Hr

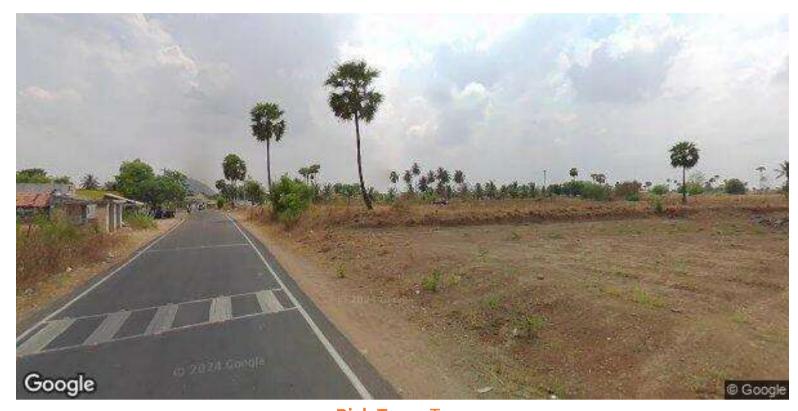
Risk Type: Turn
Risk Level: Medium
Speed Limit: 30 KM/Hr
Coordinates: 11.33071, 77.88660

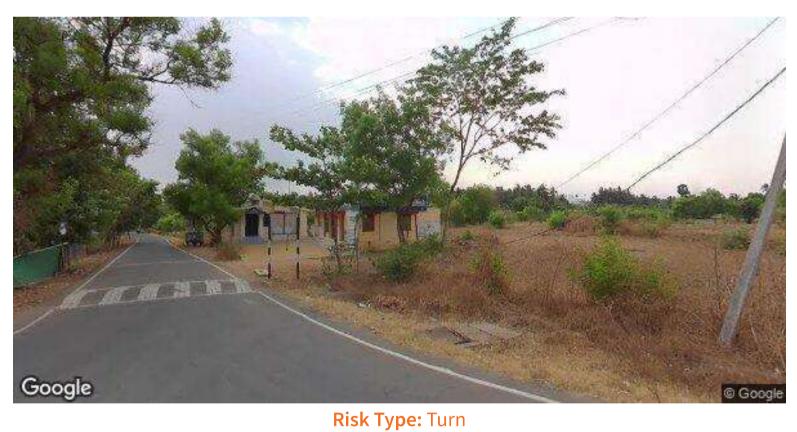
Coordinates: 11.33065, 77.88650

Risk Level: High
Speed Limit: 15 KM/Hr

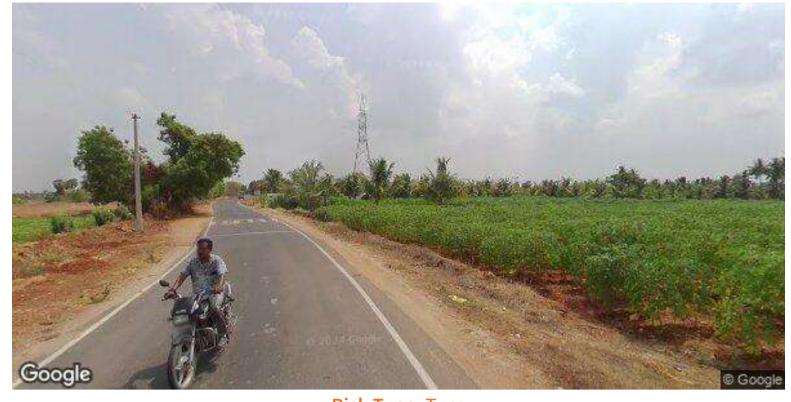
Risk Type: Turn
Risk Level: Medium
Speed Limit: 30 KM/Hr
Coordinates: 11.32155, 77.88499

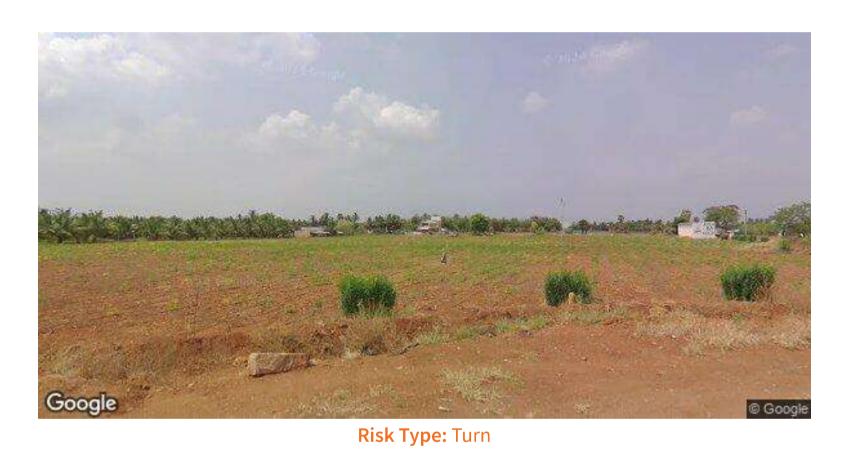
Speed Limit: 30 KM/Hr Coordinates: 11.32130, 77.88484

Risk Level: Medium

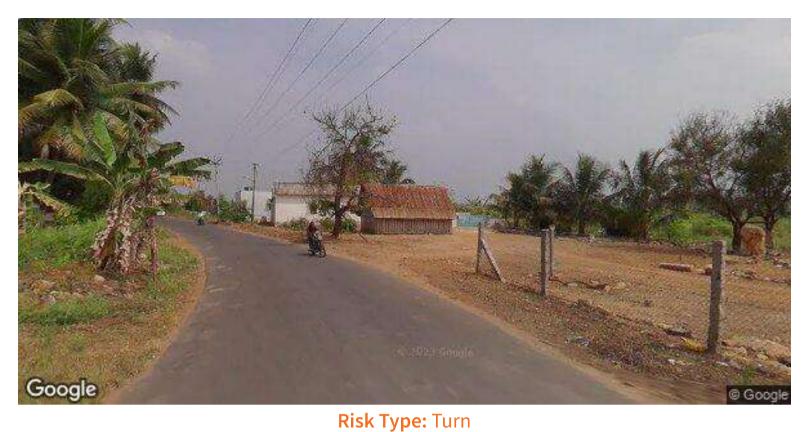
Risk Type. Turn
Risk Level: Medium
Speed Limit: 30 KM/Hr
Coordinates: 11.31205, 77.88131

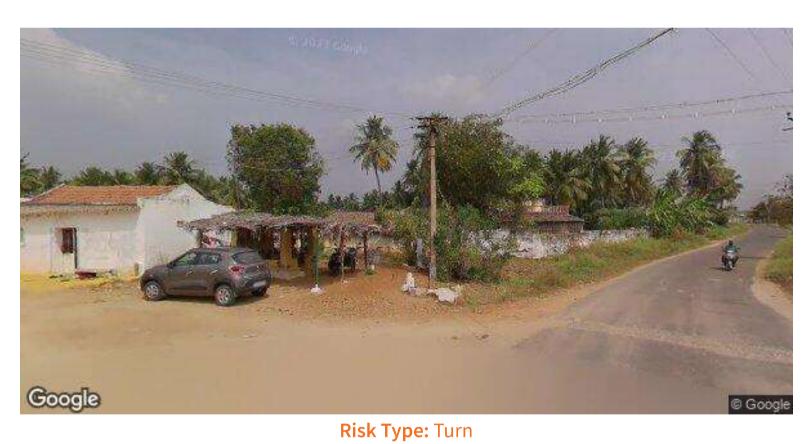
Coordinates: 11.31151, 77.88008

Risk Type: Turn
Risk Level: Medium
Speed Limit: 30 KM/Hr

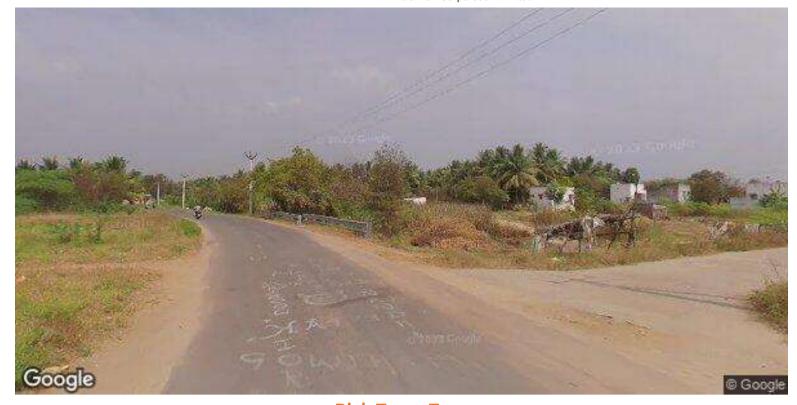
Risk Type: Turn
Risk Level: Medium
Speed Limit: 30 KM/Hr
Coordinates: 11.30805, 77.87934

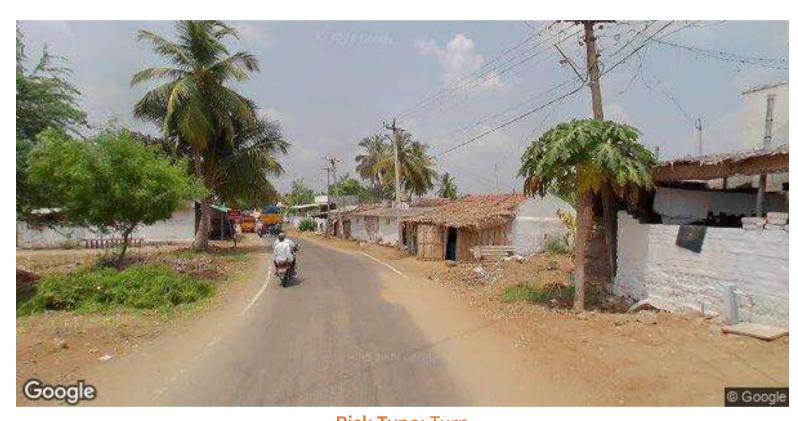
Risk Type: Turn
Risk Level: Medium
Speed Limit: 30 KM/Hr
Coordinates: 11.30625, 77.87776

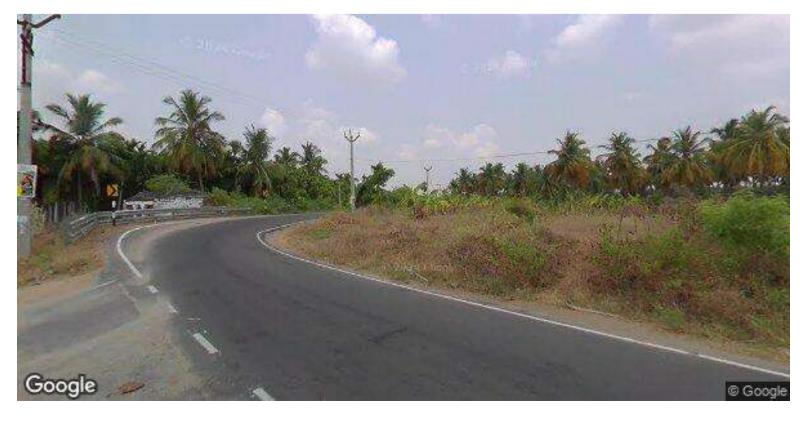
Coordinates: 11.29763, 77.87710

Risk Type: Turn
Risk Level: High
Speed Limit: 15 KM/Hr

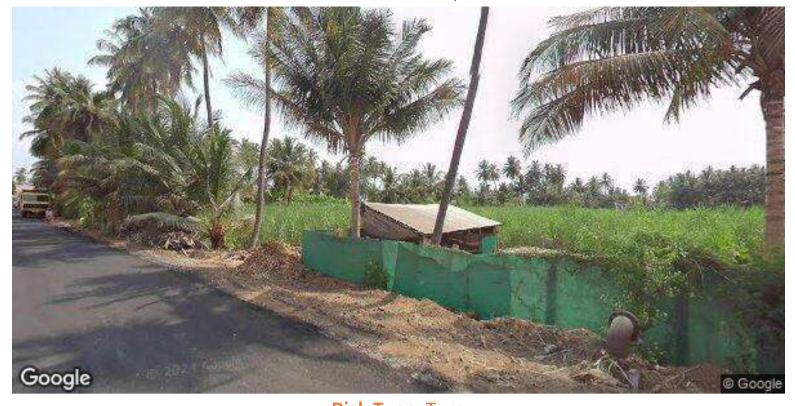
Risk Type: Turn
Risk Level: High
Speed Limit: 15 KM/Hr
Coordinates: 11.26017, 77.85606

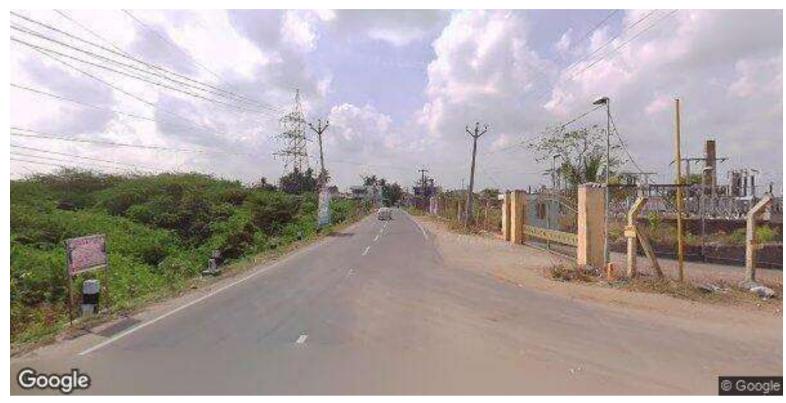
Coordinates: 11.24384, 77.86689

Risk Type: Turn
Risk Level: High
Speed Limit: 15 KM/Hr

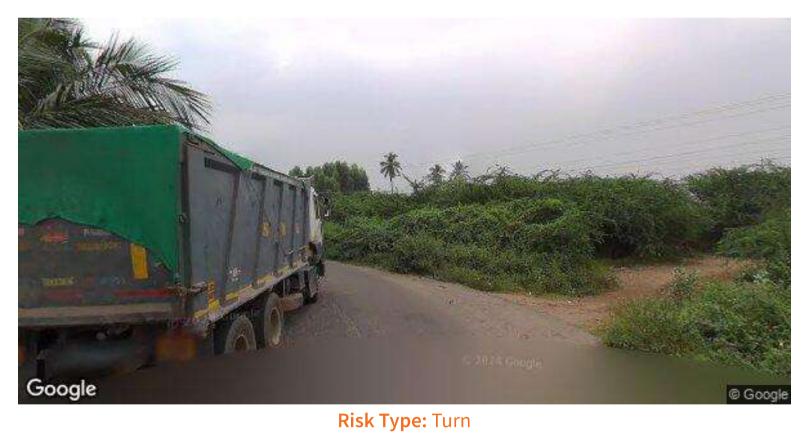
Coordinates: 11.24100, 77.86030

Risk Level: High
Speed Limit: 15 KM/Hr

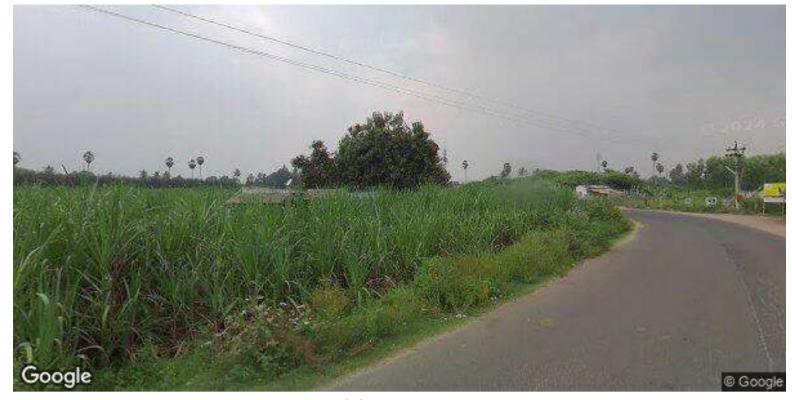
Risk Type: Turn
Risk Level: Medium
Speed Limit: 30 KM/Hr
Coordinates: 11.24196, 77.85902

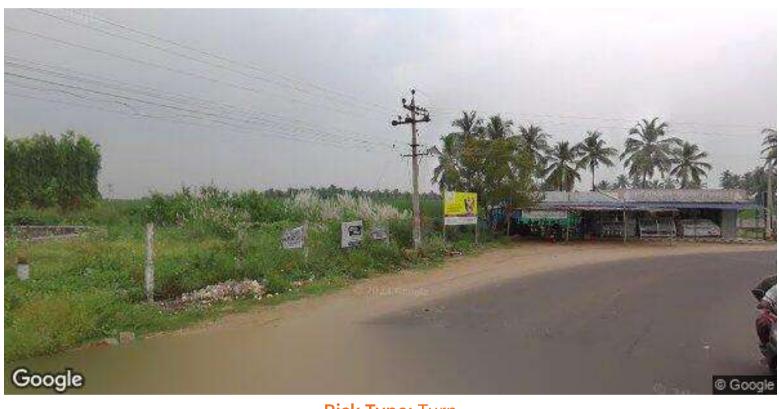
Risk Type: Turn
Risk Level: Medium
Speed Limit: 30 KM/Hr
Coordinates: 11.24193, 77.85850

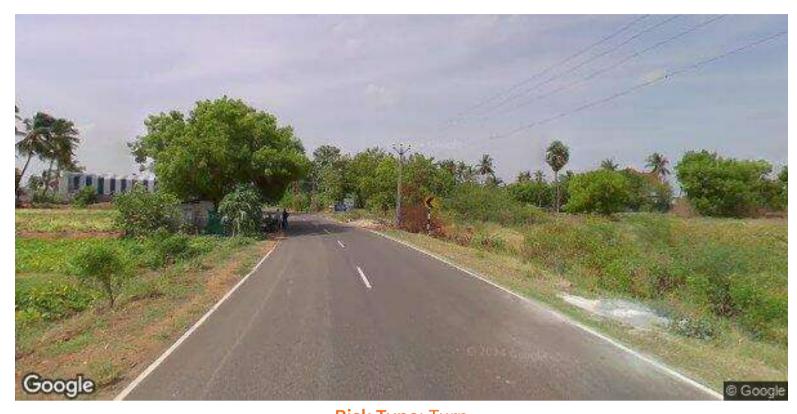
Risk Type: Turn
Risk Level: Medium
Speed Limit: 30 KM/Hr
Coordinates: 11.20949, 77.81173

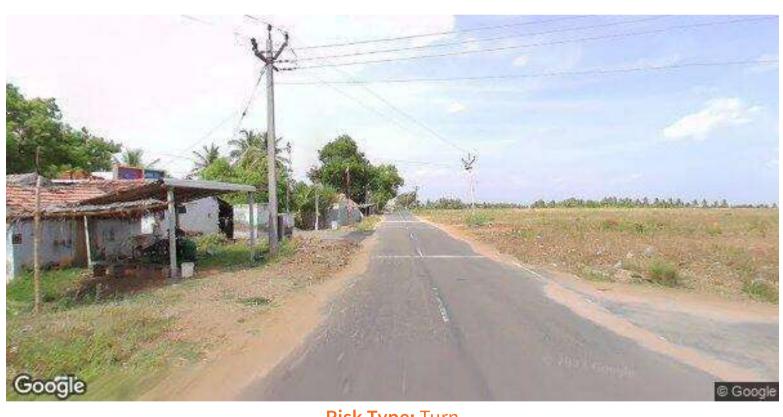
Coordinates: 11.20231, 77.79886

Risk Type: Turn
Risk Level: High
Speed Limit: 15 KM/Hr

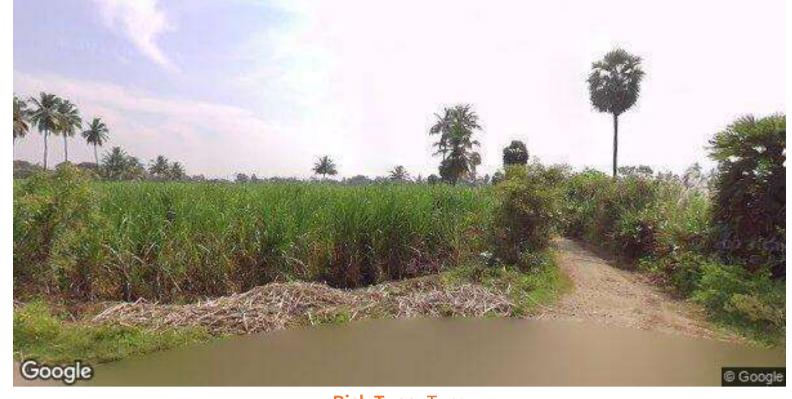
Risk Type: Turn
Risk Level: High
Speed Limit: 15 KM/Hr
Coordinates: 11.18798, 77.80052

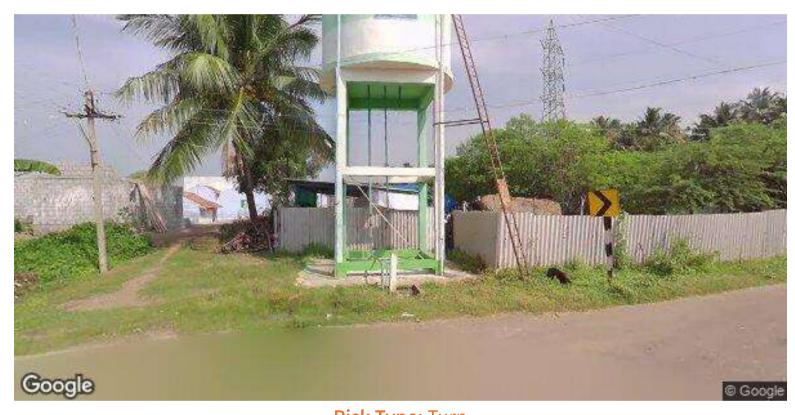
Risk Type: Turn
Risk Level: High
Speed Limit: 15 KM/Hr
Coordinates: 11.18779, 77.79733

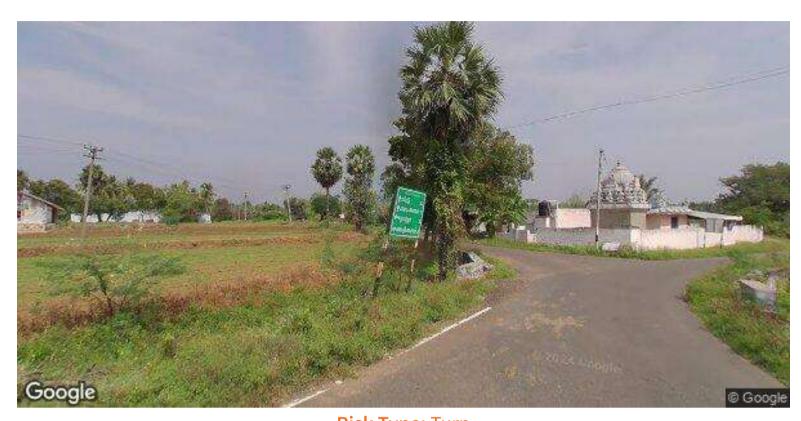
Coordinates: 11.18312, 77.79425

Risk Type: Turn
Risk Level: High
Speed Limit: 15 KM/Hr

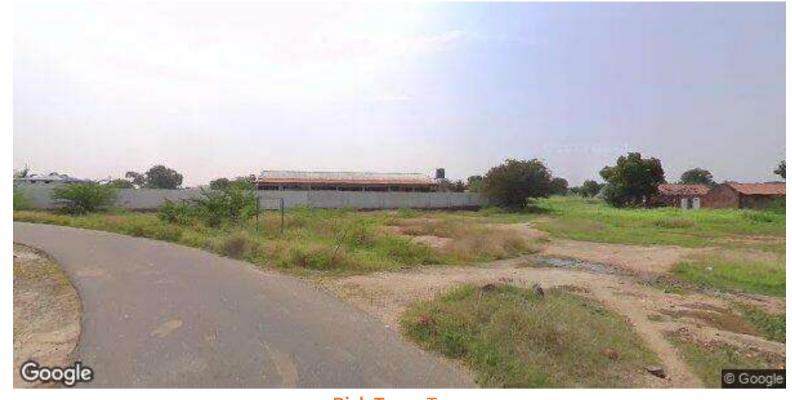
Risk Type: Turn
Risk Level: Medium
Speed Limit: 30 KM/Hr
Coordinates: 11.17594, 77.79491

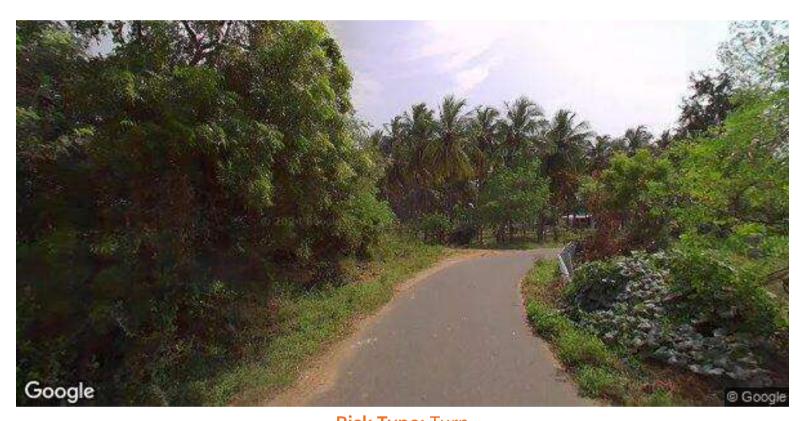
Risk Type: Turn
Risk Level: Medium
Speed Limit: 30 KM/Hr
Coordinates: 11.17301, 77.79650

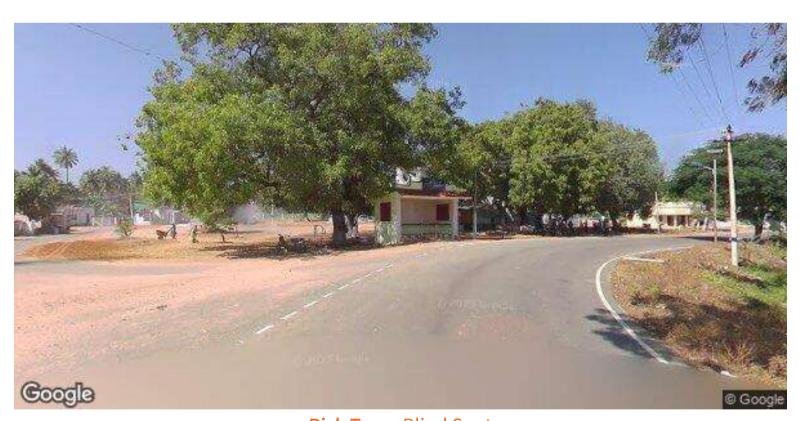
Coordinates: 11.16520, 77.79528

Risk Type: Blind Spot
Risk Level: Blind Spot
Speed Limit: 10 KM/Hr

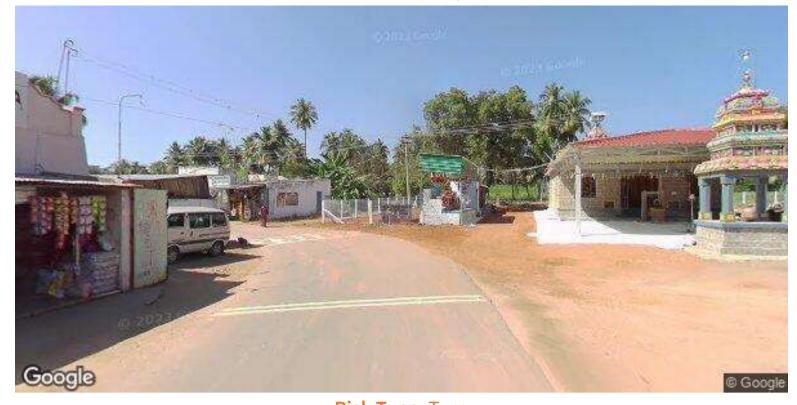
Risk Type: Turn
Risk Level: Medium
Speed Limit: 30 KM/Hr
Coordinates: 11.16499, 77.79473

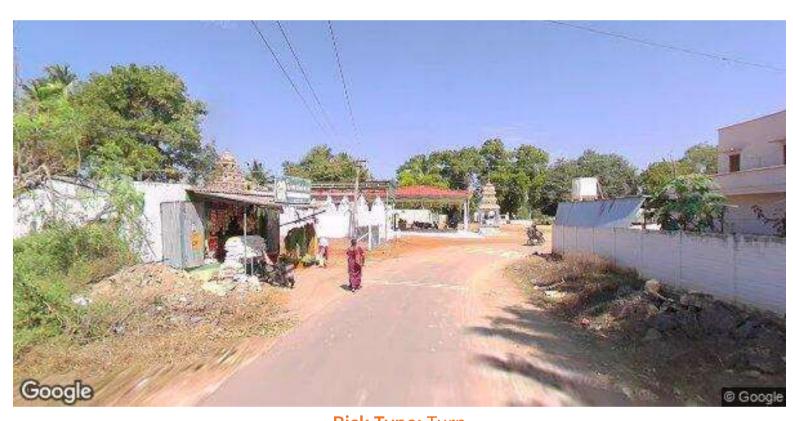
Risk Type: Turn
Risk Level: High
Speed Limit: 15 KM/Hr
Coordinates: 11.16470, 77.79449

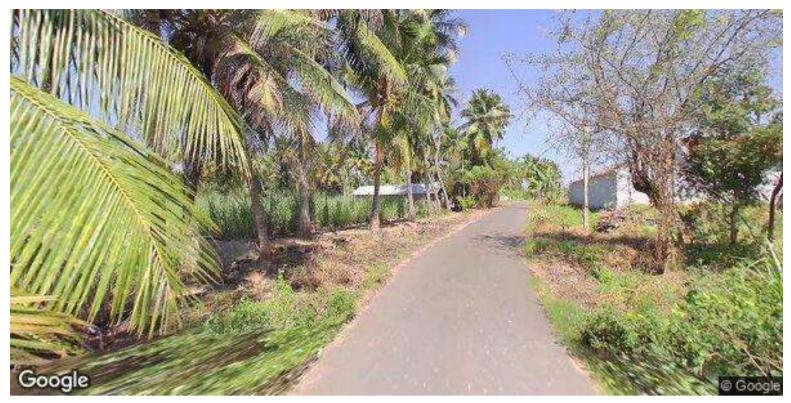
Risk Type: Turn
Risk Level: Medium
Speed Limit: 30 KM/Hr
Coordinates: 11.15590, 77.79390

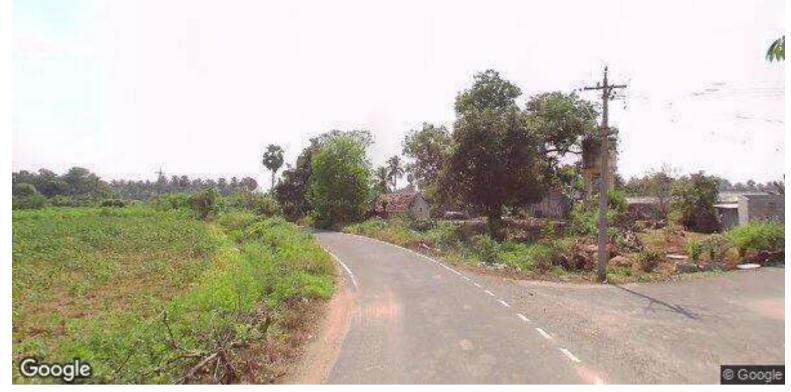
Risk Type: Turn
Risk Level: Medium
Speed Limit: 30 KM/Hr
Coordinates: 11.13966, 77.79872

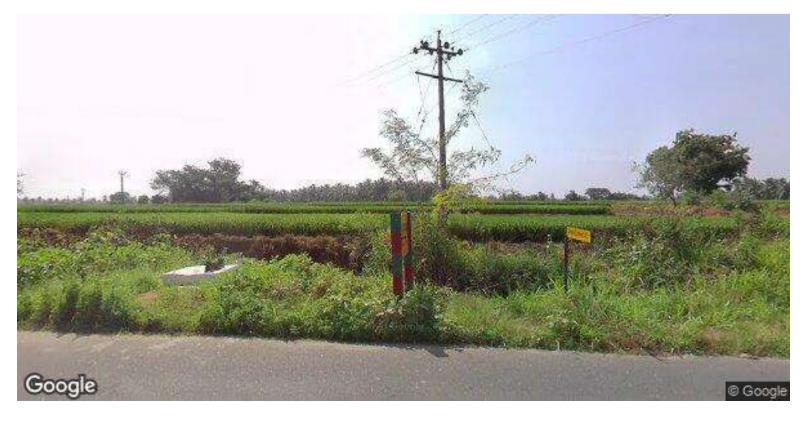
Coordinates: 11.13519, 77.79955

Risk Type: Turn
Risk Level: High
Speed Limit: 15 KM/Hr

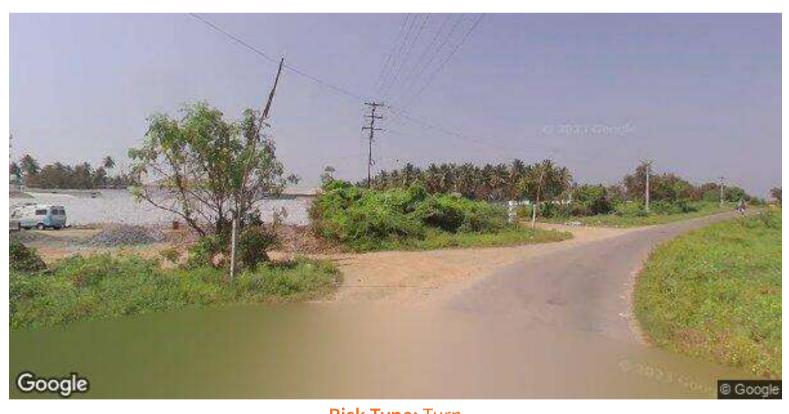
Coordinates: 11.12680, 77.80416

Risk Type: Turn
Risk Level: Medium
Speed Limit: 30 KM/Hr

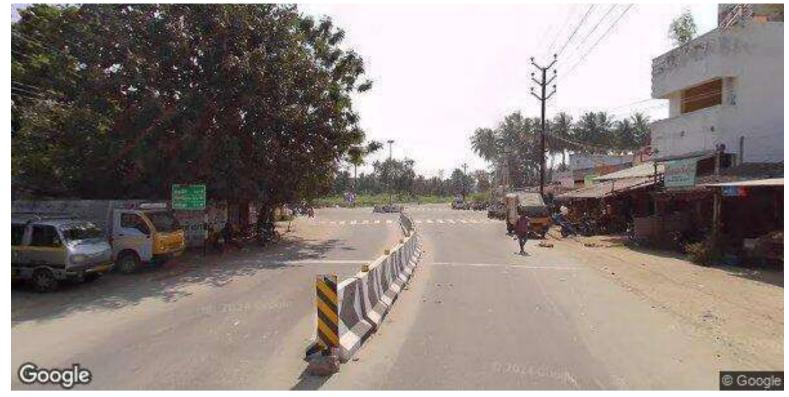
Risk Type: Turn
Risk Level: High
Speed Limit: 15 KM/Hr
Coordinates: 11.12661, 77.80462

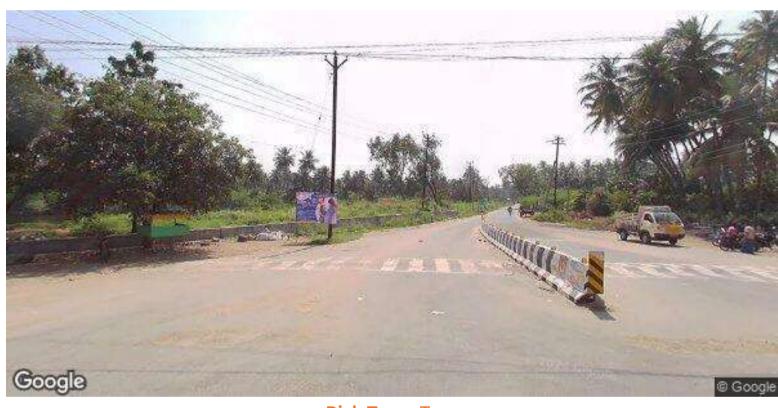
Coordinates: 11.12613, 77.80463

Risk Type: Turn
Risk Level: High
Speed Limit: 15 KM/Hr
