# JOURNEY RISK MANAGEMENT (JRM) STUDY

# Salem Terminal to ADHOC SRI GARUDA AGENCY UNIT II, 330720 JANANEYSHRI FUELS

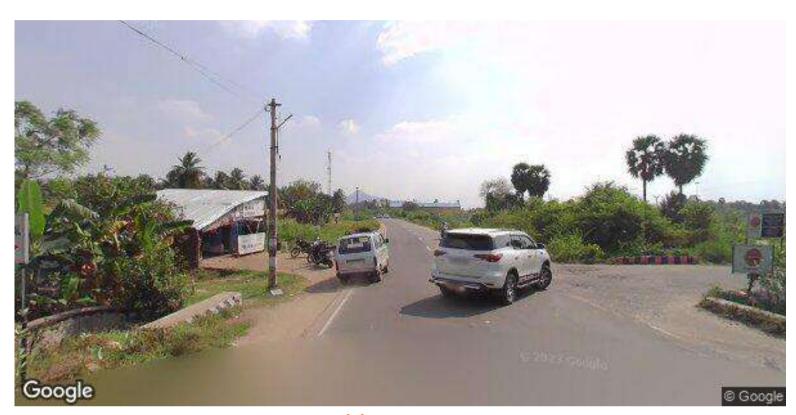
Risk Type: Turn
Risk Level: High
Speed Limit: 15 KM/Hr
Coordinates: 11.44029, 77.87544

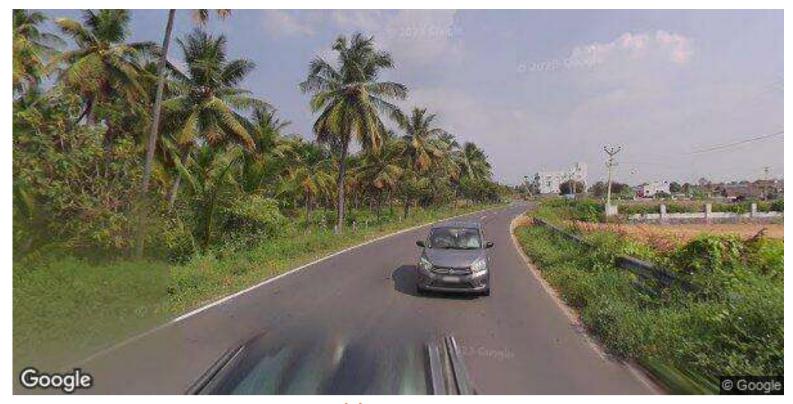
Risk Type: Turn
Risk Level: Medium
Speed Limit: 30 KM/Hr
Coordinates: 11.45357, 77.85789

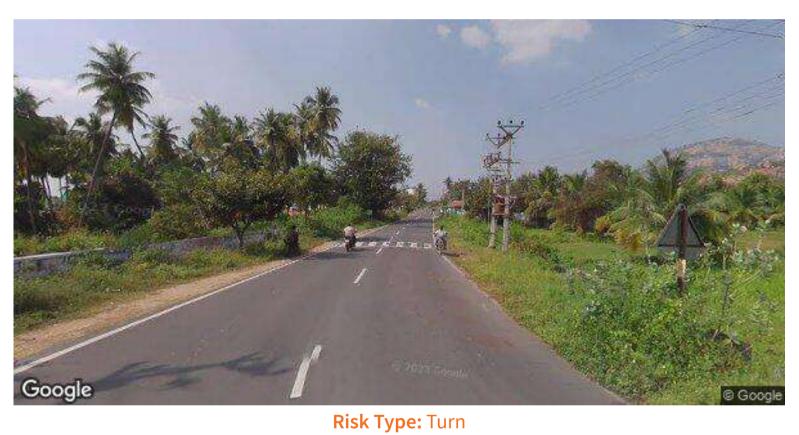
Risk Level: Medium
Speed Limit: 30 KM/Hr
Coordinates: 11.45352, 77.85698

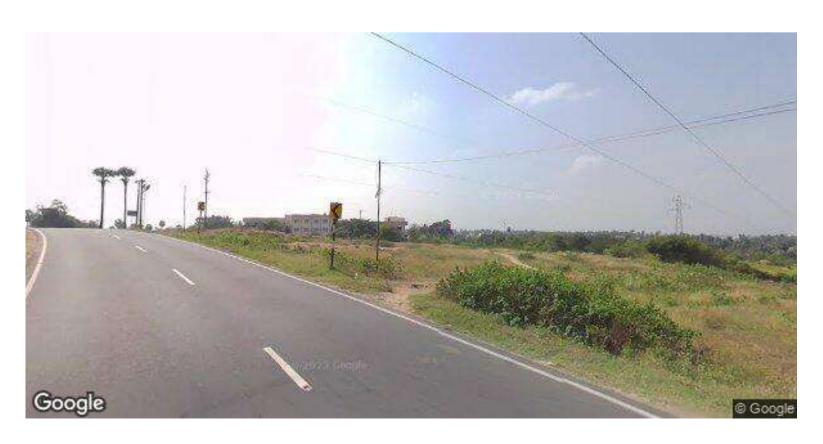
Risk Type: Turn
Risk Level: Medium
Speed Limit: 30 KM/Hr

**Coordinates:** 11.46048, 77.85036

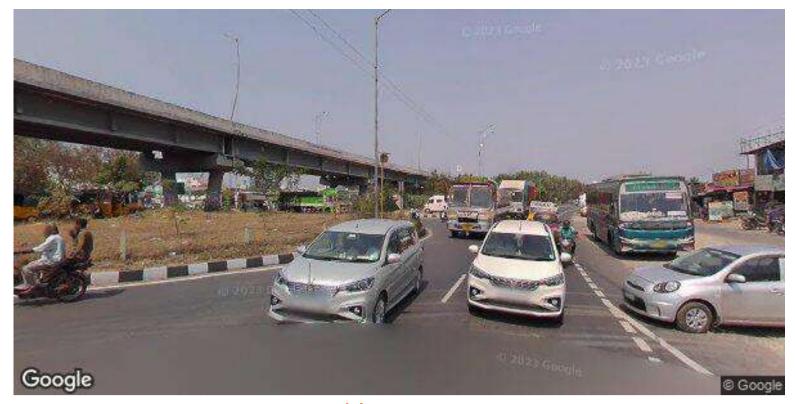
Risk Type: Turn
Risk Level: High
Speed Limit: 15 KM/Hr
Coordinates: 11.43001, 77.67575

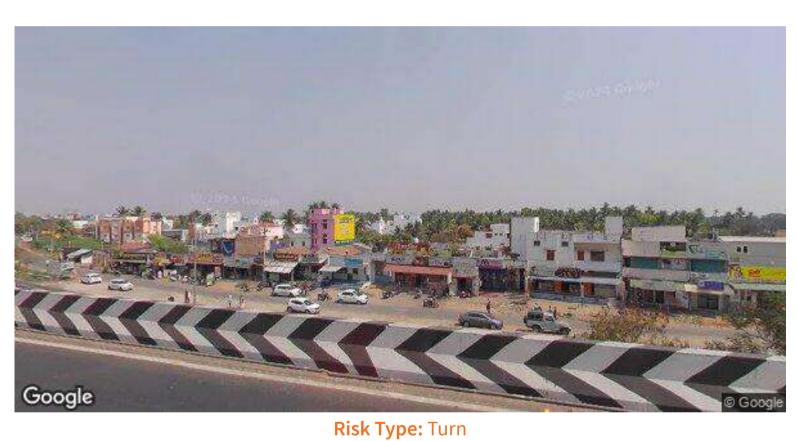
Risk Level: Medium
Speed Limit: 30 KM/Hr
Coordinates: 11.43003, 77.67551

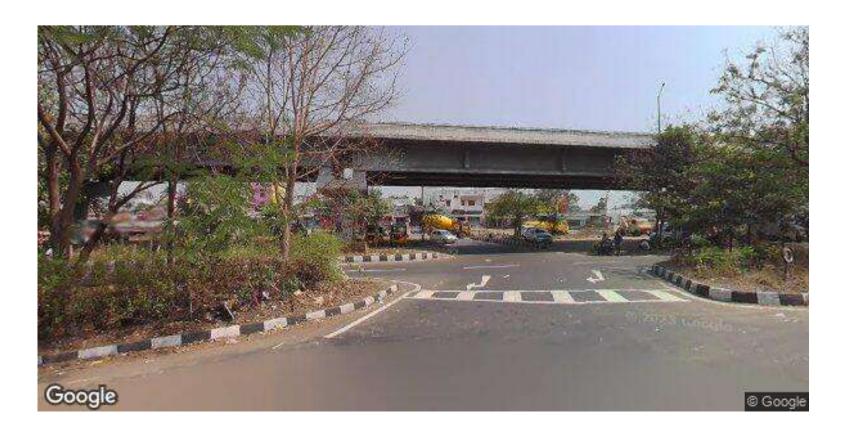
Risk Type: Turn
Risk Level: High
Speed Limit: 15 KM/Hr

**Coordinates:** 11.43026, 77.67525

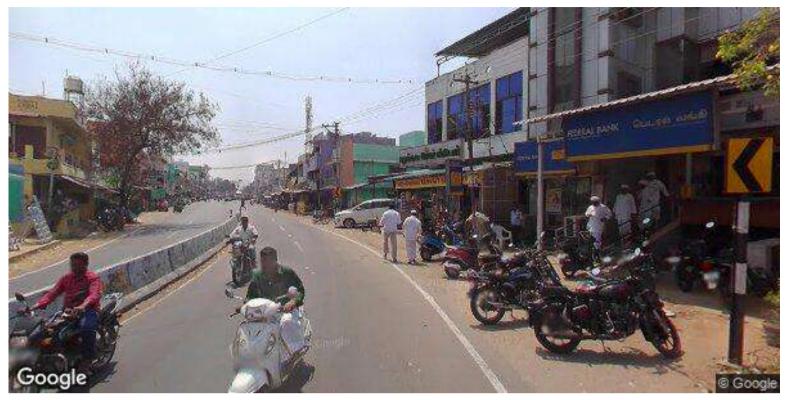
Risk Type: Turn
Risk Level: Medium
Speed Limit: 30 KM/Hr
Coordinates: 11.43769, 77.67810

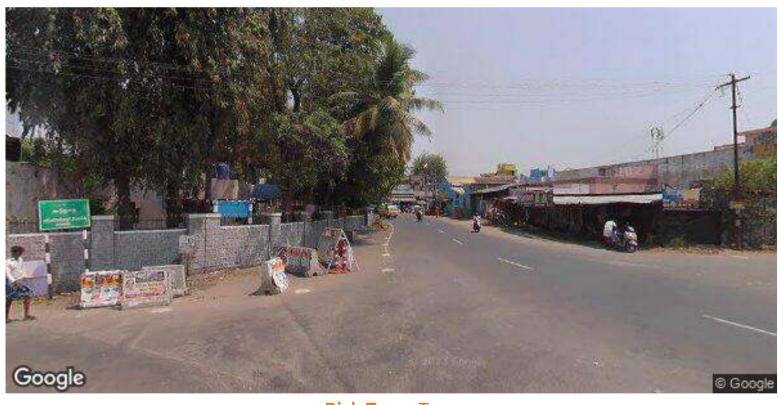
Risk Type: Turn
Risk Level: High
Speed Limit: 15 KM/Hr
Coordinates: 11.43863, 77.68223

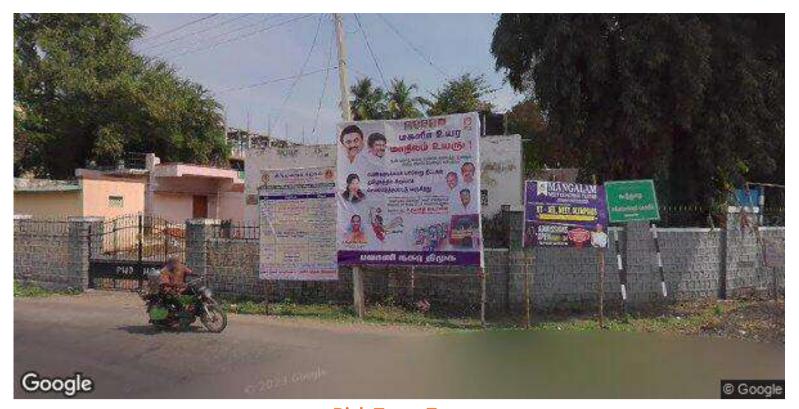
Risk Type: Turn
Risk Level: Medium
Speed Limit: 30 KM/Hr
Coordinates: 11.43871, 77.68228

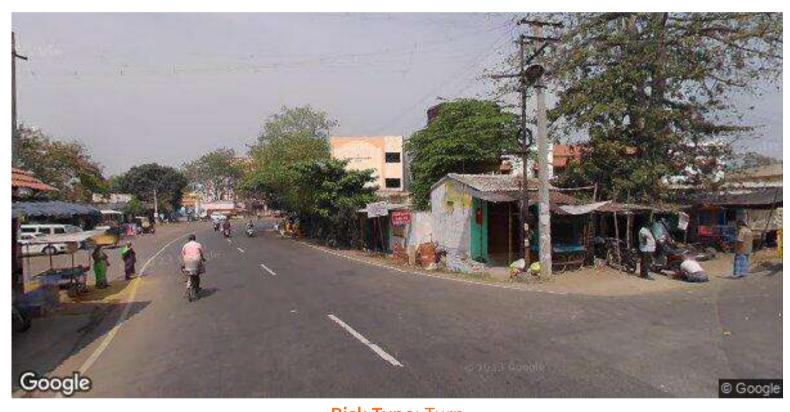
Risk Type: Turn
Risk Level: Medium
Speed Limit: 30 KM/Hr
Coordinates: 11.43965, 77.68224

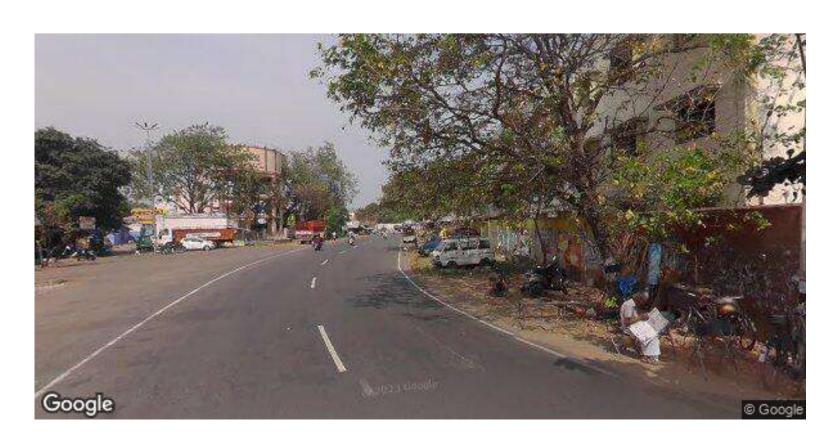
Risk Type: Turn
Risk Level: Medium
Speed Limit: 30 KM/Hr

**Coordinates:** 11.43997, 77.68198

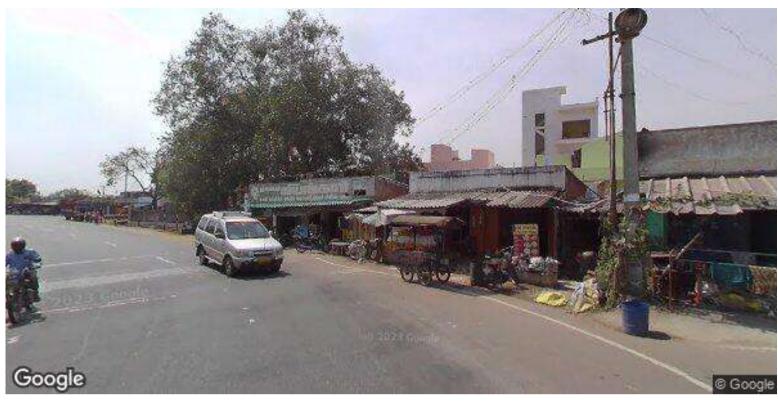
Risk Type: Turn
Risk Level: High
Speed Limit: 15 KM/Hr
Coordinates: 11.44105, 77.68187

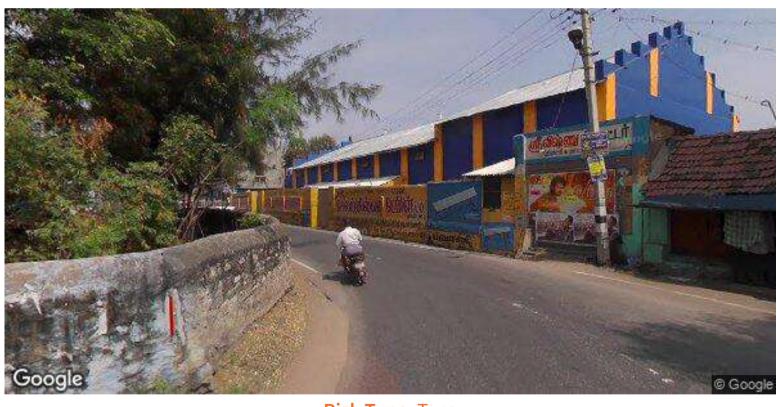
Risk Type: Turn
Risk Level: High
Speed Limit: 15 KM/Hr
Coordinates: 11.44119, 77.68217

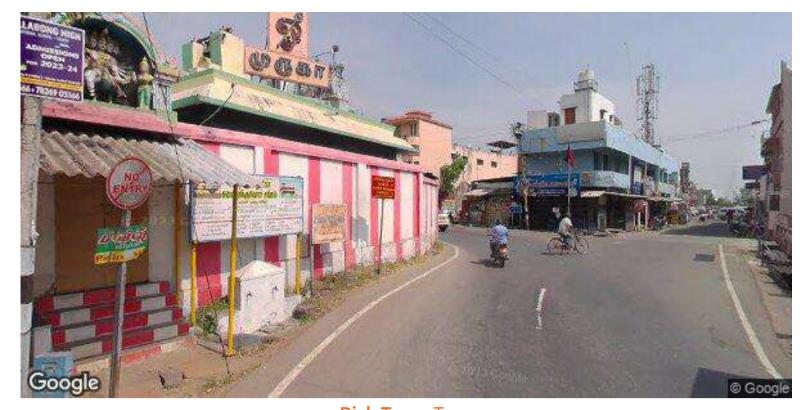
Risk Type: Turn
Risk Level: Medium
Speed Limit: 30 KM/Hr
Coordinates: 11.44295, 77.68261

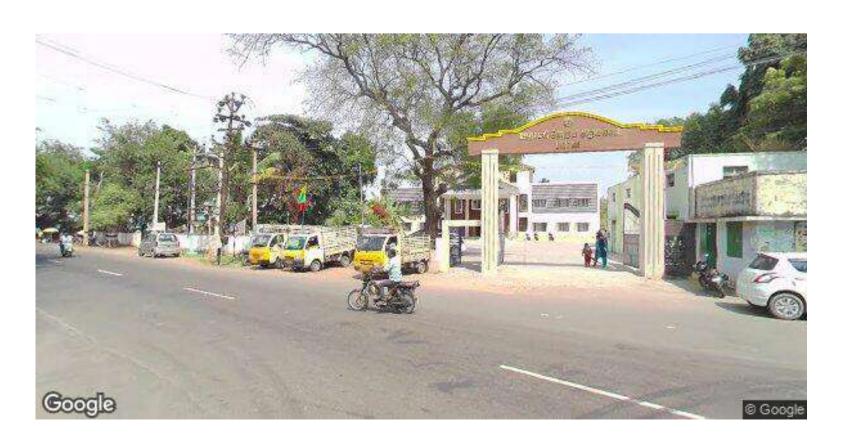
Risk Type: Turn
Risk Level: High
Speed Limit: 15 KM/Hr

**Coordinates:** 11.44853, 77.68331

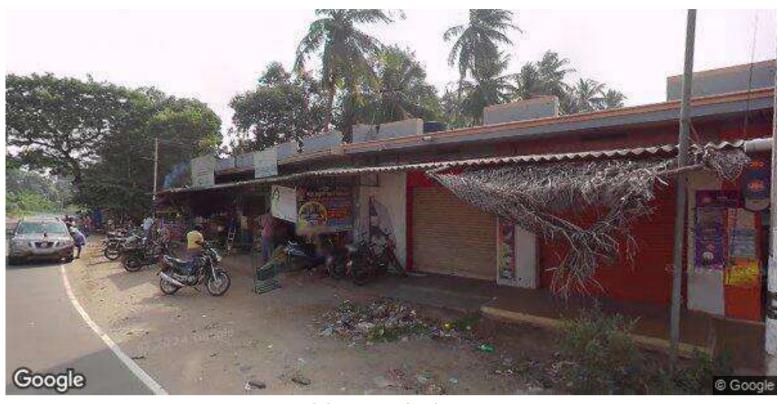
Risk Type: Blind Spot
Risk Level: Blind Spot
Speed Limit: 10 KM/Hr

**Coordinates:** 11.52420, 77.52412
