JOURNEY RISK MANAGEMENT STUDY REPORT

FOR IOCL TRICHY TERMINAL

**IOCL TIRCHY TERMINAL (10.7753, 78.8368) TO SIFA AGENCIES (10.759889 ,
79.837977), TOTAL DISTANCE -124 KM**

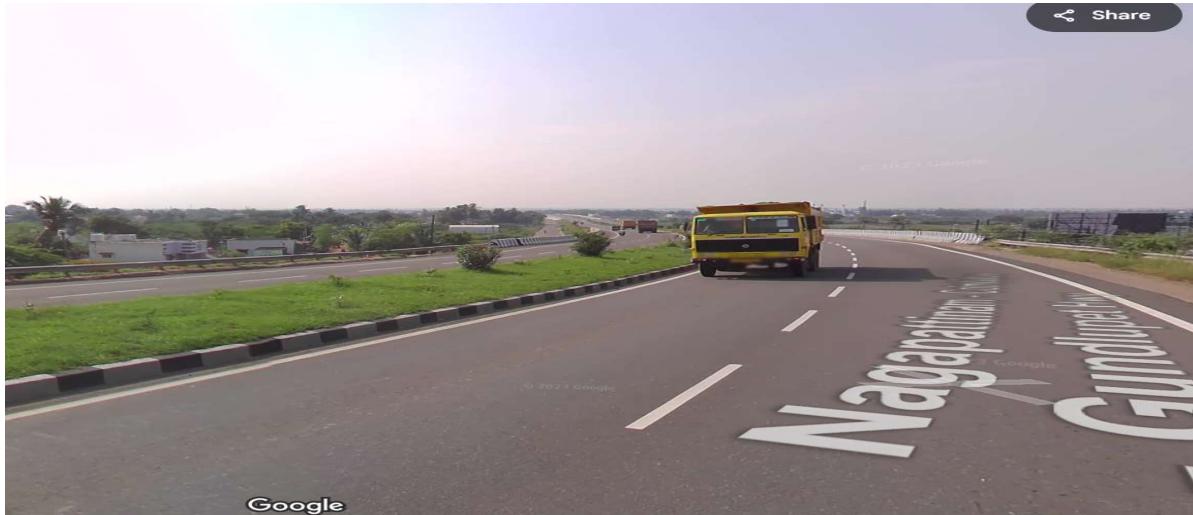
IMAGE: SHARP TURN RISK LEVEL: - MEDIUM, COORDI 10.726561431768483, 79.06521400420263

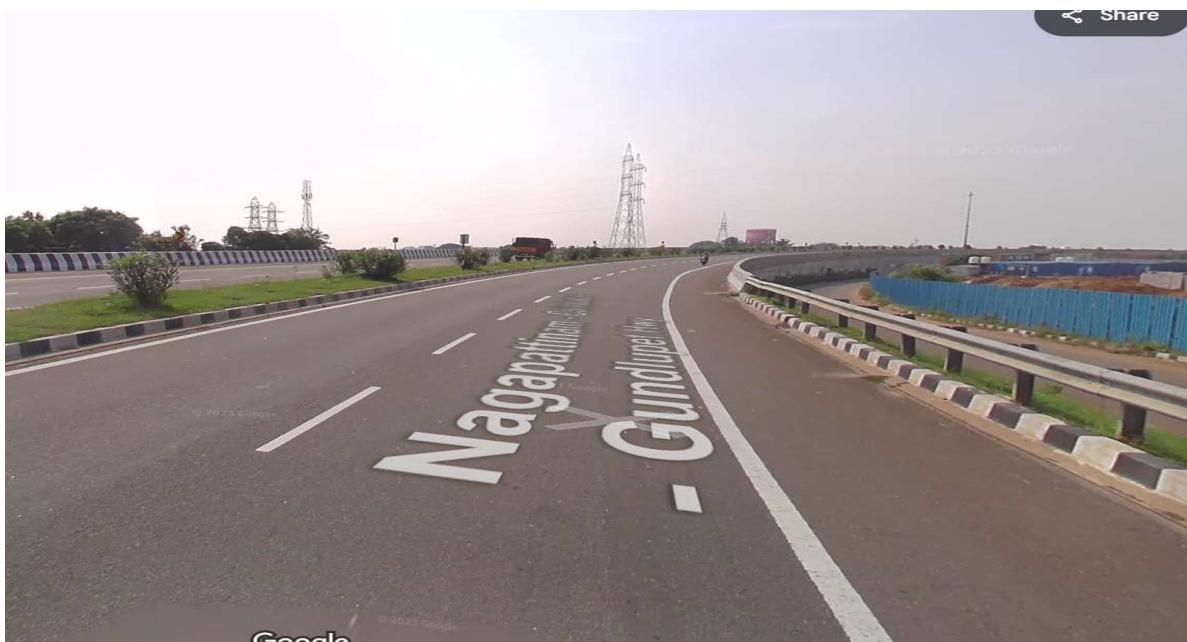
IMAGE: SHARP TURN RISK LEVEL: - MEDIUM, COORDI 10.72308854798758, 79.0698337039081

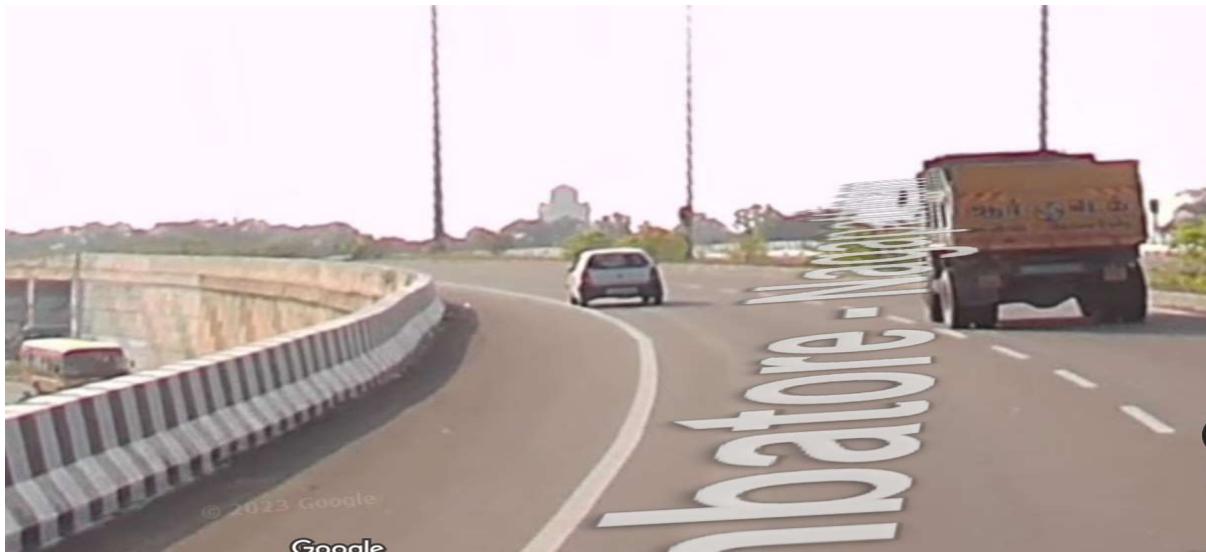
IMAGE: SHARP TURN RISK LEVEL: - MEDIUM, COORDI 10.73705102370136, 79.10766164424598

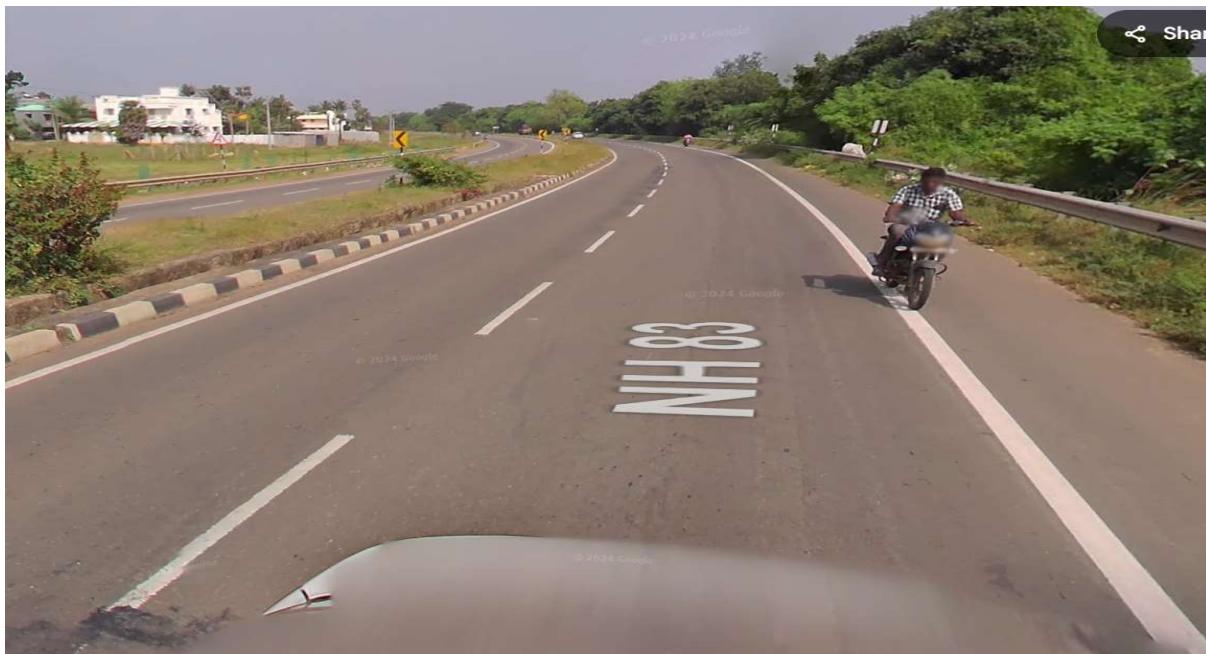
IMAGE: SHARP TURN RISK LEVEL: - MEDIUM, COORDI 10.74328897463726, 79.14225760188724

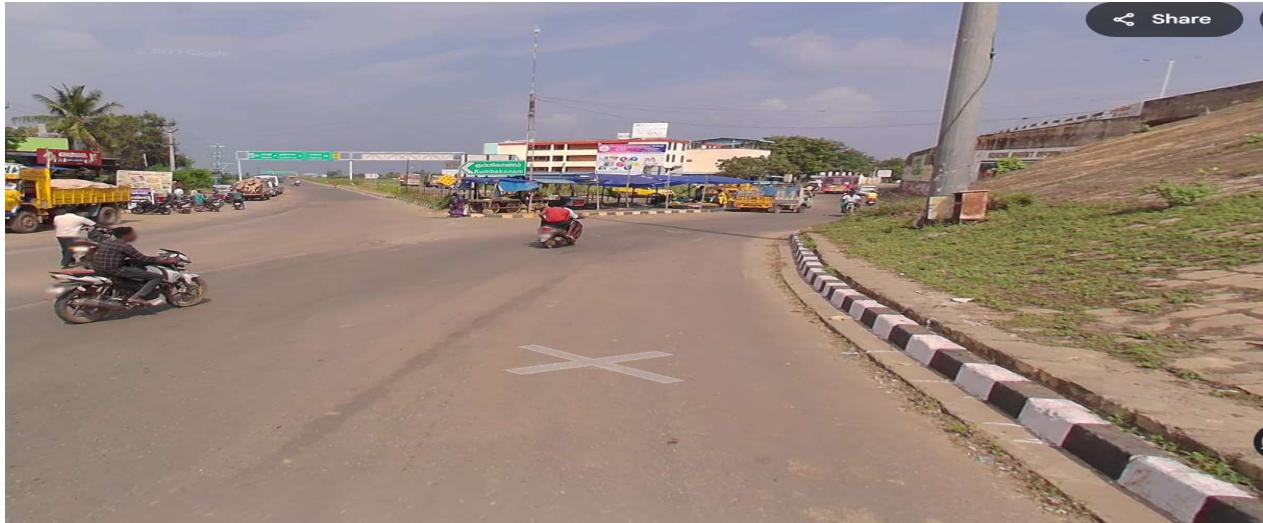
IMAGE: SHARP TURN RISK LEVEL: - MEDIUM, COORDI 10.780404751602815, 79.16734250741605

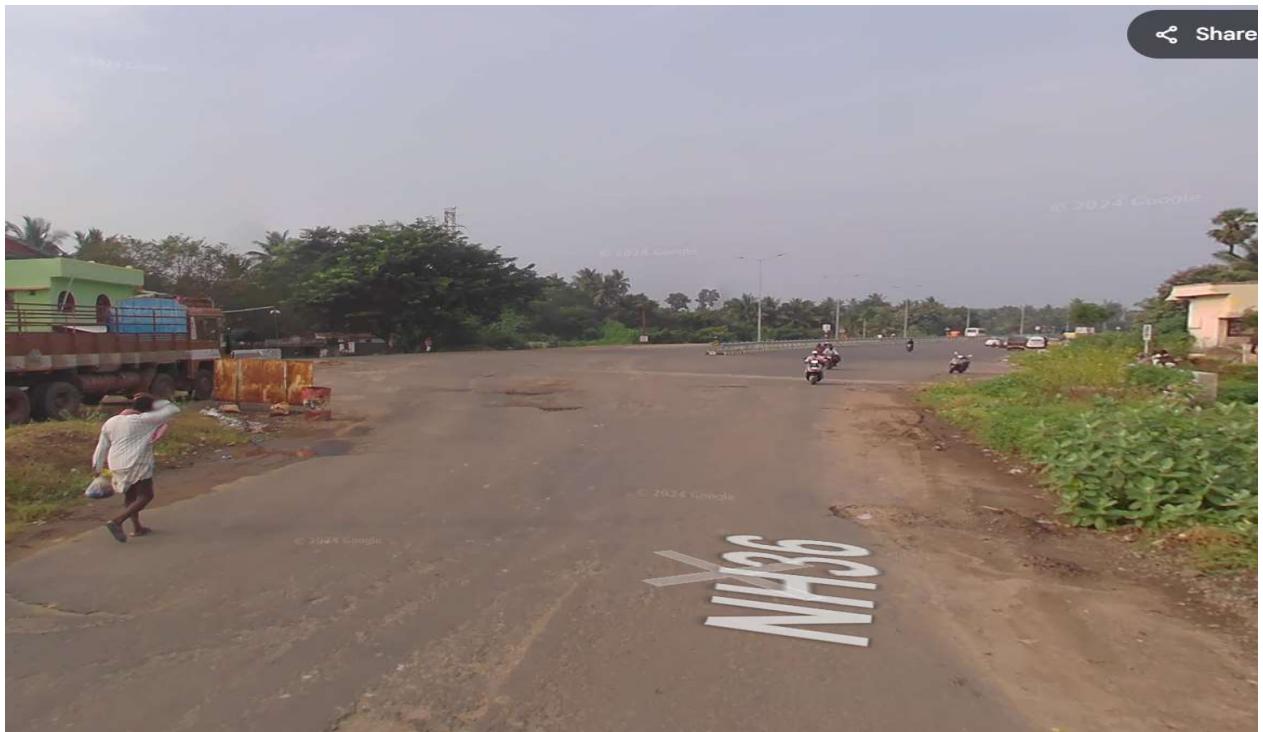
IMAGE: SHARP TURN RISK LEVEL: - MEDIUM, COORDI 10.954296172087506, 79.34774637212439

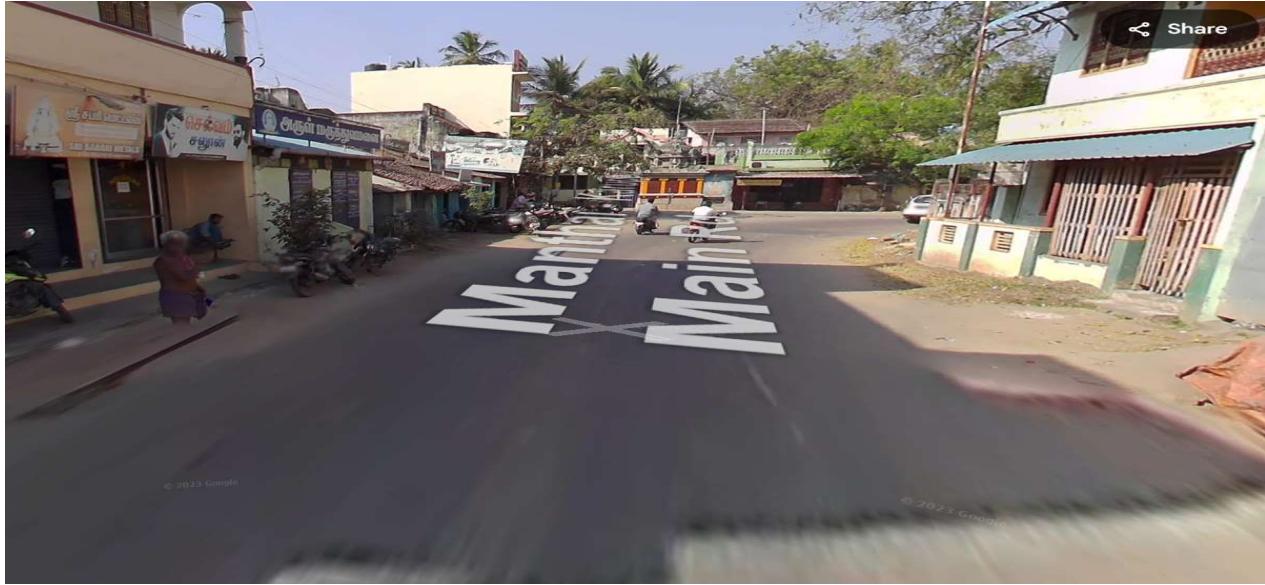
IMAGE: SHARP TURN RISK LEVEL: - MEDIUM, COORDI 10.955808147992787, 79.36573625410698

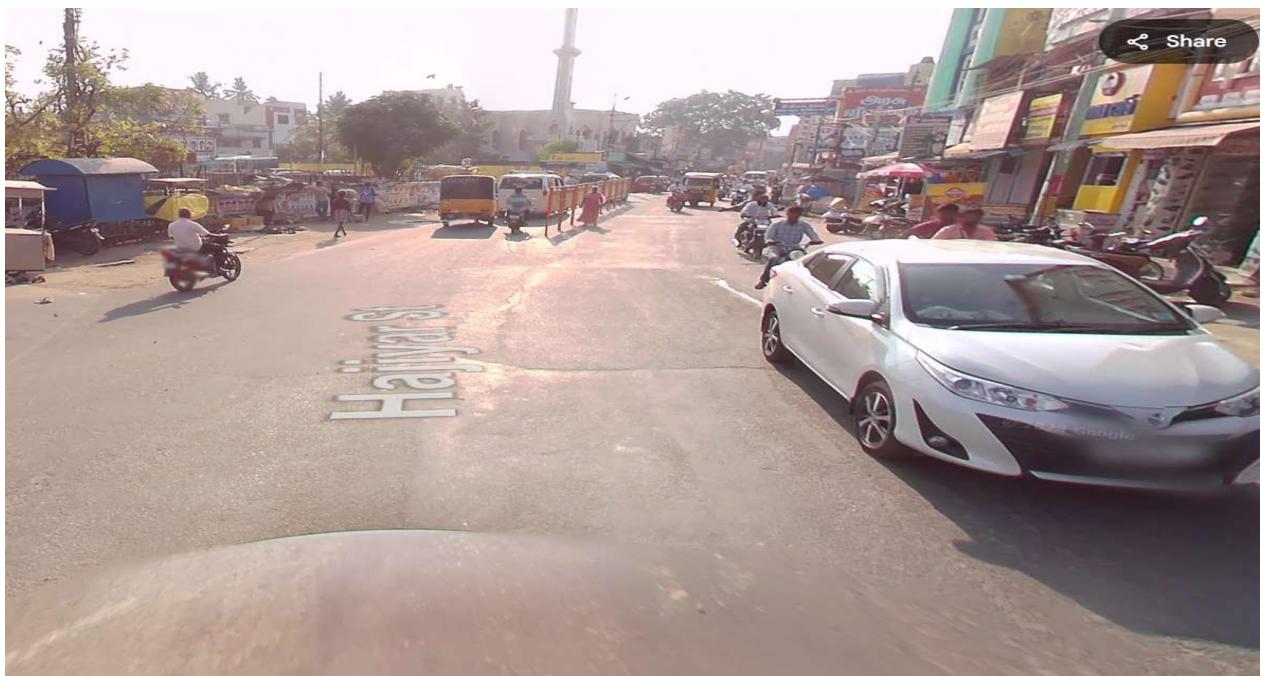
IMAGE: SHARP TURN RISK LEVEL: - MEDIUM, COORDI 10.960551970688885, 79.38611597224178

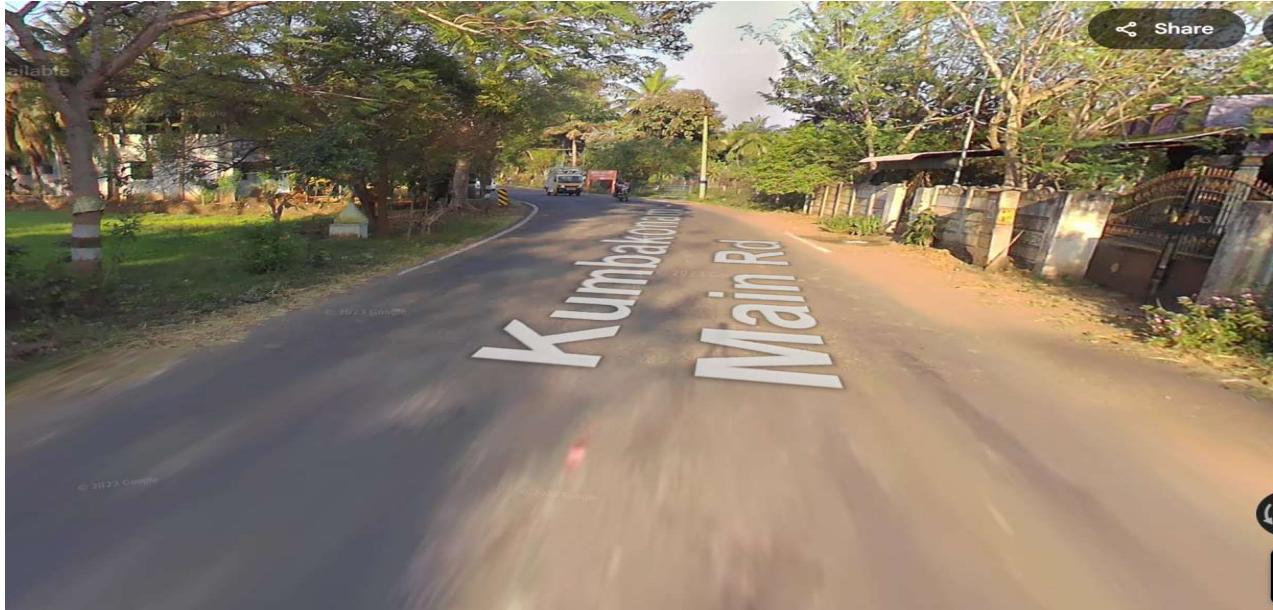
IMAGE: SHARP TURN RISK LEVEL: - MEDIUM, COORDI 10.998322729754582, 79.53231697386092

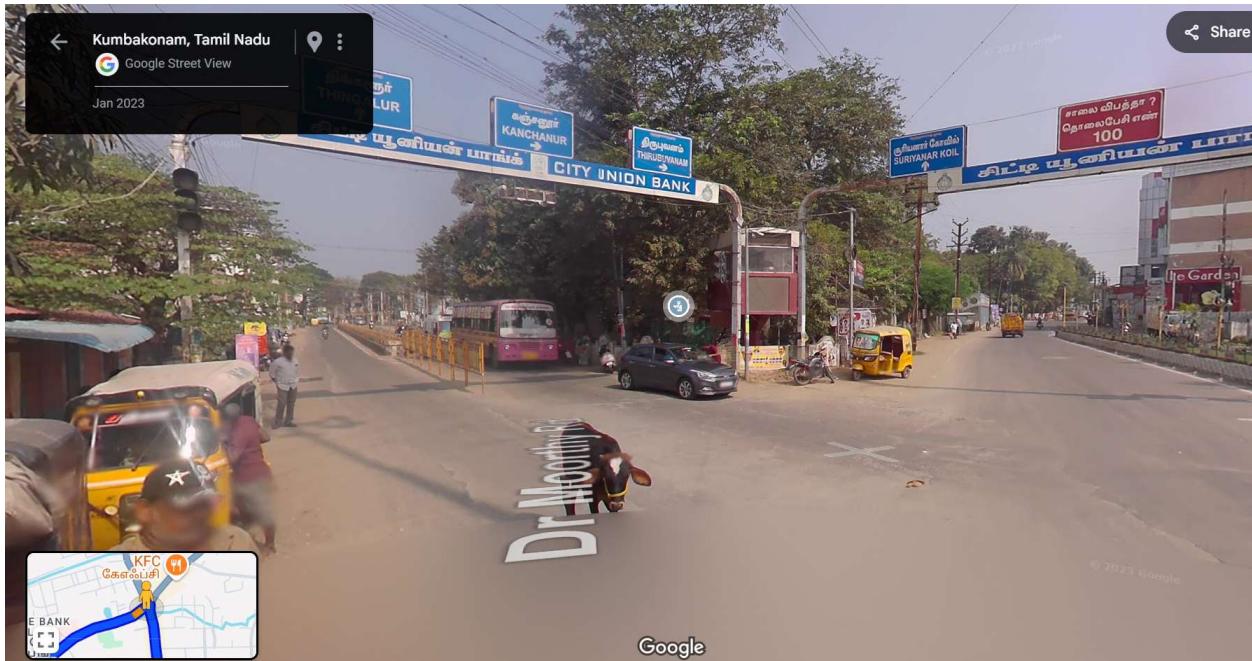
IMAGE: SHARP TURN RISK LEVEL: - MEDIUM, COORDI 10.97664252932043, 79.46227340774438

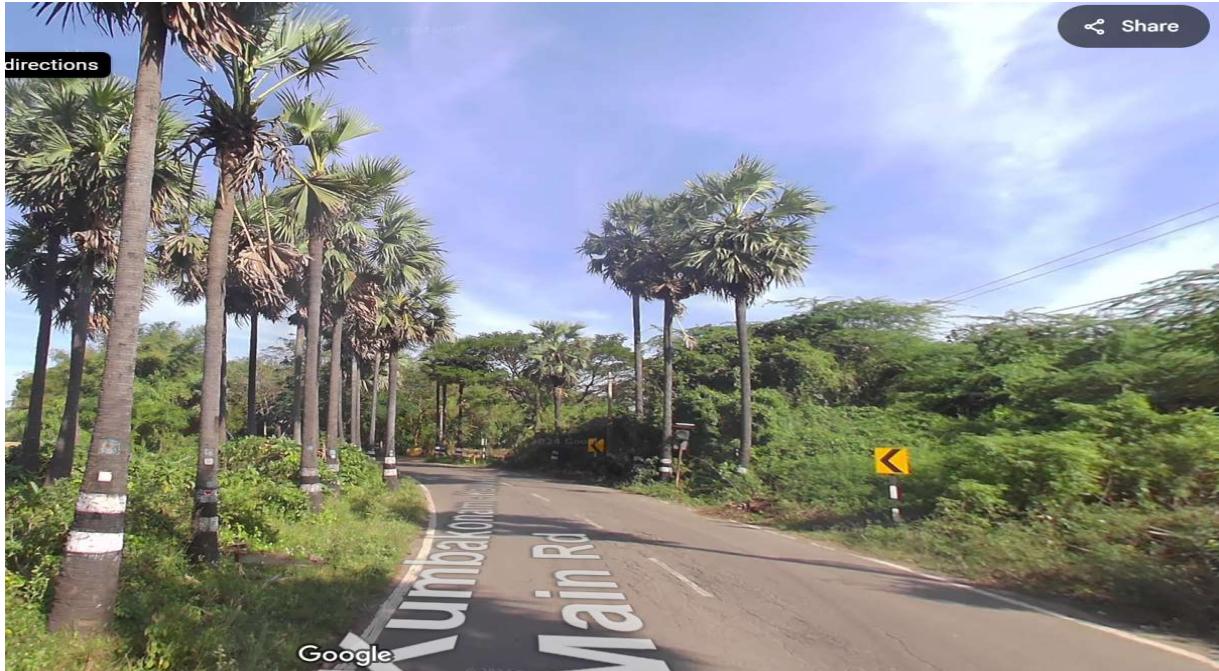
IMAGE: SHARP TURN RISK LEVEL: - MEDIUM, COORDI 11.000530877432295, 79.54660314053001

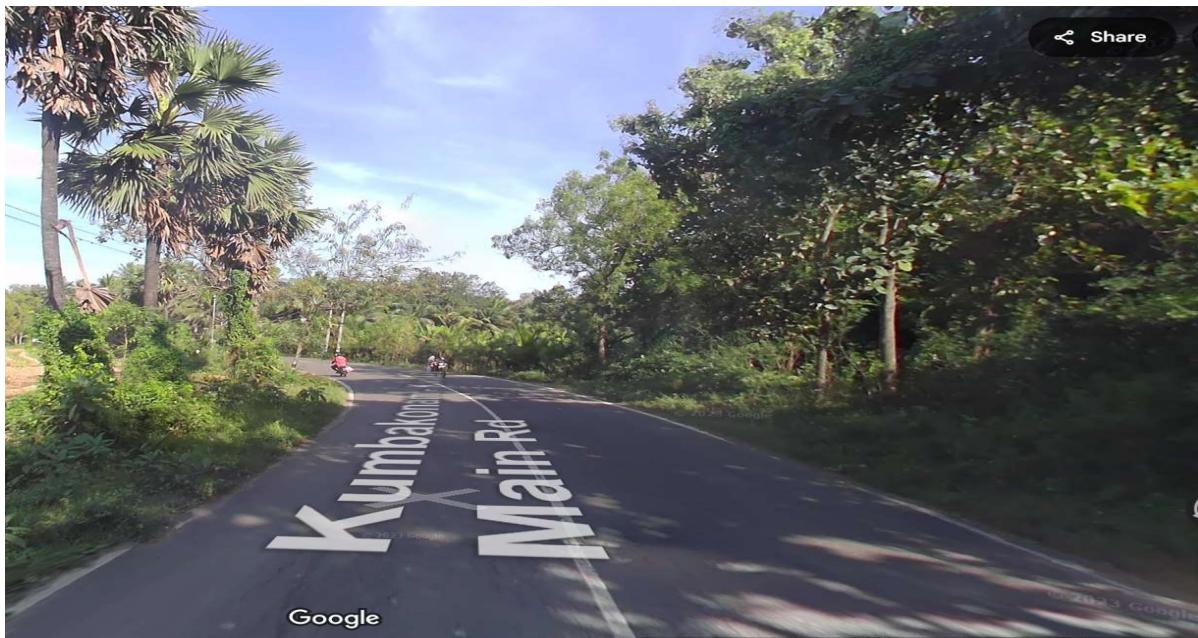
IMAGE: SHARP TURN RISK LEVEL: - MEDIUM, COORDI 10.994194075371174, 79.56081163873246

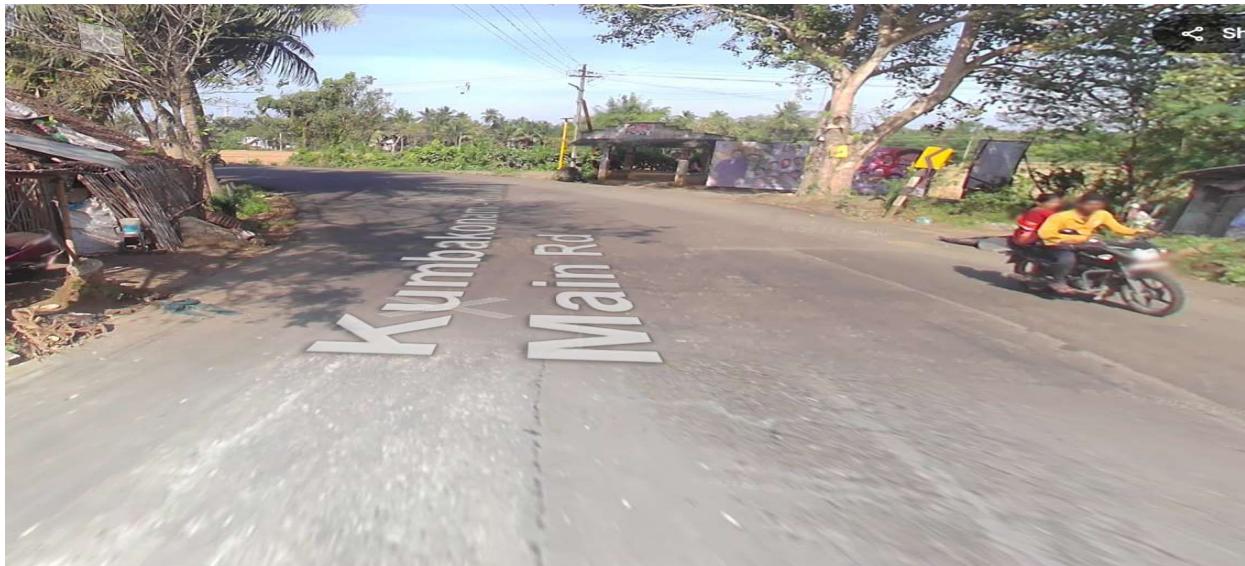
IMAGE: SHARP TURN RISK LEVEL: - MEDIUM, COORDI 10.992066778173717, 79.56820237764057

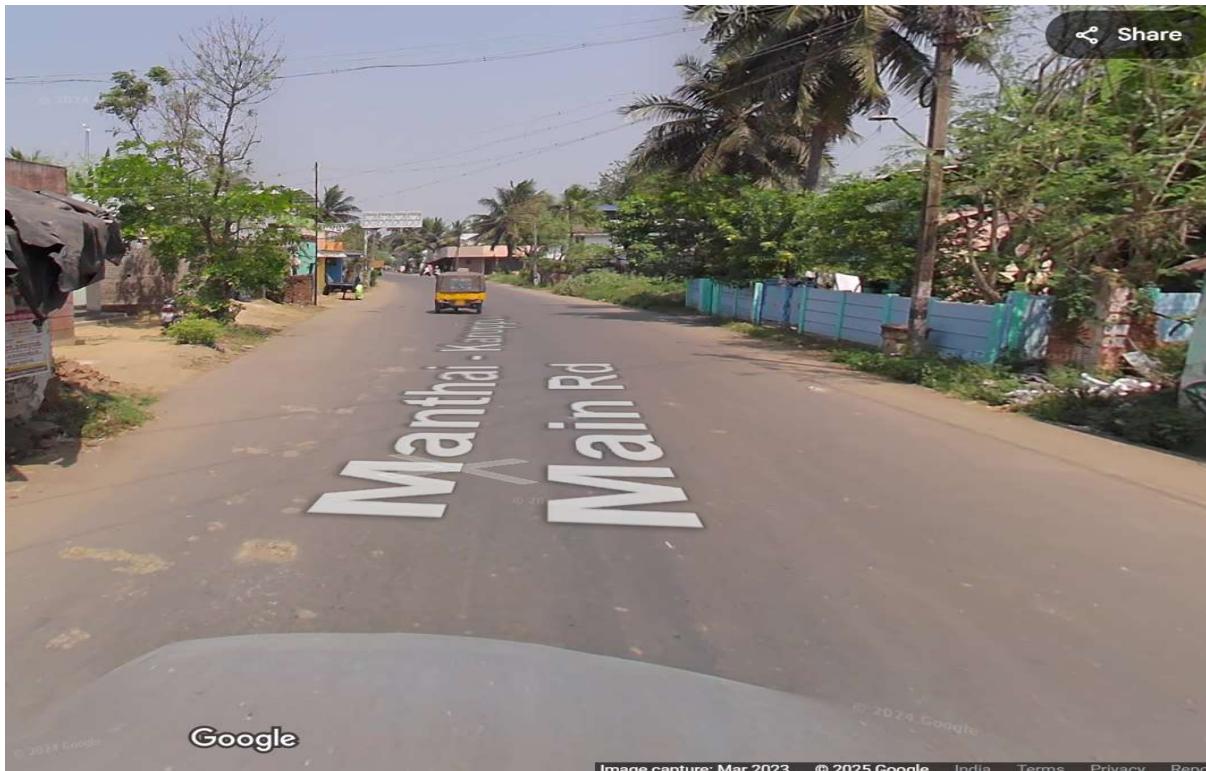
IMAGE: SHARP TURN RISK LEVEL: - MEDIUM, COORDI 10.99122294842798, 79.57203662086194

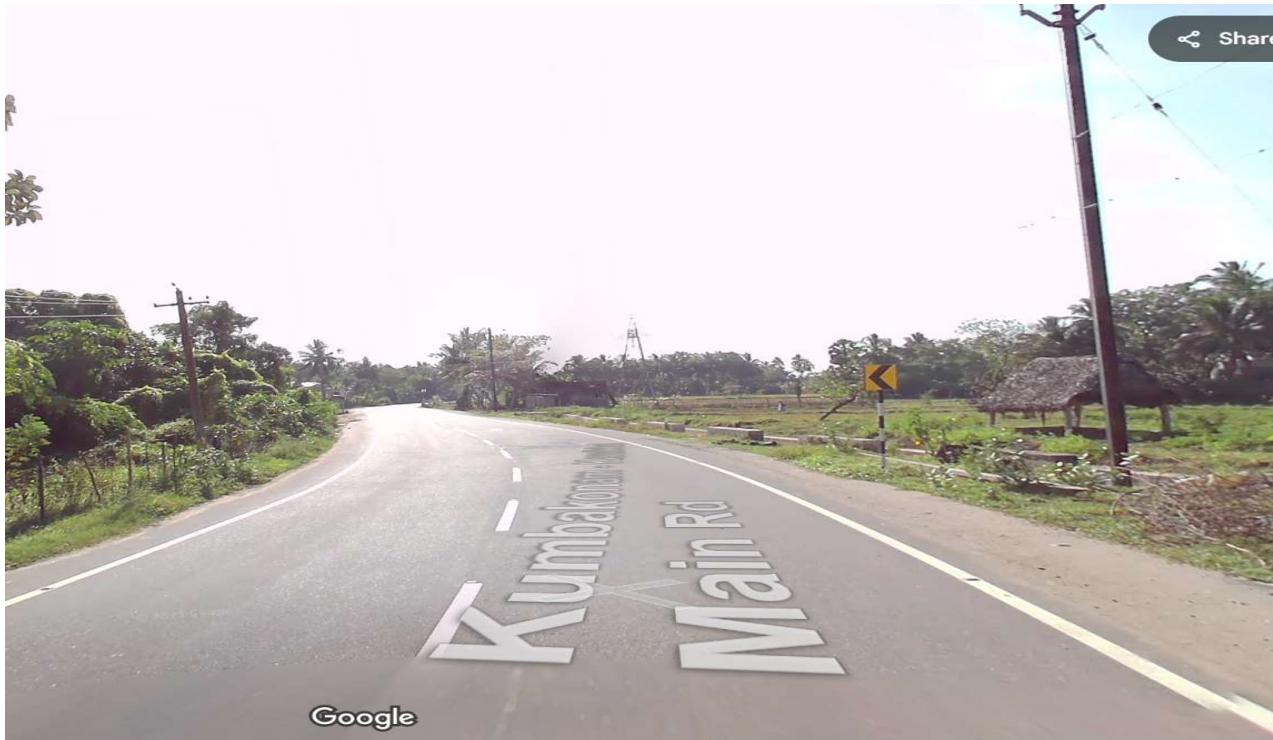
IMAGE: SHARP TURN RISK LEVEL: - MEDIUM, COORDI 10.987740544991665, 79.58142784769393

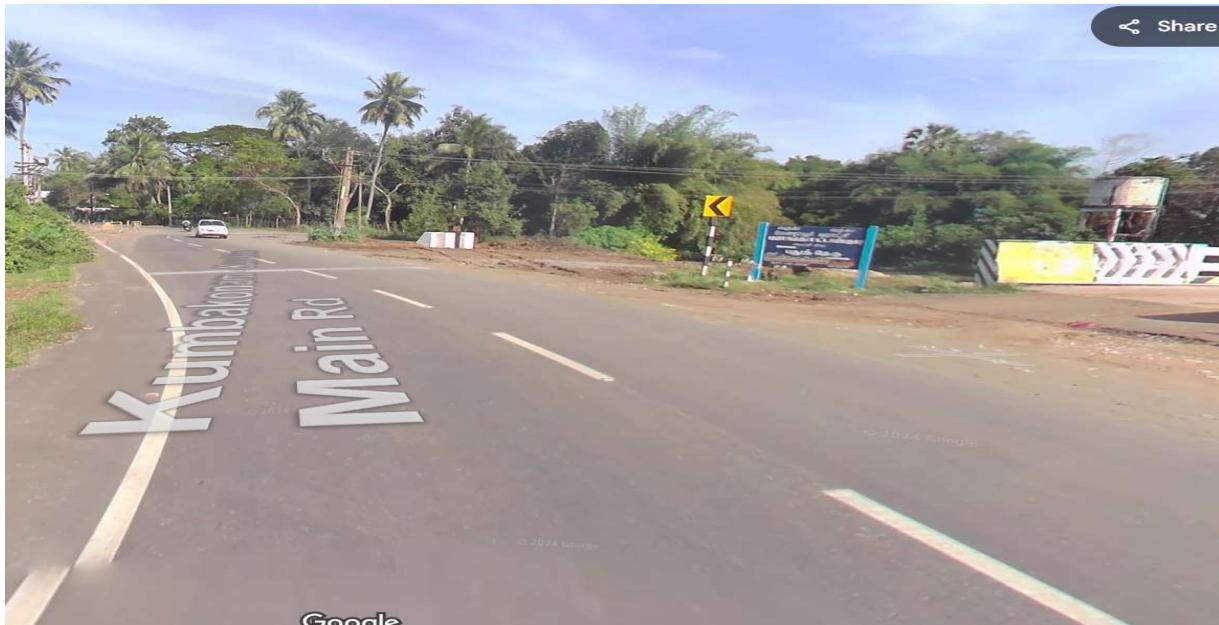
IMAGE: SHARP TURN RISK LEVEL: - MEDIUM, COORDI 10.987540562736278, 79.5871215963912

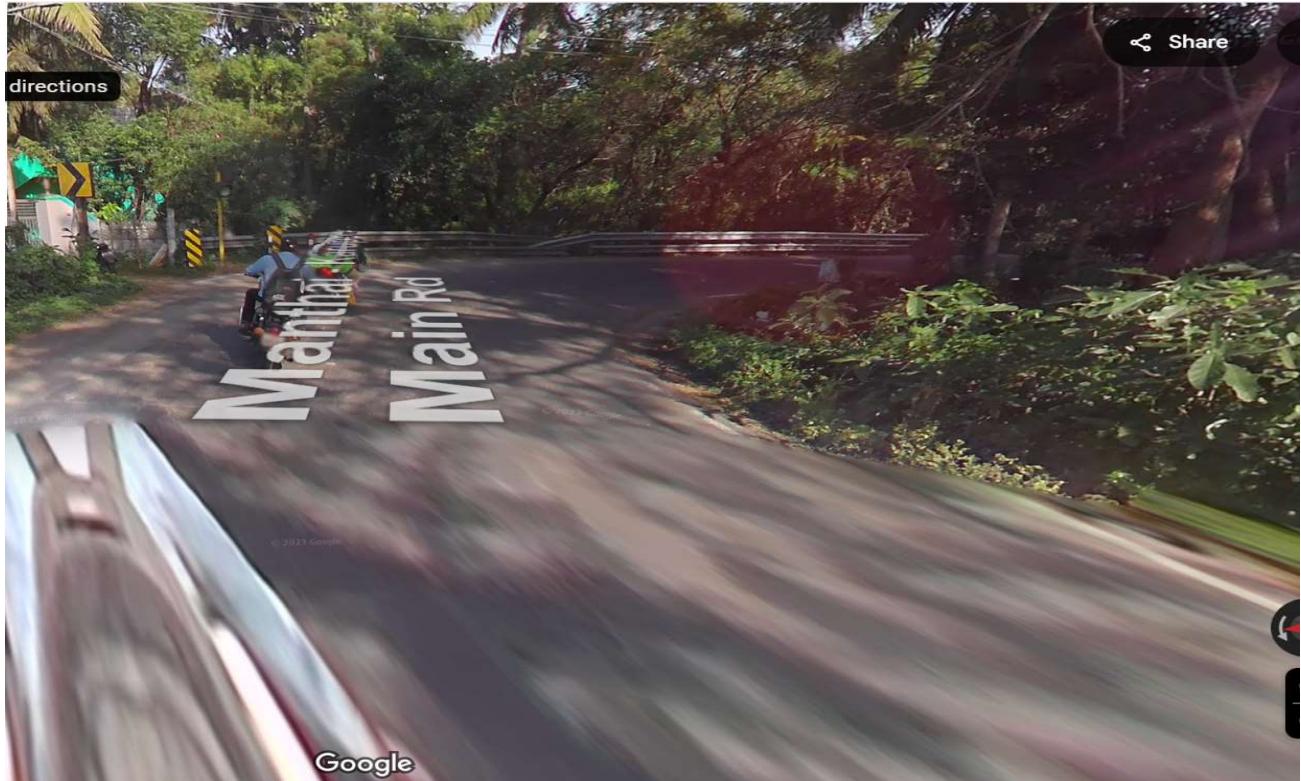
IMAGE: SHARP TURN RISK LEVEL: - MEDIUM, COORDI 10.98257682421649, 79.603774136502

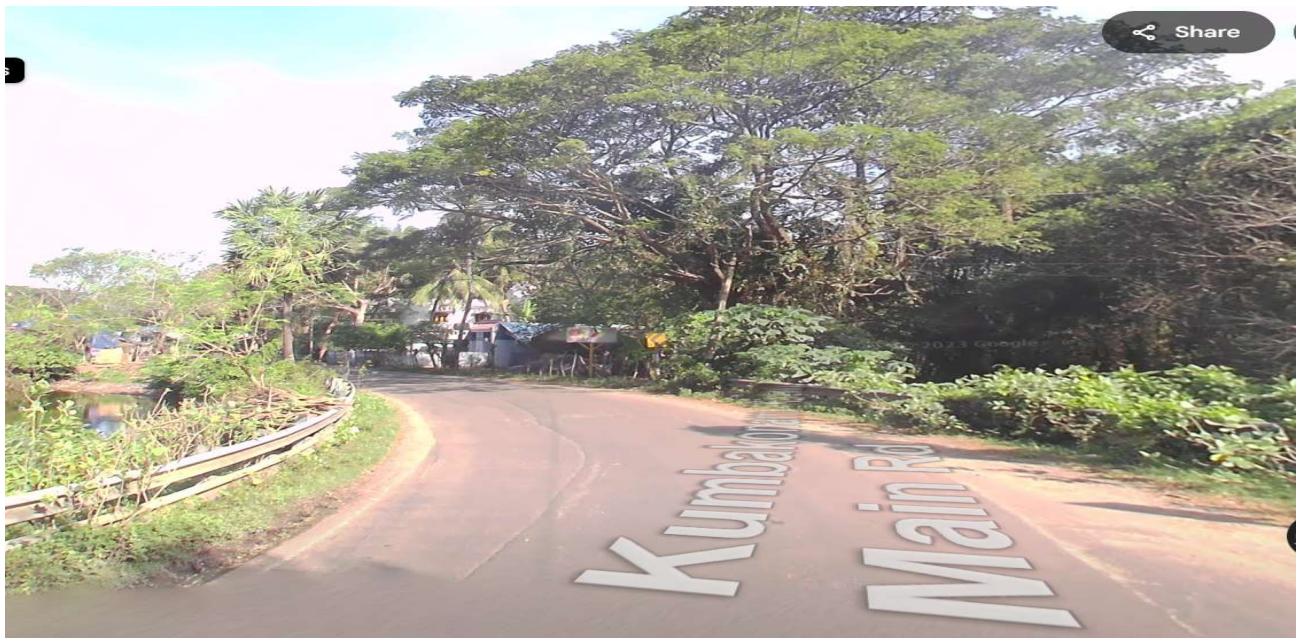
IMAGE: SHARP TURN RISK LEVEL: - MEDIUM, COORDI 10.997468072824544, 79.52261457790277

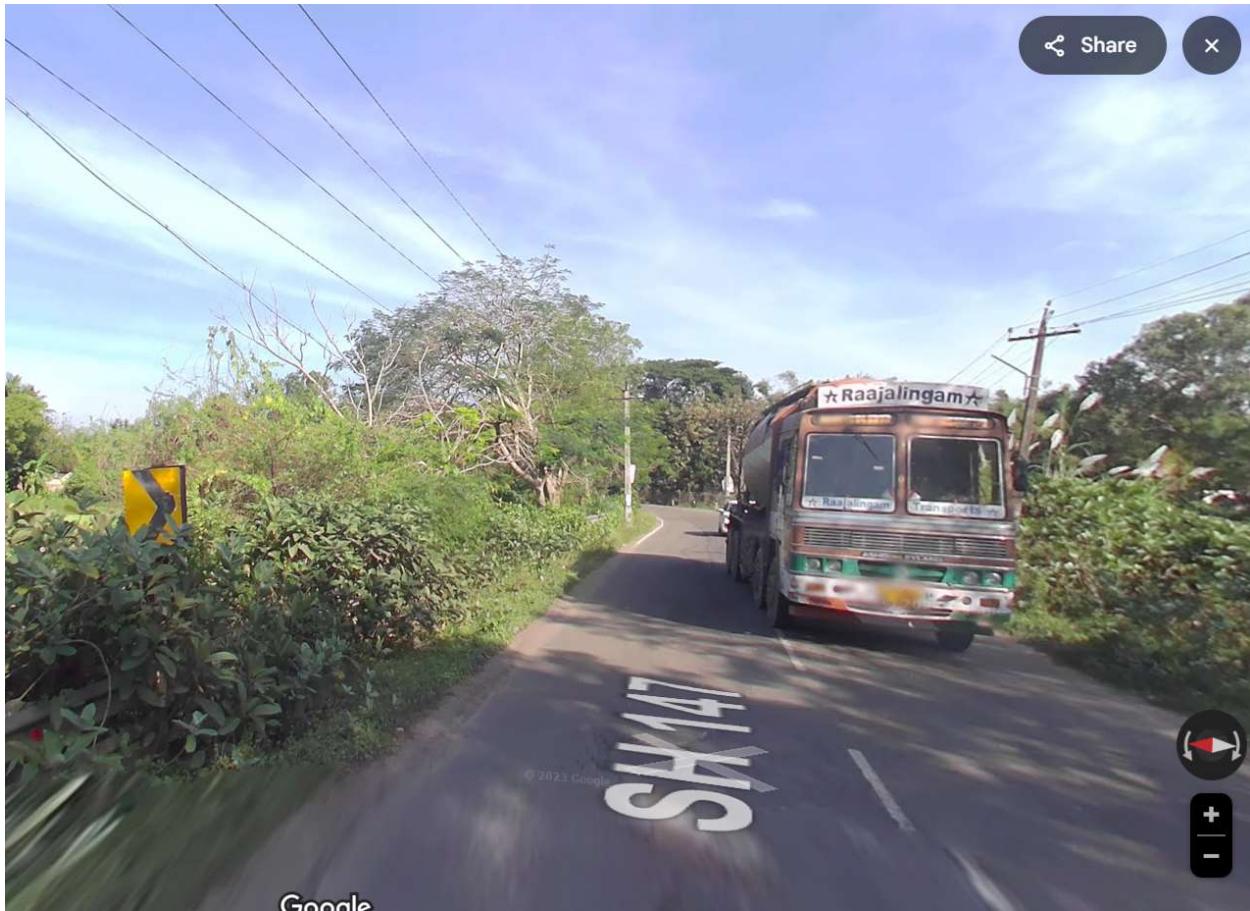
IMAGE: SHARP TURN RISK LEVEL: - MEDIUM, COORDI 10.978642804669425, 79.61216319719159

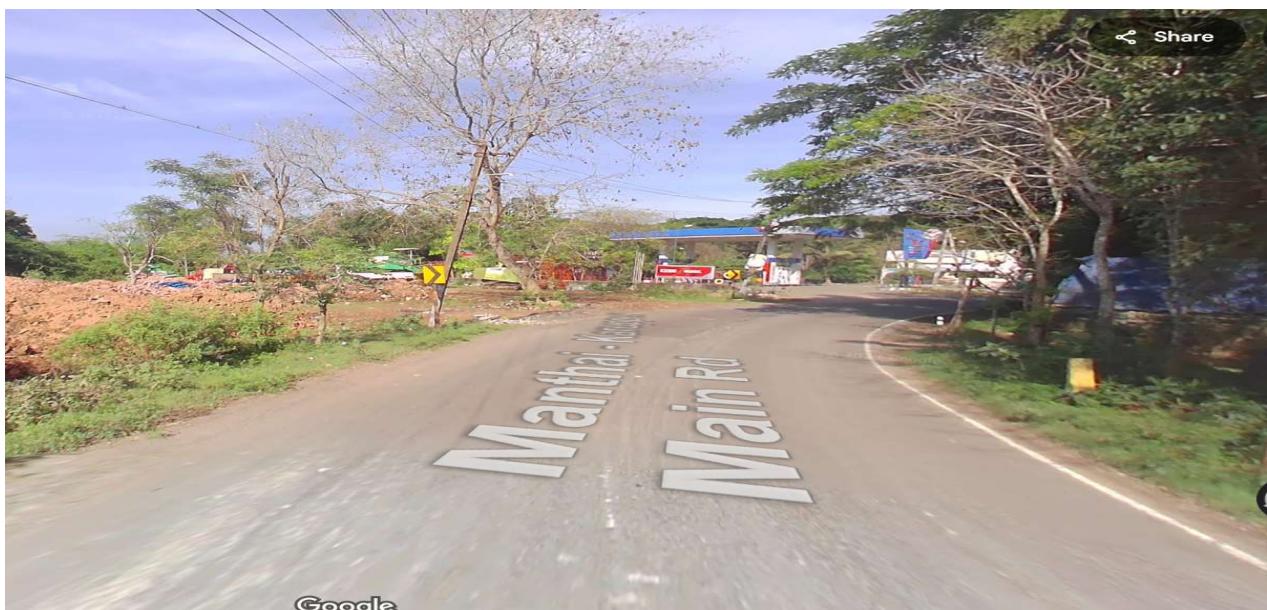
IMAGE: SHARP TURN RISK LEVEL: - MEDIUM, COORDI 10.980311502737374, 79.6269924536789

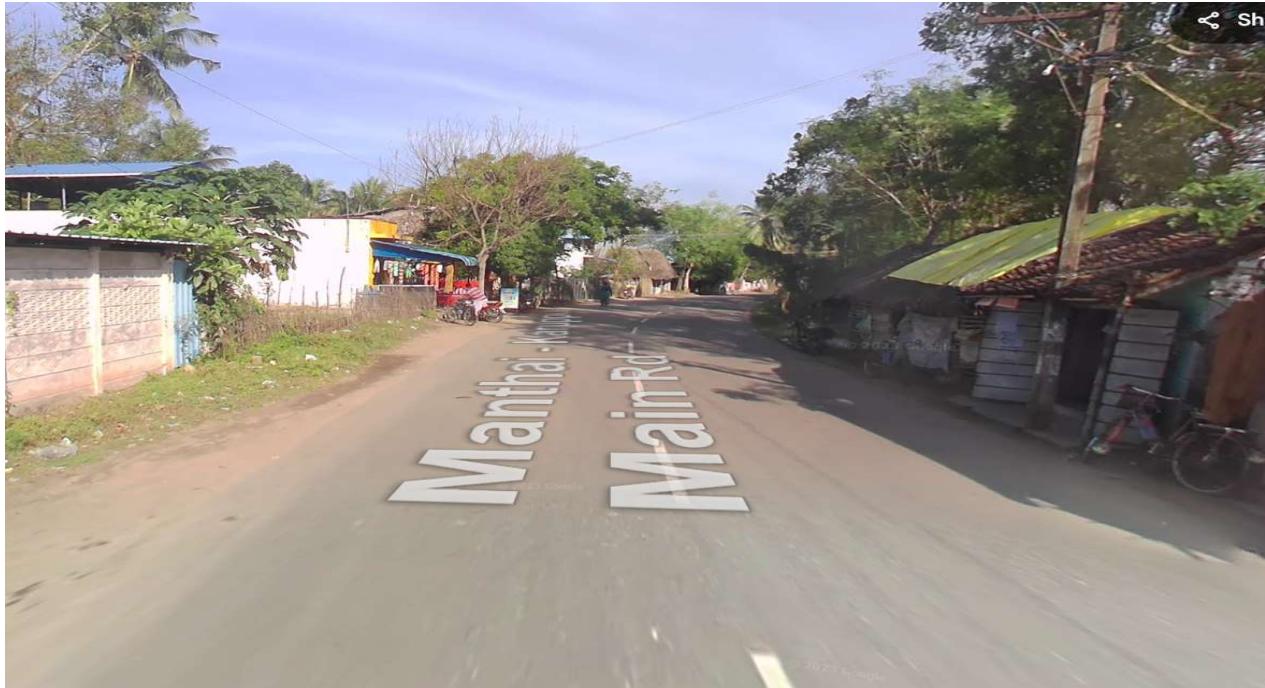
IMAGE: SHARP TURN RISK LEVEL: - MEDIUM, COORDI 10.981093919837123, 79.63238714523666

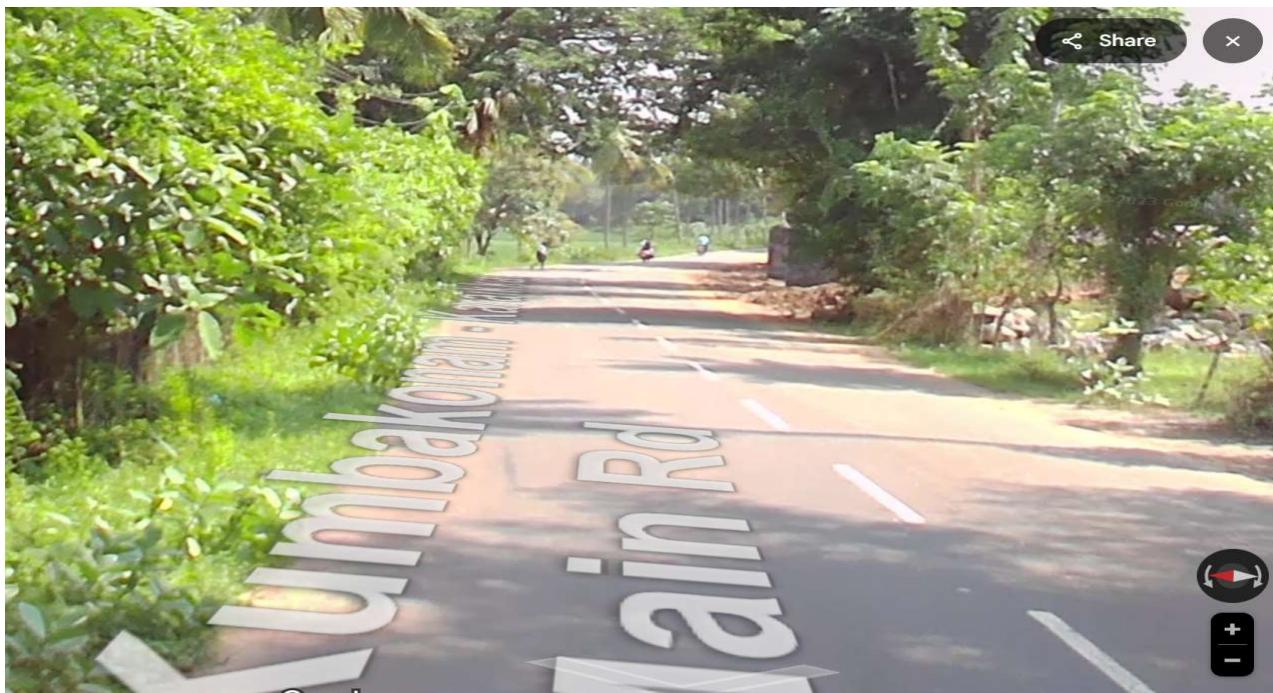
IMAGE: SHARP TURN RISK LEVEL: - MEDIUM, COORDI 10.981093919837123, 79.63238714523666

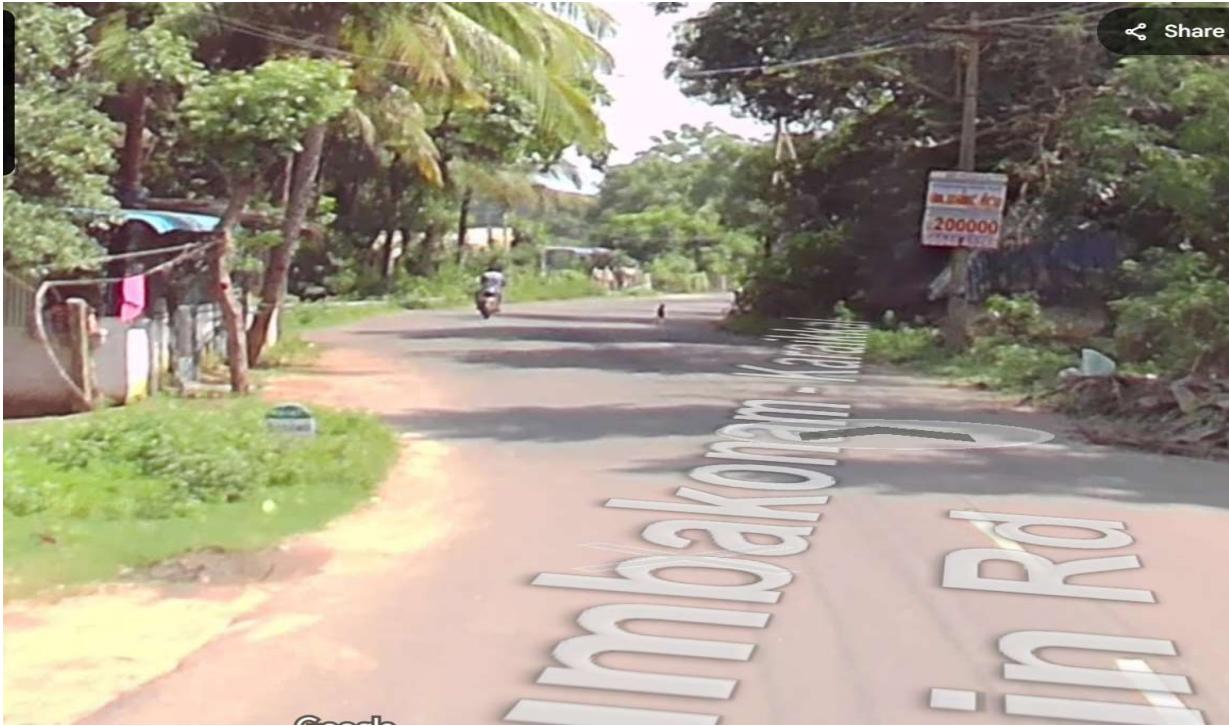
IMAGE: SHARP TURN RISK LEVEL: - MEDIUM, COORDI 10.980289845806885, 79.64038449669609

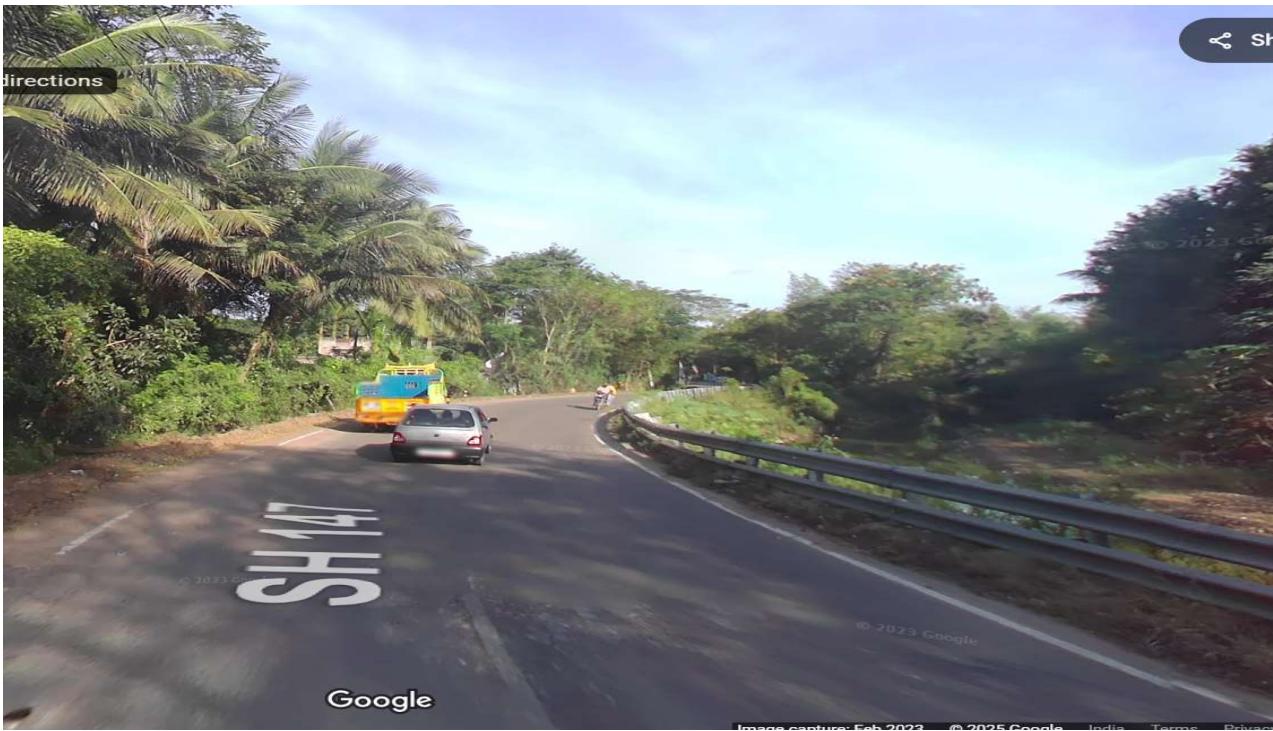
IMAGE: SHARP TURN RISK LEVEL: - MEDIUM, COORDI 10.980974794669736, 79.65339382615088

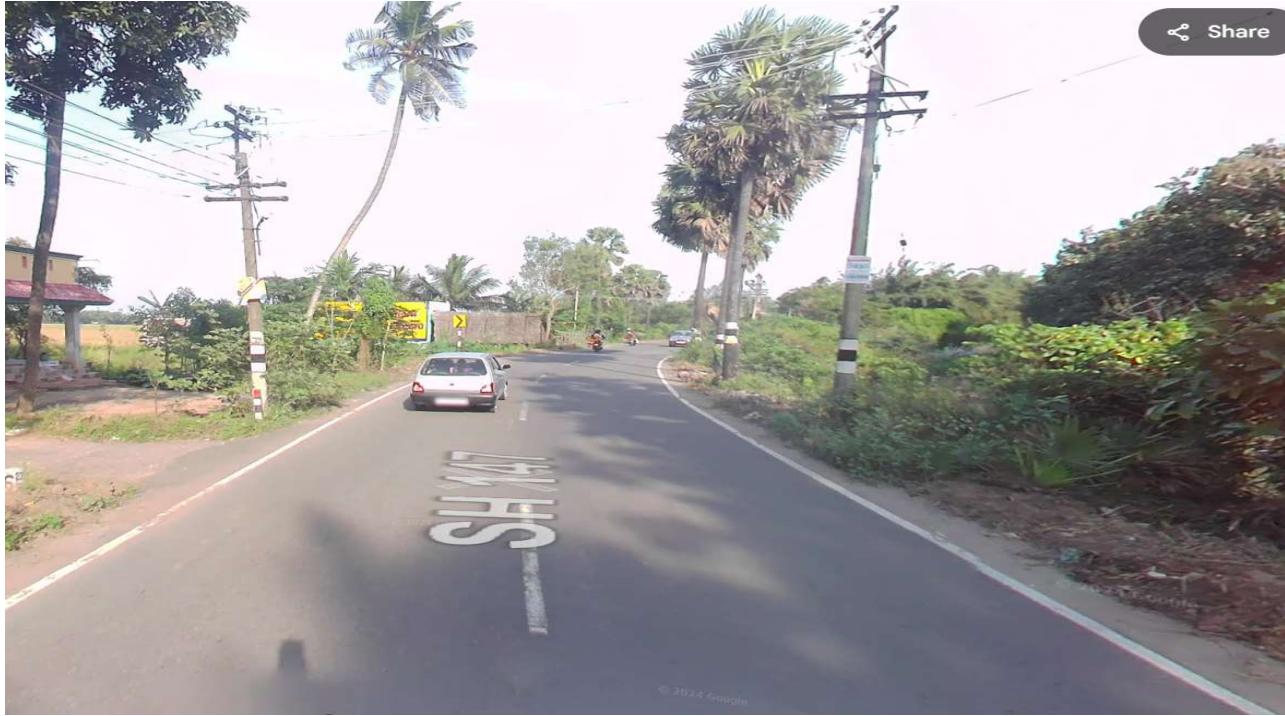
IMAGE: SHARP TURN RISK LEVEL: - MEDIUM, COORDI 10.981434236664478, 79.65609416186935

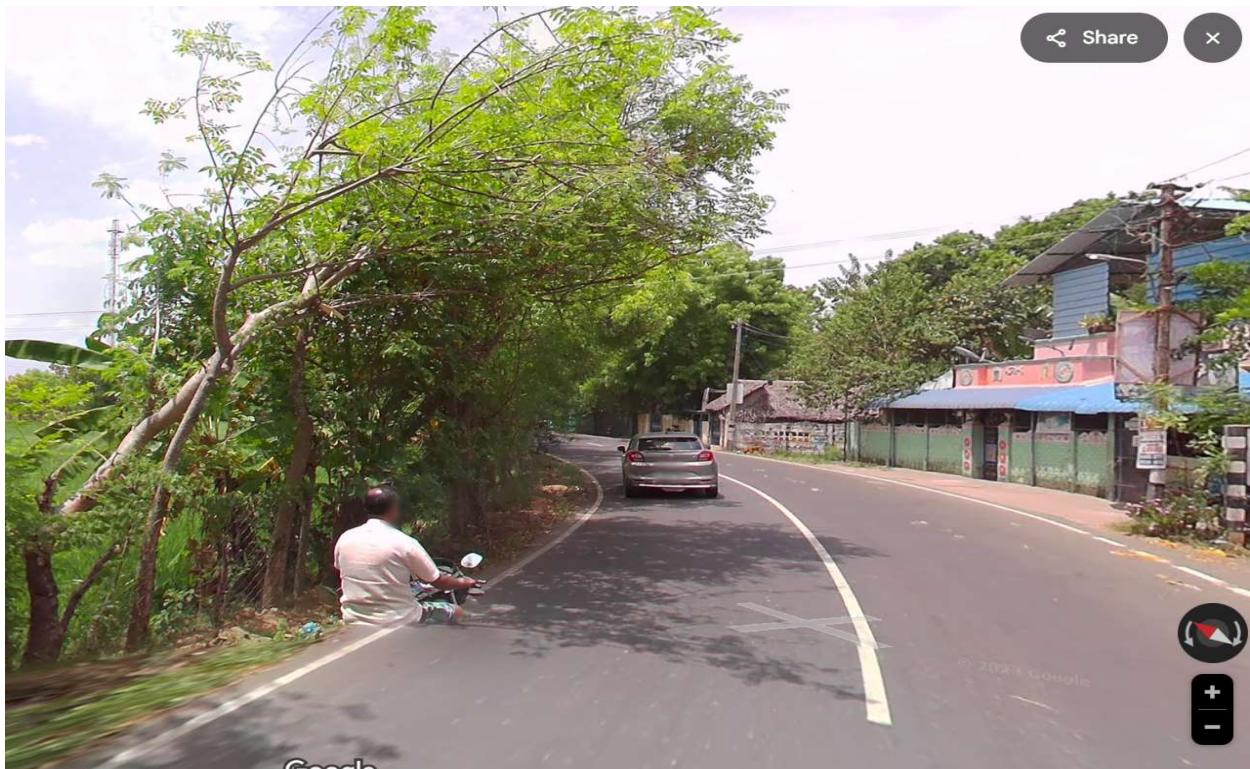
IMAGE: SHARP TURN RISK LEVEL: - MEDIUM, COORDI 10.98205716524272, 79.66772881733506

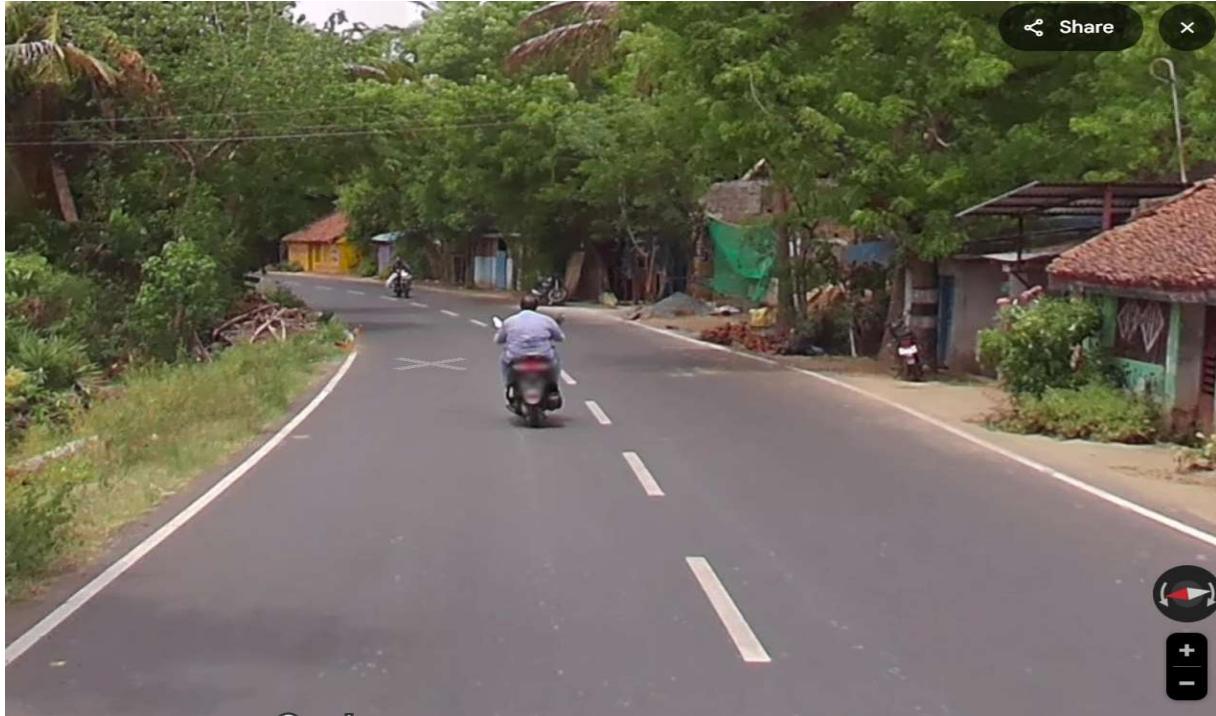
IMAGE: SHARP TURN RISK LEVEL: - MEDIUM, COORDI 10.983622084540597, 79.67921211595166
