JOURNEY RISK MANAGEMENT STUDY REPORT

FOR IOCL TRICHY TERMINAL

**IOCL TIRCHY TERMINAL (10.7753, 78.8368) TO SIFA AGENCIES (10.759889 ,
79.837977), TOTAL DISTANCE -124 KM**

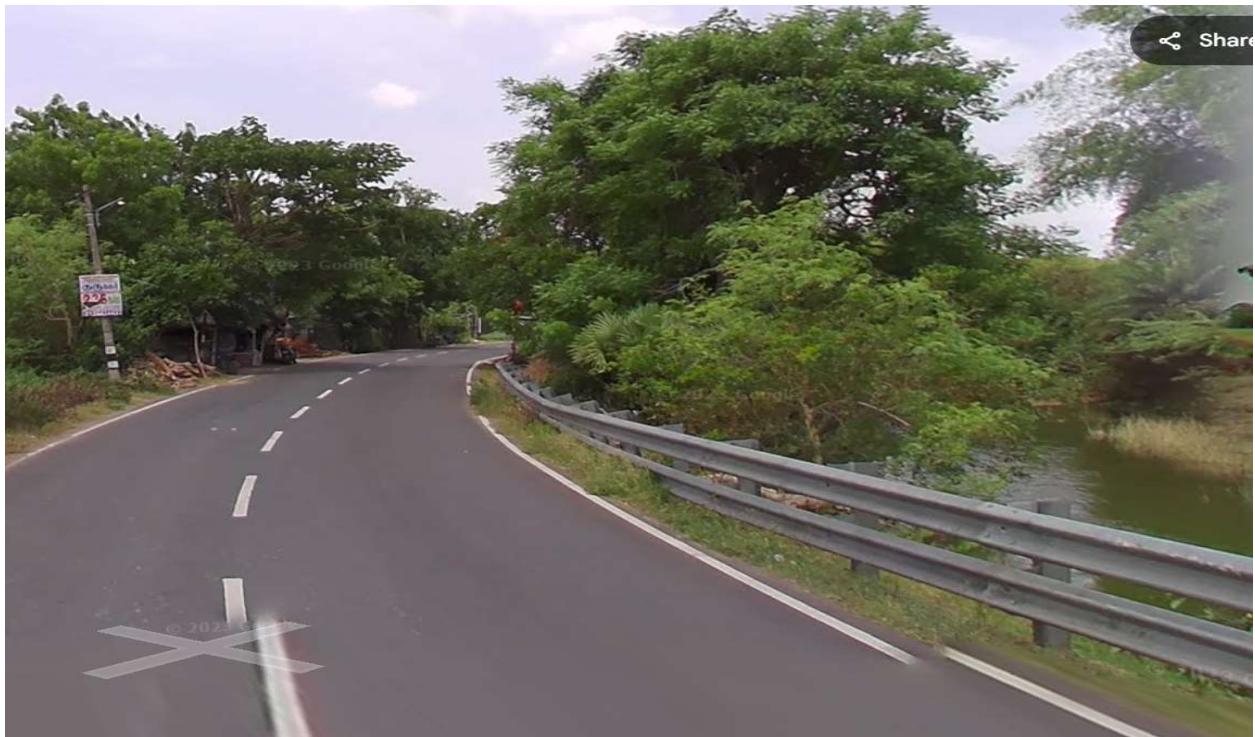
IMAGE: SHARP TURN RISK LEVEL: - MEDIUM, COORDI 10.983611079081712, 79.6794698558881

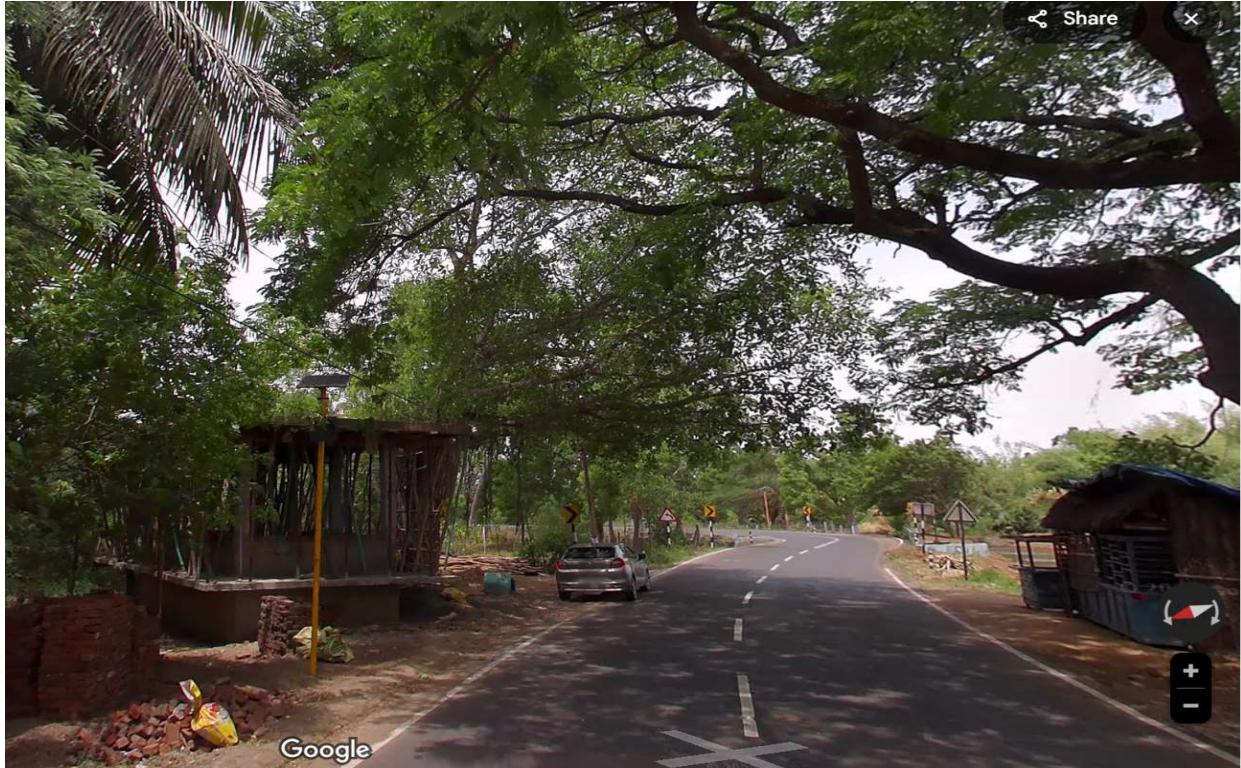
IMAGE: SHARP TURN RISK LEVEL: - MEDIUM, COORDI 10.983623141682171, 79.6834547111762

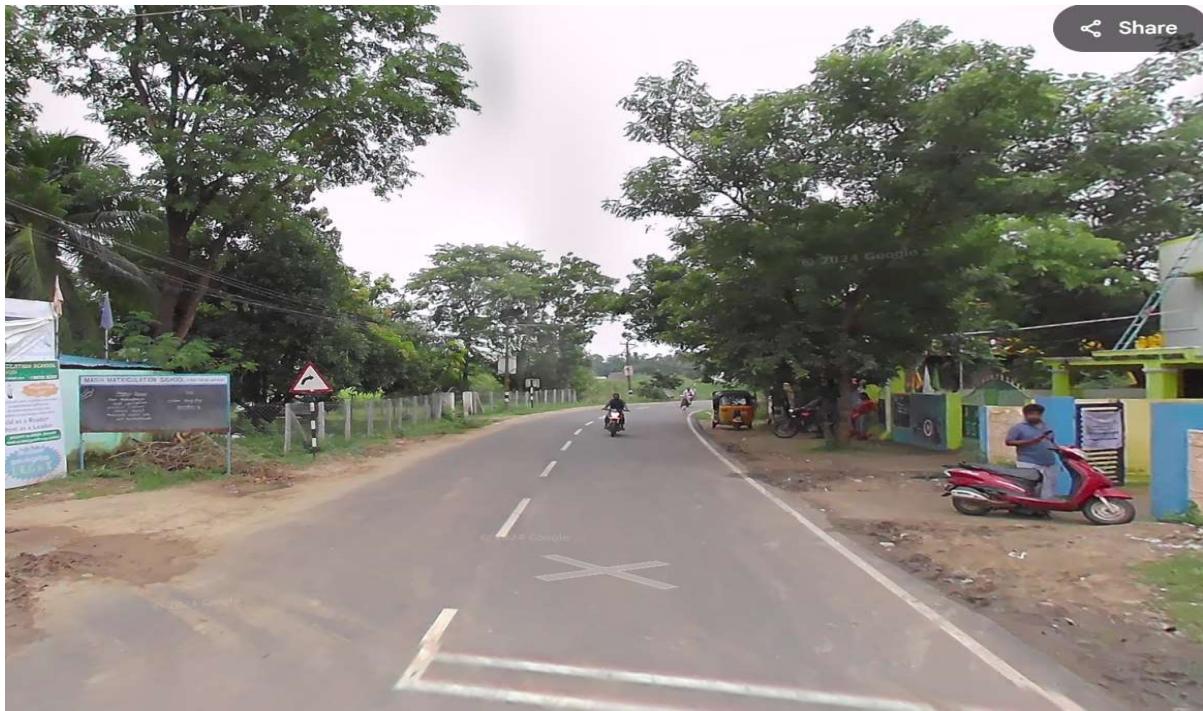
IMAGE: SHARP TURN RISK LEVEL: - MEDIUM, COORDI 10.981989652855994, 79.690124444837

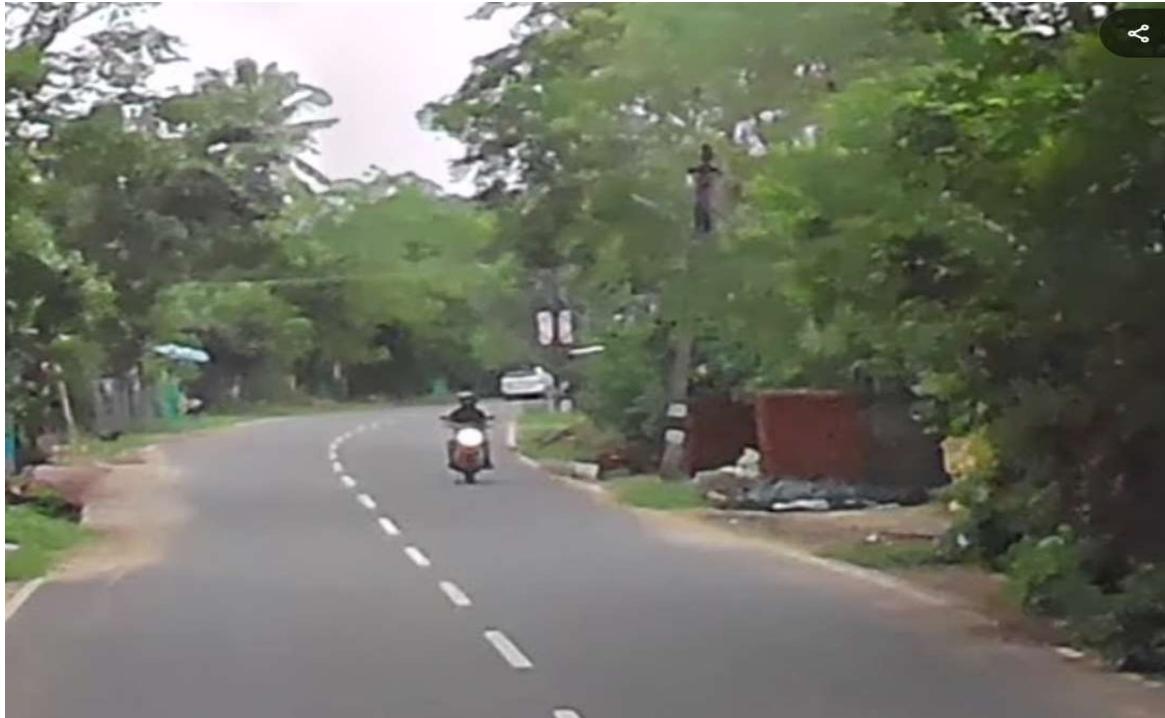
IMAGE: SHARP TURN RISK LEVEL: - MEDIUM, COORDI 10.97900065737536, 79.69900788046597

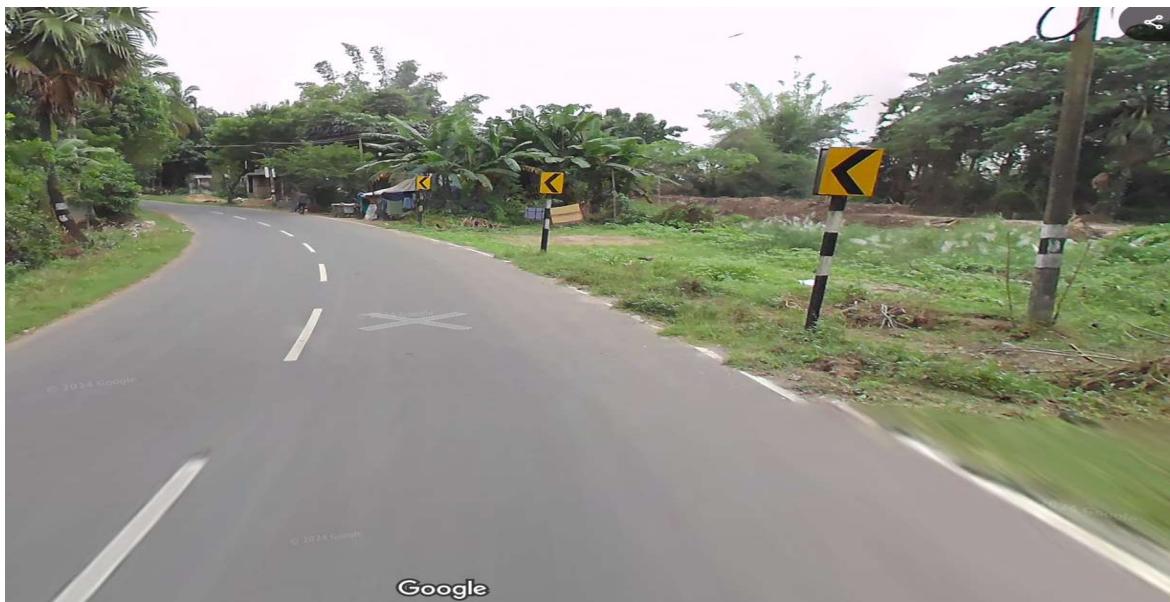
IMAGE: SHARP TURN RISK LEVEL: - MEDIUM, COORDI 10.97614303989356, 79.70712467304794

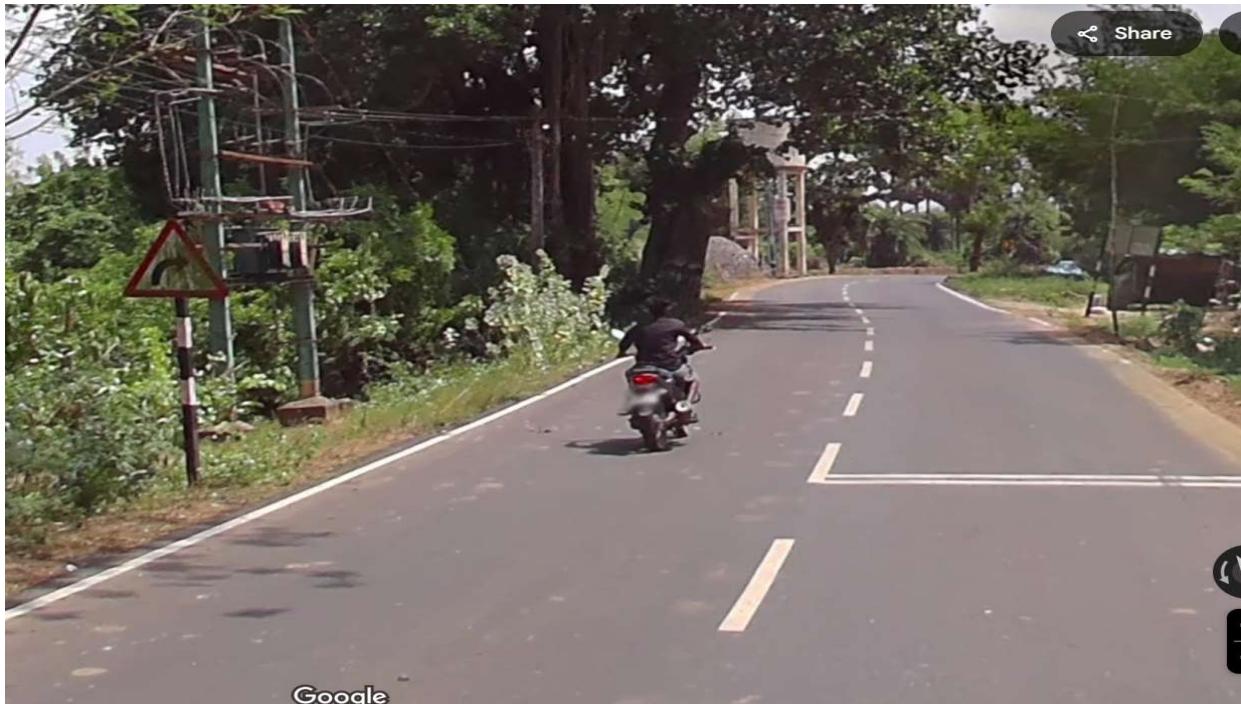
IMAGE: SHARP TURN RISK LEVEL: - MEDIUM, COORDI 10.977932476045517, 79.71594218031824

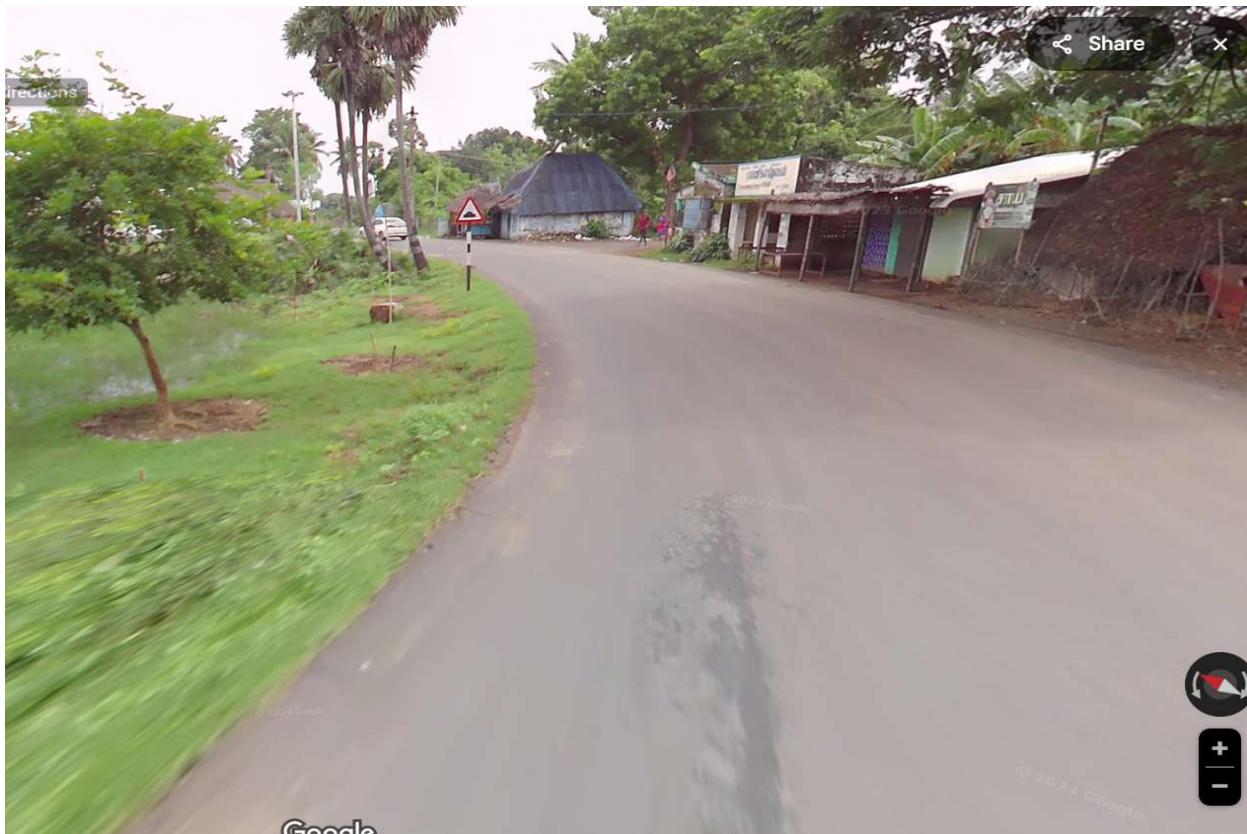
IMAGE: SHARP TURN RISK LEVEL: - MEDIUM, COORDI 10.977607564144272, 79.7244128789247

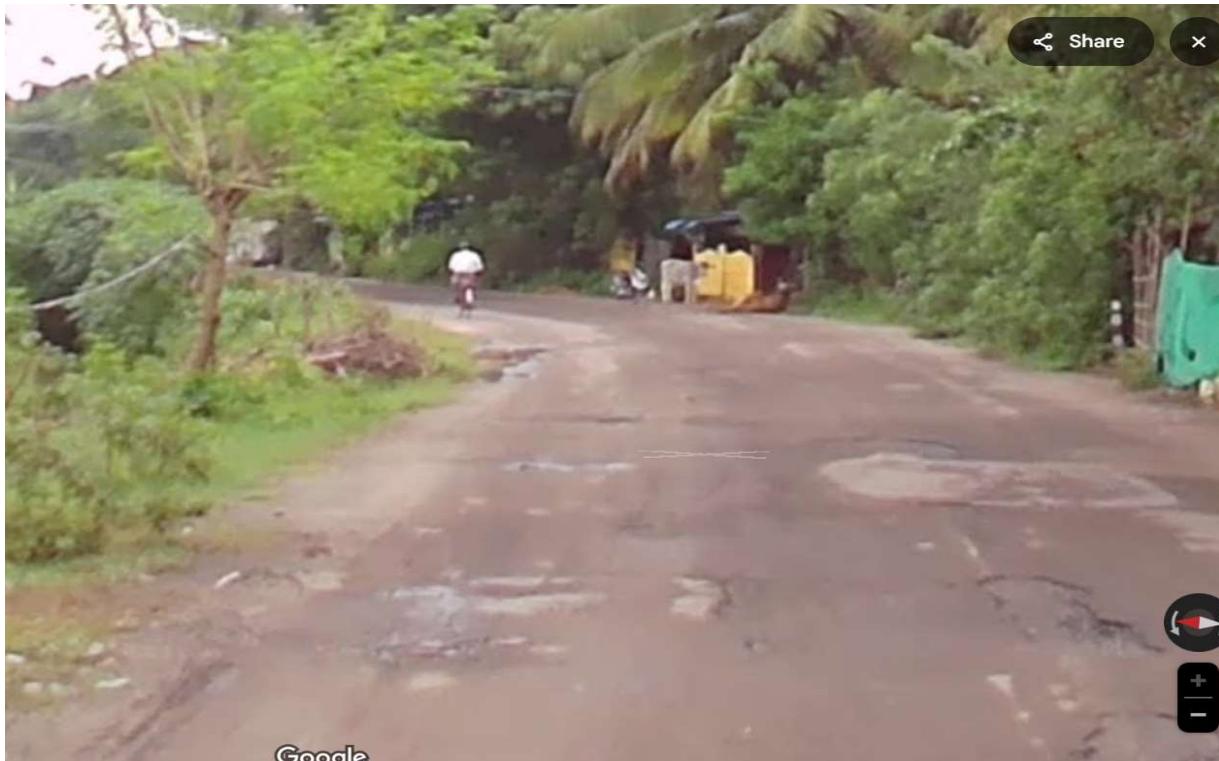
IMAGE: SHARP TURN RISK LEVEL: - MEDIUM, COORDI 10.976343782644864, 79.74606516666324

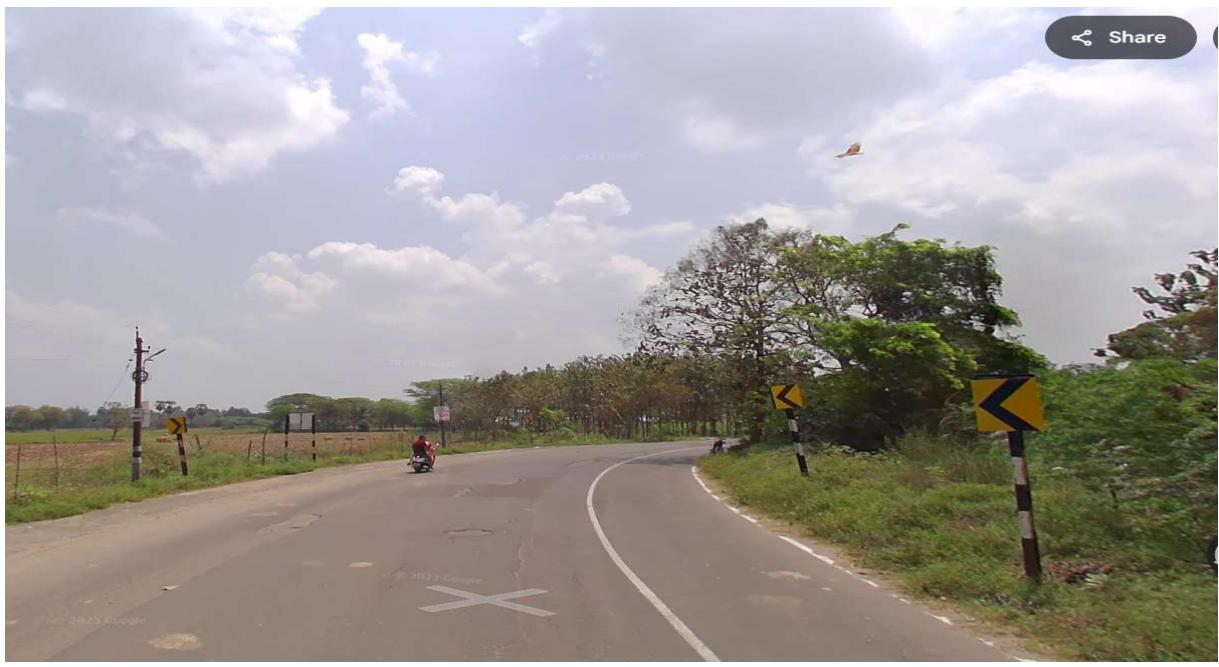
IMAGE: SHARP TURN RISK LEVEL: - MEDIUM, COORDI 10.976143547065968, 79.75277076450837

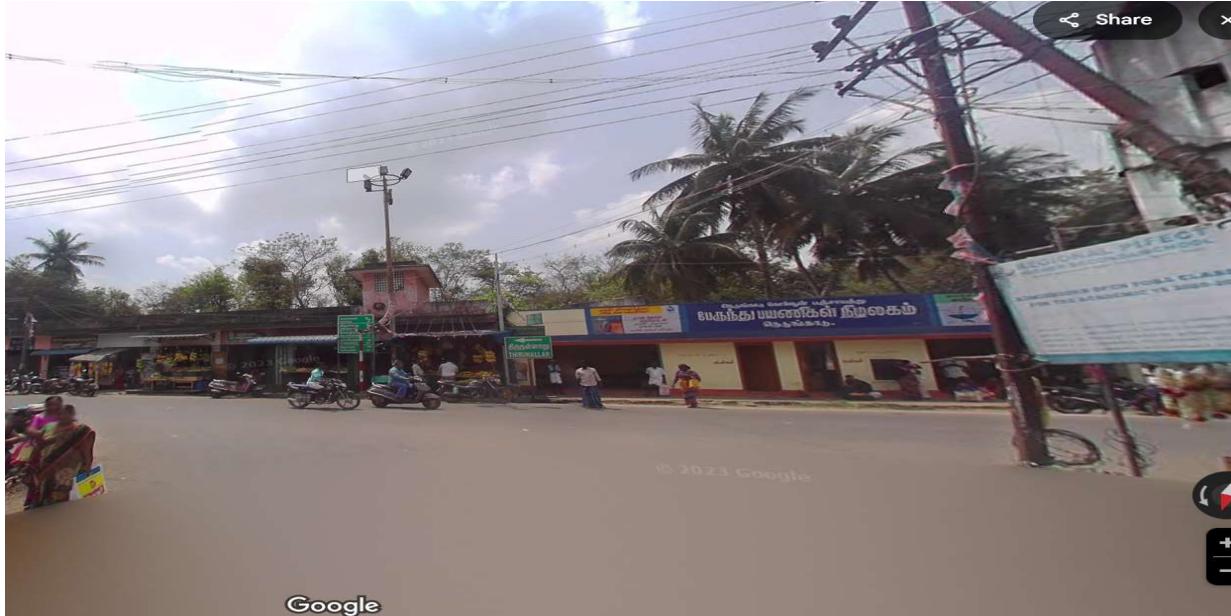
IMAGE: SHARP TURN RISK LEVEL: - MEDIUM, COORDI 10.97406285566265, 79.77076007615538

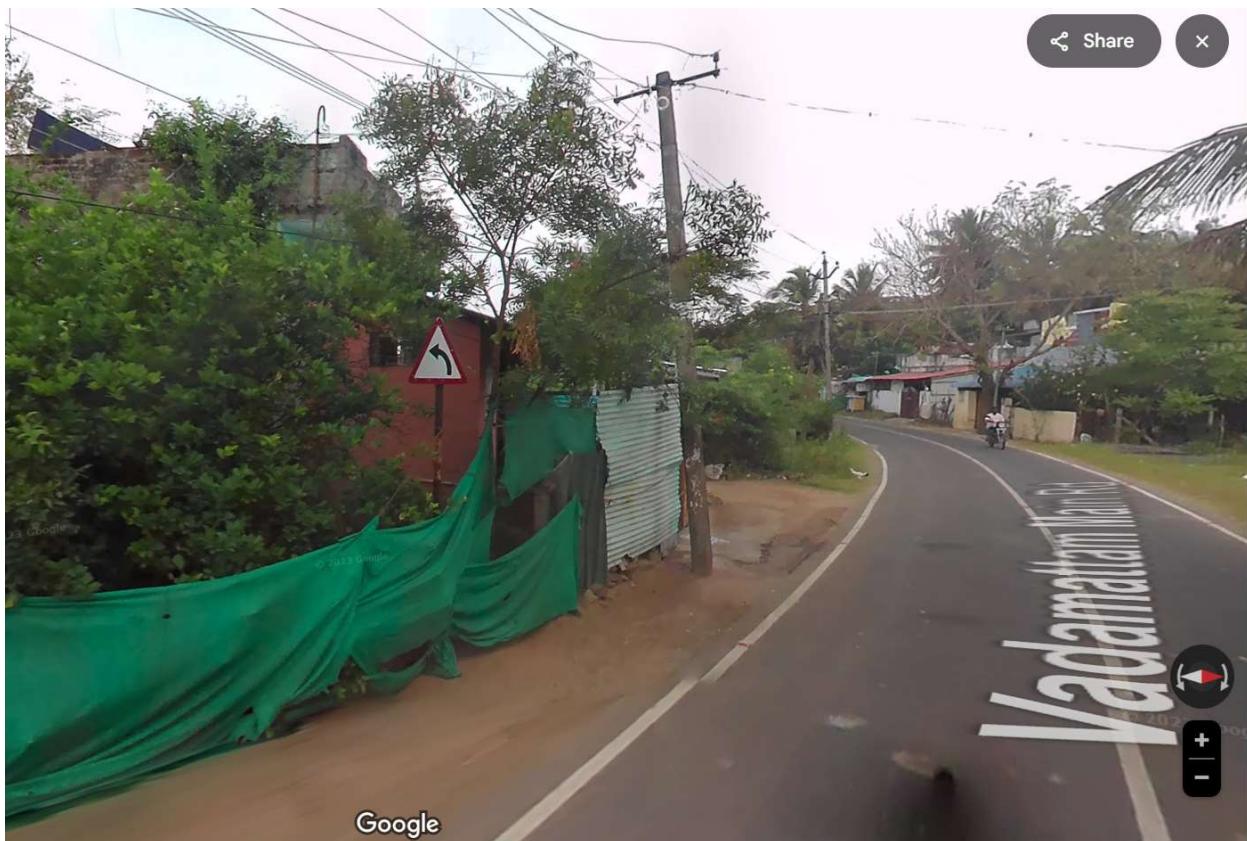
IMAGE: SHARP TURN RISK LEVEL: - MEDIUM, COORDI 10.966870491363219, 79.79981994069612

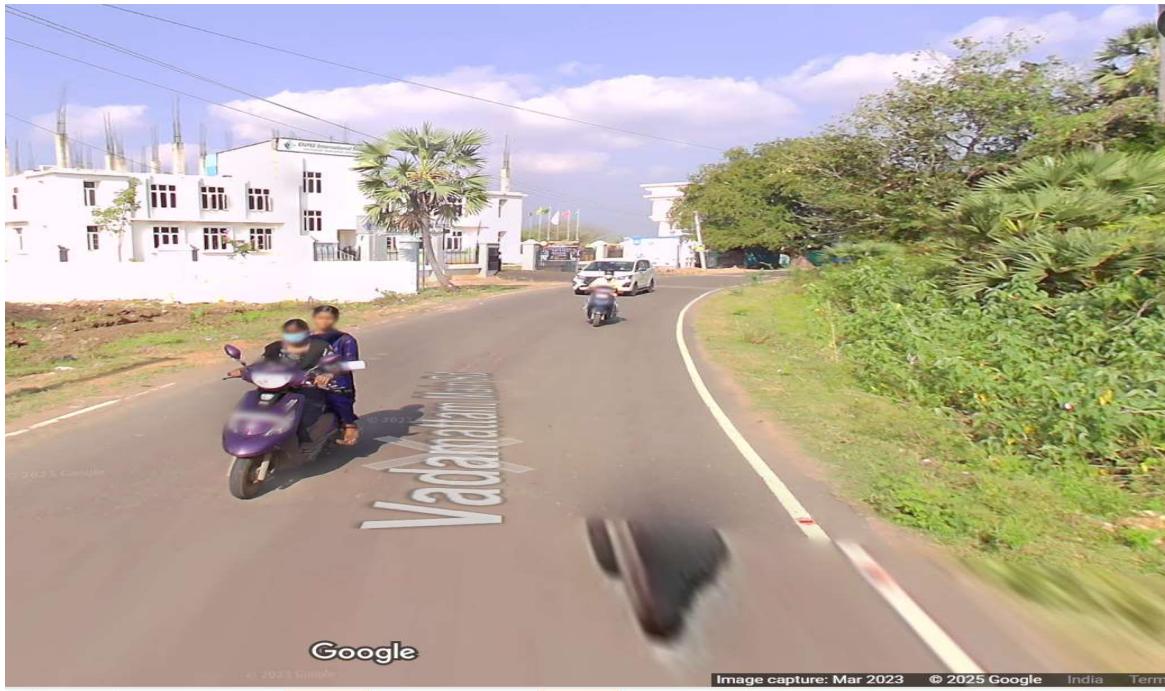
IMAGE: SHARP TURN RISK LEVEL: - MEDIUM, COORDI 10.960160926774313, 79.81119260218072

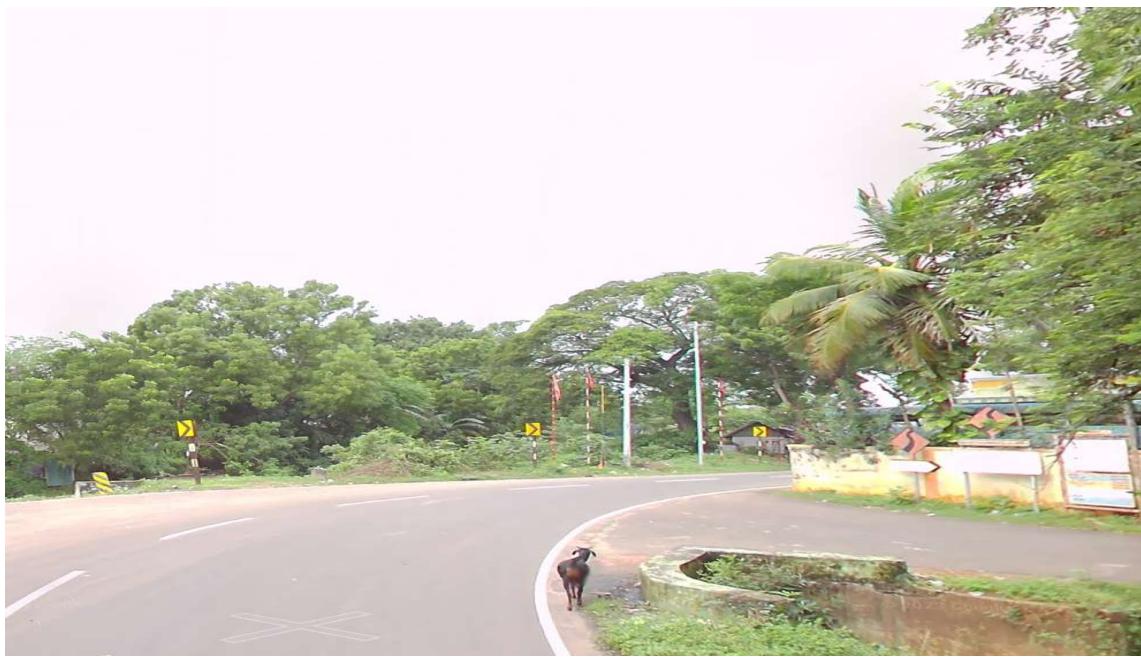
IMAGE: SHARP TURN RISK LEVEL: - MEDIUM, COORDI 10.960160926774313, 79.81119260218072
