JOURNEY RISK MANAGEMENT (JRM) STUDY

Salem Terminal TO MUTHU CORPORATION UNIT II

Route Safety Analysis Report

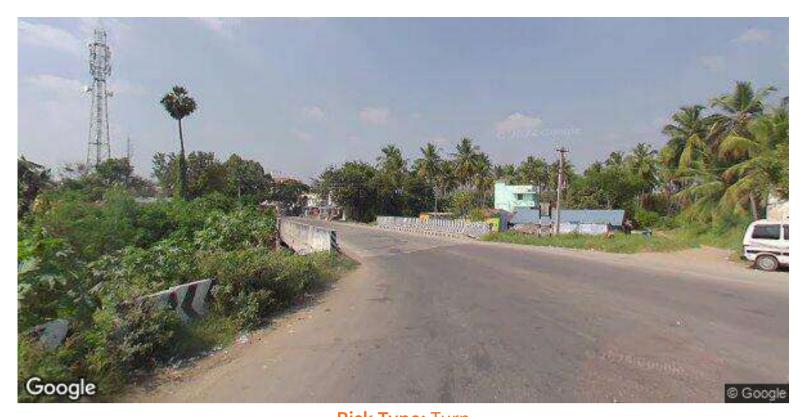
Risk Type: Turn
Speed Limit: 15 KM/Hr
Distance from Start: 1.36 km
Coordinates: 11.44893, 77.87413

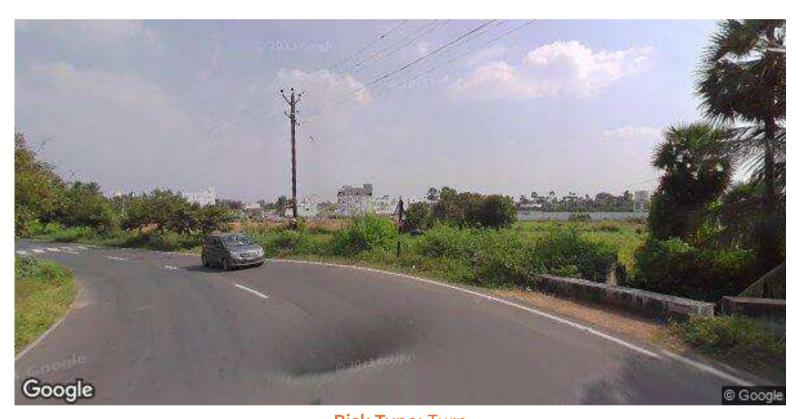
Risk Type: Turn
Speed Limit: 15 KM/Hr
Distance from Start: 3.34 km
Coordinates: 11.45350, 77.85700

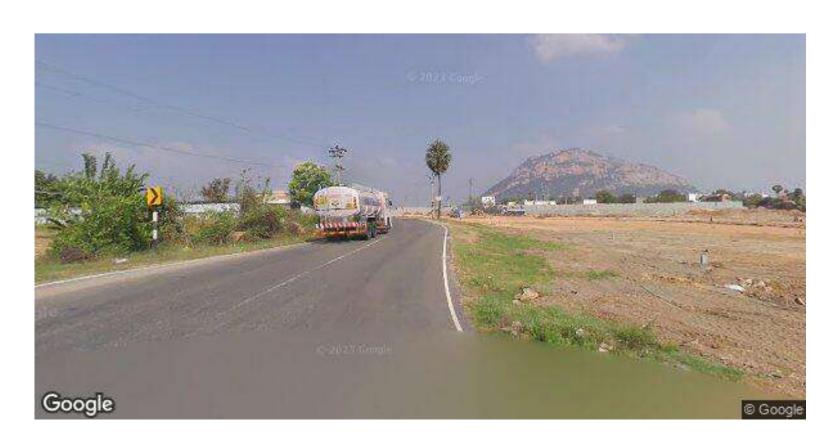
Risk Type: Turn
Speed Limit: 15 KM/Hr
Distance from Start: 4.12 km

Coordinates: 11.45845, 77.85141

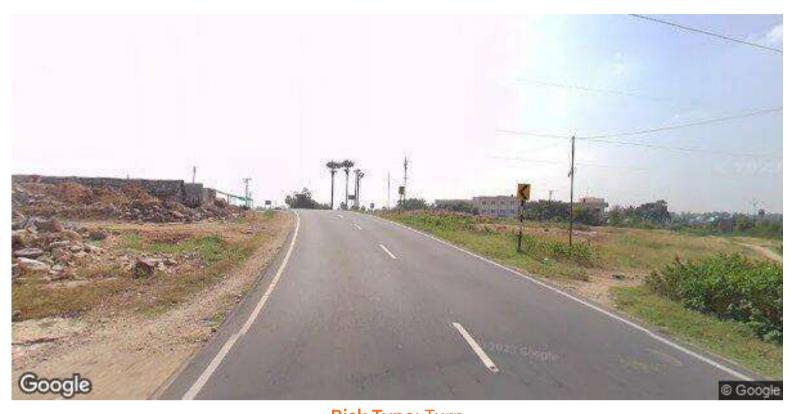
Risk Type: Turn
Speed Limit: 15 KM/Hr
Distance from Start: 4.37 km
Coordinates: 11.46046, 77.85037

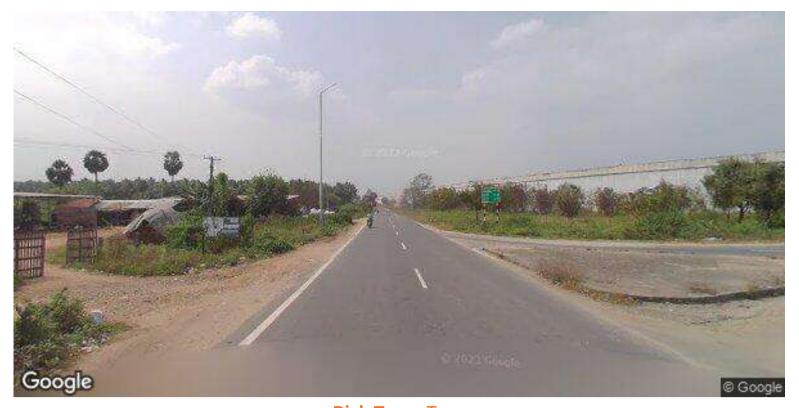
Risk Type: Turn
Speed Limit: 15 KM/Hr
Distance from Start: 8.38 km
Coordinates: 11.45542, 77.81725

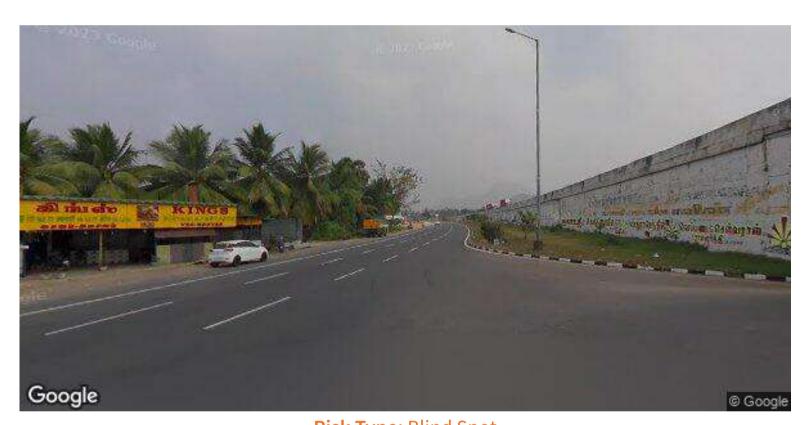
Risk Type: Blind Spot
Speed Limit: 10 KM/Hr
Distance from Start: 8.52 km
Coordinates: 11.45634, 77.81673

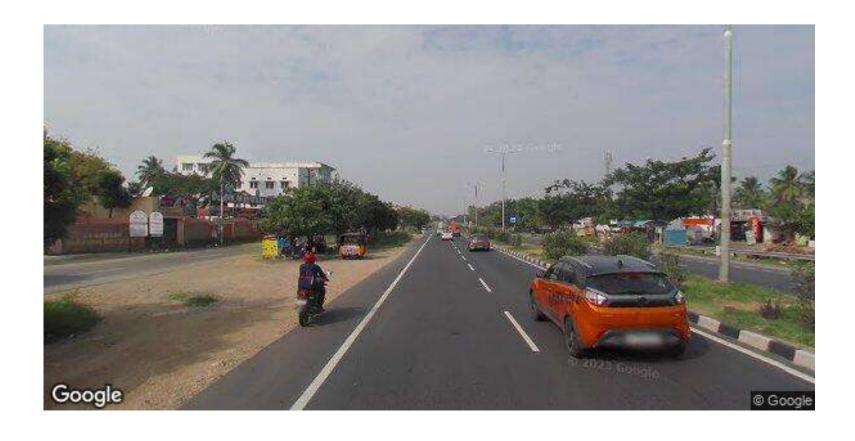
Risk Type: Blind Spot Speed Limit: 10 KM/Hr Distance from Start: 18.67 km

Coordinates: 11.44530, 77.72783

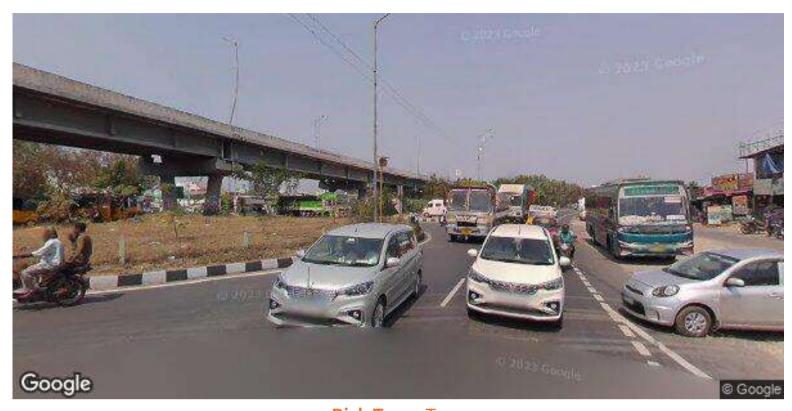
Risk Type: Turn
Speed Limit: 15 KM/Hr
Distance from Start: 24.89 km
Coordinates: 11.43001, 77.67575

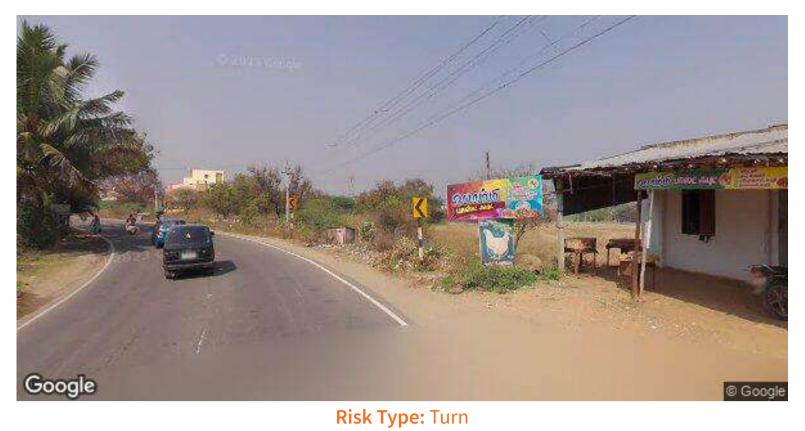
Speed Limit: 15 KM/Hr
Distance from Start: 25.98 km
Coordinates: 11.43346, 77.66700

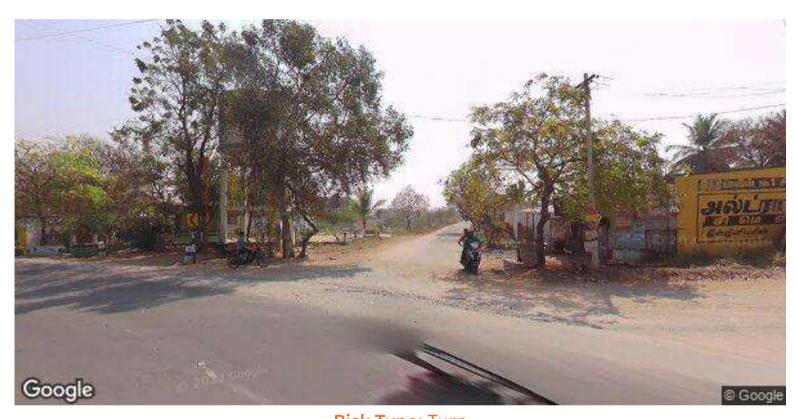
Risk Type: Turn
Speed Limit: 15 KM/Hr
Distance from Start: 26.17 km
Coordinates: 11.43225, 77.66561

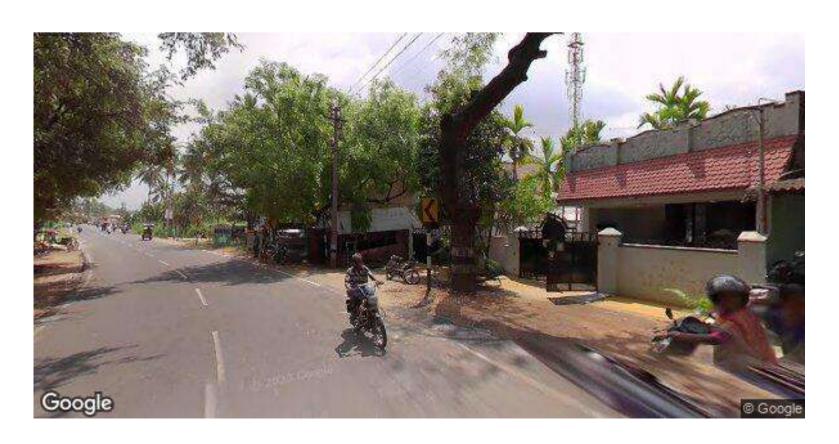
Risk Type: Turn
Speed Limit: 15 KM/Hr
Distance from Start: 36.97 km

Coordinates: 11.42837, 77.56935

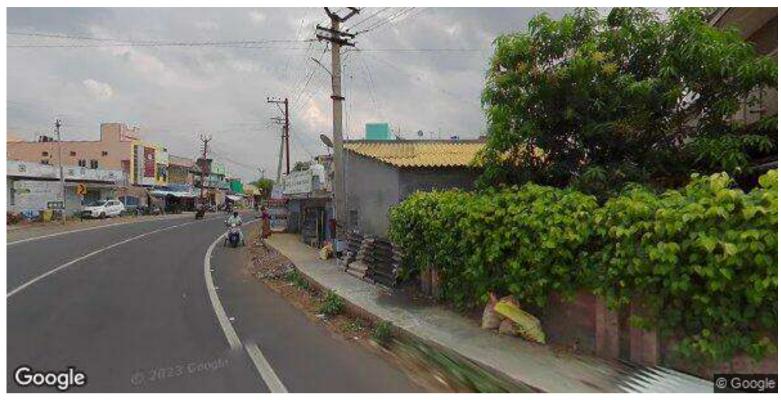
Risk Type: Turn
Speed Limit: 15 KM/Hr
Distance from Start: 37.39 km
Coordinates: 11.42821, 77.56543

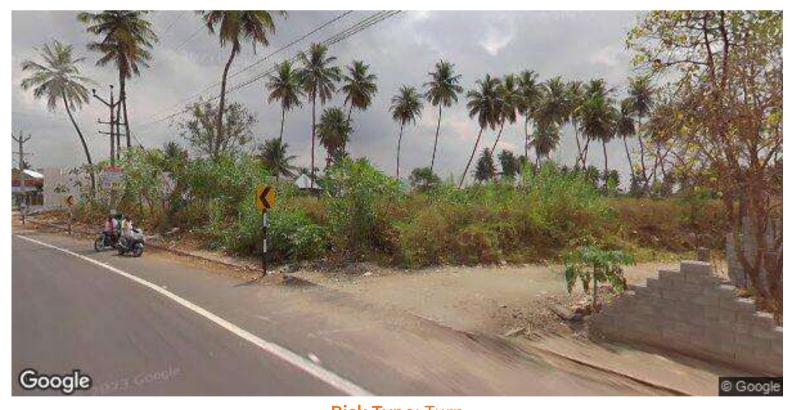
Risk Type: Turn
Speed Limit: 15 KM/Hr
Distance from Start: 37.61 km
Coordinates: 11.42707, 77.56407

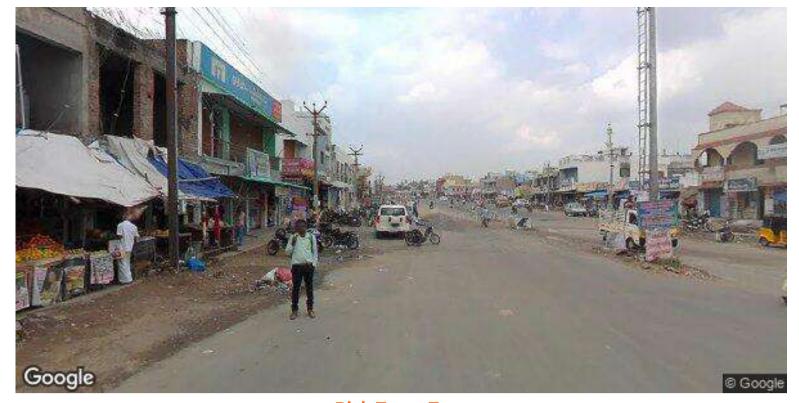
Risk Type: Turn
Speed Limit: 15 KM/Hr
Distance from Start: 38.45 km
Coordinates: 11.42329, 77.55798

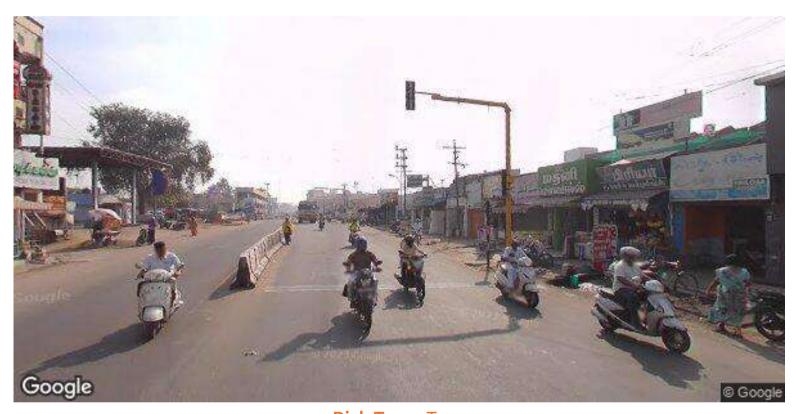
Risk Type: Turn
Speed Limit: 15 KM/Hr
Distance from Start: 52.40 km
Coordinates: 11.45490, 77.43549
