JOURNEY RISK MANAGEMENT (JRM) STUDY

Salem Terminal TO SAMIAPPA ENTERPRISES

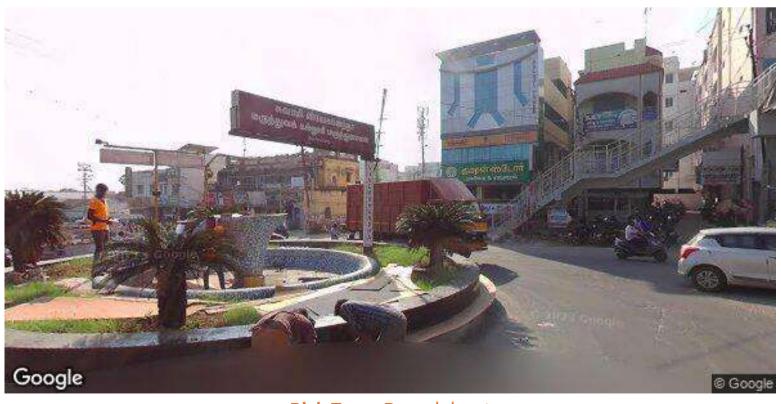
Coordinates: 11.38395, 77.89480

Risk Type: Roundabout
Risk Level: High
Speed Limit: 15 KM/Hr

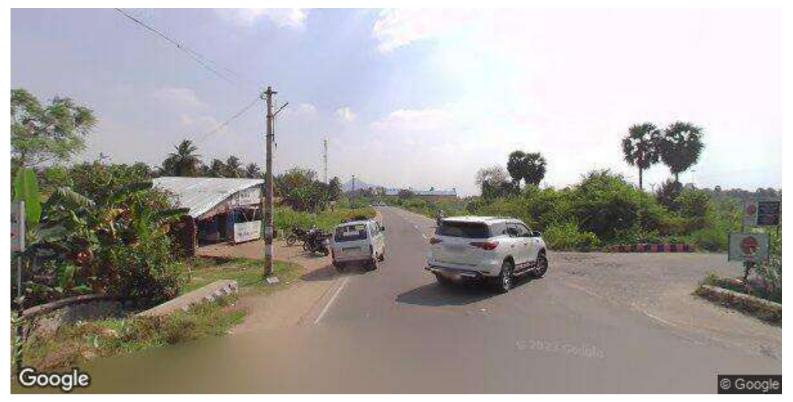
Coordinates: 11.44029, 77.87544

Risk Type: Blind Spot Risk Level: Blind Spot Speed Limit: 10 KM/Hr

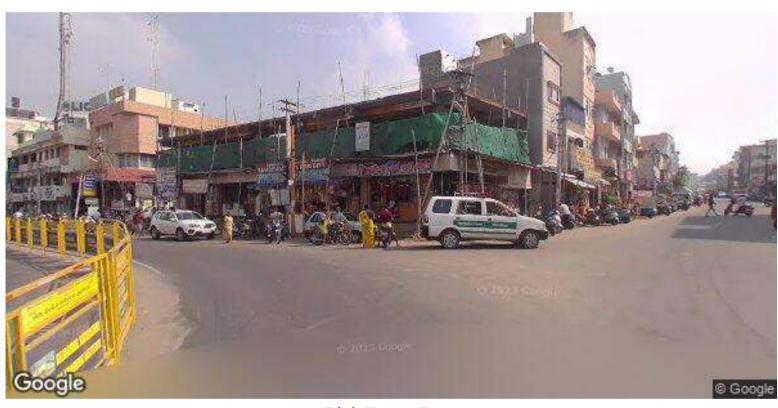
Coordinates: 11.37868, 77.89498

Risk Type: Turn
Risk Level: High
Speed Limit: 15 KM/Hr

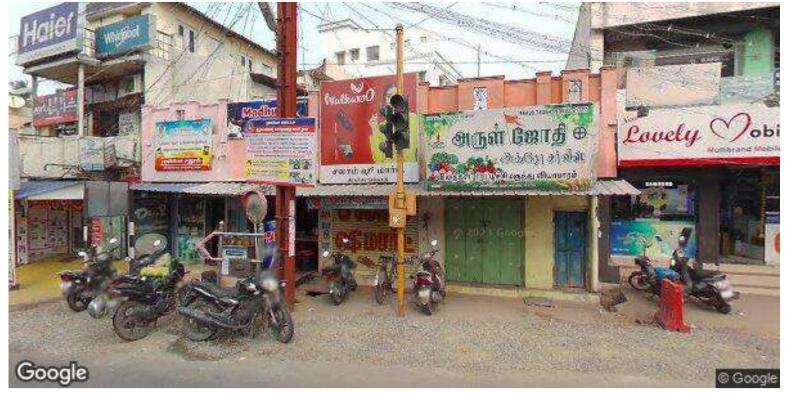
Coordinates: 11.37850, 77.89453

Risk Type: Turn
Risk Level: High
Speed Limit: 15 KM/Hr

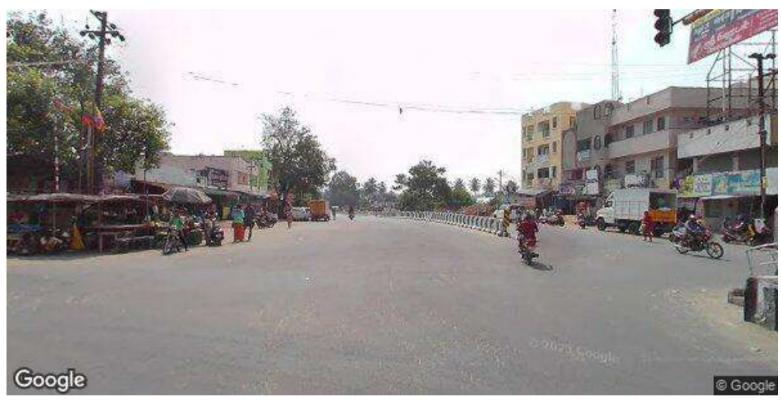
Coordinates: 11.36604, 77.88887

Risk Type: Turn
Risk Level: High
Speed Limit: 15 KM/Hr

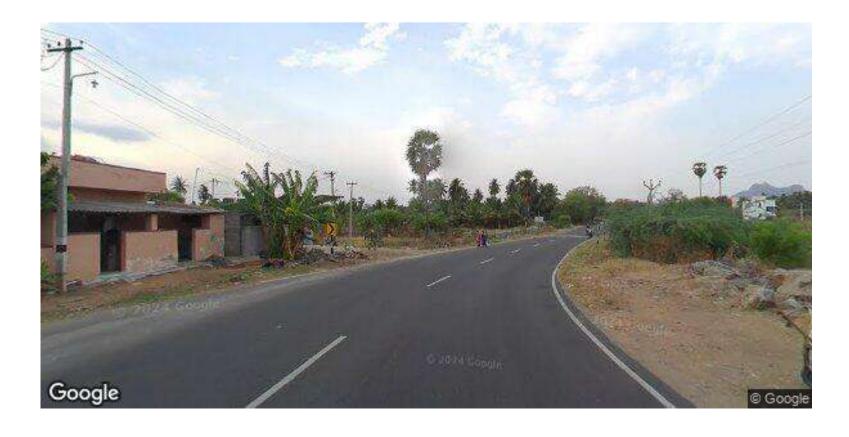
Coordinates: 11.33882, 77.86218

Risk Type: Turn
Risk Level: Medium
Speed Limit: 30 KM/Hr

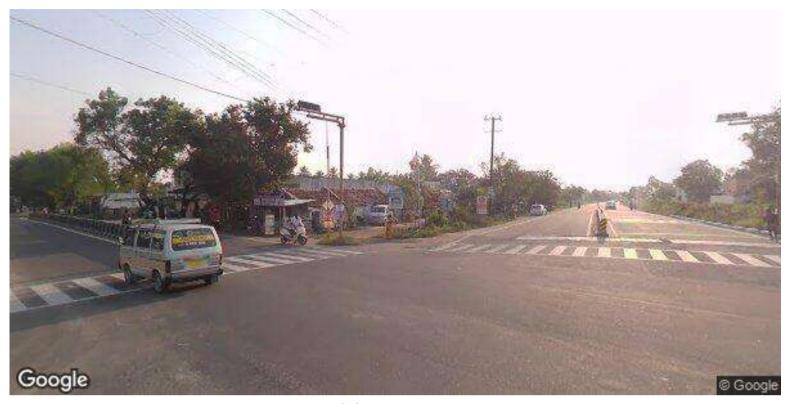
Risk Type: Turn
Risk Level: High
Speed Limit: 15 KM/Hr
Coordinates: 11.29899, 77.75806

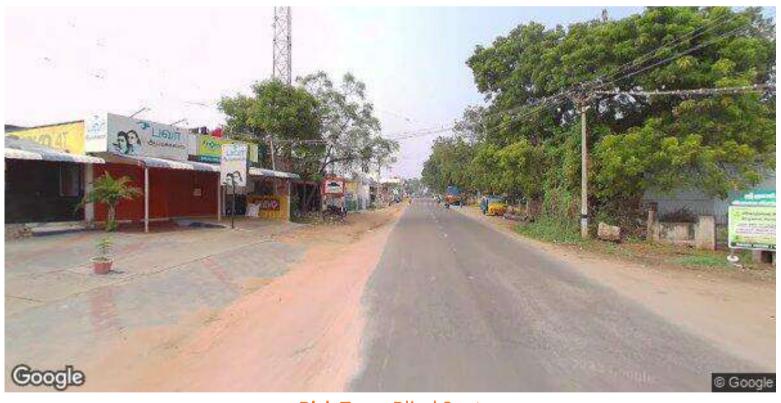
Coordinates: 11.23890, 77.77738

Risk Type: Blind Spot Risk Level: Blind Spot Speed Limit: 10 KM/Hr

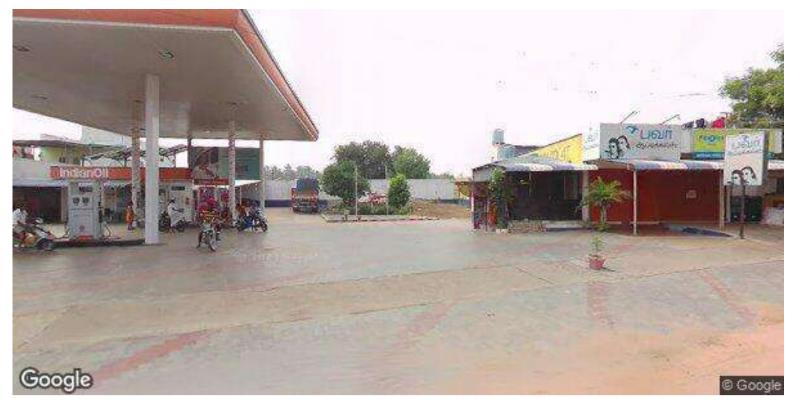
Risk Type: Turn
Risk Level: Medium
Speed Limit: 30 KM/Hr
Coordinates: 11.23890, 77.77725

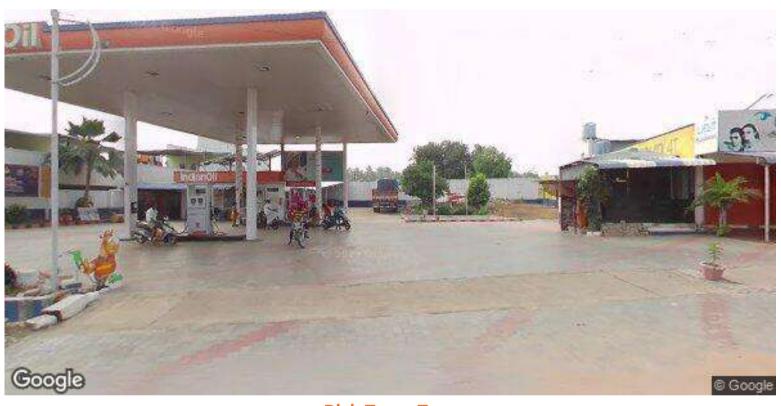
Coordinates: 11.23887, 77.77720

Risk Type: Turn
Risk Level: Medium
Speed Limit: 30 KM/Hr
