JOURNEY RISK MANAGEMENT (JRM) STUDY

Salem Terminal To SREE PALANIVEL TRADERS

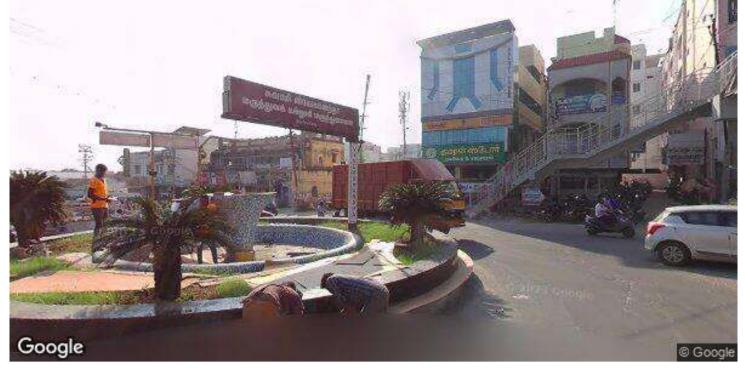
Risk Type: Roundabout
Risk Level: High
Speed Limit: 15 KM/Hr
Coordinates: 11.38395, 77.89480

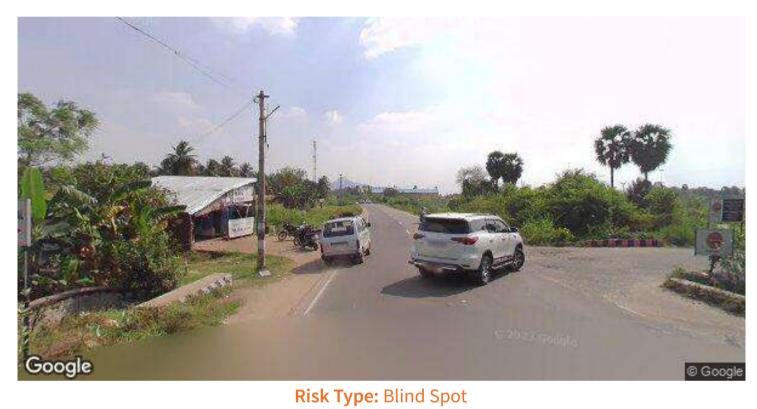
Risk Level: Blind Spot
Speed Limit: 10 KM/Hr
Coordinates: 11.44029, 77.87544

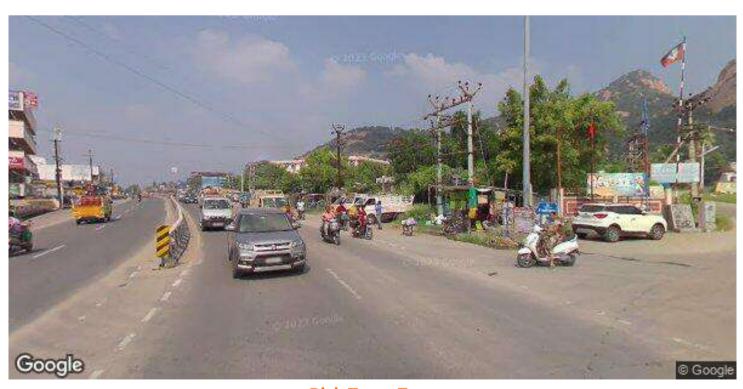
Risk Type: Turn
Risk Level: Medium

Speed Limit: 30 KM/Hr Coordinates: 11.39671, 77.88878

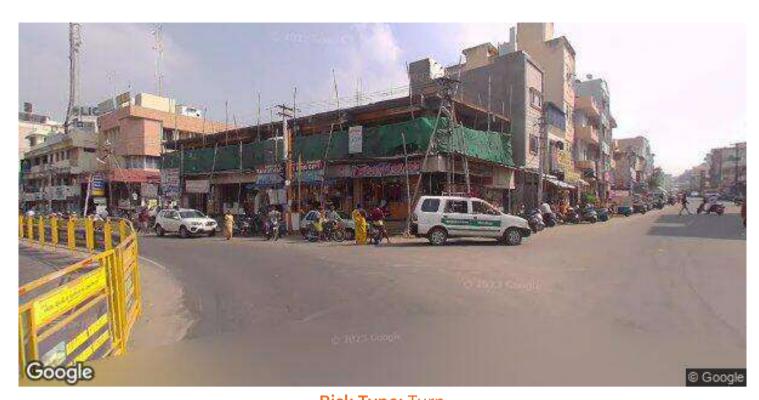
Risk Type: Turn
Risk Level: High
Speed Limit: 15 KM/Hr
Coordinates: 11.37868, 77.89498

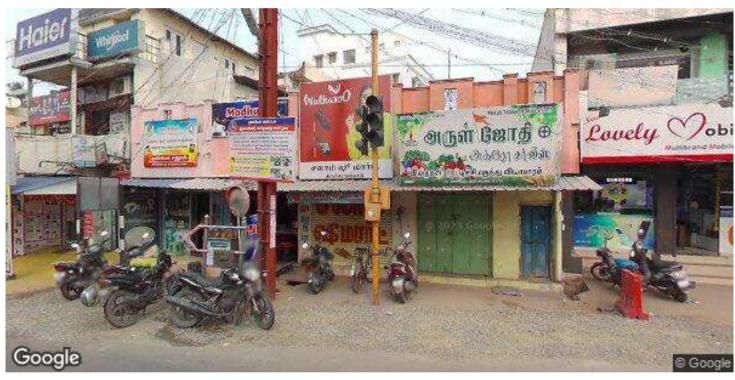
Risk Type: Turn
Risk Level: High
Speed Limit: 15 KM/Hr
Coordinates: 11.37850, 77.89453

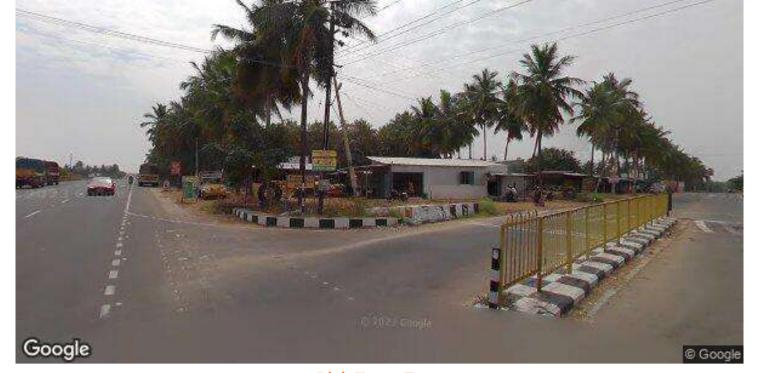
Risk Type: Turn
Risk Level: High
Speed Limit: 15 KM/Hr
Coordinates: 11.30859, 77.92918

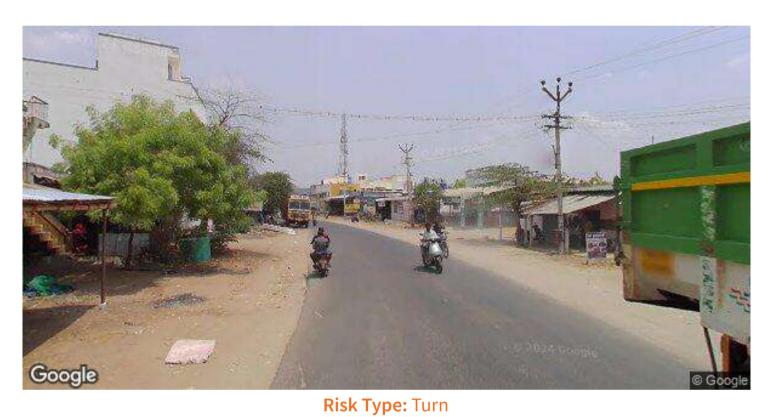
Risk Level: Medium
Speed Limit: 30 KM/Hr
Coordinates: 11.24192, 77.87363

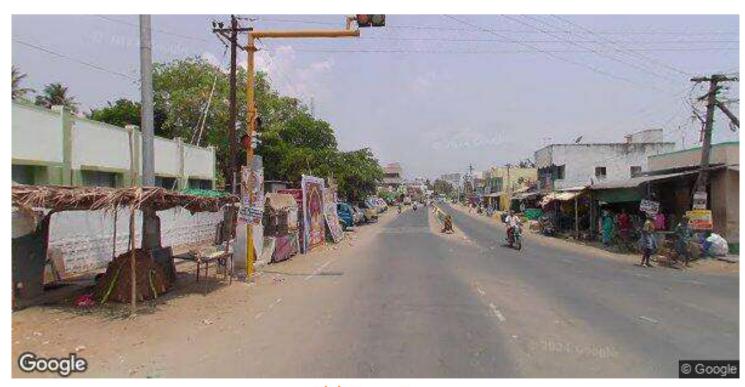
Risk Type: Turn Risk Level: High

Speed Limit: 15 KM/Hr Coordinates: 11.24001, 77.87368

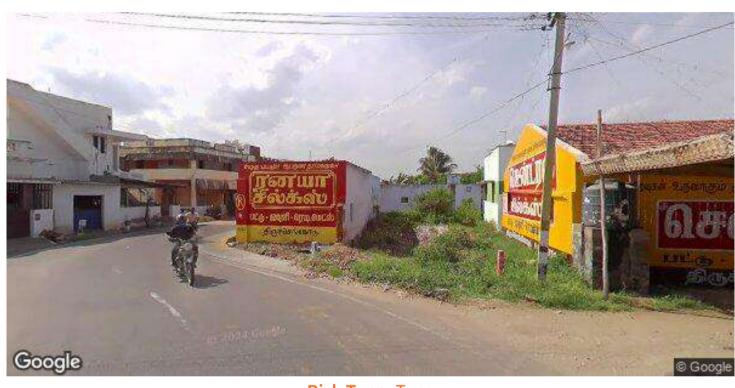
Risk Type: Turn
Risk Level: Medium
Speed Limit: 30 KM/Hr
Coordinates: 11.24111, 77.86893

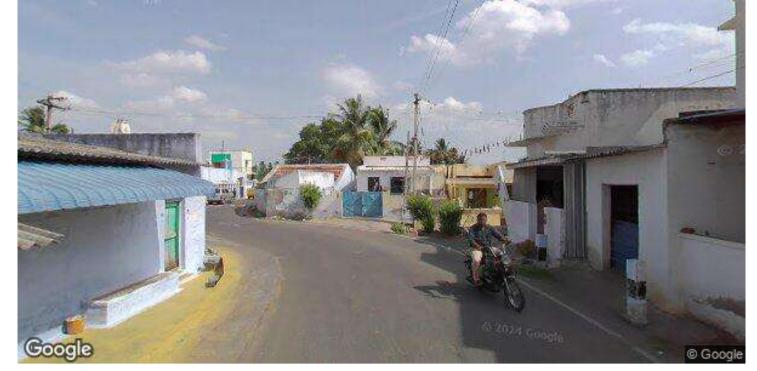
Risk Type: Turn
Risk Level: Medium
Speed Limit: 30 KM/Hr
Coordinates: 11.24127, 77.86879

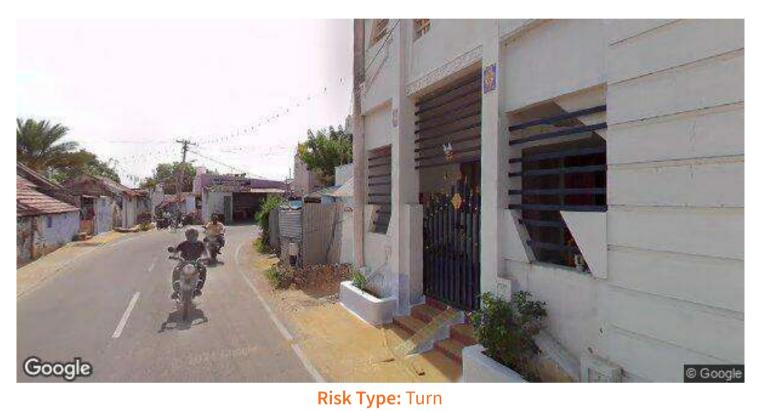
Risk Level: High
Speed Limit: 15 KM/Hr
Coordinates: 11.24157, 77.86876

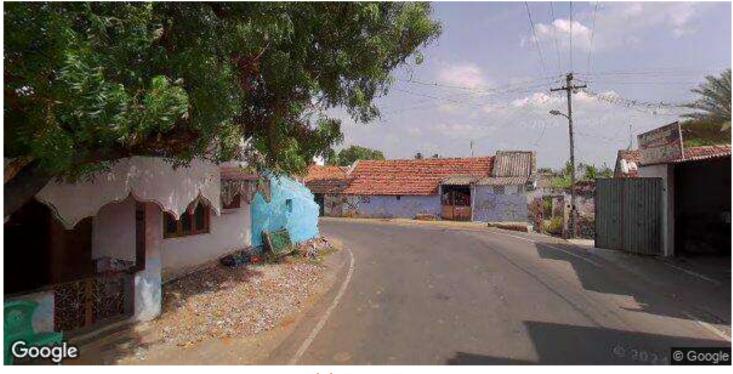
Risk Type: Turn Risk Level: High

Speed Limit: 15 KM/Hr Coordinates: 11.24167, 77.86843

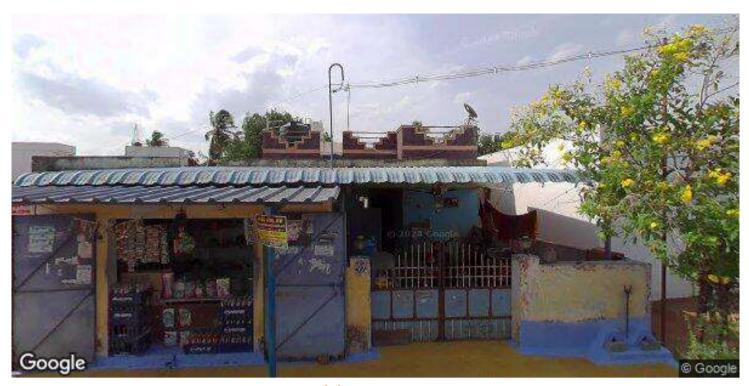
Risk Type: Turn
Risk Level: High
Speed Limit: 15 KM/Hr
Coordinates: 11.24242, 77.86833

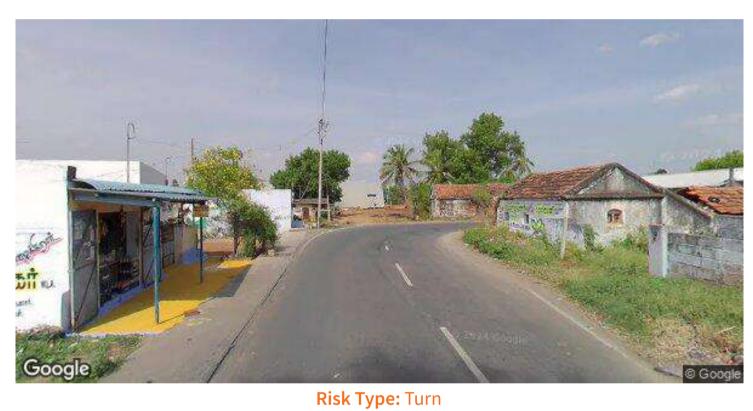
Risk Level: Medium
Speed Limit: 30 KM/Hr
Coordinates: 11.24249, 77.86820

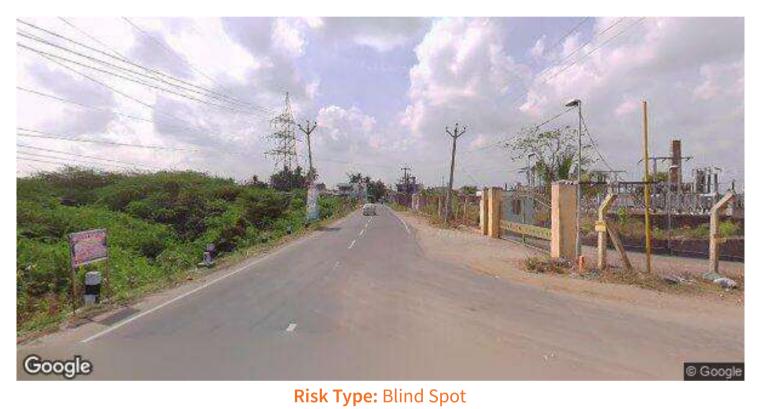
Risk Level: Blind Spot
Speed Limit: 10 KM/Hr
Coordinates: 11.24384, 77.86689

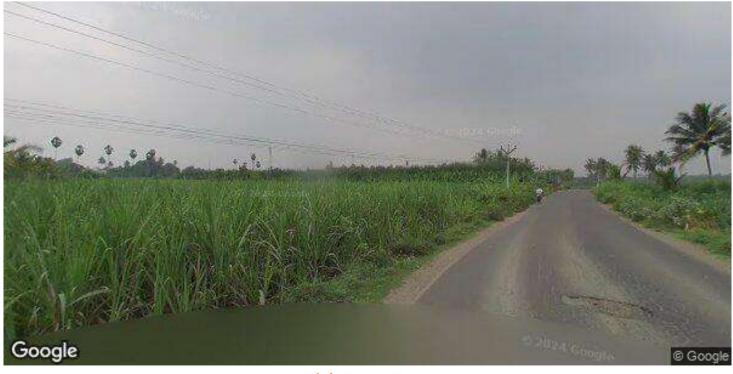
Risk Type: Turn Risk Level: High

Speed Limit: 15 KM/Hr Coordinates: 11.24101, 77.86023

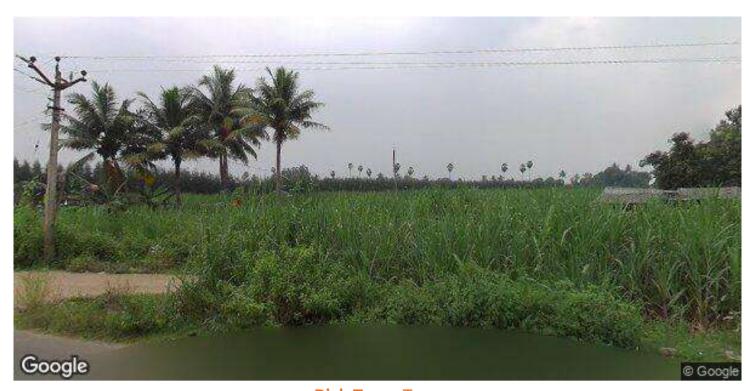
Risk Type: Turn
Risk Level: Medium
Speed Limit: 30 KM/Hr
Coordinates: 11.24195, 77.85907

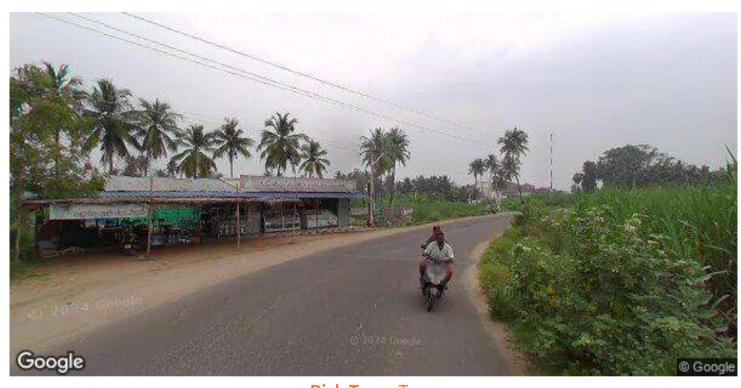
Risk Type: Turn
Risk Level: Medium
Speed Limit: 30 KM/Hr

Coordinates: 11.24198, 77.85860

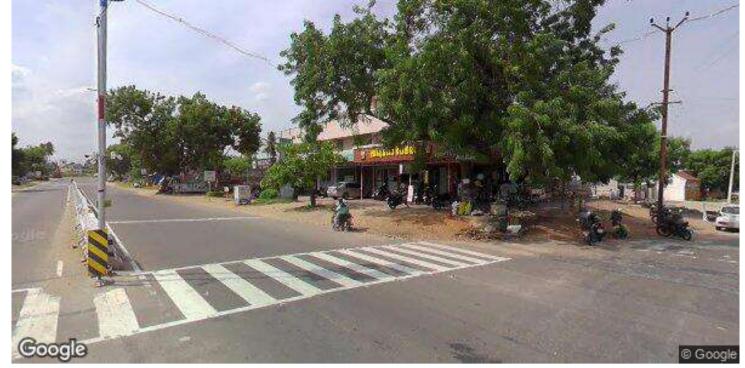
Risk Type: Turn
Risk Level: High
Speed Limit: 15 KM/Hr

Coordinates: 11.22377, 77.83980

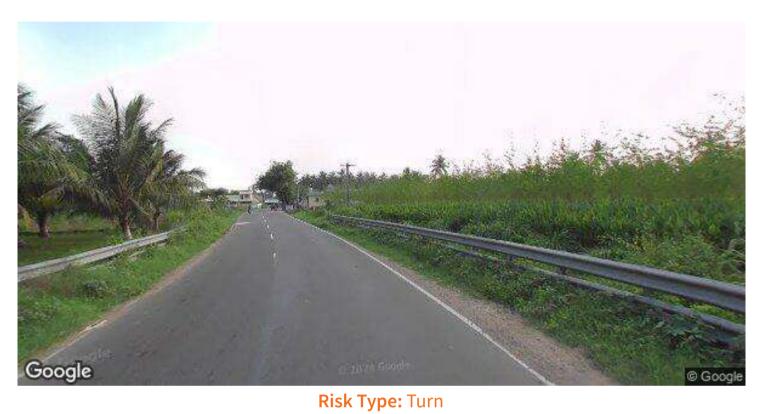
Risk Level: Medium
Speed Limit: 30 KM/Hr
Coordinates: 11.12703, 77.85401

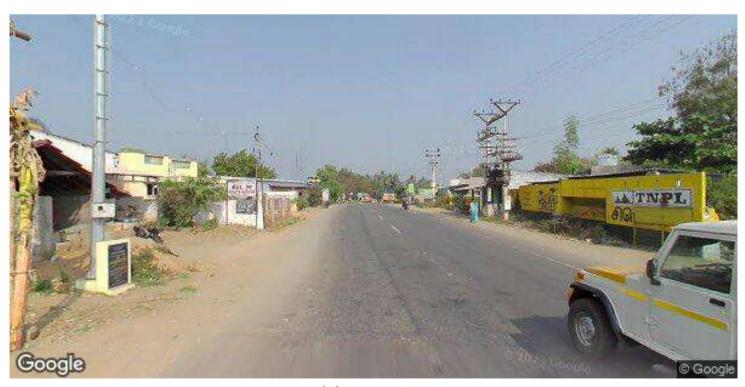
Risk Type: Turn Risk Level: High

Speed Limit: 15 KM/Hr

Coordinates: 11.07882, 77.86529
