JOURNEY RISK MANAGEMENT (JRM) STUDY

Salem Terminal To SRI KRISHNA AGENCIES

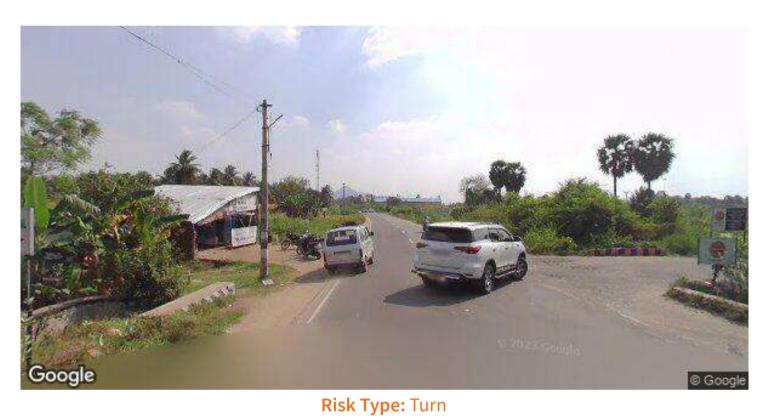
Risk Level: High
Speed Limit: 15 KM/Hr
Coordinates: 11.44029, 77.87544

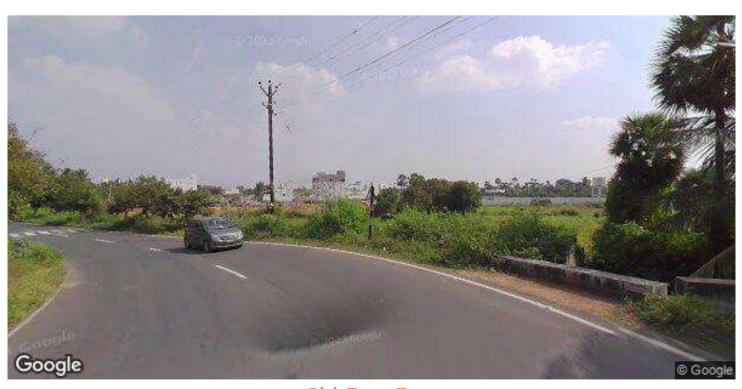
Risk Type: Turn
Risk Level: Medium

Speed Limit: 30 KM/Hr Coordinates: 11.45350, 77.85700

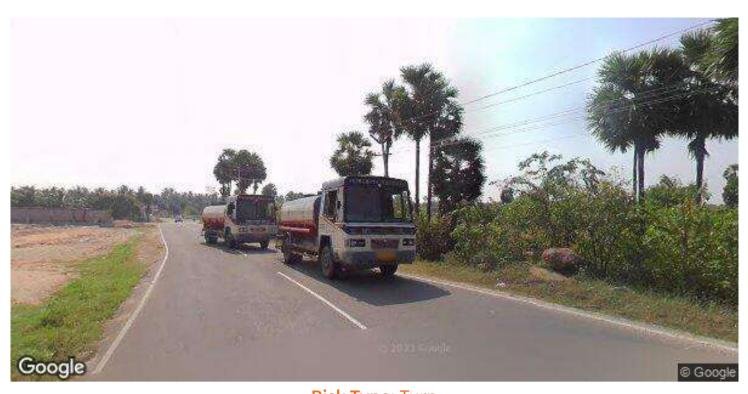
Risk Type: Turn
Risk Level: Medium
Speed Limit: 30 KM/Hr
Coordinates: 11.45833, 77.85146

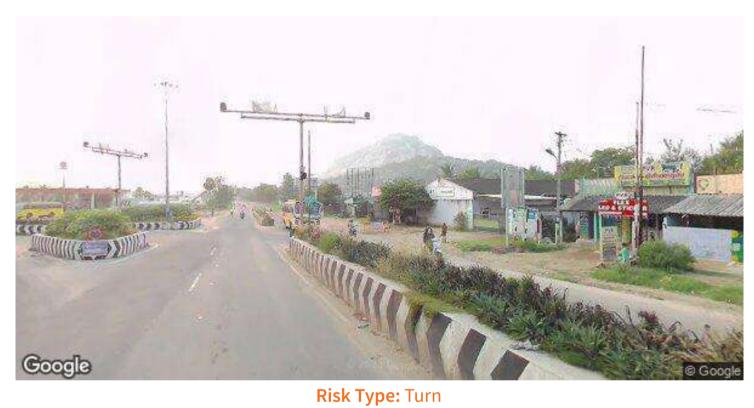
Risk Type. Turn
Risk Level: Medium
Speed Limit: 30 KM/Hr
Coordinates: 11.46312, 77.84886

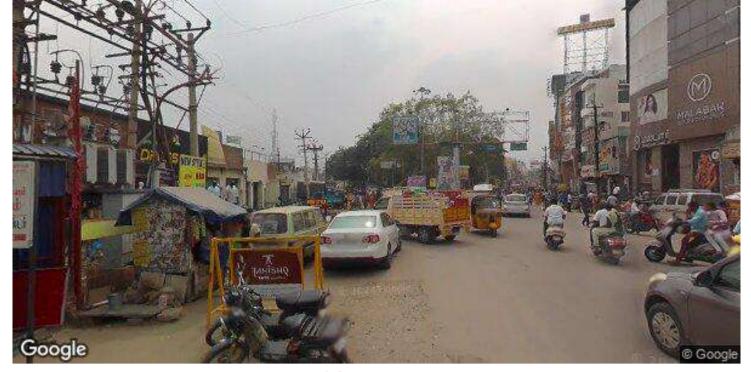
Risk Type: Turn
Risk Level: Medium
Speed Limit: 30 KM/Hr
Coordinates: 11.34493, 77.73032

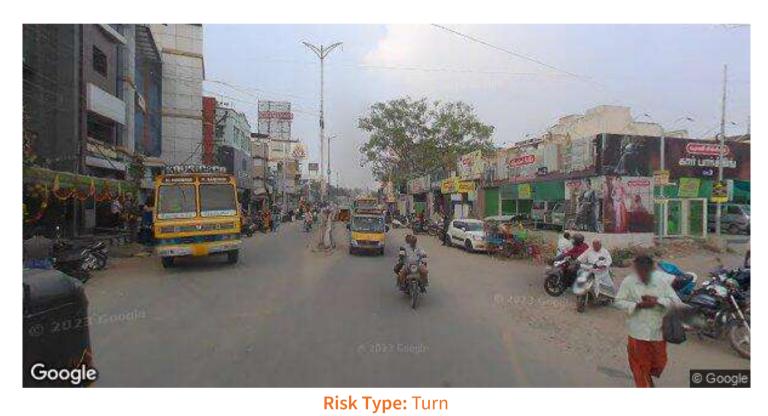
Risk Level: Medium
Speed Limit: 30 KM/Hr
Coordinates: 11.34487, 77.73024

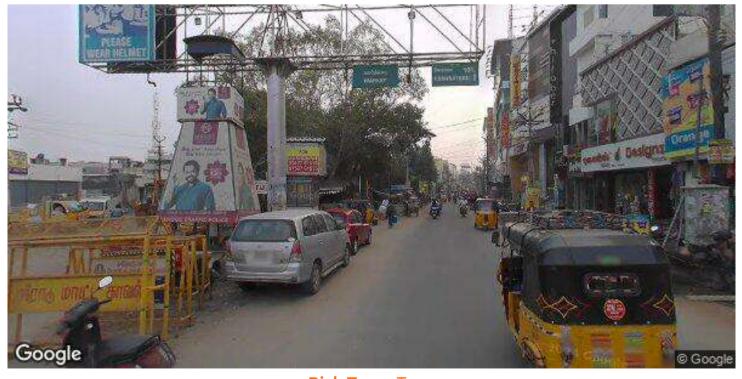
Risk Type: Turn
Risk Level: Medium

Speed Limit: 30 KM/Hr Coordinates: 11.34470, 77.73018

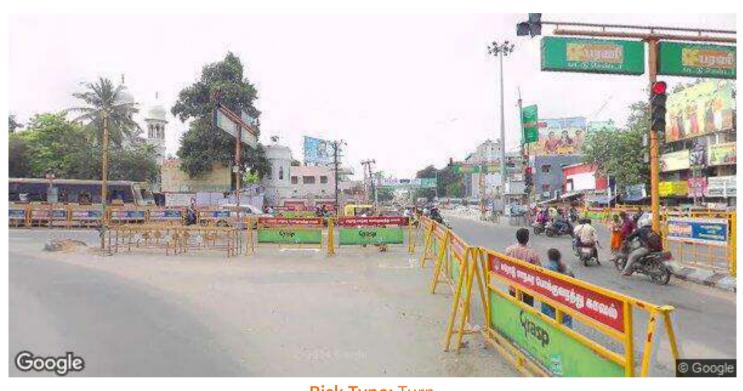
Risk Type: Turn
Risk Level: Medium
Speed Limit: 30 KM/Hr
Coordinates: 11.33914, 77.72659

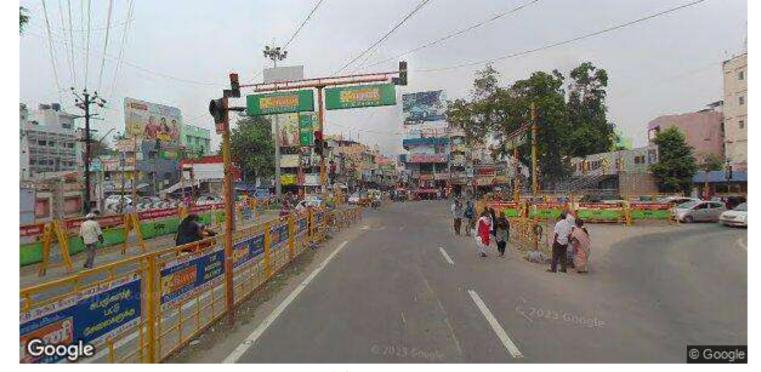
Risk Type: Turn
Risk Level: High
Speed Limit: 15 KM/Hr
Coordinates: 11.33890, 77.72637

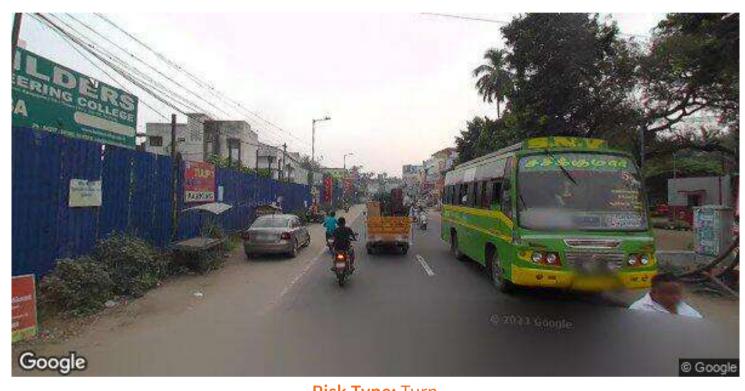
Risk Type: Turn
Risk Level: High
Speed Limit: 15 KM/Hr
Coordinates: 11.33281, 77.72755
